Fire test of 4mm Alpolic A2 cladding fixed to Aclad 4000 framing system in accordance with BS 8414.2-2015 (Amdt 1) as modified by AS 5113-2016

Test Report

Report number: FNW 7936

Client: Architectural Façade Cladding Solutions Pty Ltd

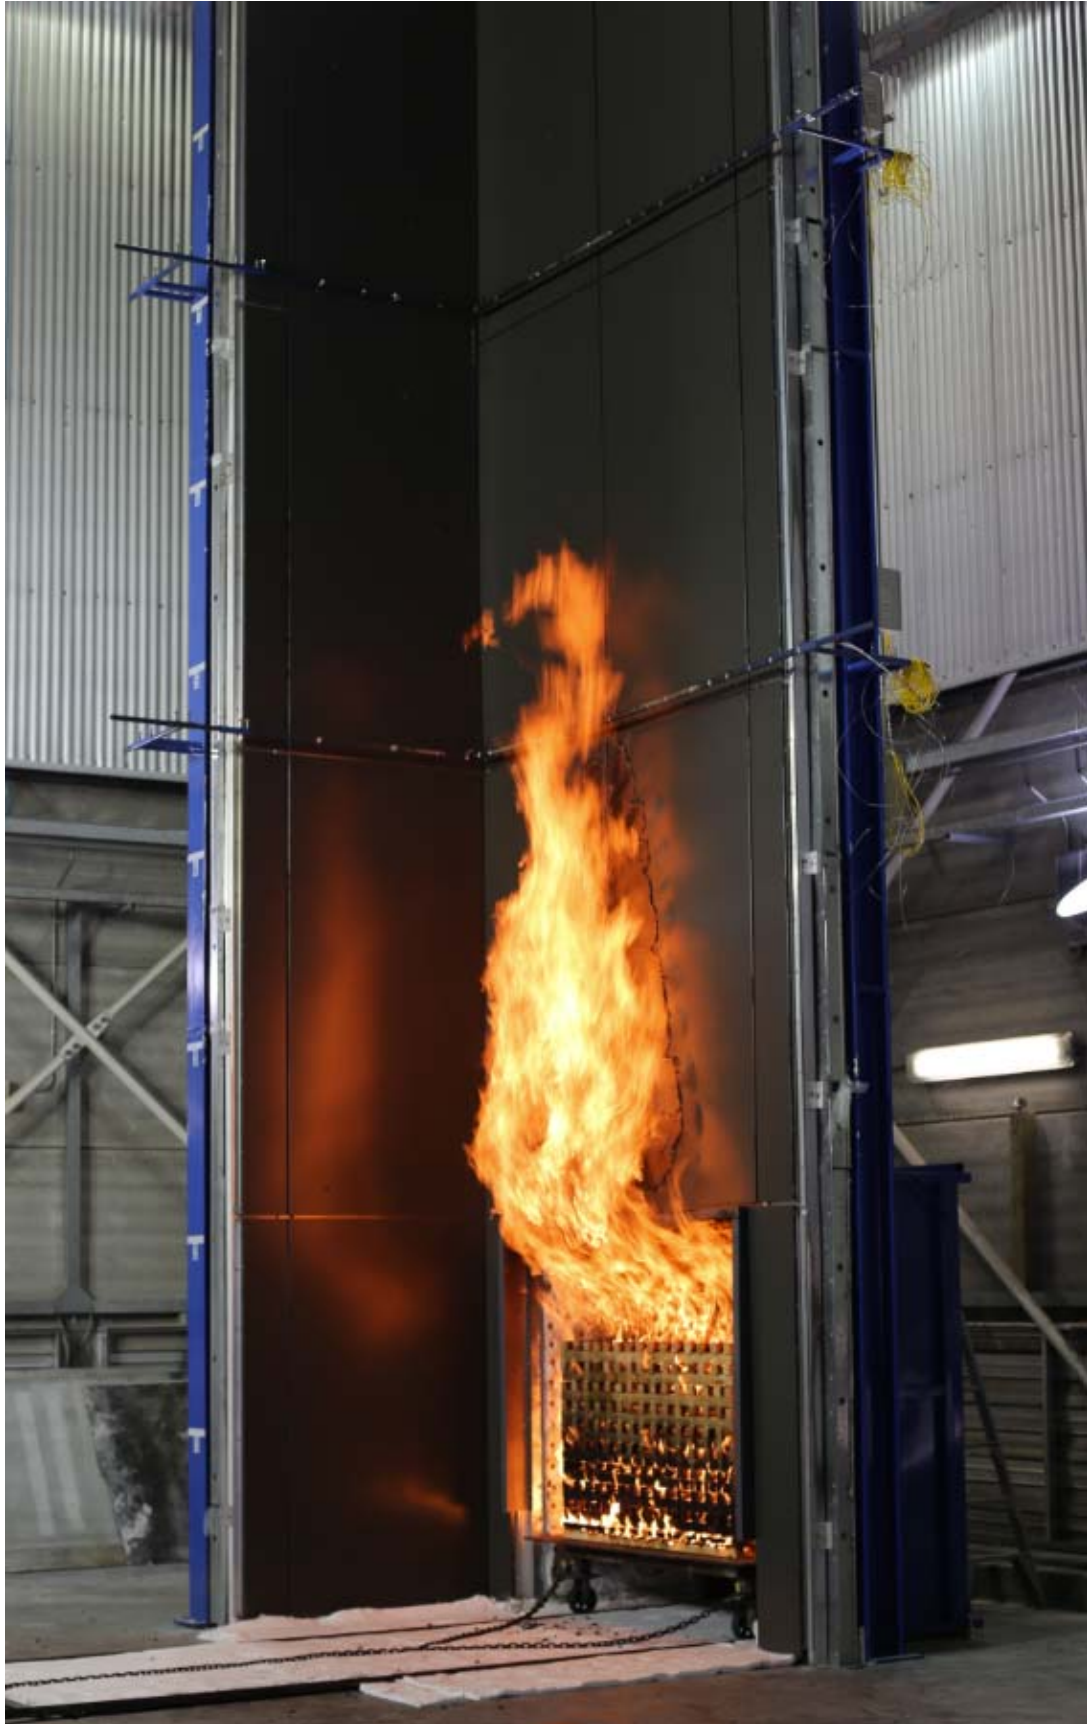
Figure C3 – Exposed face of the specimen at 3 minutes after crib ignition

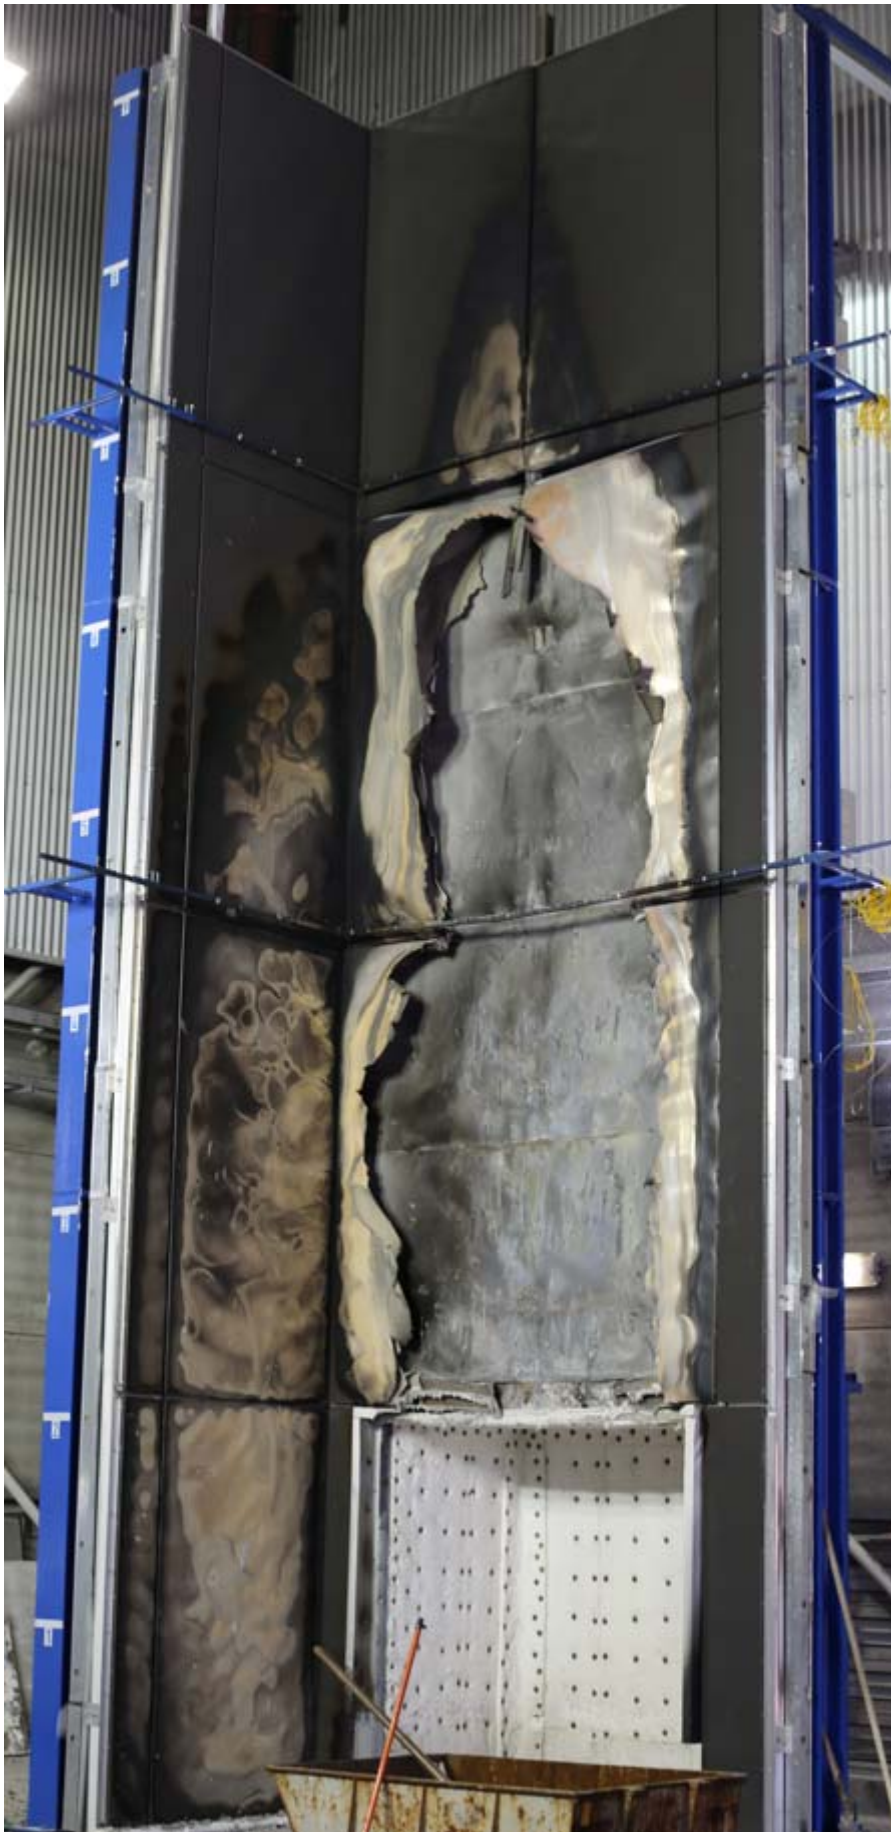
Figure C9 – Exposed face of the specimen at the conclusion of the test

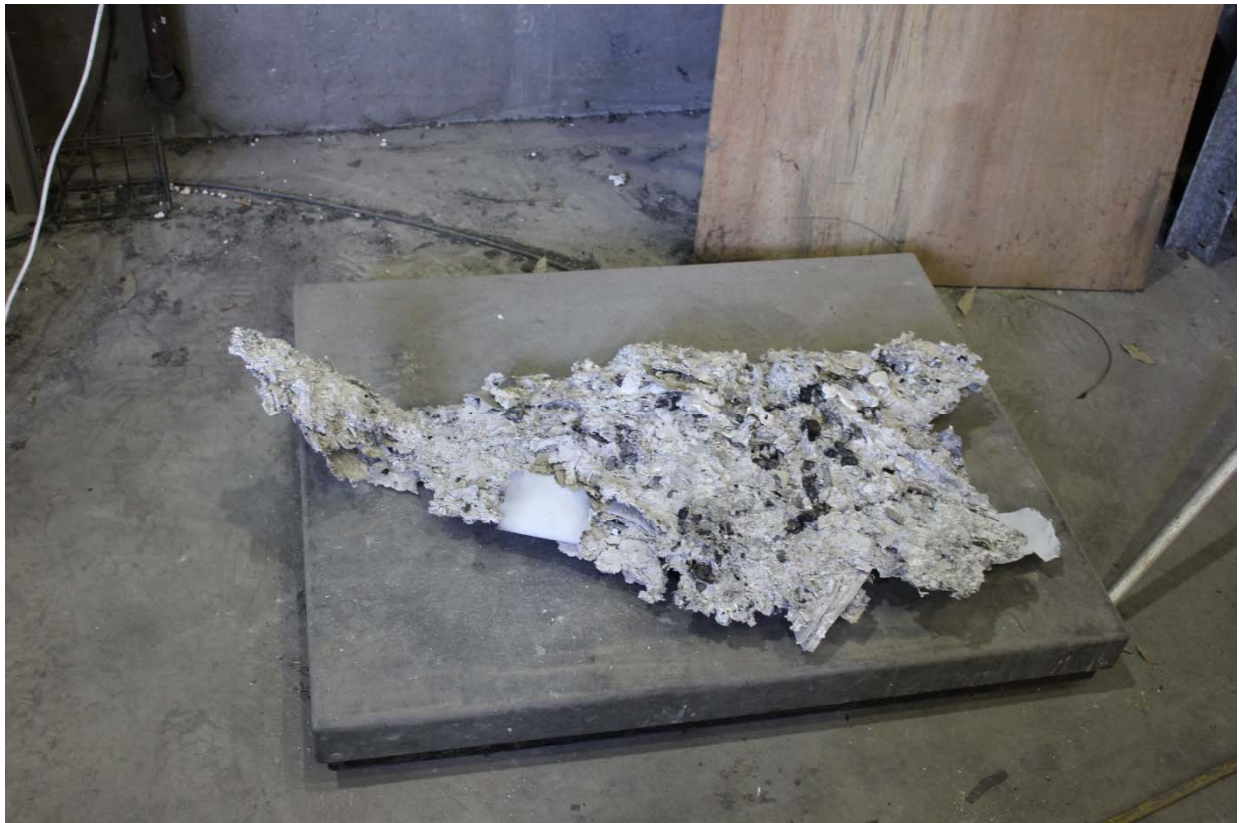
Figure C10 –Debris collected at the conclusion of the test

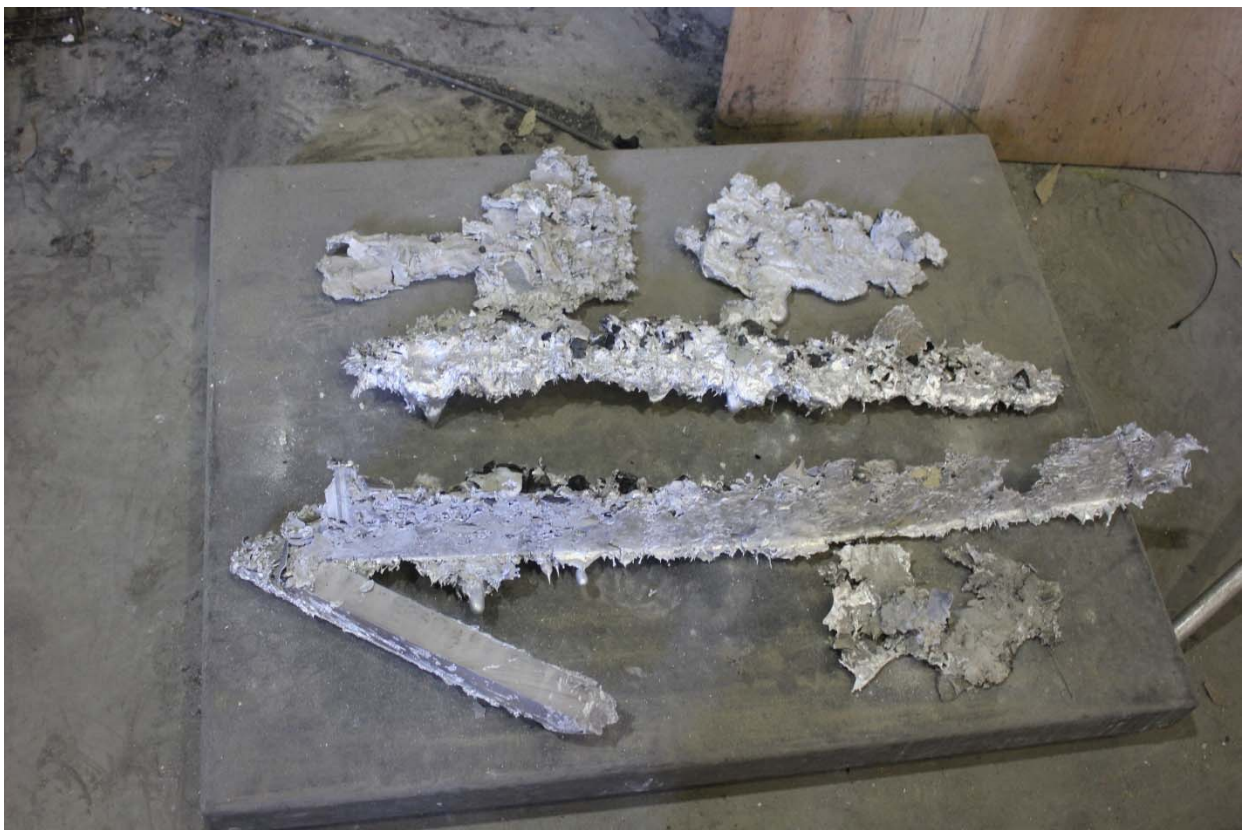
Figure C11 – Debris collected at the conclusion of the test

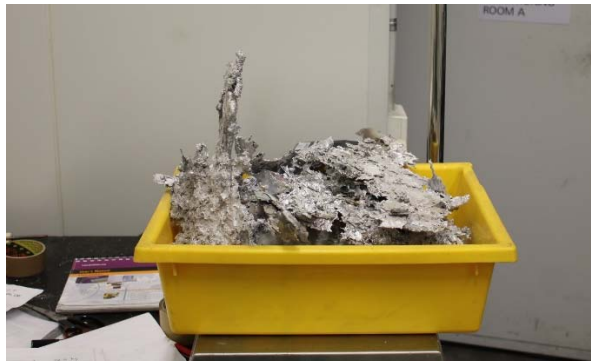
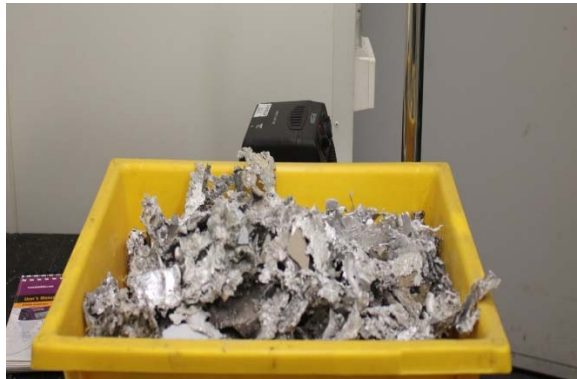
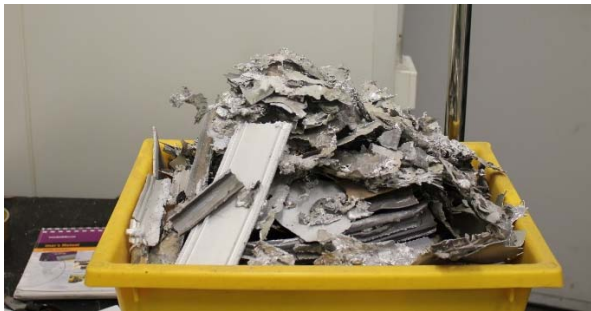
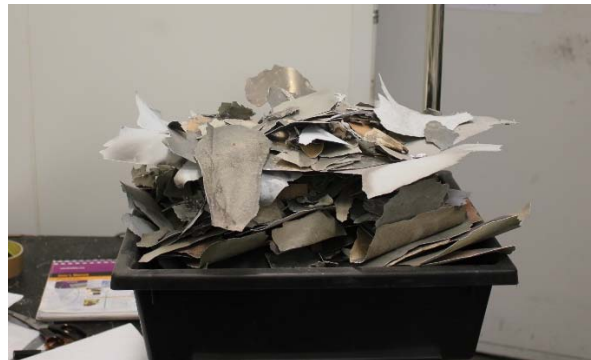
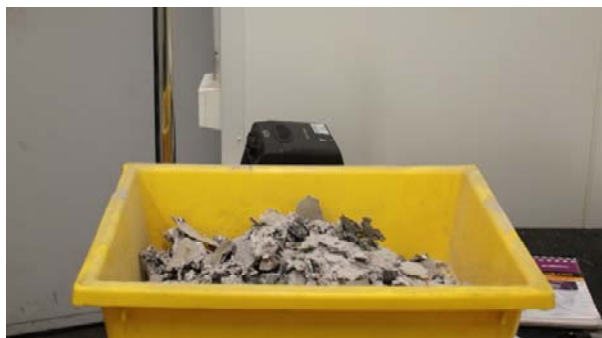
Debris	No. of fragments	Result (g)
Total mass of debris less than 100g	~710	11,353
Total mass of debris between 100g and 200g	12	1,521
Total mass of debris between 200g and 300g	3	731
Total mass of debris between 300g and 400g	0	0
Total mass of debris between 400g and 500g	1	402
Total mass of debris with a mass greater than 500g	5	32,433
The total mass of debris		46,440

Figure C12 – Debris collected at the conclusion of the test

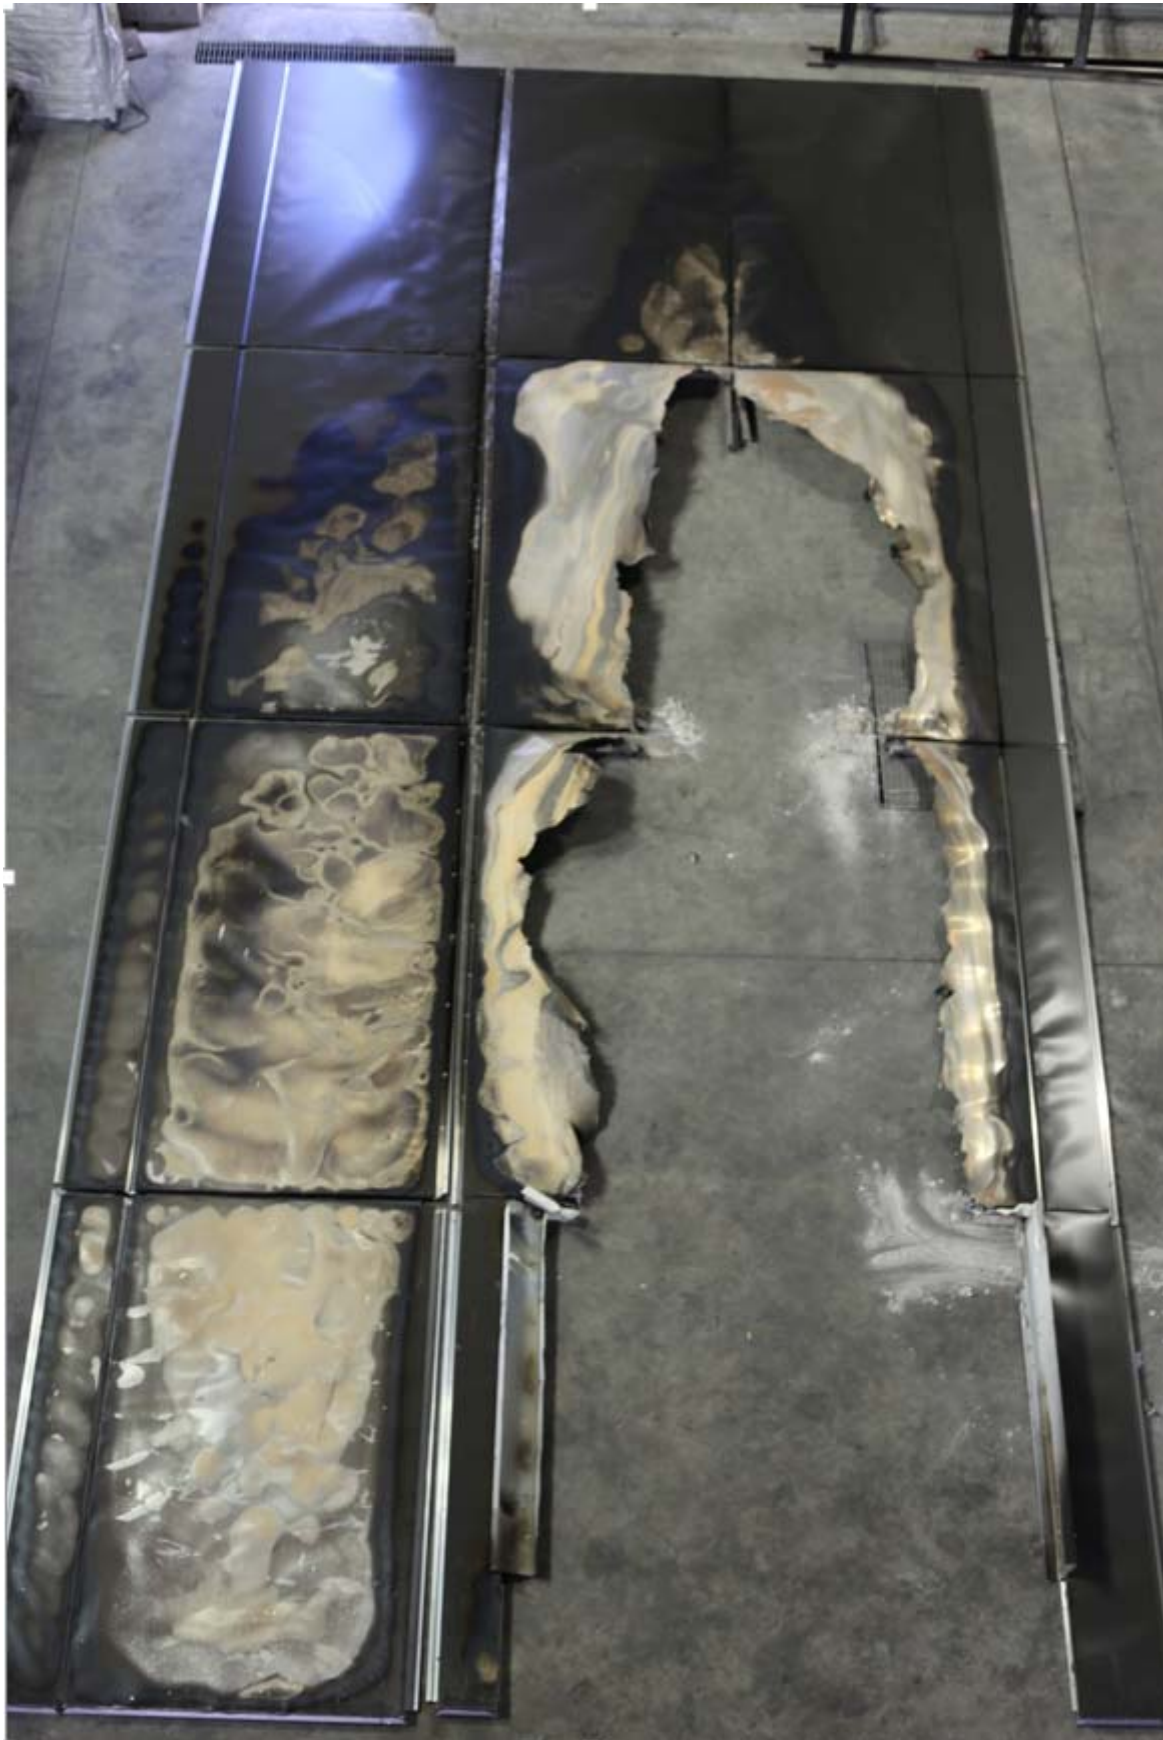
Time	Observation
Day following test	The exposed aluminium skin buckled from the core and melted, refer to Figure D1 and Figure D2 for more detail.
	The core dislodged and melted above the combustion chamber opening and along the central joint. Melting does not extend to the top of the specimen or beyond the minimum confines of the specimen on wing wall. Refer to Figure D3 and Figure D4 for more detail.
	Smoke staining and heat damage of Galvabond air seal sheet layer on the exposed side evident on the main wall above the combustion chamber. Molten aluminium also evident on the face of the air seal sheet. Refer to Figure D5 and Figure D6 for more detail.
	Smoke staining (not melting or charring) of Rockwool layer on the exposed side evident on the main wall above the combustion chamber. Refer to Figure D7 and Figure D8 for more detail.
	Localized smoke staining and charring on the exposed side of the plasterboard layer evident on the main wall above the combustion chamber. Refer to Figure D9 for more detail.

Figure D1 – Damage to the exposed aluminium skin at the conclusion of testing

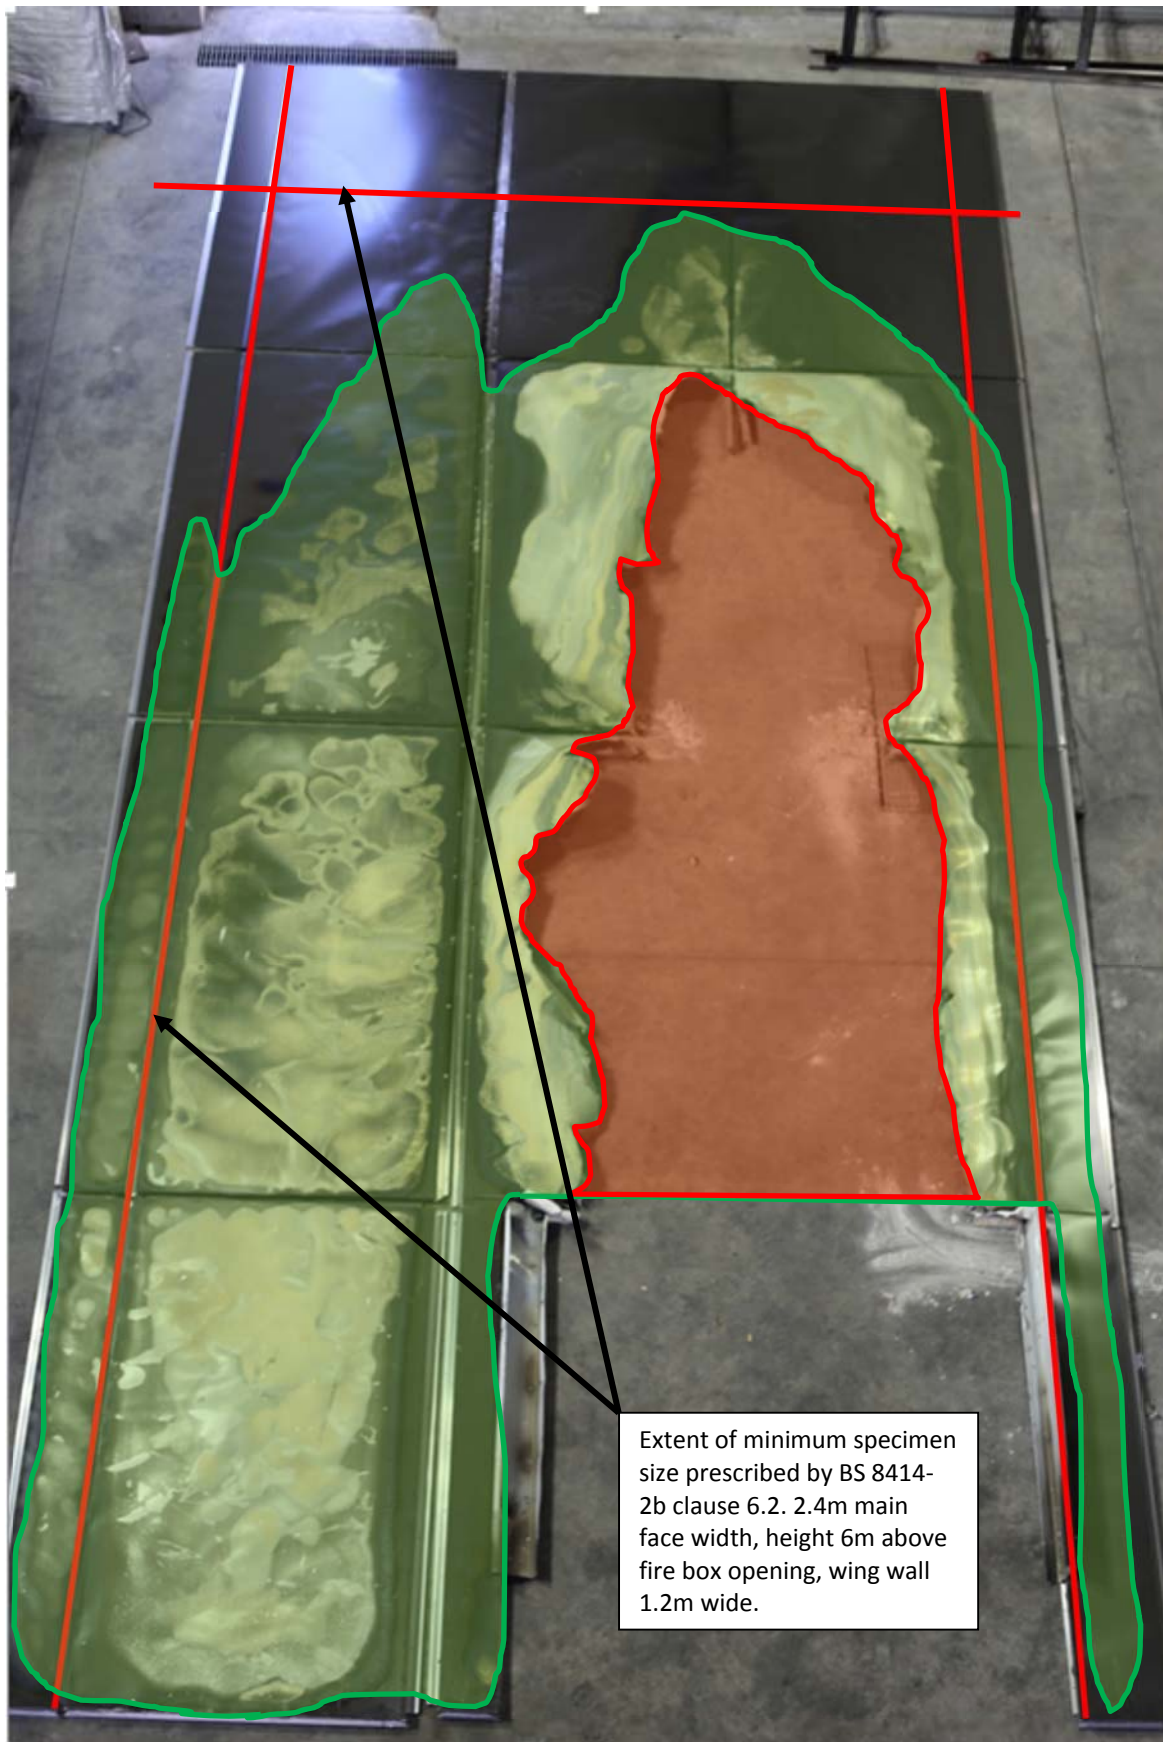
Approximate extent of the aluminium skin melted from the core

Approximate extent of the aluminium skin buckled from the core

Figure D2 – Damage of the exposed aluminium skin at the conclusion of testing

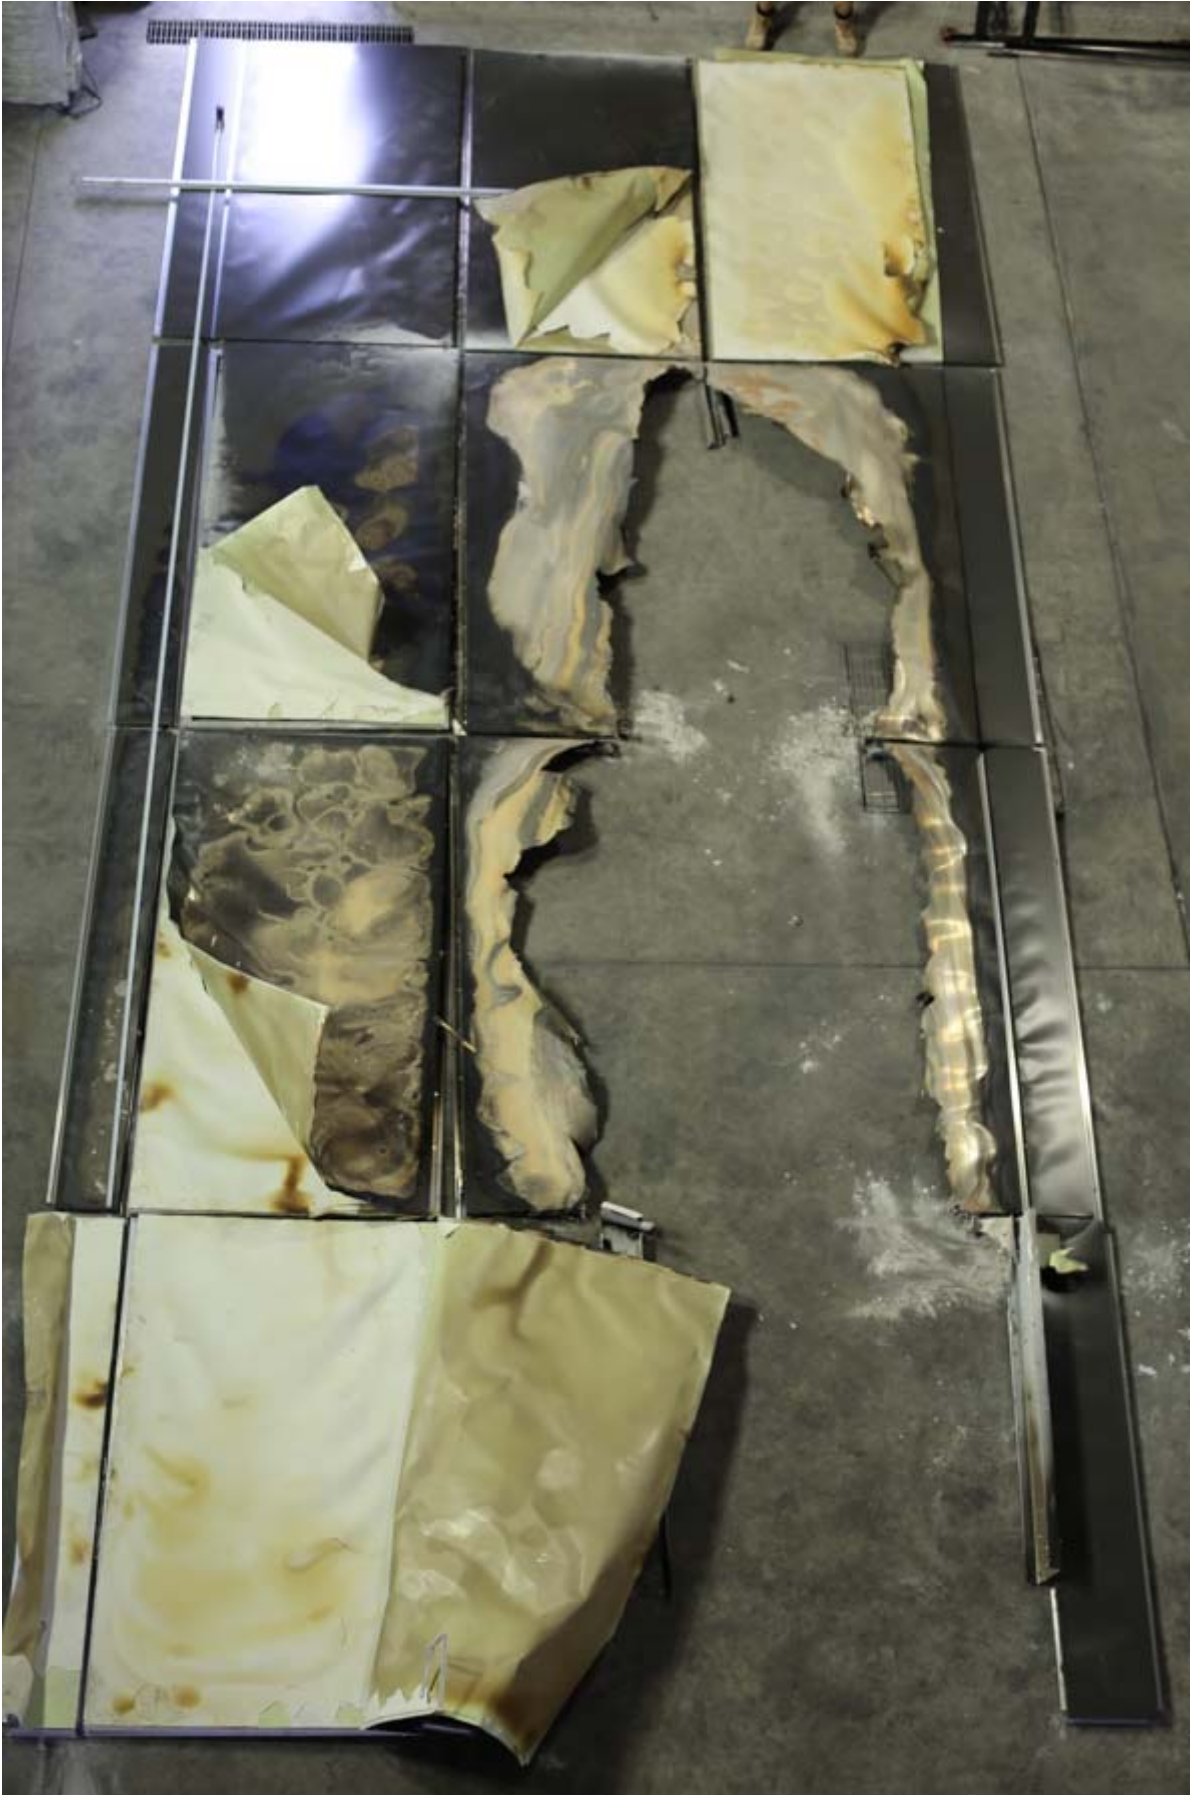
Figure D3 – Damage to the core at the conclusion of testing

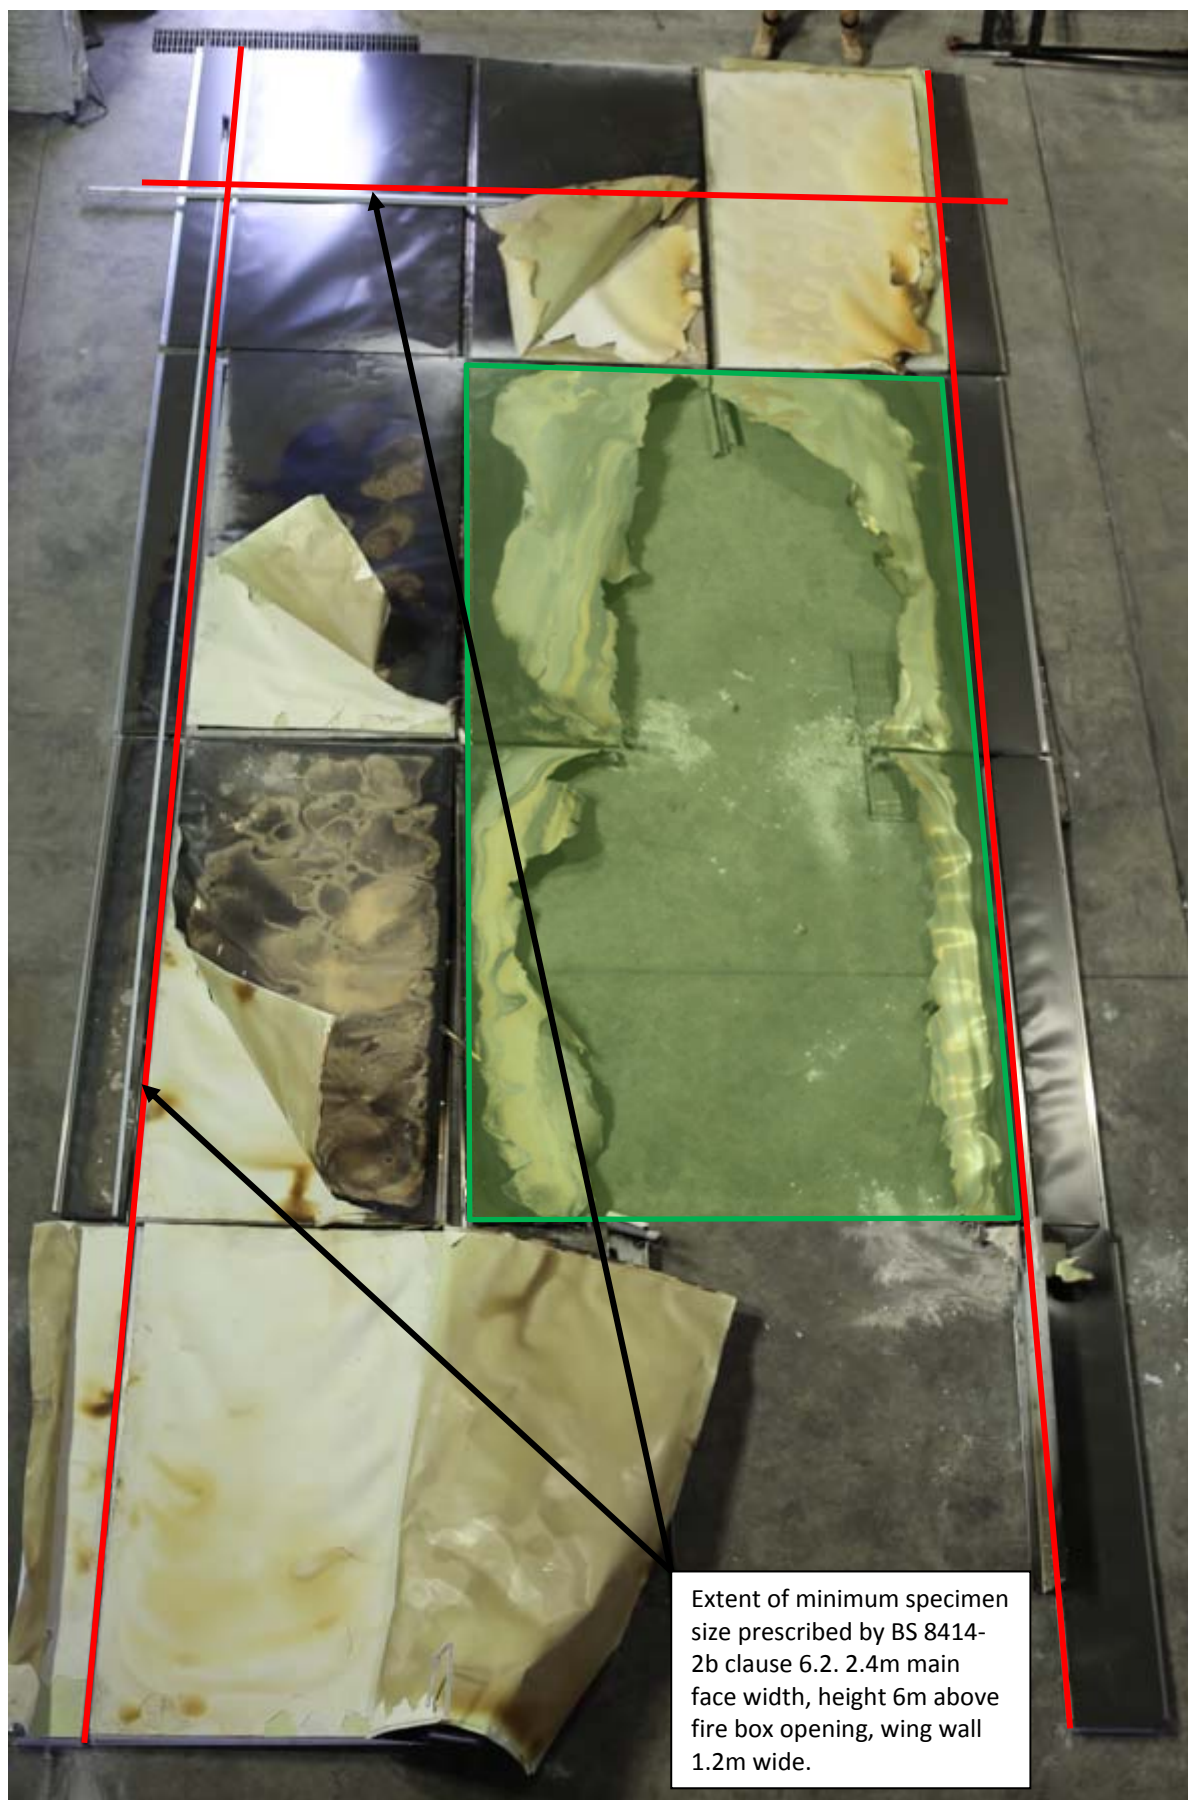
Approximate extent of the core dislodged and melted

Figure D4 – Damage to the core at the conclusion of testing

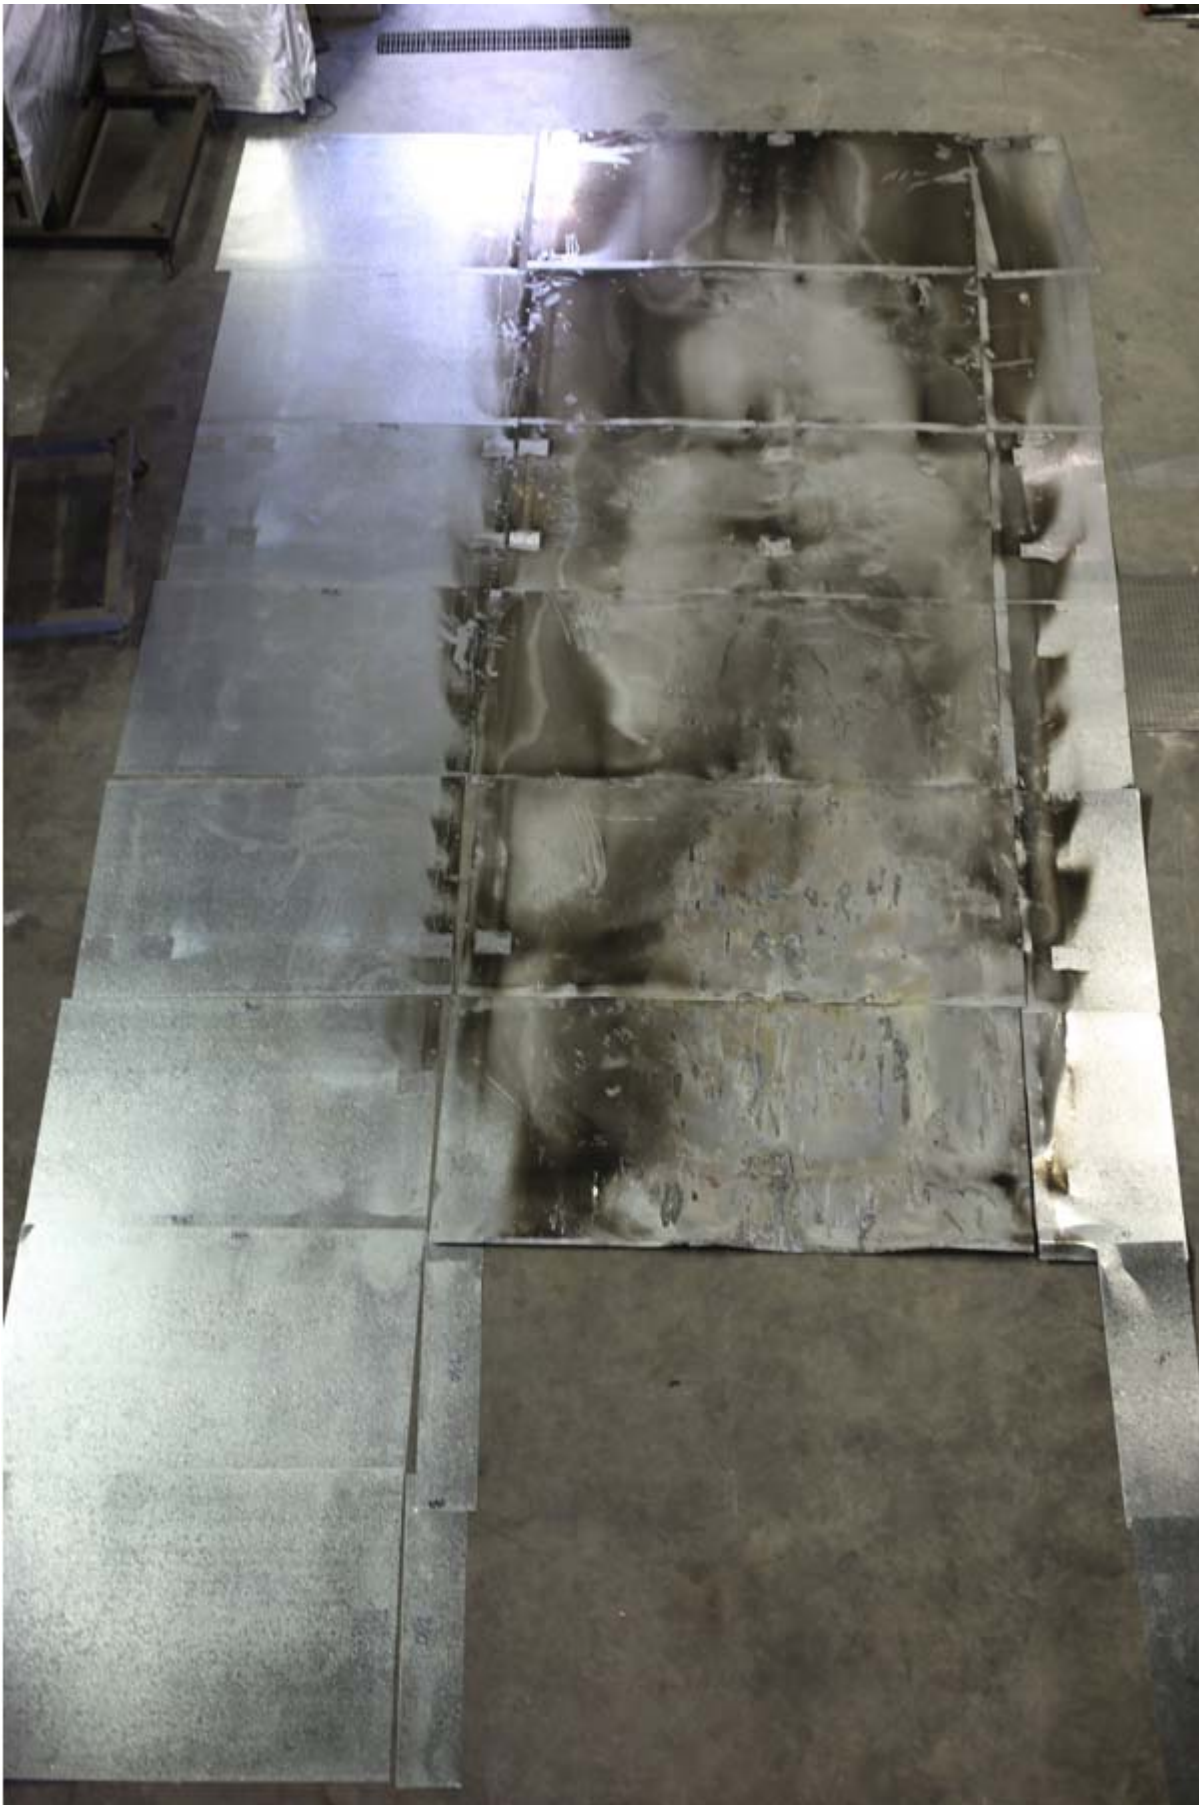
Figure D5 – Damage to the Galvabond air seal sheet layer at the conclusion of testing

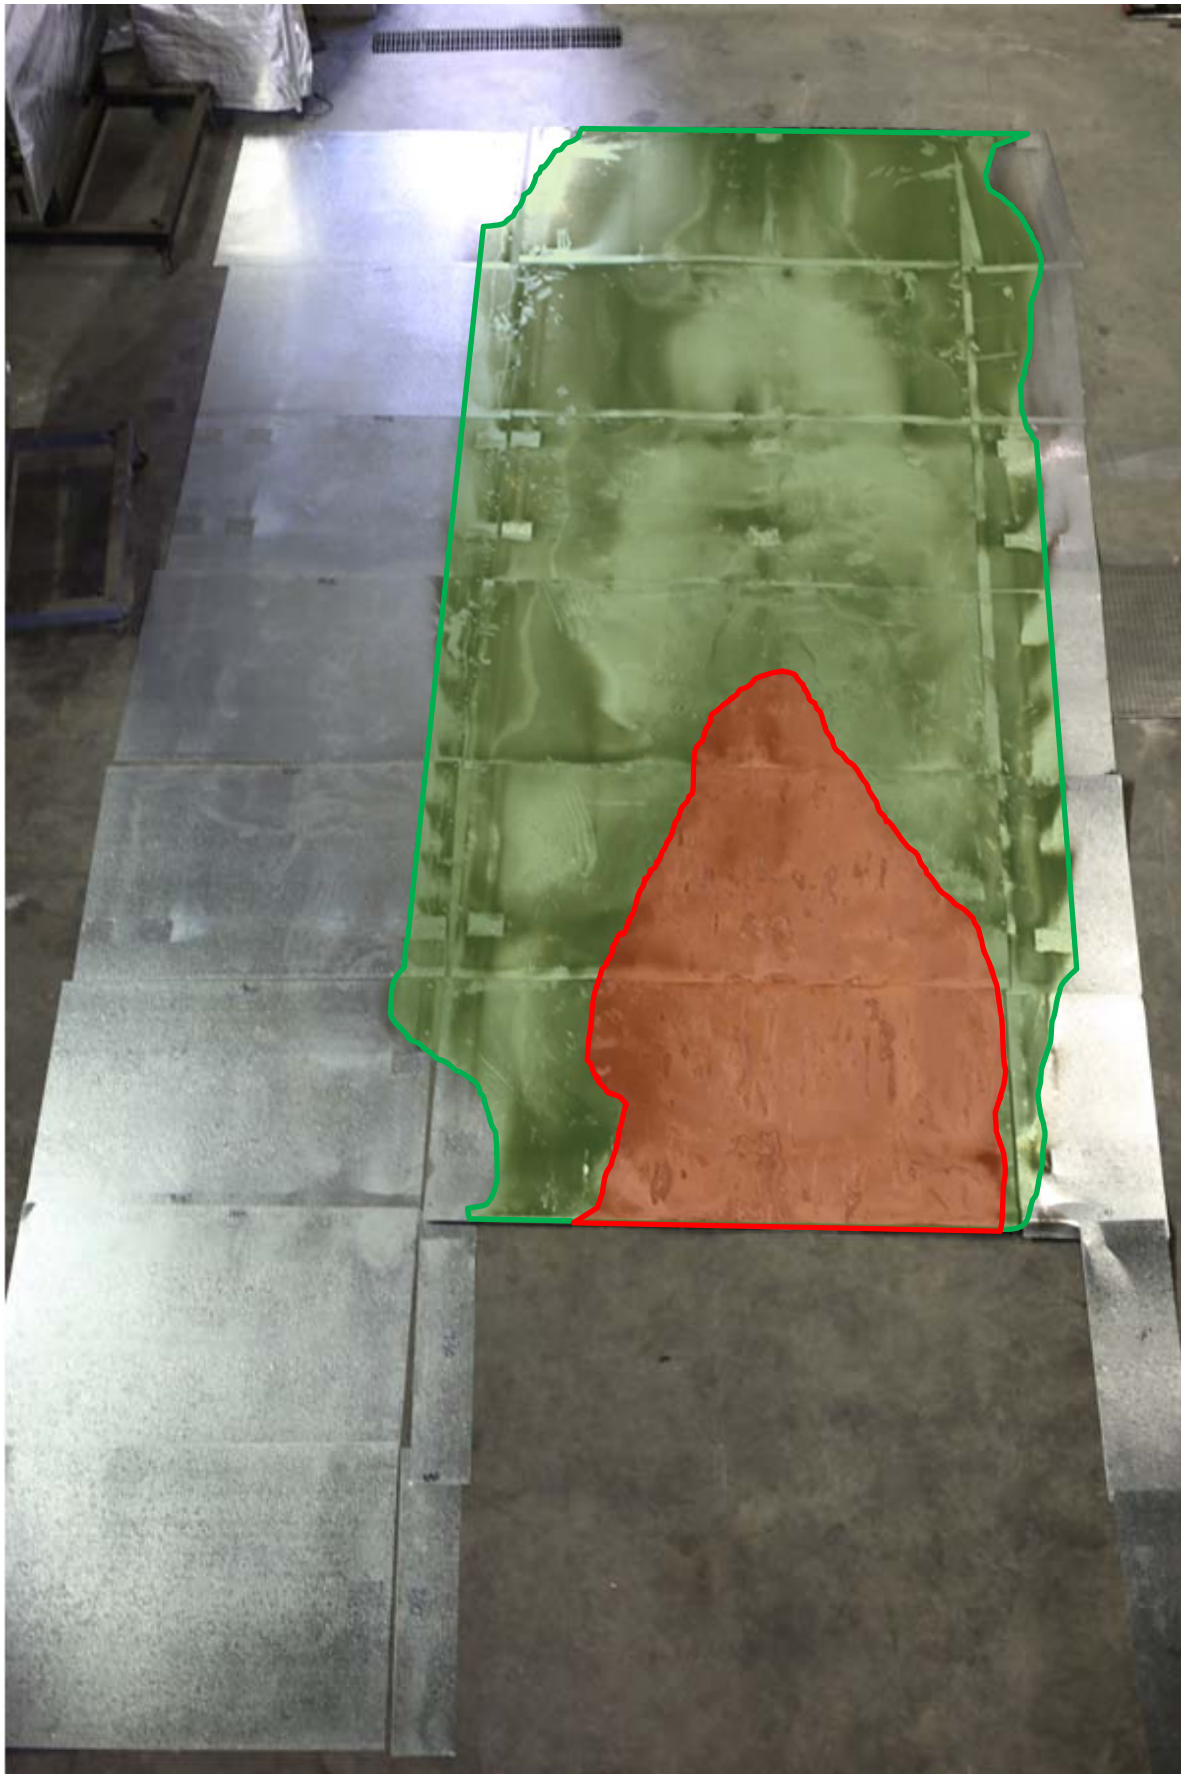
Approximate extent of the smoke staining to Galvabond air seal sheet

Approximate extent of heat damage to Galvabond air seal sheet

Figure D6 – Damage to the Galvabond air seal sheet layer at the conclusion of testing

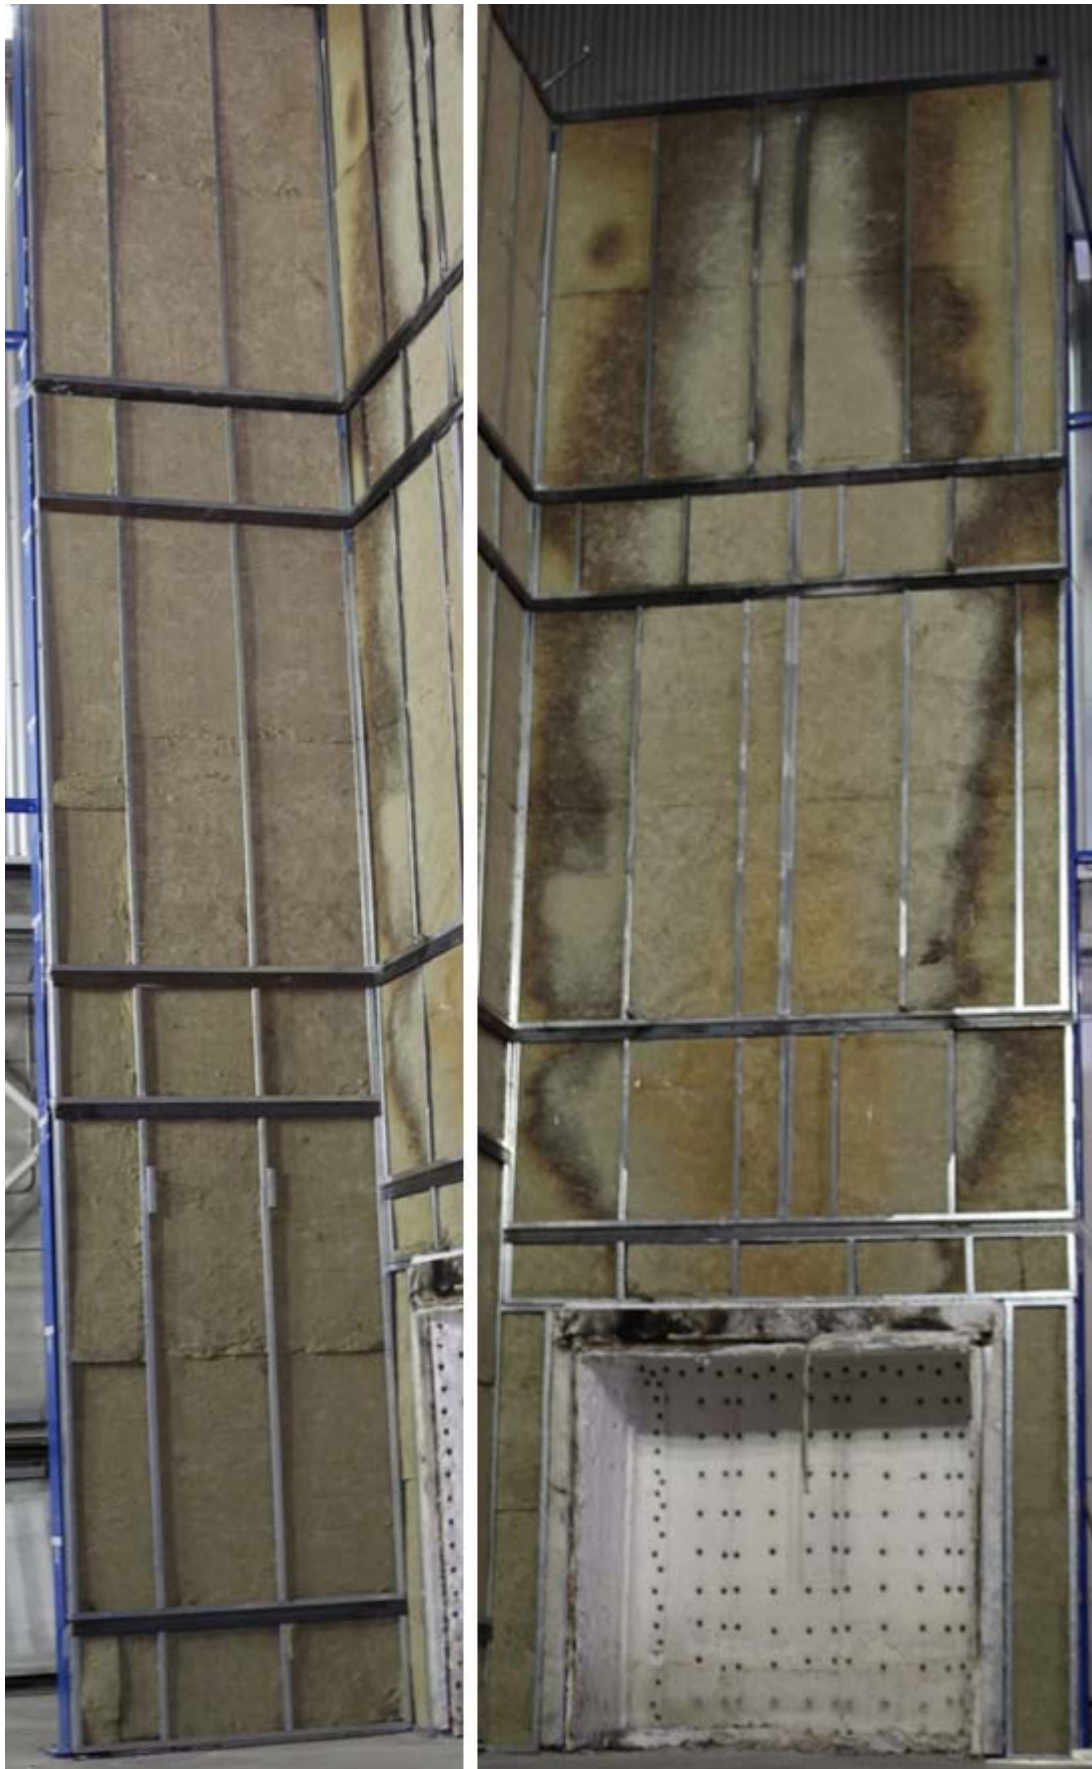
Figure D7 – Damage to the Rockwool layer at the conclusion of testing
