Fire test of 4mm Alpolic A2 cladding fixed to Aclad 4000 framing system in accordance with BS 8414.2-2015 (Amdt 1) as modified by AS 5113-2016

Test Report

Report number: FNW 7936

Client: Architectural Façade Cladding Solutions Pty Ltd

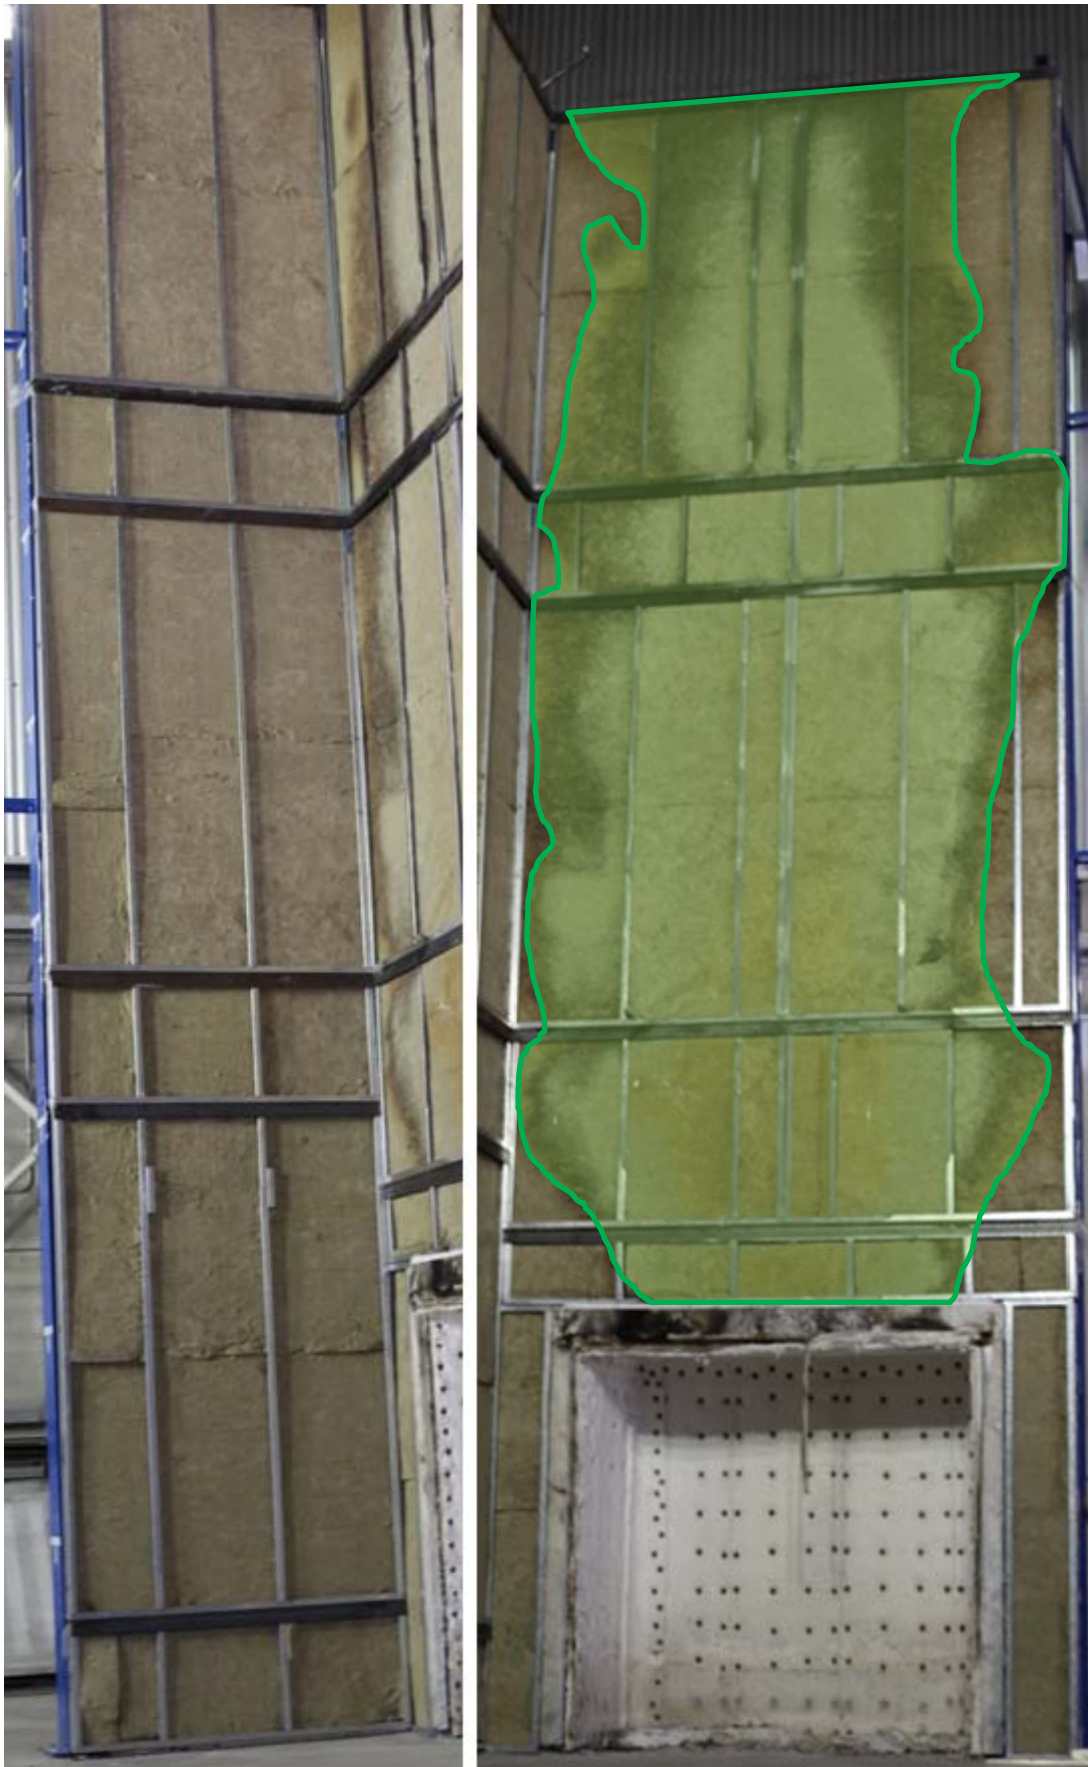
Approximate extent of smoke staining to the Rockwool layer

Figure D8 – Damage to the Rockwool layer at the conclusion of testing

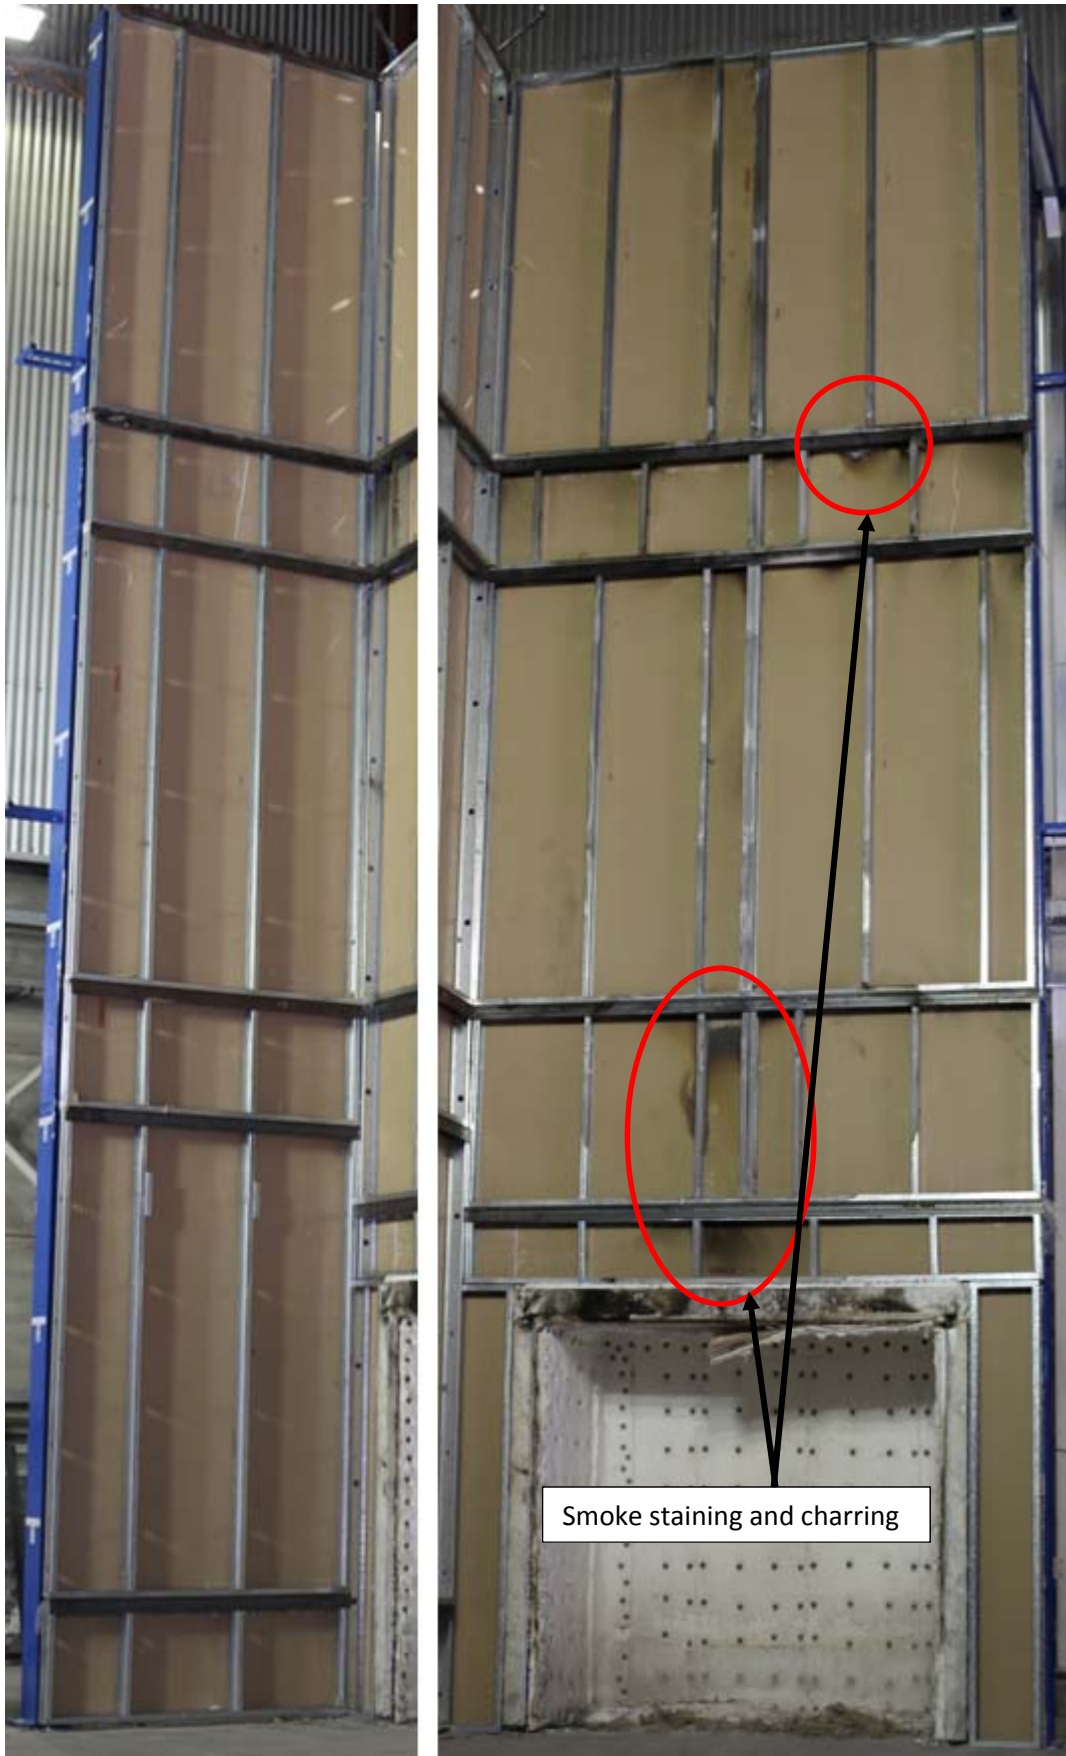
Figure D9 – Damage to the exposed side of plasterboard layer at the conclusion of testing

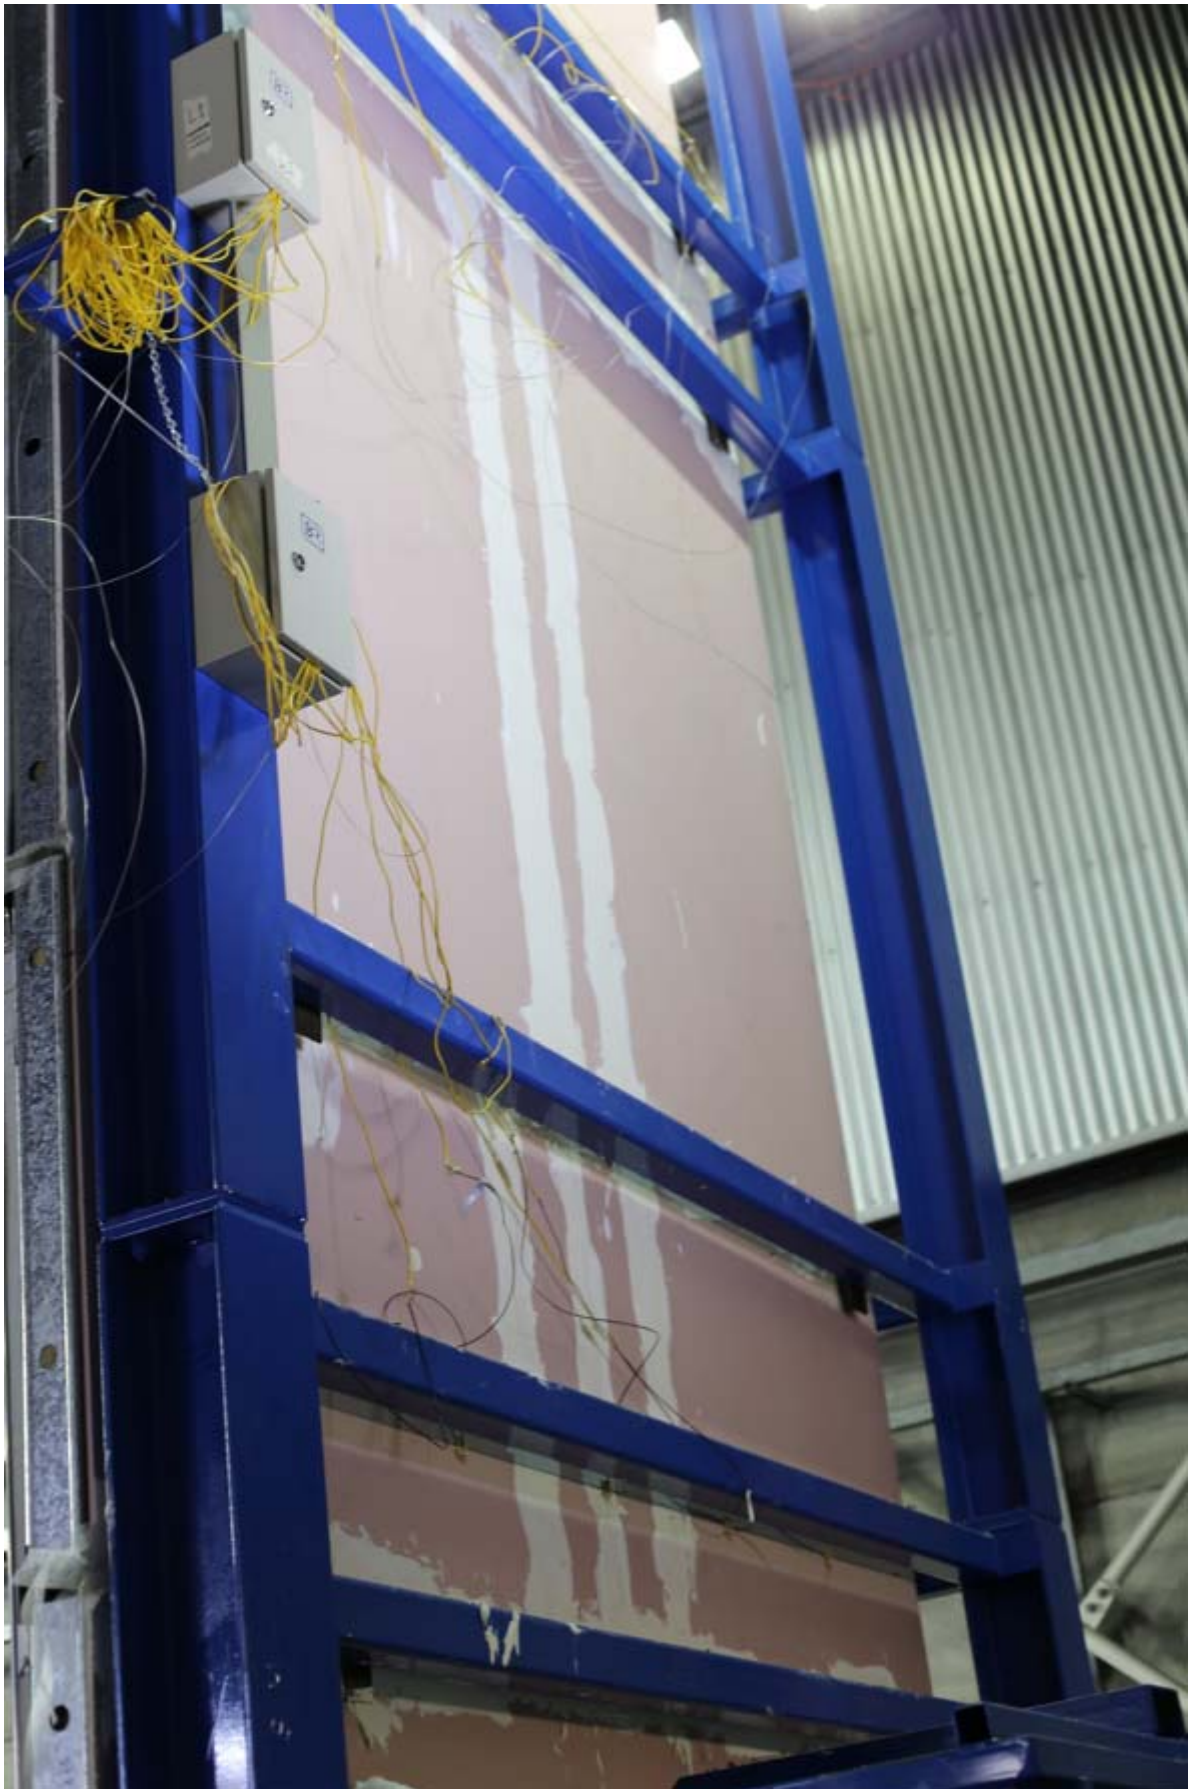
No damage observed on the plasterboard on the unexposed side of the specimen. Refer to Figure D10 for more detail.

Figure D10 – Undamaged state of the unexposed side of plasterboard layer at the conclusion of testing
