13 St Ann Street

Site Photo Report

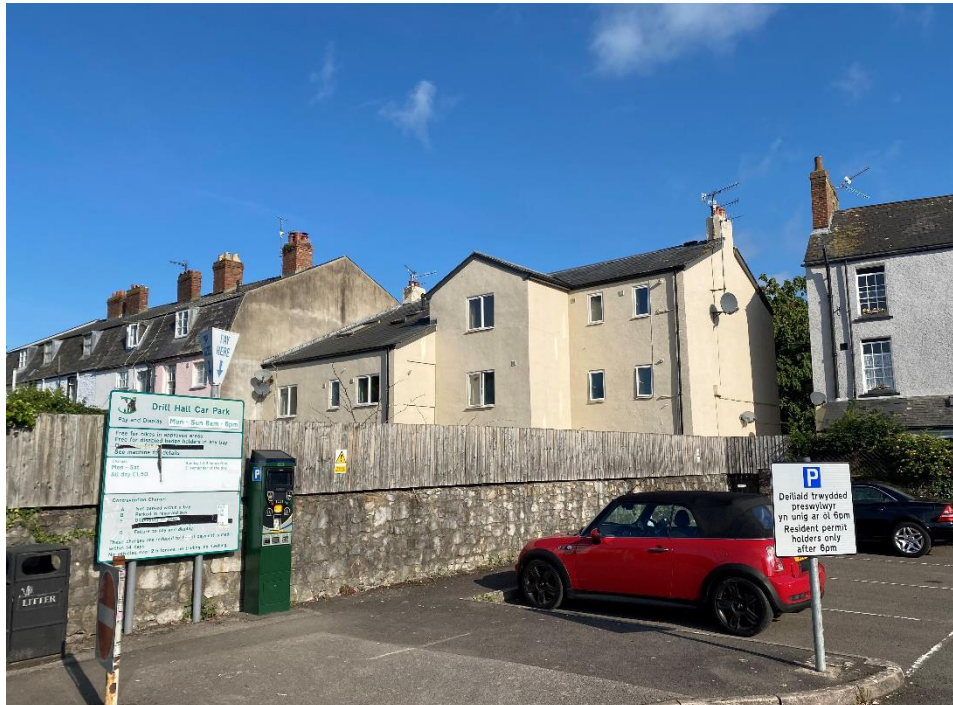
Figure 1 View of property from Lower Church Street Car Park (North West)

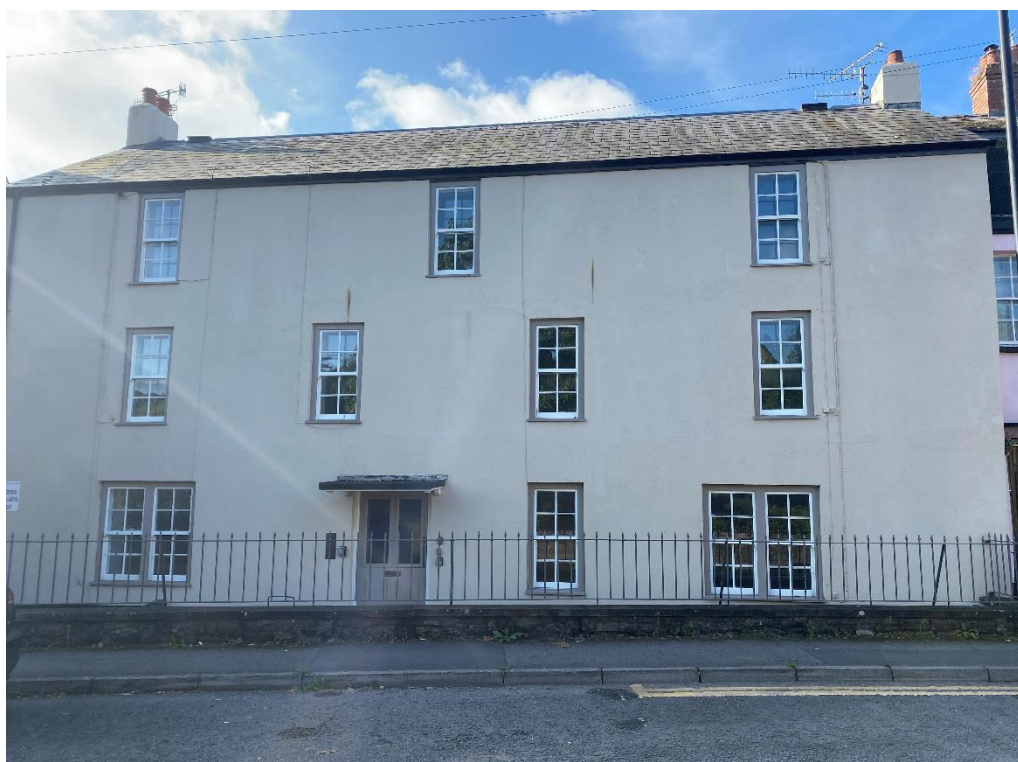
Figure 2 View of property from St Ann Street (South View)

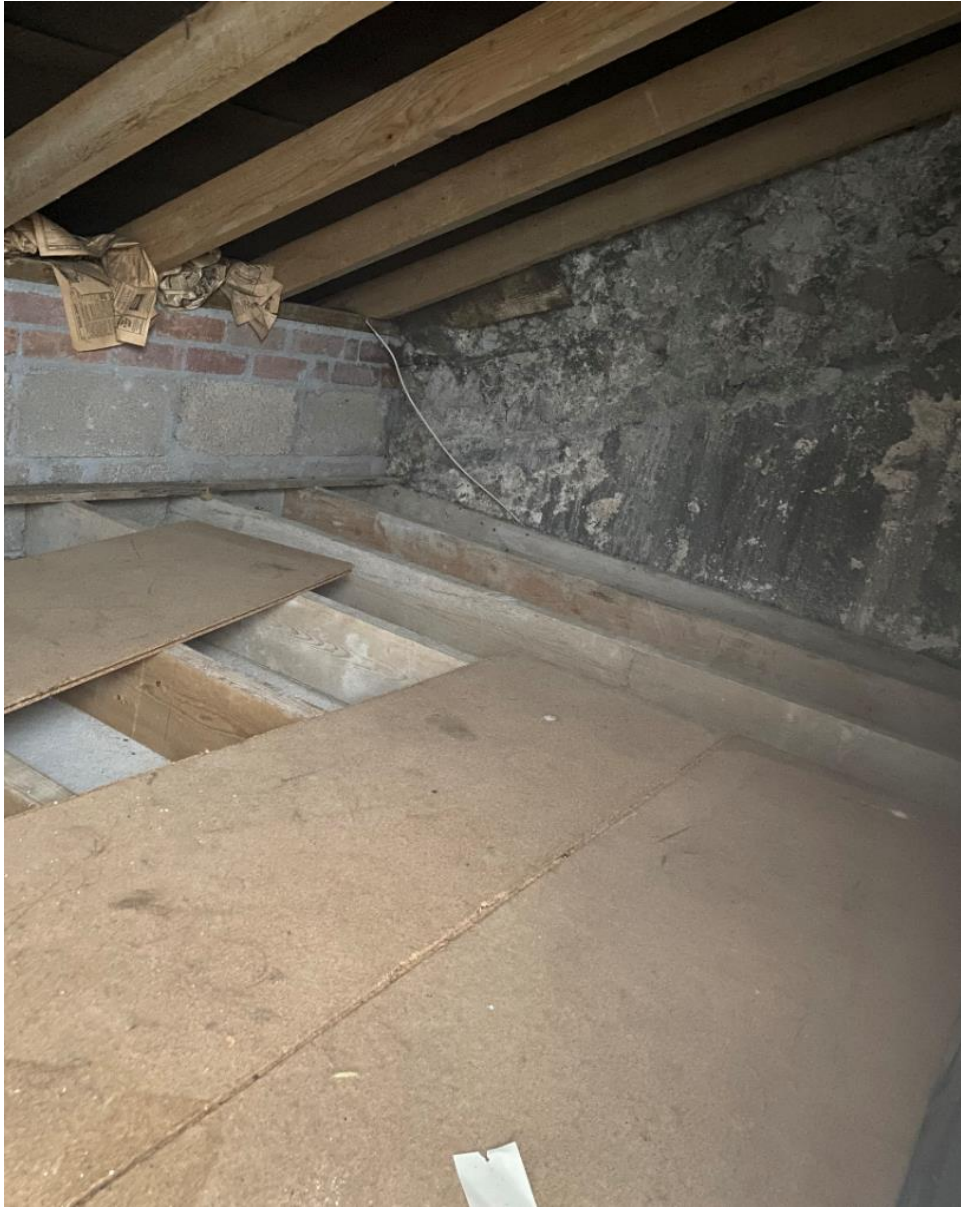
Figure 3 View in attic of property (Showing rafters and general condition)

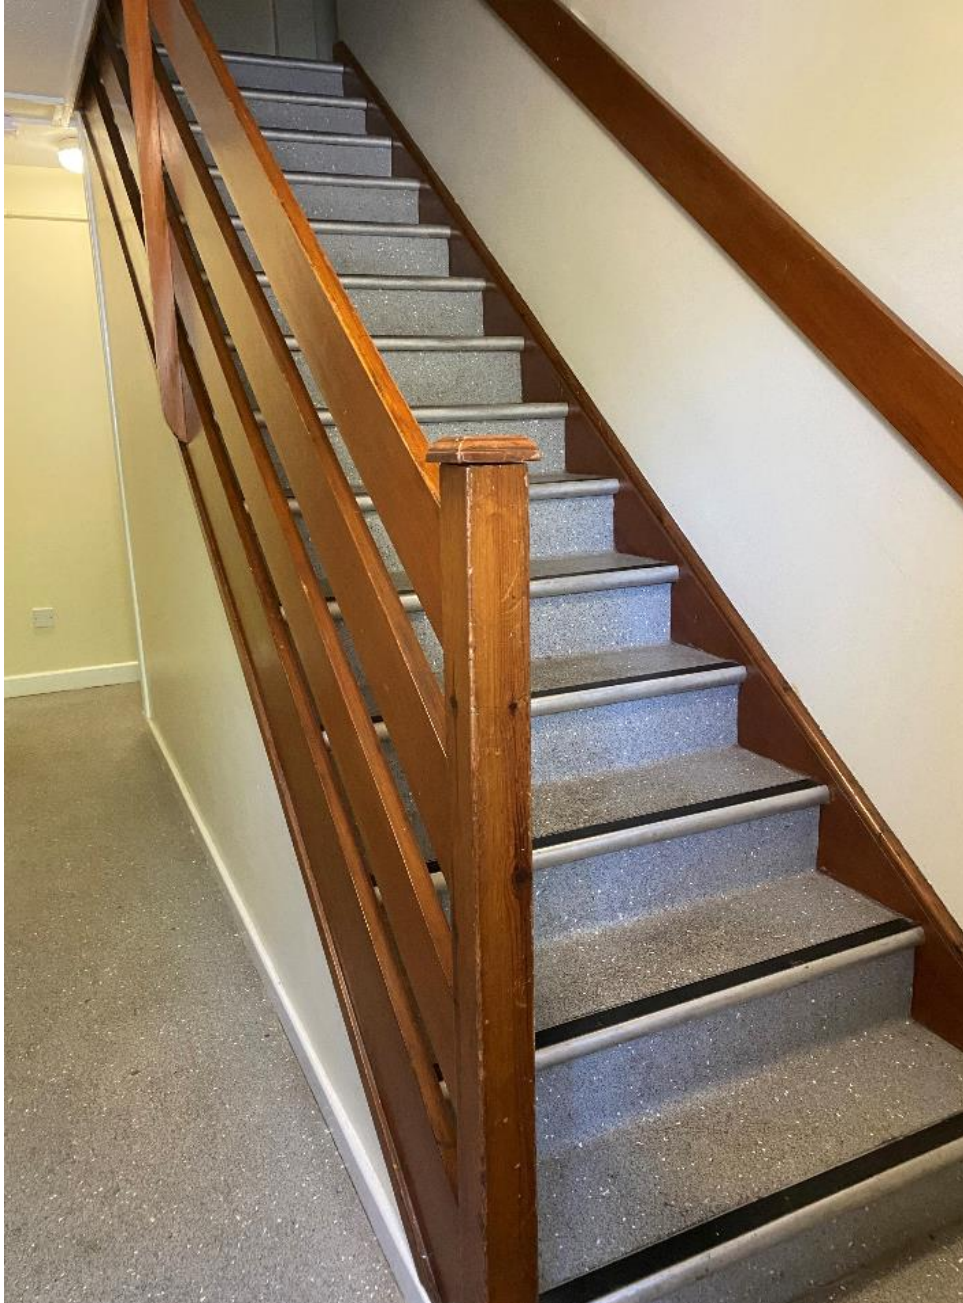
Figure 4 View of stairway and hallway on ground floor (Front door is behind camera view)

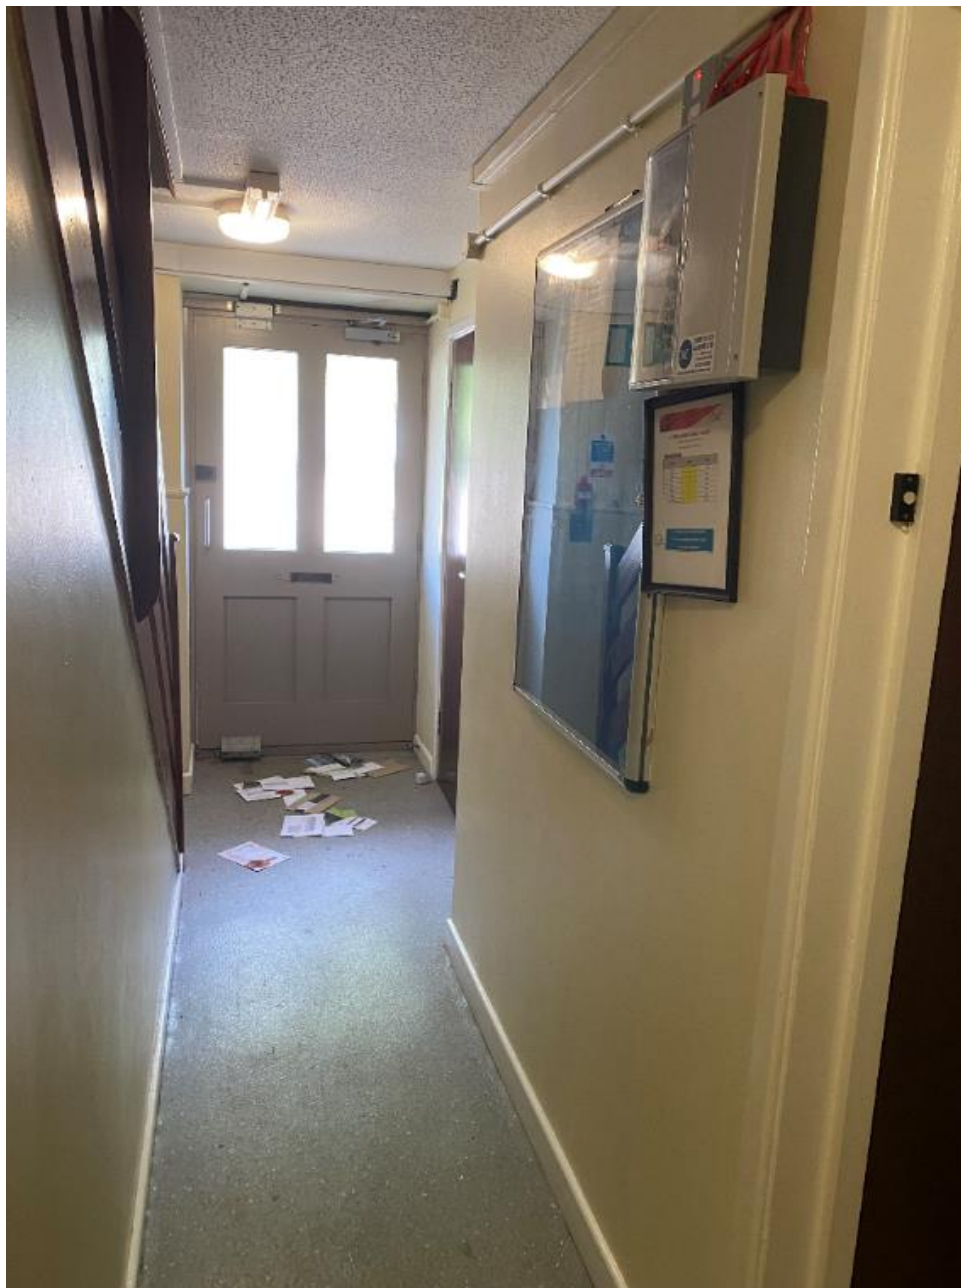
Figure 5 View on entrance door and hallway on ground floor (Fuse box and notice board in view)

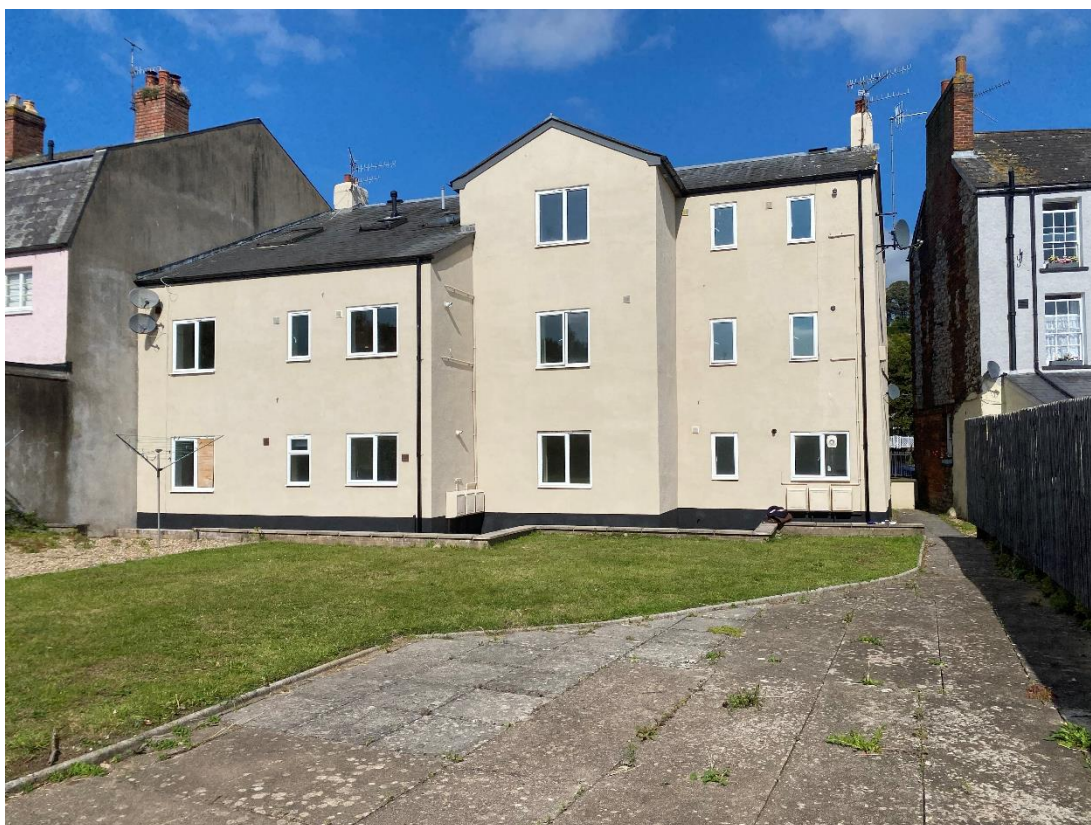
Figure 6 View of property from rear garden (North view)

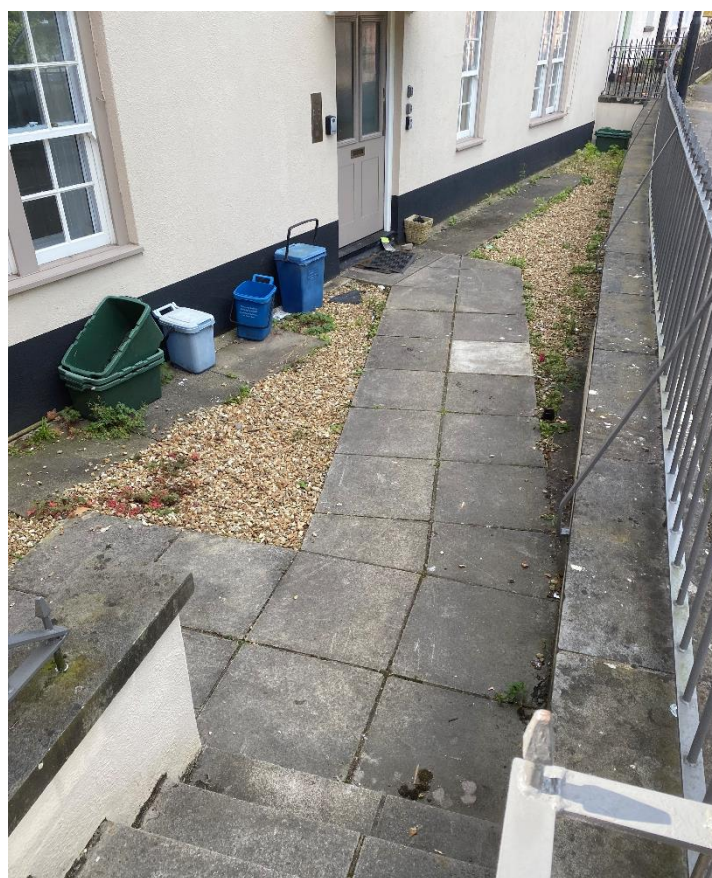
Figure 7 View of entrance pathway to front door (Photo taken from entrance from St Ann Street road, at top of 4 steps)

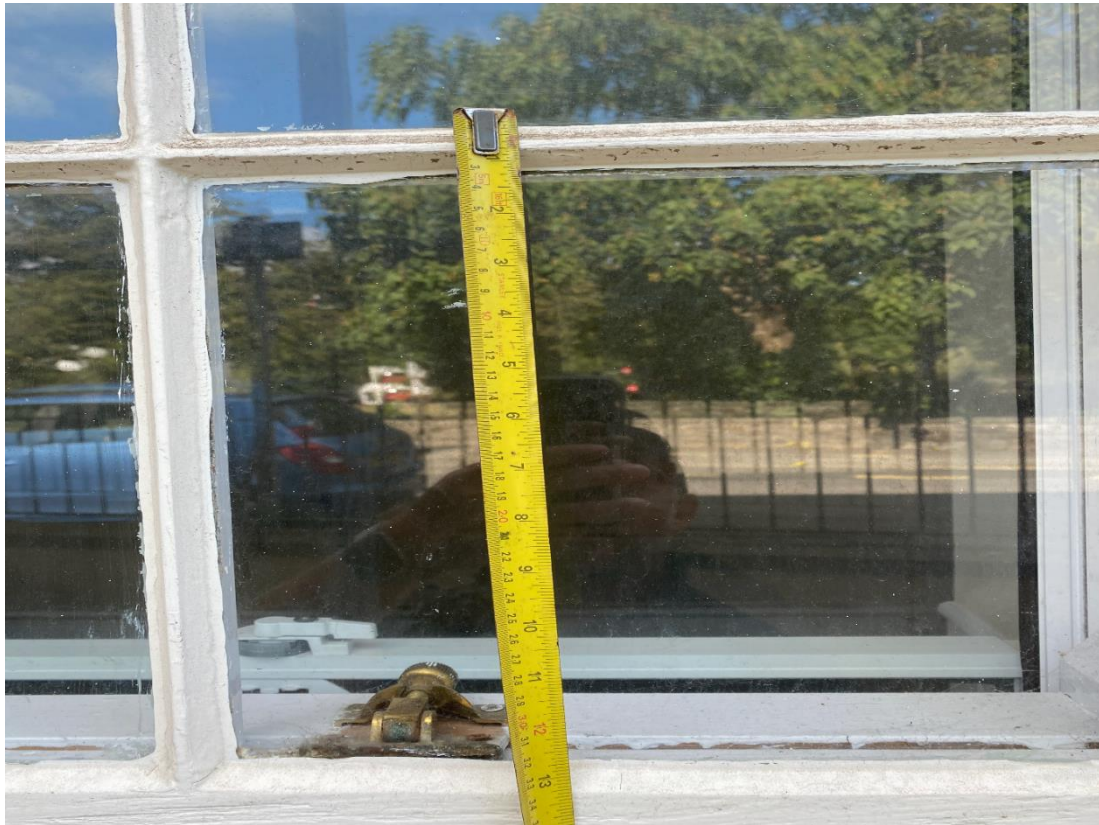
Figure 9 View to indicate size of pane of glass (Tape measure for scale)

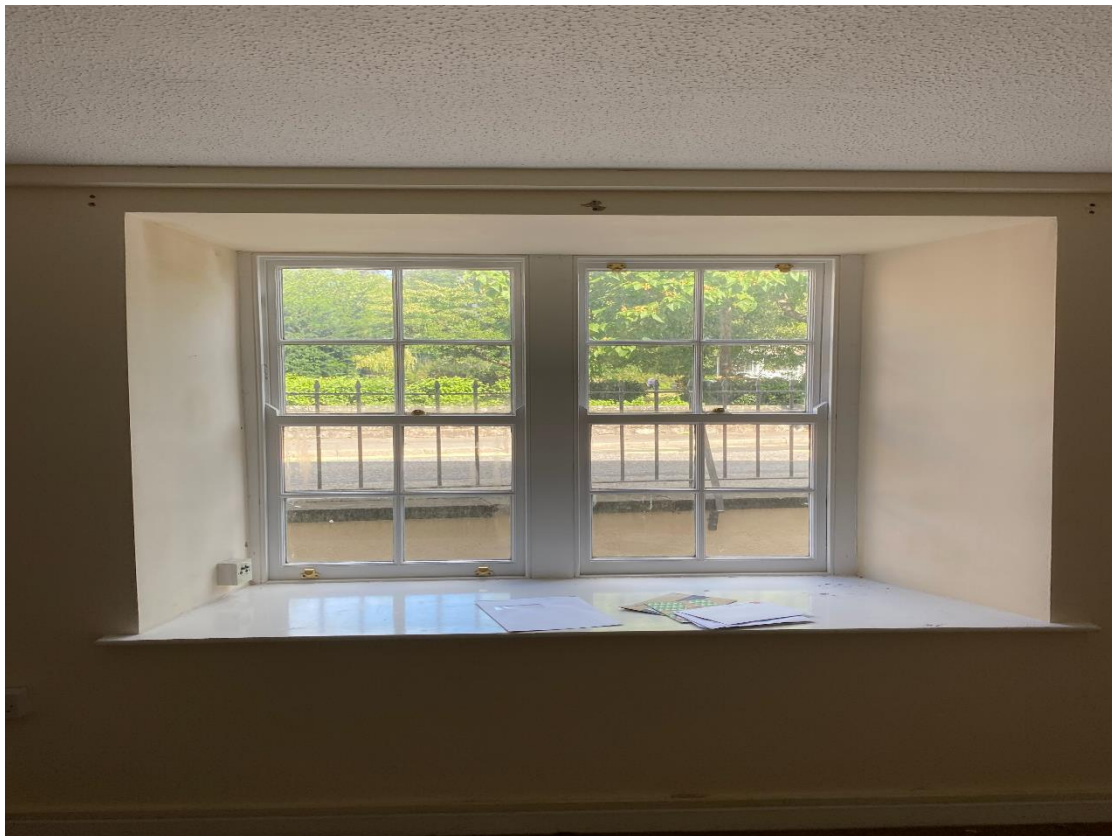
Figure 8 View of double window from inside of flat 1 on ground floor (North View)

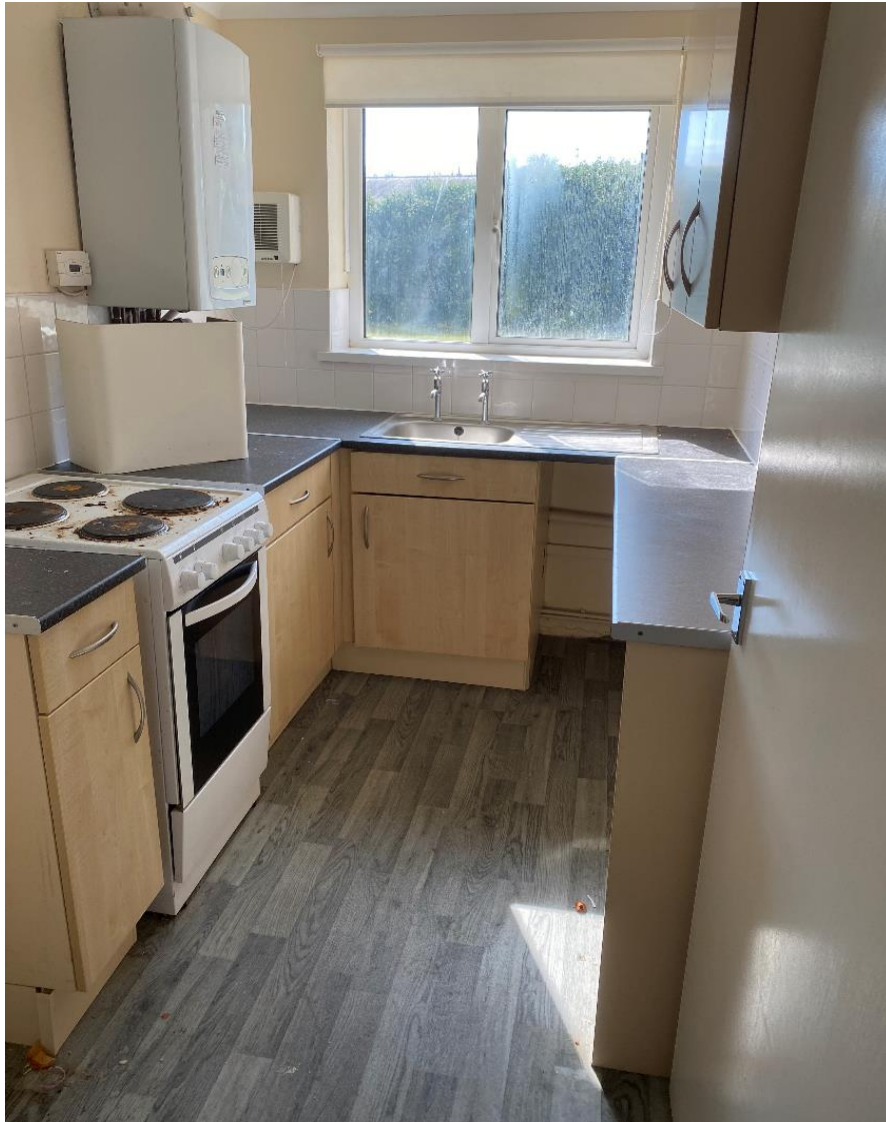
Figure 10 View of current kitchen inside of flat 4 (South view)

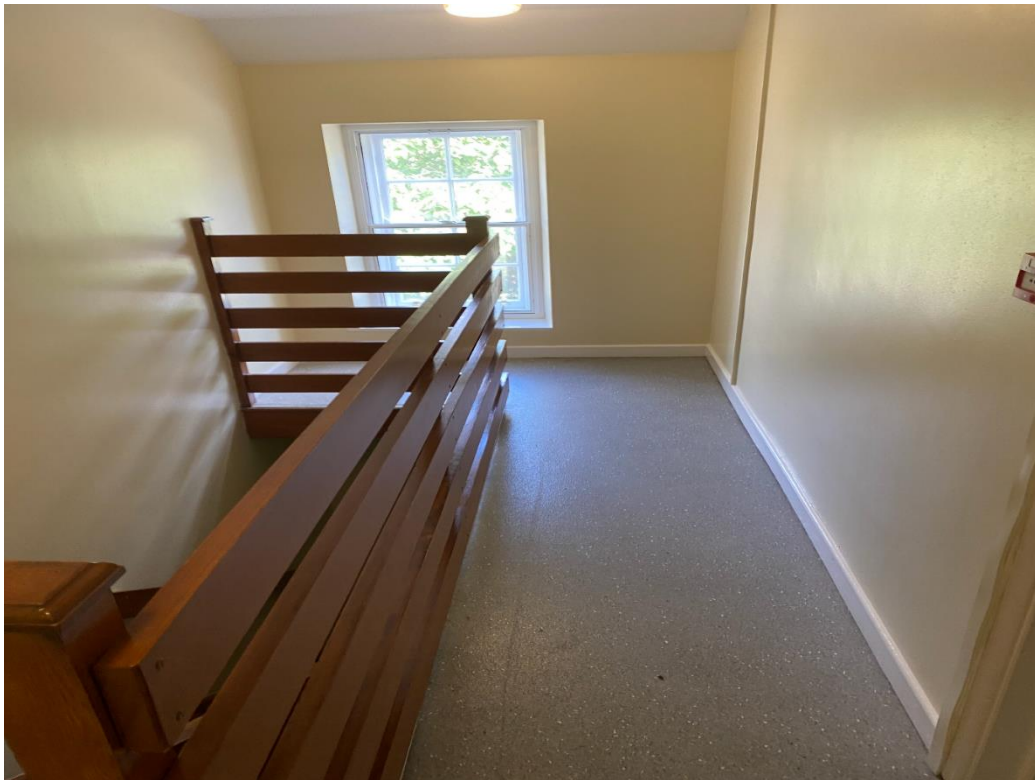
Figure 11 View of top floor landing hallway (North View)

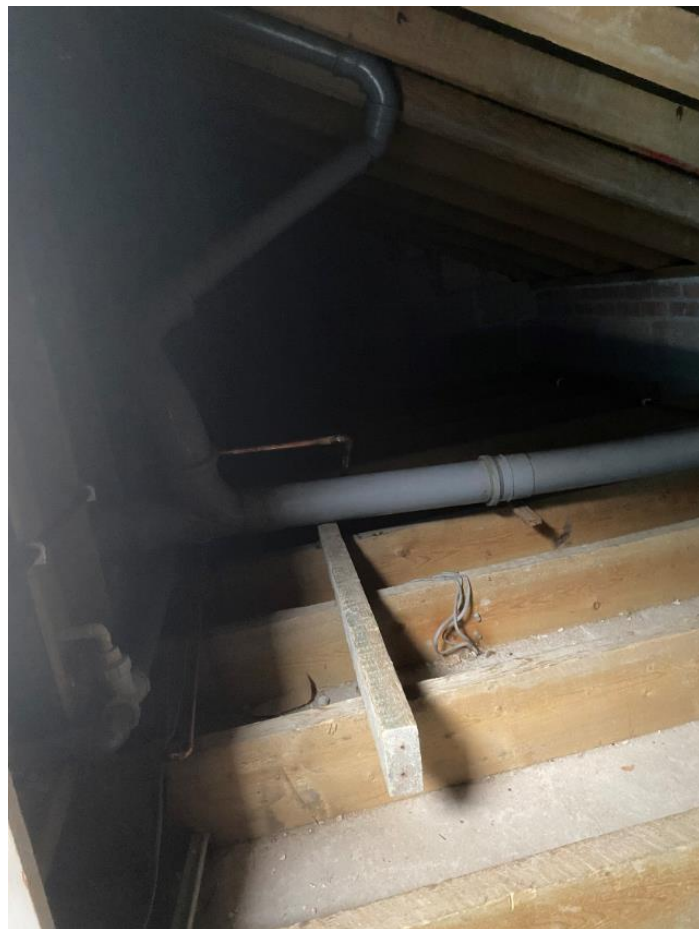
Figure 12 View of attic (Showing waste rainwater pipe)

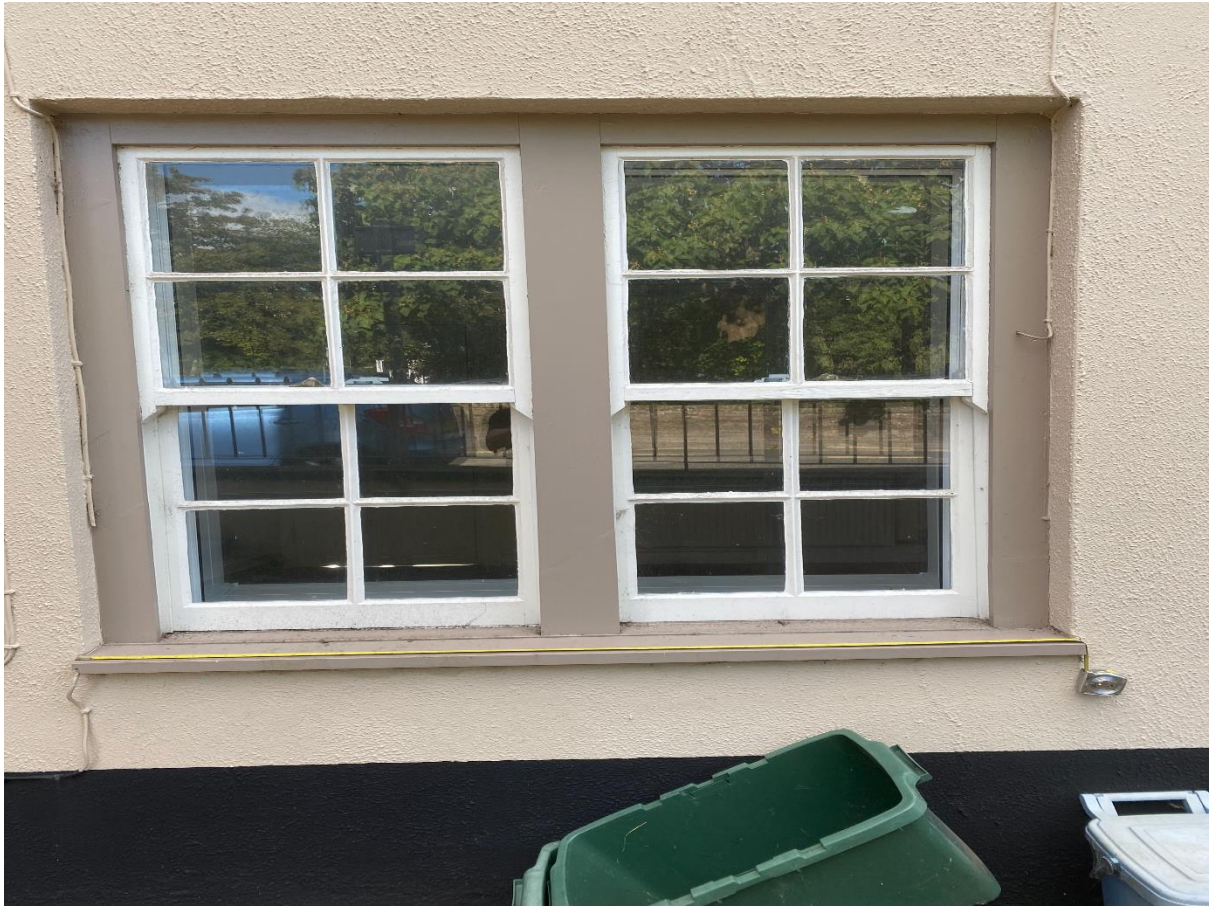
Figure 14 View of window from outside of property (South view of flat 1 window from front pavement area)

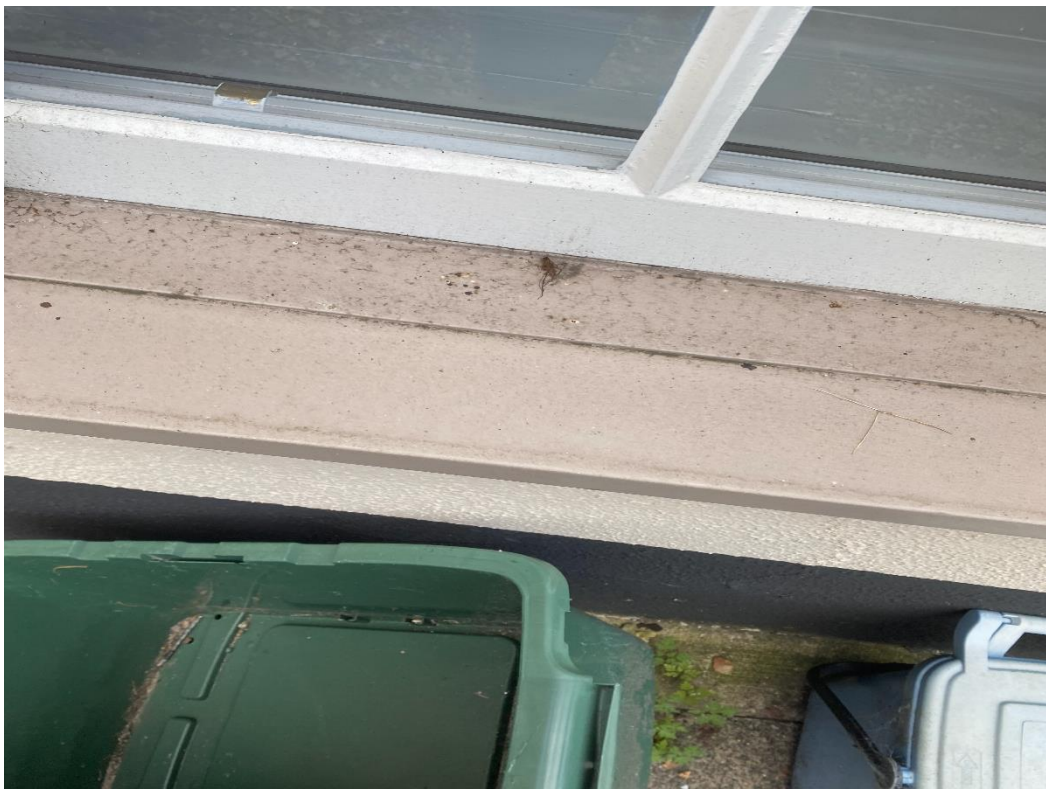
Figure 13 View of outside window sill underneath flat 1 (South view from front pavement area)

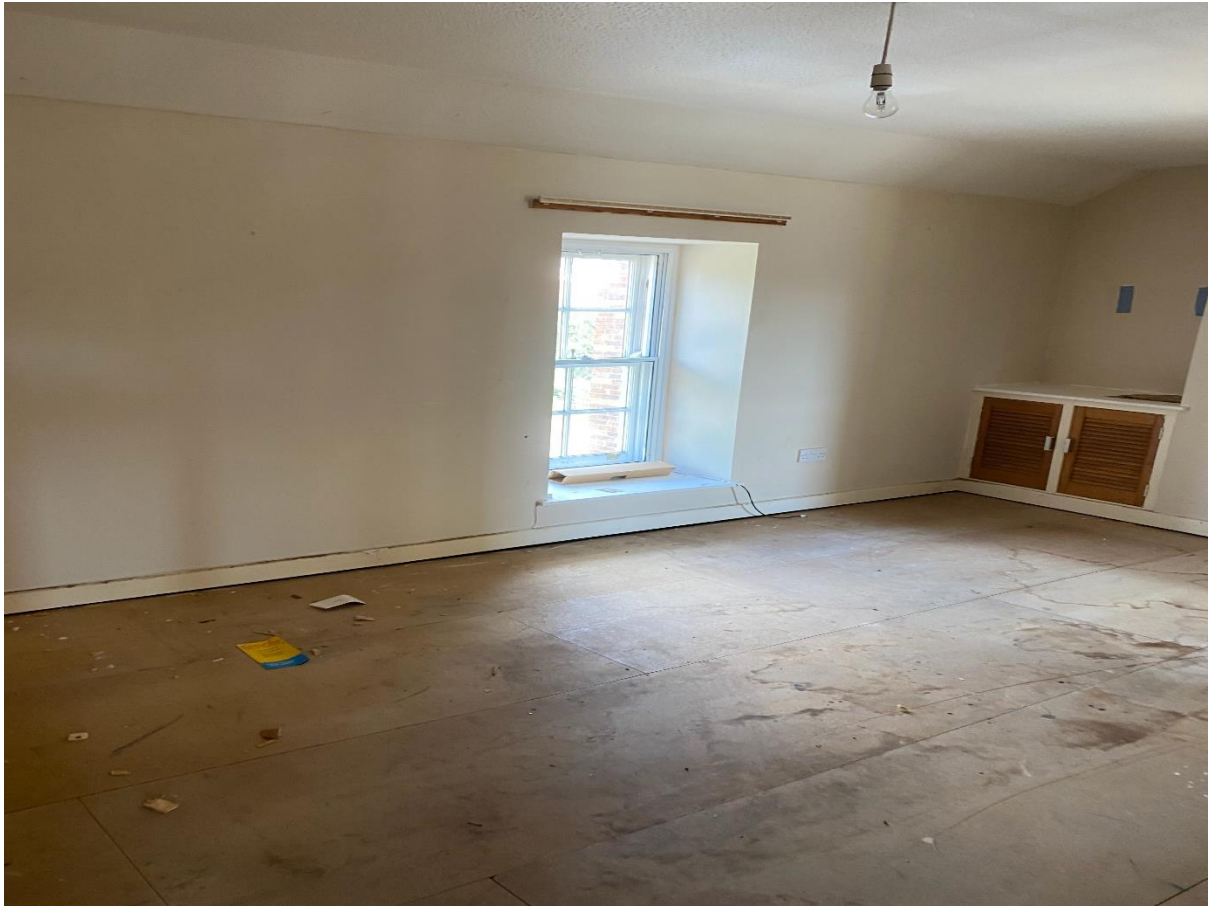
Figure 15 View of living room in flat 6 showing single window frame and floorboard condition (North east view)
