# REPORT OF INSPECTION 2024/5

by Joint Inspection Team for Building Safety (JIT)

**GARTH COURT,  
Abbey Road, Llandudno. LL30 2HF**

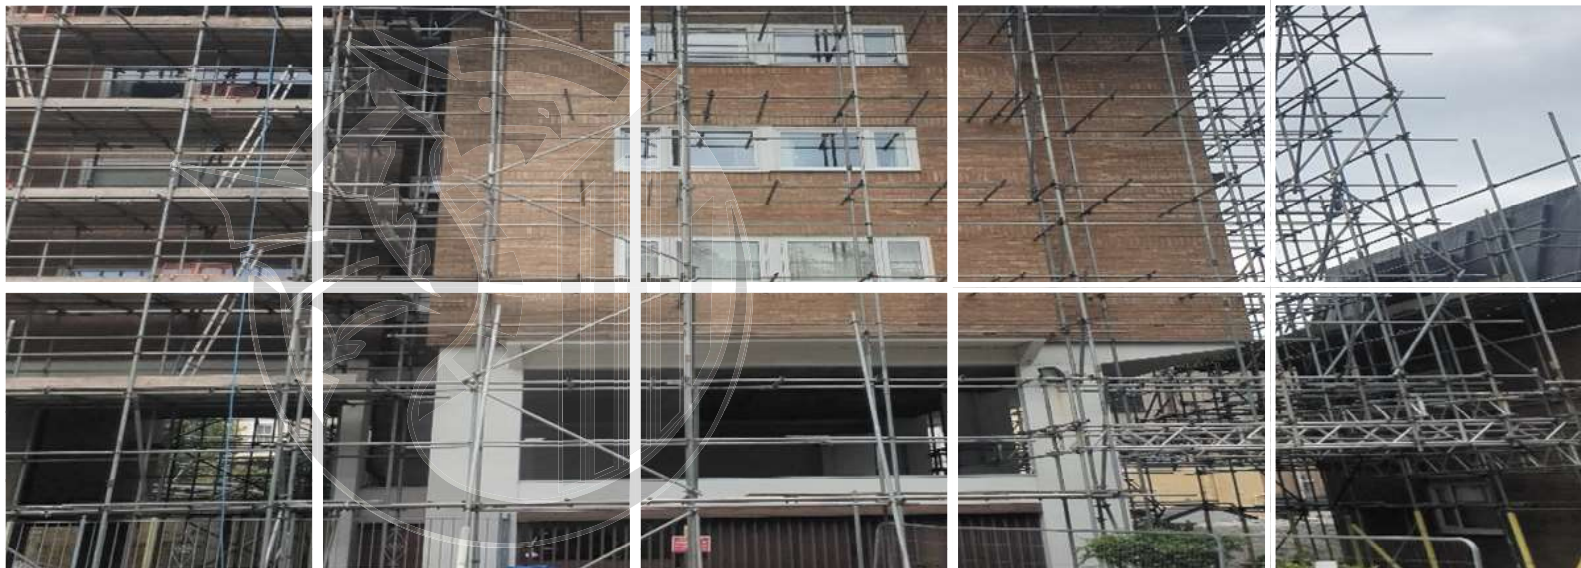
- 9.3 At Garth Court, recent works to the mansard section have raised concerns regarding the fire performance of the waterproofing system applied. The building features a steeply pitched mansard roof which, due to its angle and adjacency to occupied flats, falls within the definition of an external wall. Initial planning applications had been submitted for a full roof renewal, which would have included replacement of the entire structure. However, the most recent application proposed a scaled back scope of works, resulting in a more limited refurbishment approach. We have engaged with the local authority building control team, who provided their justification for accepting the revised works, including correspondence with stakeholders involved in the project. Although we have not seen a formal completion certificate, and no response has been received to our most recent communication outlining these concerns in full, the matter remains unresolved from a fire performance standpoint.

While the works have been framed as a like for like repair and the intention was not to alter the structure, the material used, Duracoat, is a polymer-based product containing solvents and is not supported by test data for use on vertical or near vertical wall applications. Although it has achieved BROOF(t4) under UK standards for flat roofing, this test is not recognised under EN 13501 for wall applications, and the product carries no Euroclass fire rating. Based on its composition, it would likely achieve a classification no better than Class D to F. The current BBA certificate for Duracoat clearly states it is not suitable for use on walls, which is significant given the fire risk associated with the mansard (wall) construction build-up.

The original build up likely included a bitumen felt with mineral finish, which may have achieved potentially low-class D with the mineral finish. However, this was laid over combustible backing materials typical of the construction era, such as OSB sheathing, EPS insulation, and wood wool board known as Tectum board, all of which contribute to fire loading and propagation. Importantly, while bitumen is combustible, it is a heavier oil derived material lower down the refining chain. In that sense, it behaves more like diesel when compared to highly volatile substances like petrol. Bitumen tends to ignite more slowly, requiring sustained exposure to heat before combustion, and typically has a more stable and delayed burn profile. In contrast, solvent based and polymeric coatings such as Duracoat are more volatile and can ignite quickly, increasing the rate of fire development.

The JIT believes the fire resistance of the mansard section has been marginally reduced and that overall fire risk has slightly increased as a result. This case presents an opportunity for learning and reflection, particularly where pitched surfaces form part of the external wall. It highlights the need to apply a more precautionary approach when substituting materials that lack test evidence or Euroclass ratings, and to reconsider the threshold between repair and alteration where fire safety is concerned.

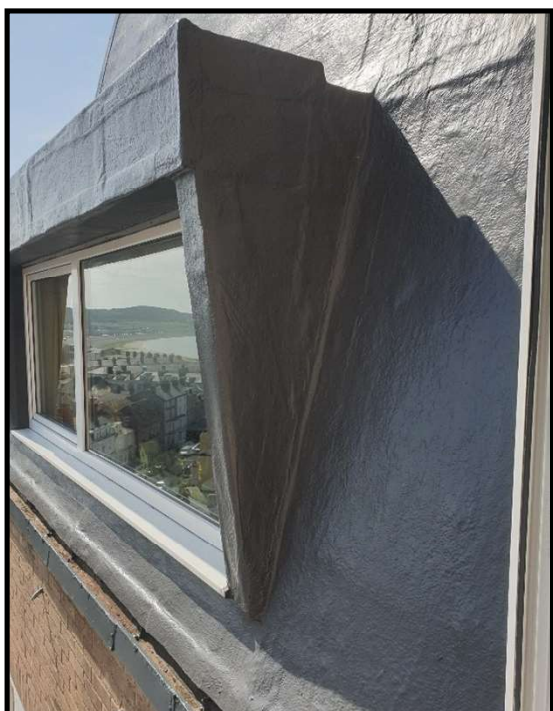
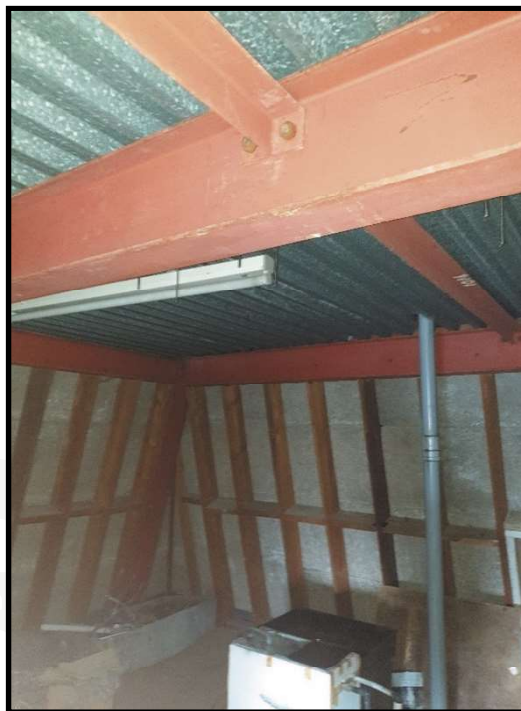
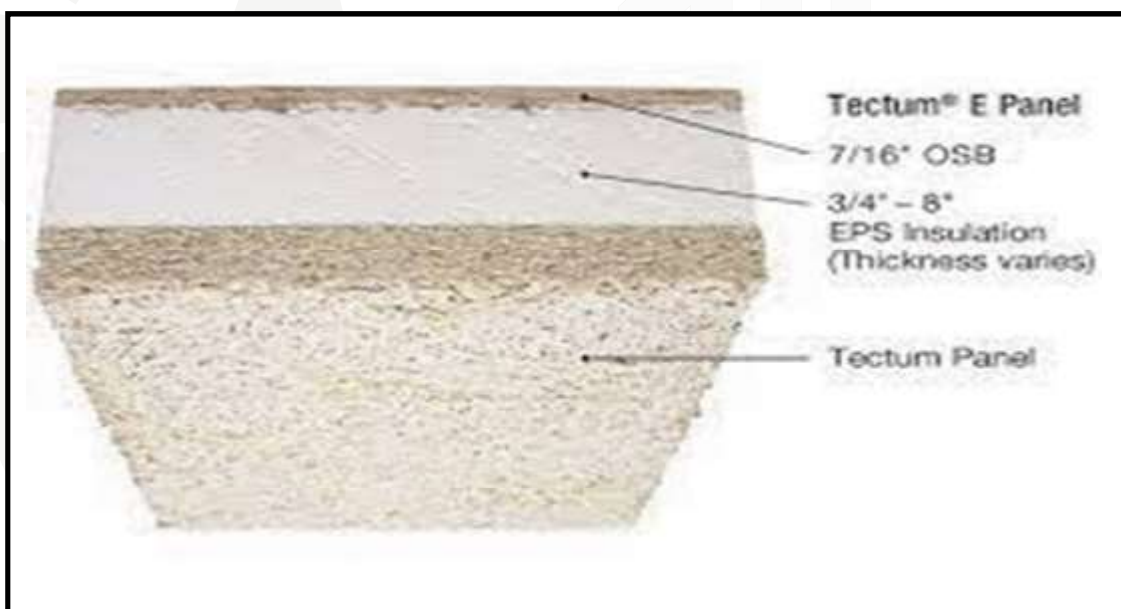
- 9.4 The building is served by lower ground floor car parking, storage units that attach around part of the perimeter of the basement floor, that includes area like MEP rooms. They have their own dedicated access and egress points, separating them from the residential areas.

- 9.5 No lightning protection system was observed during the inspection at Garth Court. The building is a high-rise residential block with a combination of combustible and conductive materials at roof level, increasing its vulnerability to lightning strikes. In line with BS EN 62305-2:2012, a formal risk assessment should be undertaken to determine whether protection is required. Given the height, occupancy, and construction of the building, it is likely that protection measures would be recommended and should be addressed by the responsible person.

- The JIT recommend that a formal risk assessment In line with BS EN 62305-2:2012 should be undertaken to determine whether protection is required. Given the height, occupancy, and construction of the building, it is likely that protection measures would be recommended and should be addressed by the responsible person.

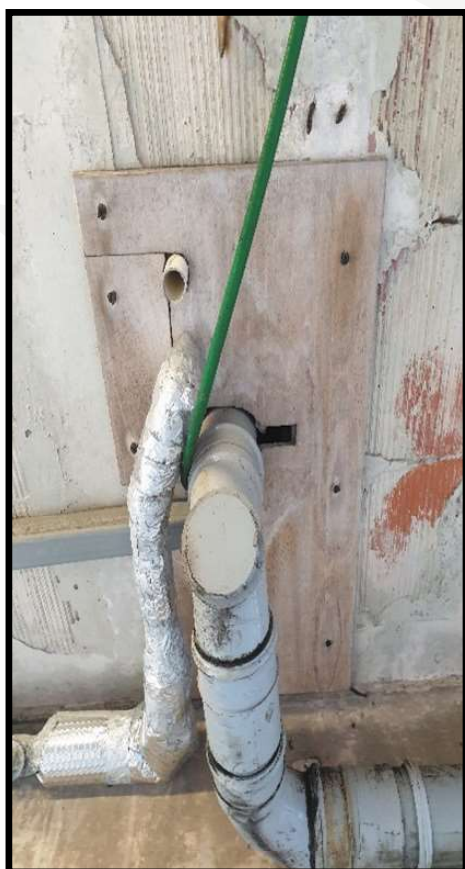
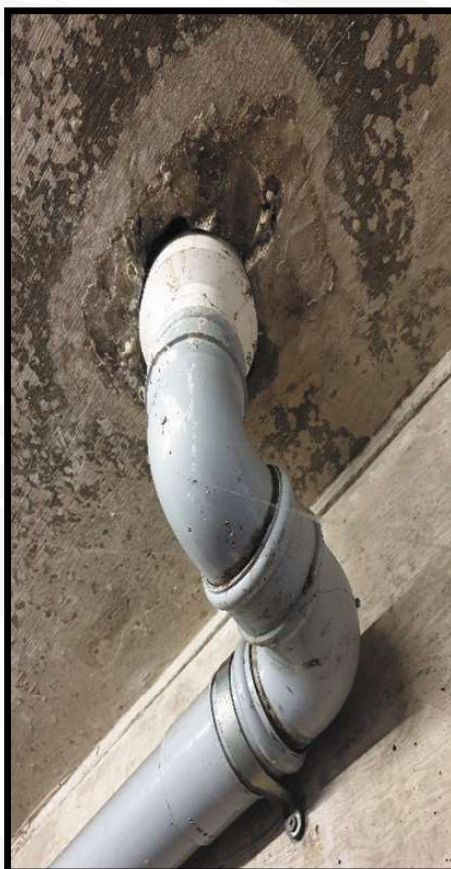
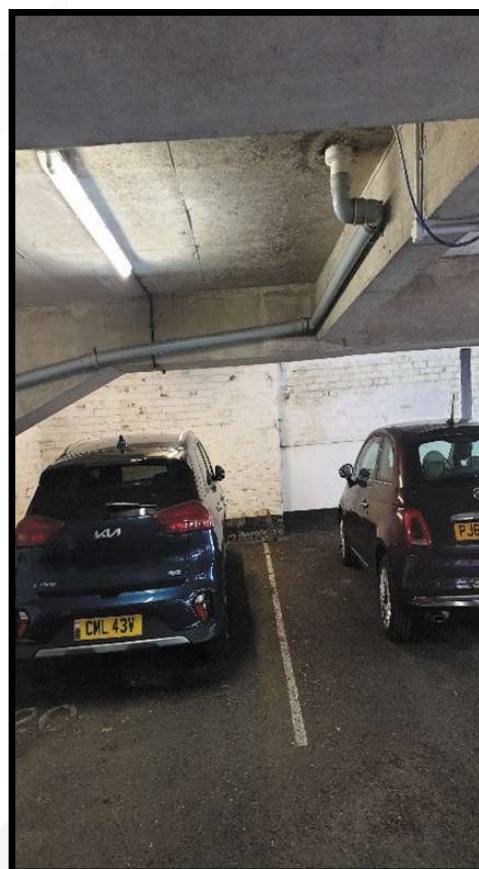
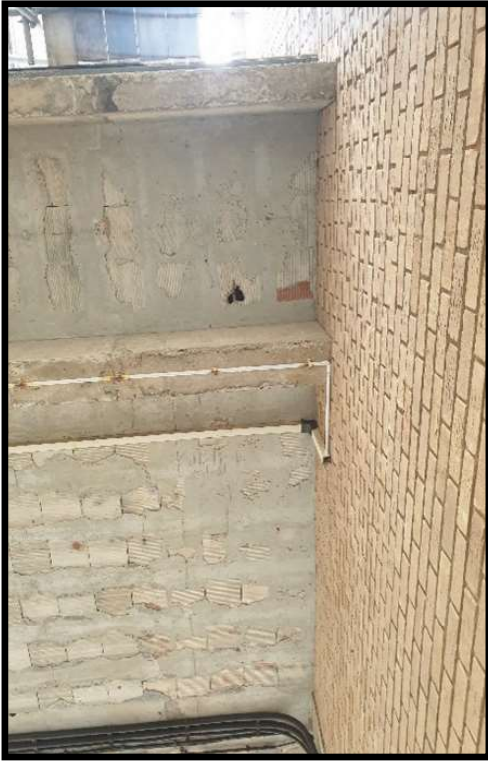
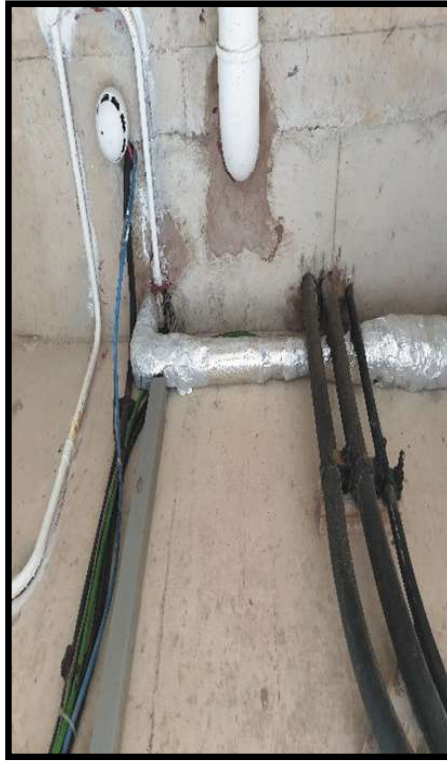
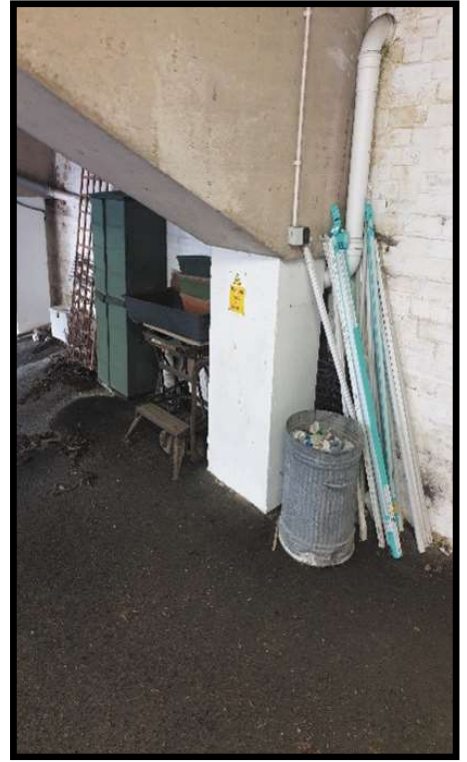
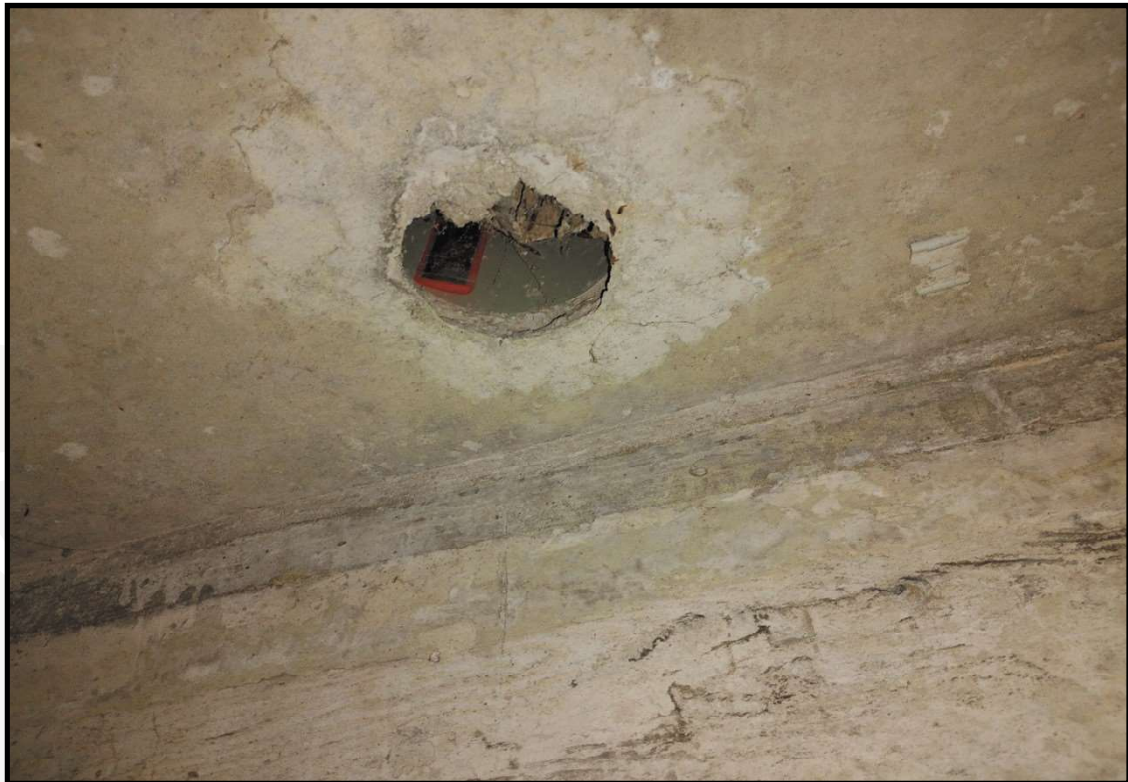
- 9.6 The lower ground floor car park is open sided, providing some natural ventilation, but several fire safety concerns were noted. There were multiple holes in the soffit of the floor slabs, including visible damage to the clay infill blocks and unsealed service penetrations. Soil stacks running through the area lacked fire collars at the slab junctions, leaving openings that compromise vertical compartmentation between floors. The general condition of the car park was poor, with signs of disrepair and inadequate house keeping, including the storage of combustible materials and general waste. The presence of electric vehicles introduces an increased fire risk, particularly due to the high energy release and difficulty of extinguishment associated with battery fires. In its current condition, the car park presents a number of risks that should be addressed through improved maintenance, reinstatement of passive fire protection, and a clear strategy for managing EV and ICE vehicle fire hazards.

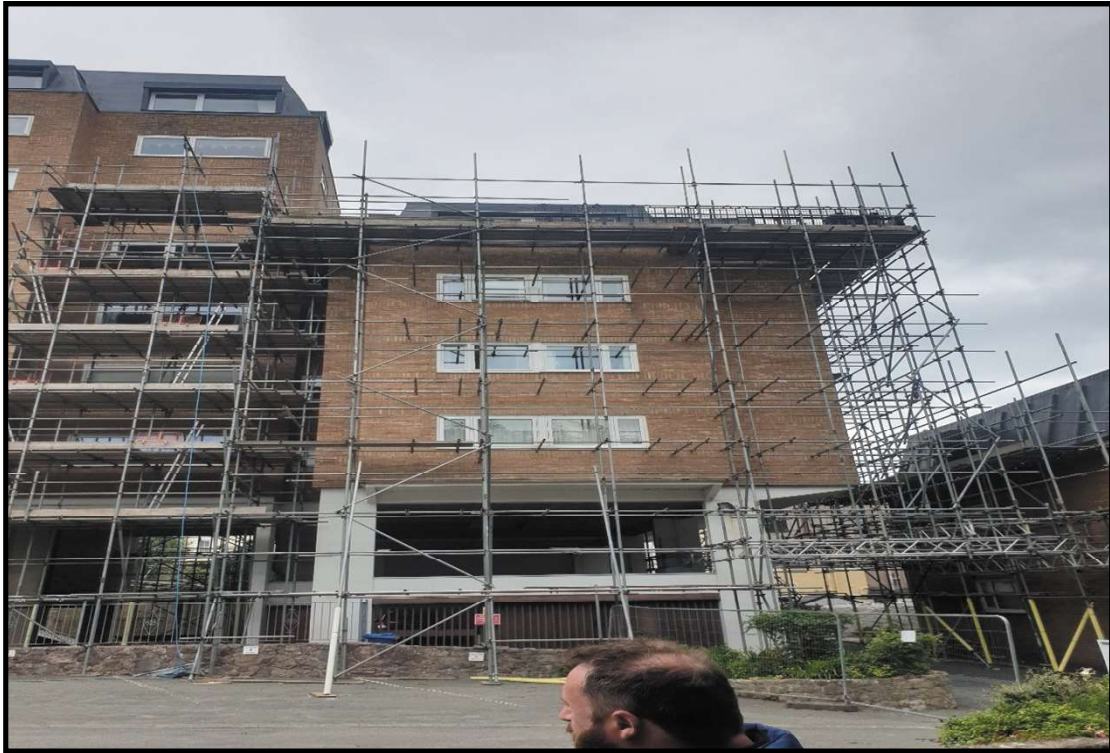
- 9.7 Scaffolding has been in place around the building for approximately 2 years, originally erected to support roofing works. At the time of inspection, there were no confirmed plans for its removal, as further verification of the completed roof works remains outstanding. The extended retention of the scaffold still presents a potential fire risk. The structure can provide a means for external fire spread between levels. Given the duration of its presence and the uncertainty around completion timelines, the scaffold arrangement should be reviewed as part of the fire risk assessment, and appropriate control measures considered.

- The JIT recommend that all scaffolding structures be removed at the earliest opportunity once works have concluded around the building.
- 14.2 The waste bins were stored externally along the north elevation of the building in an area that is open and accessible to the public. While the space is covered by CCTV surveillance, its open nature presents a potential risk of arson, deliberate interference, or vandalism. The presence of combustible refuse in an unsecured area adjacent to the building increases exposure, particularly given the potential for ignition sources and the proximity to the final exit at the foot of the protected staircase.

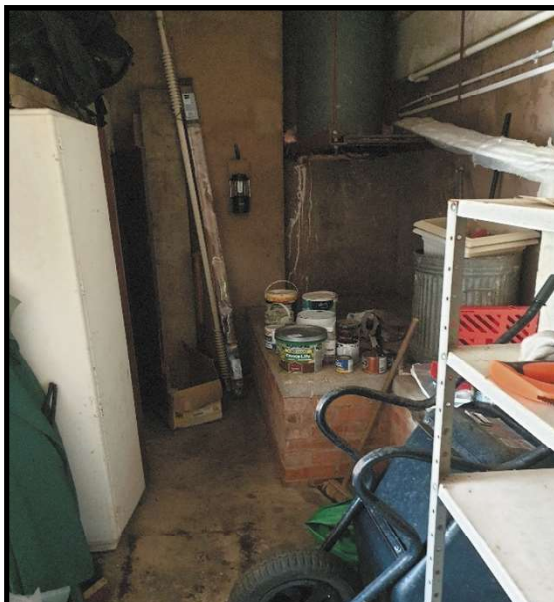
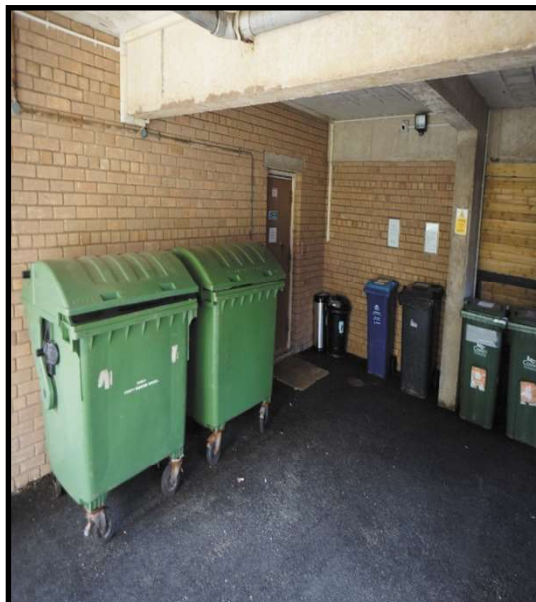
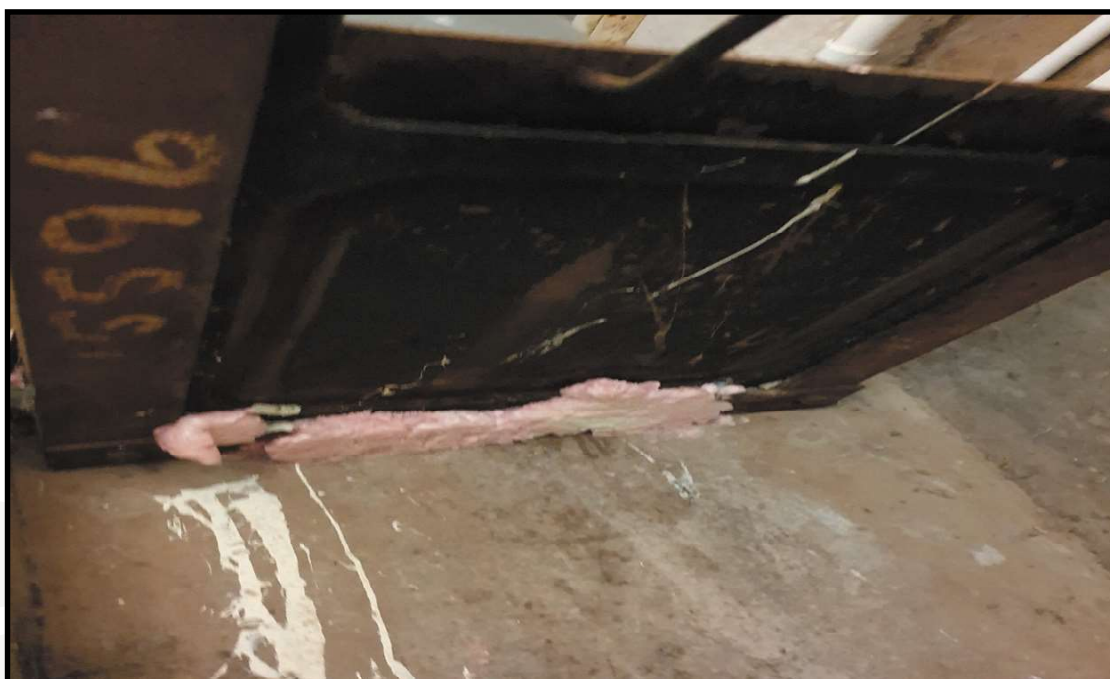
- 9.8 The bin chute formerly discharged into the waste storage room located at 1st floor level, where a manual chute shut off door remains in place. The chute has since been decommissioned, with the rear section sealed using expanding foam. This room has been repurposed as a general storage area and was observed to contain a notable quantity of combustible materials, including paints, cleaning products, plastic containers, and other general fire loading. The room is fitted with a fire alarm device, providing local detection coverage, and access is via double doors with louvred ventilation, offering some passive smoke dispersal. The original waste chute hoppers on each floor are likely behind a stud partition wall adjacent to the stair lobby.

The bins are now stored externally along the north elevation of the building in an area that is open and accessible to the public. While the space is covered by CCTV surveillance, its open nature presents a potential risk of arson, deliberate interference, or vandalism. The presence of combustible refuse in an unsecured area adjacent to the building increases exposure, particularly given the potential for ignition sources and the proximity to occupied flats. The arrangement should be reviewed to determine whether additional physical security measures or enclosure would be appropriate to reduce the risk.

- The JIT recommend that the bin waste storage arrangement should be reviewed to determine whether additional physical security measures or enclosure would be appropriate to reduce the risk.

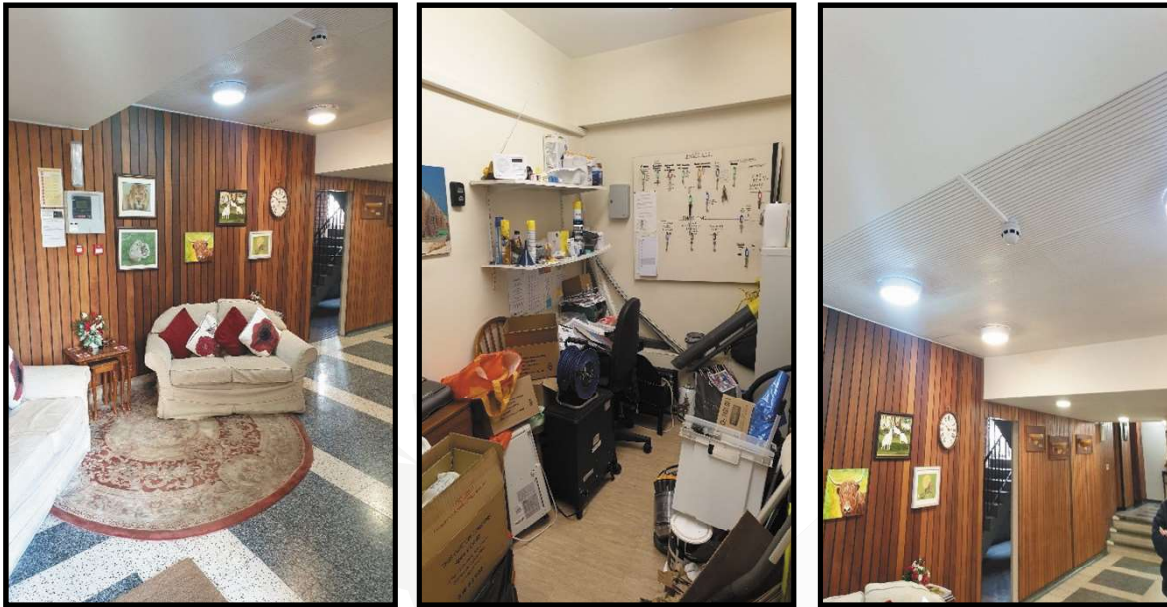
- 10.13 Poor housekeeping was observed in several caretaker managed areas, most notably within the ground-floor lobby, which contained a substantial volume of combustible material. Items included domestic style settees, decorative timber wall linings, framed paintings, soft furnishings, and various stored items. These materials introduce a significant and avoidable fire load into a space that should function as a sterile, fire resisting enclosure supporting safe evacuation. Varnished timber wall linings in particular are unlikely to meet current surface spread of flame requirements for circulation spaces, which under modern guidance should achieve at least Class B-s3, d2 to EN 13501-1. The presence of combustible finishes and furnishings in this area represents a clear deviation from expected fire safety standards. The responsible person should review these items to reduce fire loading and maintain the lobby as a protected and effective escape route.

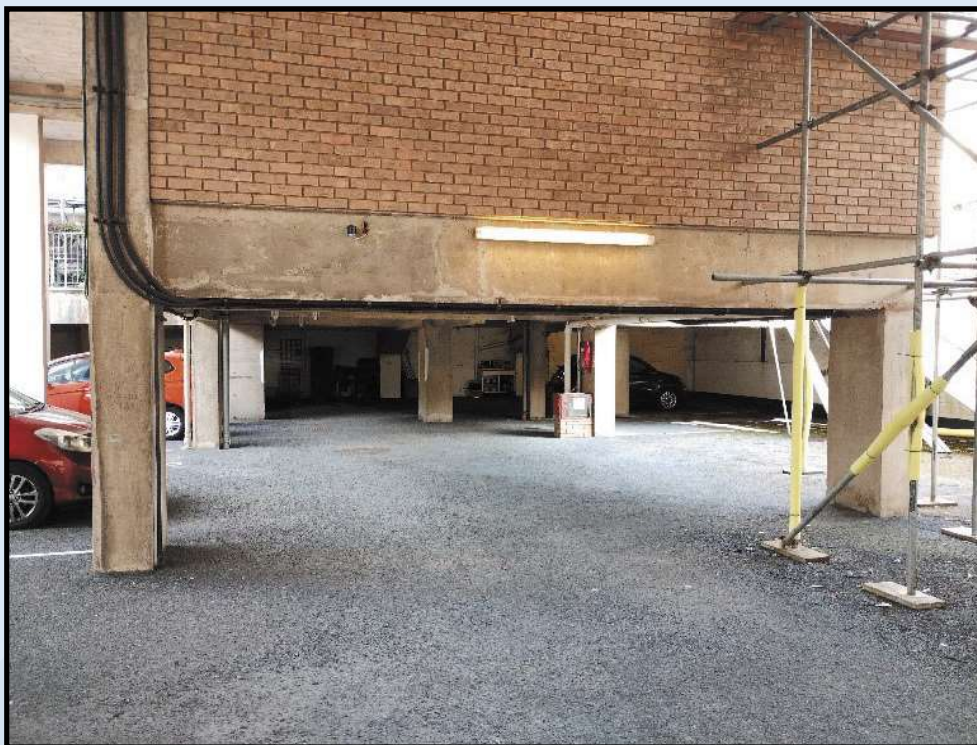
- o Within the protected corridors there were electric meter housings present.
- o Within the lower ground floor level car park there were high voltage cables mounted on the outer edge of a low-height soffit which is at risk of impact from moving vehicles at <2.0m in height.

- The JIT recommend that these cables are either moved to a location where the risk of impact is lower or that the cables are enclosed within a robust and secure trunking system and appropriate signage is provided to the area where the car park soffit height changes.
