## Bishton-Llanmartin Overbridge M4 23A-24 51 Principal Inspection Report 2025/26

Service Provider/Consultant Name: Arcadis

Service Provider/Consultant Project Number: 30286543

T-WHIS Number: CTI/005

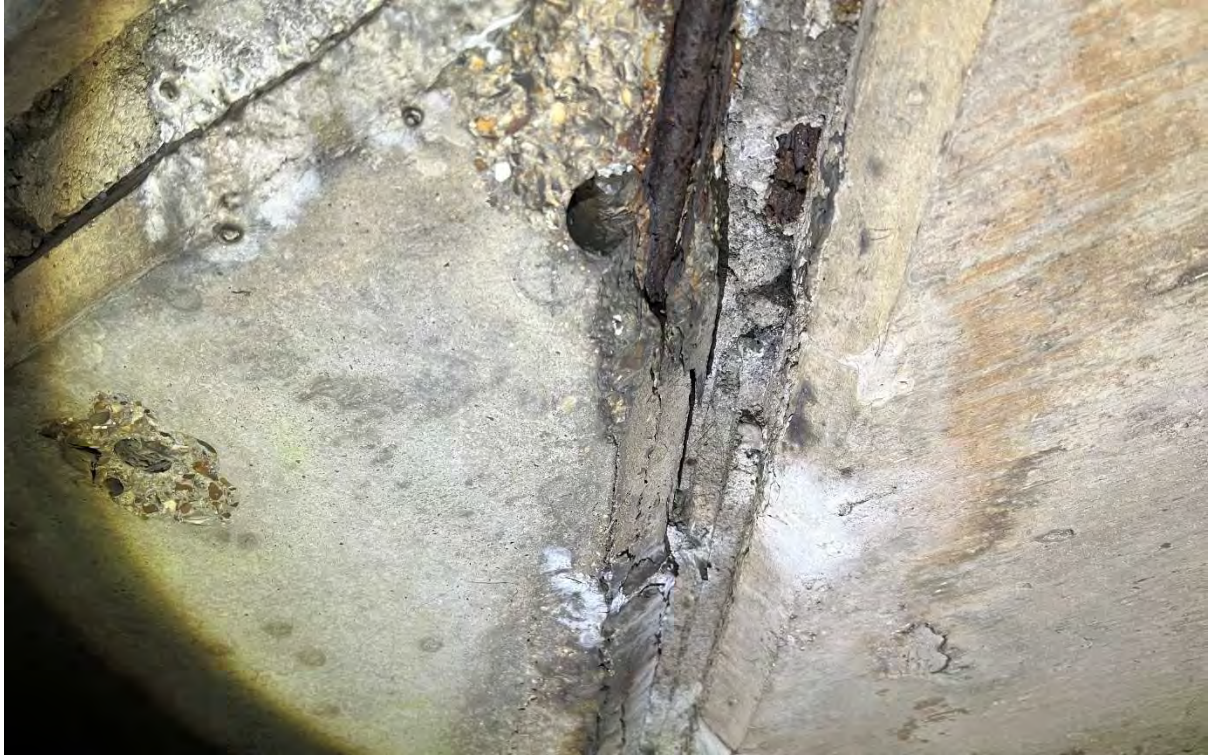
Overall, the span 1 deck soffit was in good to fair condition <sup>(4)</sup>. Two areas of spalled concrete with exposed reinforcement exhibiting minor corrosion were noted to the deck soffit. Since the previous Principal Inspection in 2019, the span 1 deck soffit does not appear to have deteriorated.

Photograph 7 - Span 1, beam 8. Area of spalling with exposed reinforcement exhibiting minor corrosion and delamination, measuring 1200x100x30mm.

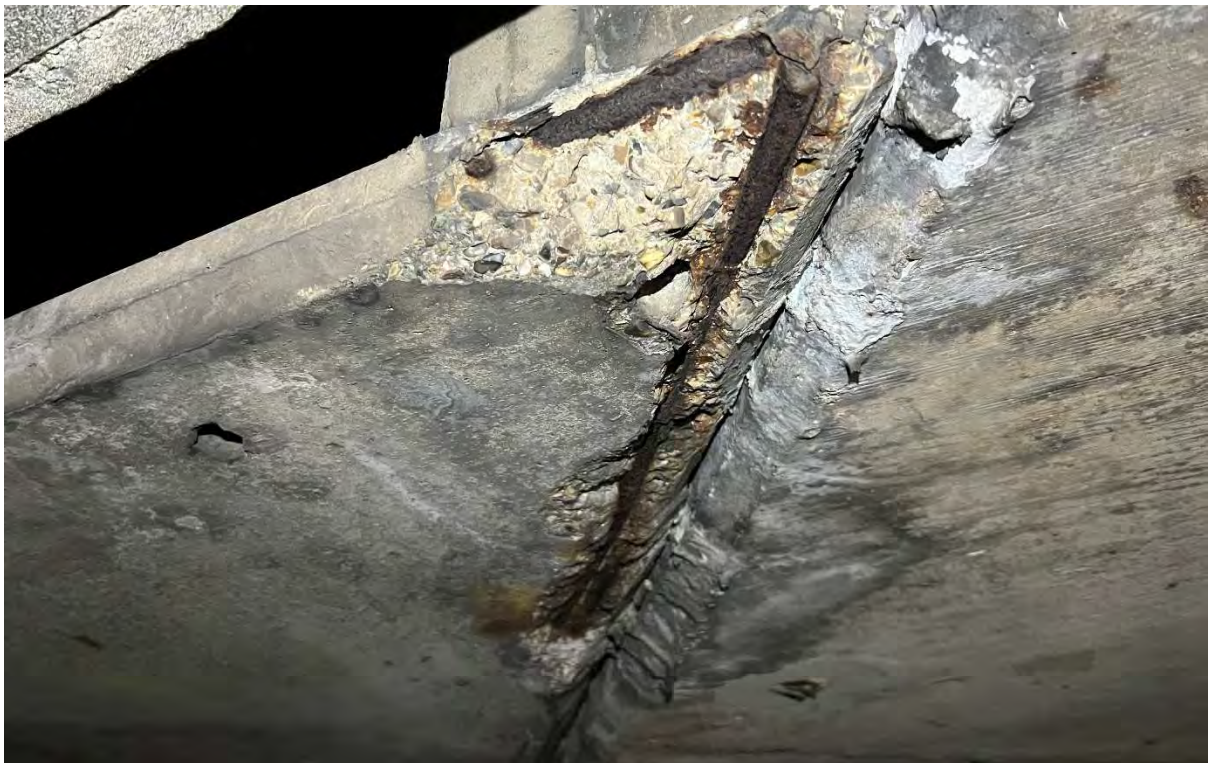
Photograph 8 - Span 1, beam 9. Area of spalling with exposed reinforcement exhibiting minor corrosion, measuring 700x100x15mm.

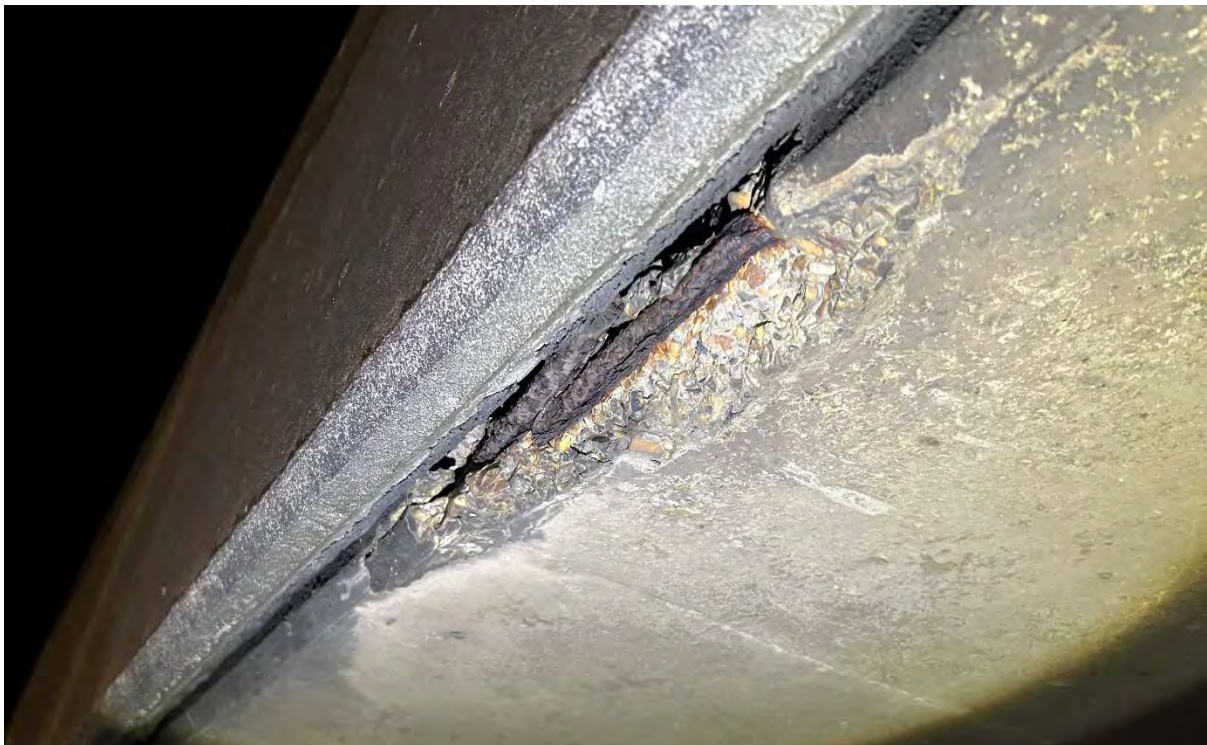
Overall, the span 2 deck soffit was in poor condition, with multiple areas in poor condition <sup>(5)</sup>. Multiple areas of spalled concrete, caused by vehicle strikes, with exposed, corroded reinforcement were observed to the bottom flanges of the beams. There is a significant loss of section to multiple beams with potential for loss of capacity. Additionally, longitudinal cracking was noted to the soffits of the beams.

Photograph 10 - Span 2 W/B, beam 1. Area of spalling with exposed reinforcement exhibiting minor corrosion, measuring 500x80x50mm.

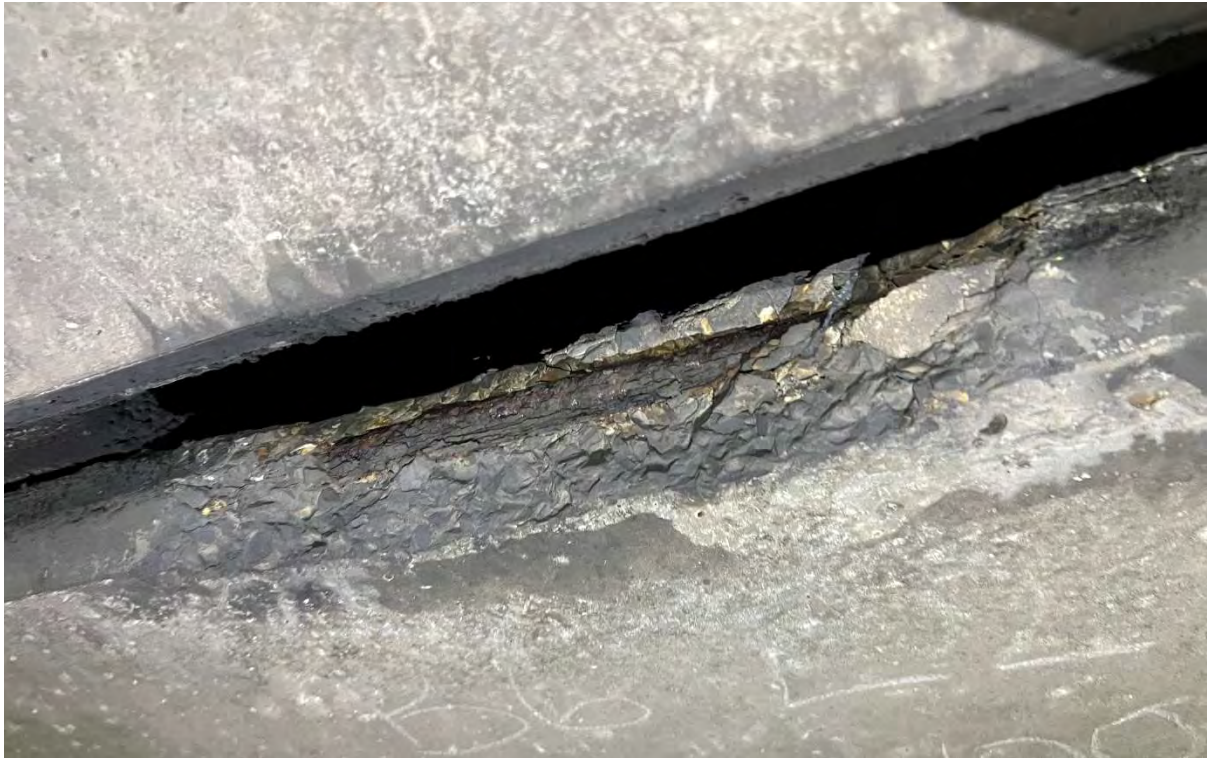
Photograph 11 - Span 2 W/B, beam 4. Area of spalling with exposed reinforcement exhibiting minor corrosion, measuring 400x80x20mm.

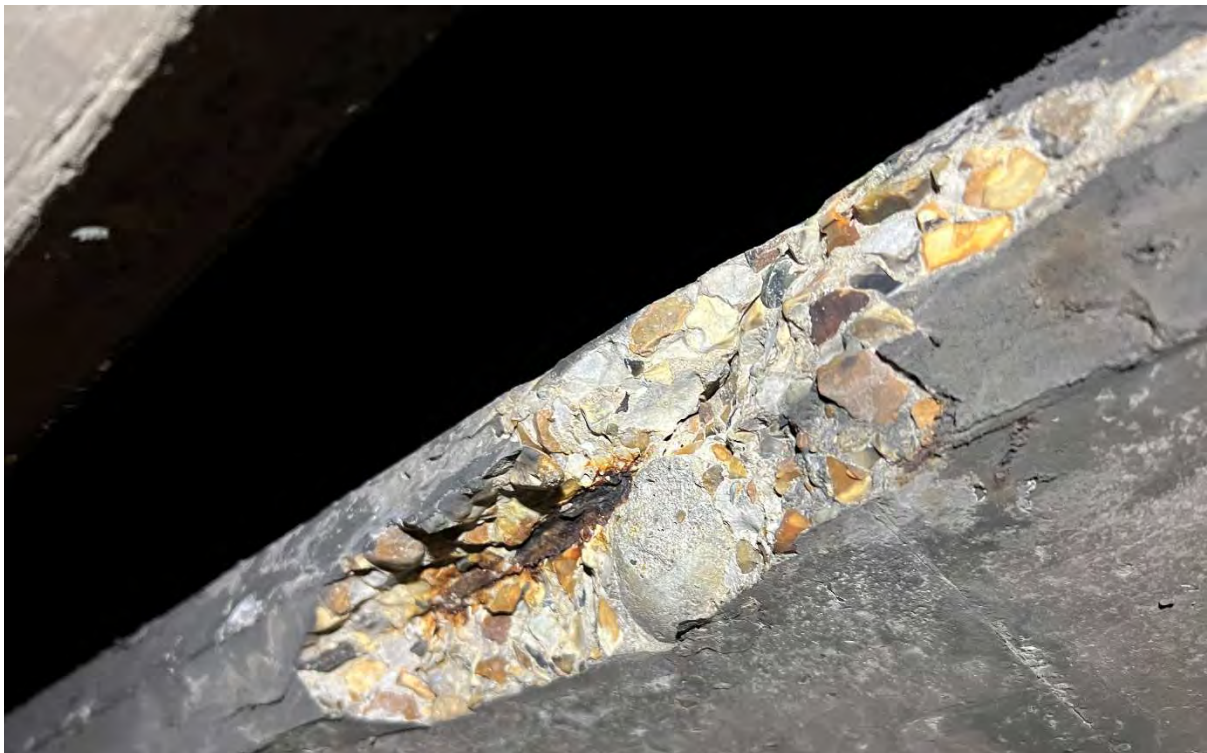
Photograph 12 - Span 2 W/B, beam 5. Area of spalling with exposed reinforcement exhibiting minor corrosion, measuring 200x60x35mm.

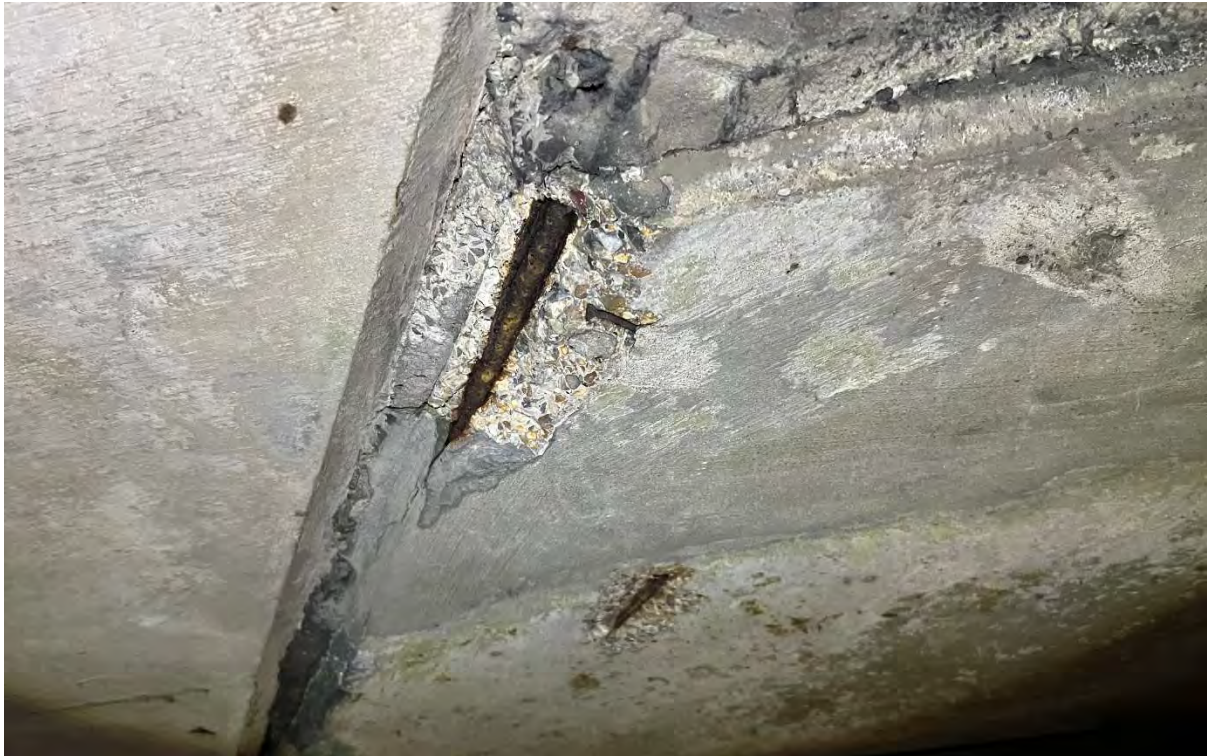
Photograph 13 - Span 2 W/B, beam 5. Sporadic areas of spalled concrete with exposed reinforcement exhibiting minor corrosion to the beam soffit.

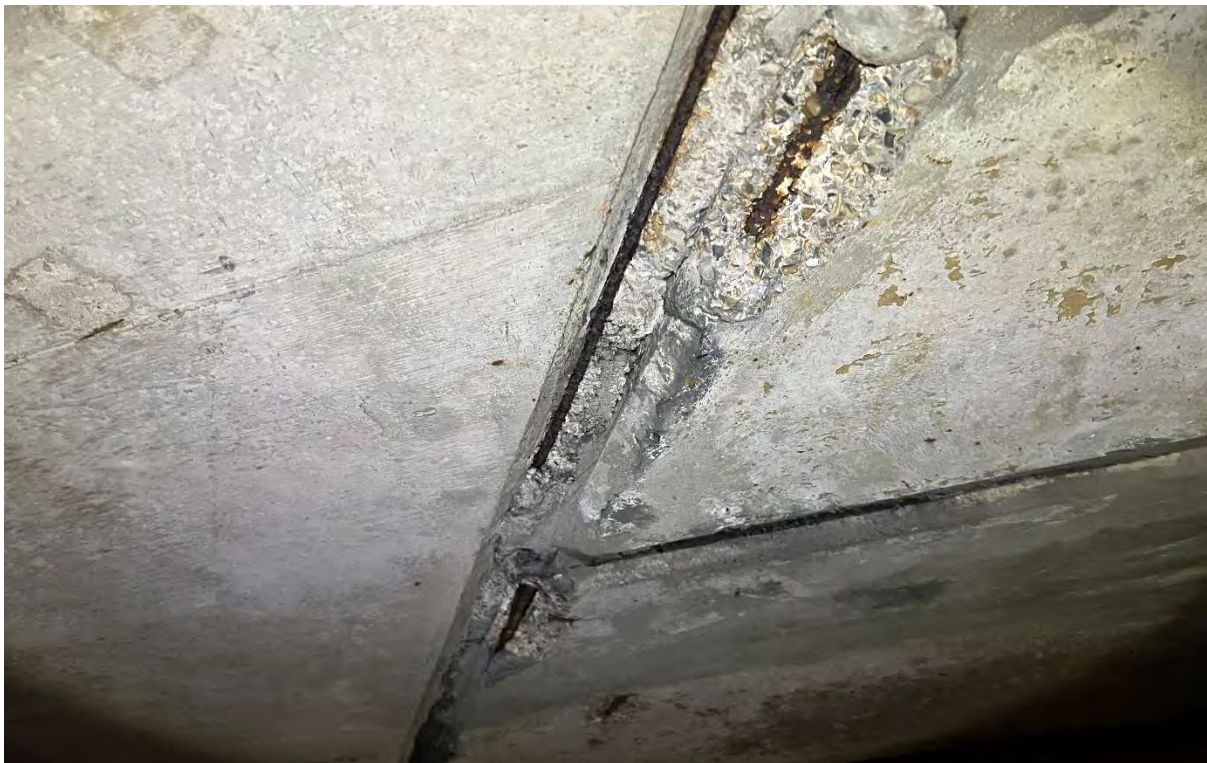
Photograph 14 - Span 2 W/B, beam 6. Sporadic areas of spalled concrete with exposed reinforcement exhibiting minor corrosion between the beam & crosshead.

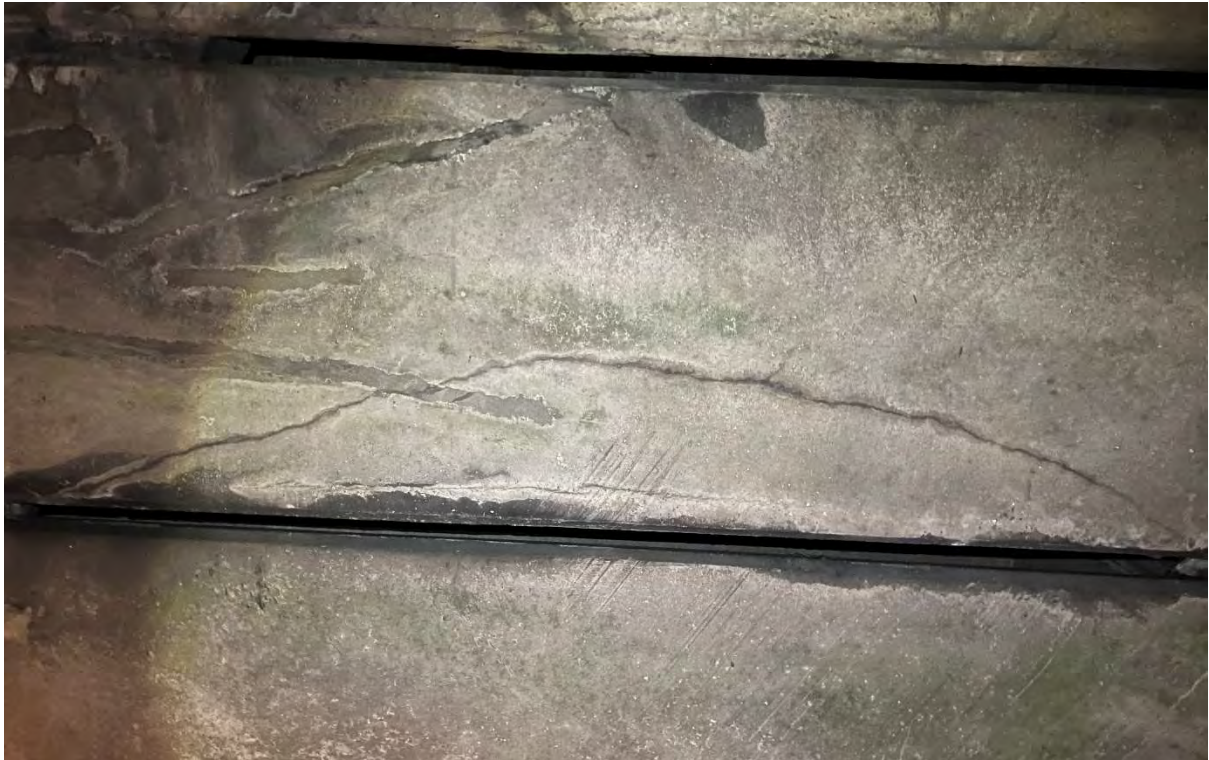
Photograph 15 – Span 2 W/B, beam 8. Longitudinal crack to deck soffit, 1200mm in length and up to 0.2mm in width.

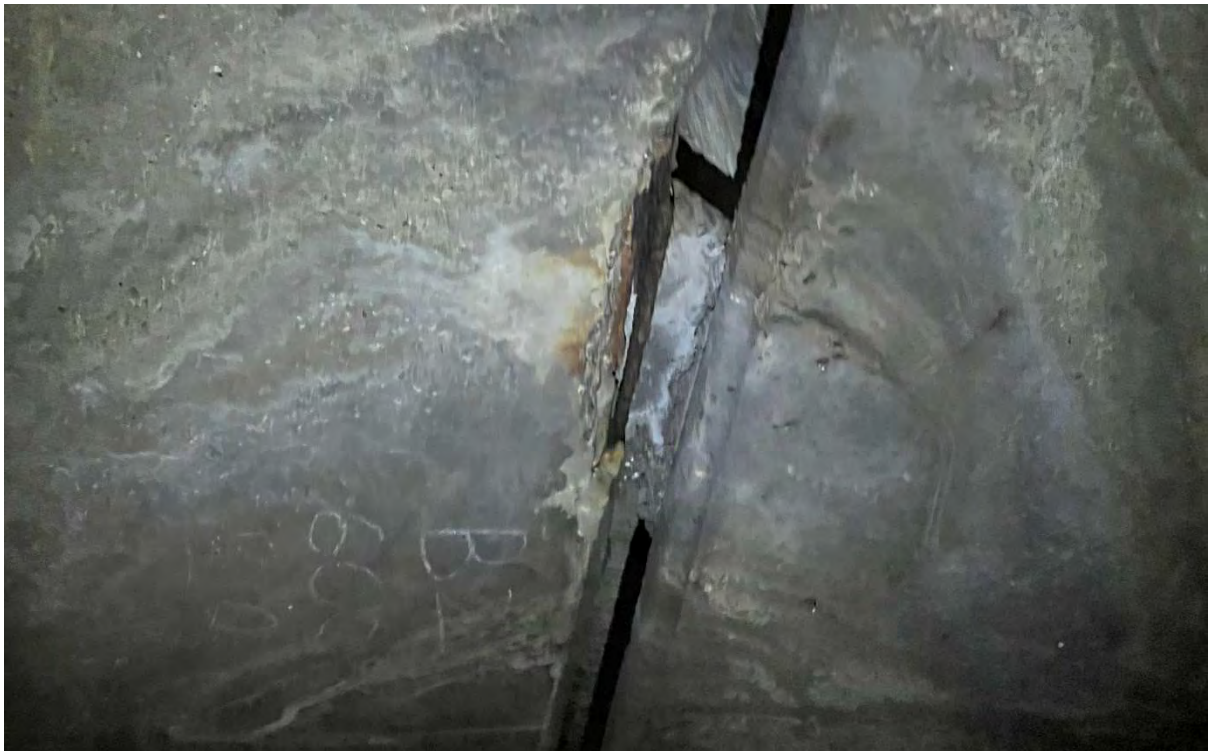
Photograph 16 - Span 2 W/B, beam 8. Area of spalling with exposed reinforcement exhibiting minor corrosion, measuring 500x80x35mm.

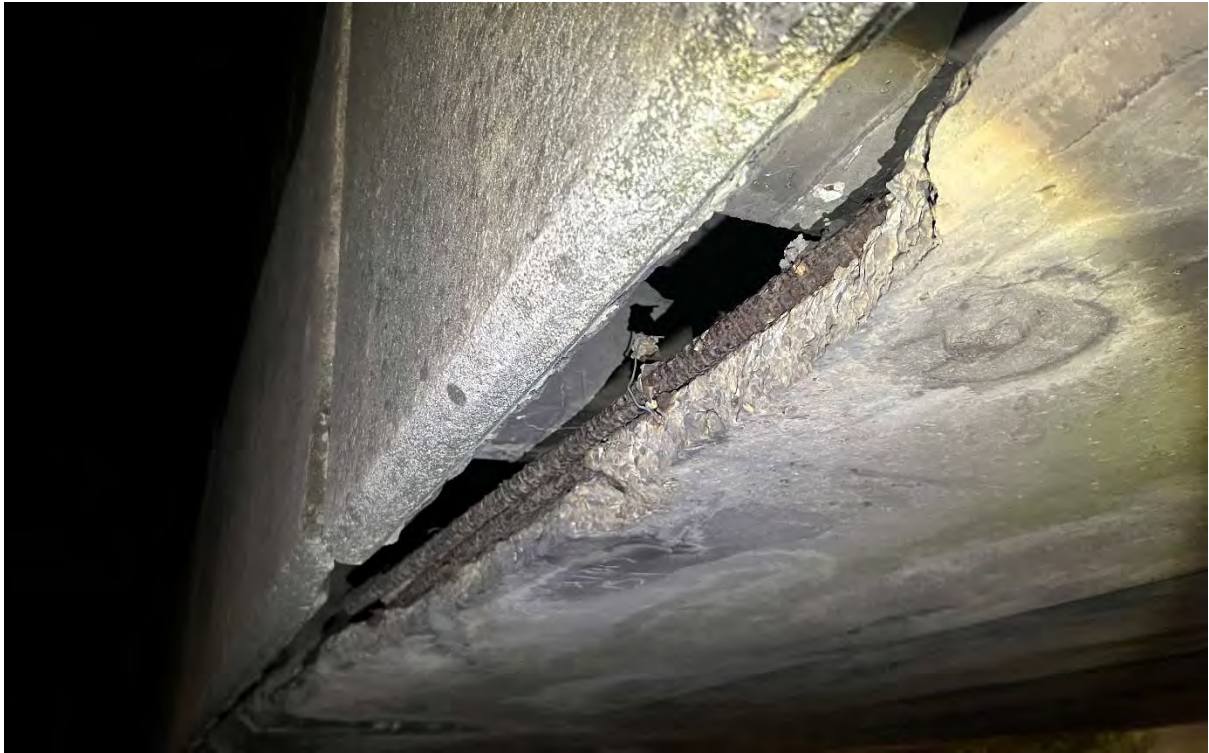
Photograph 17 - Span 2 W/B, beam 9. Area of spalling with exposed reinforcement exhibiting minor corrosion, measuring 2500x80x100mm.

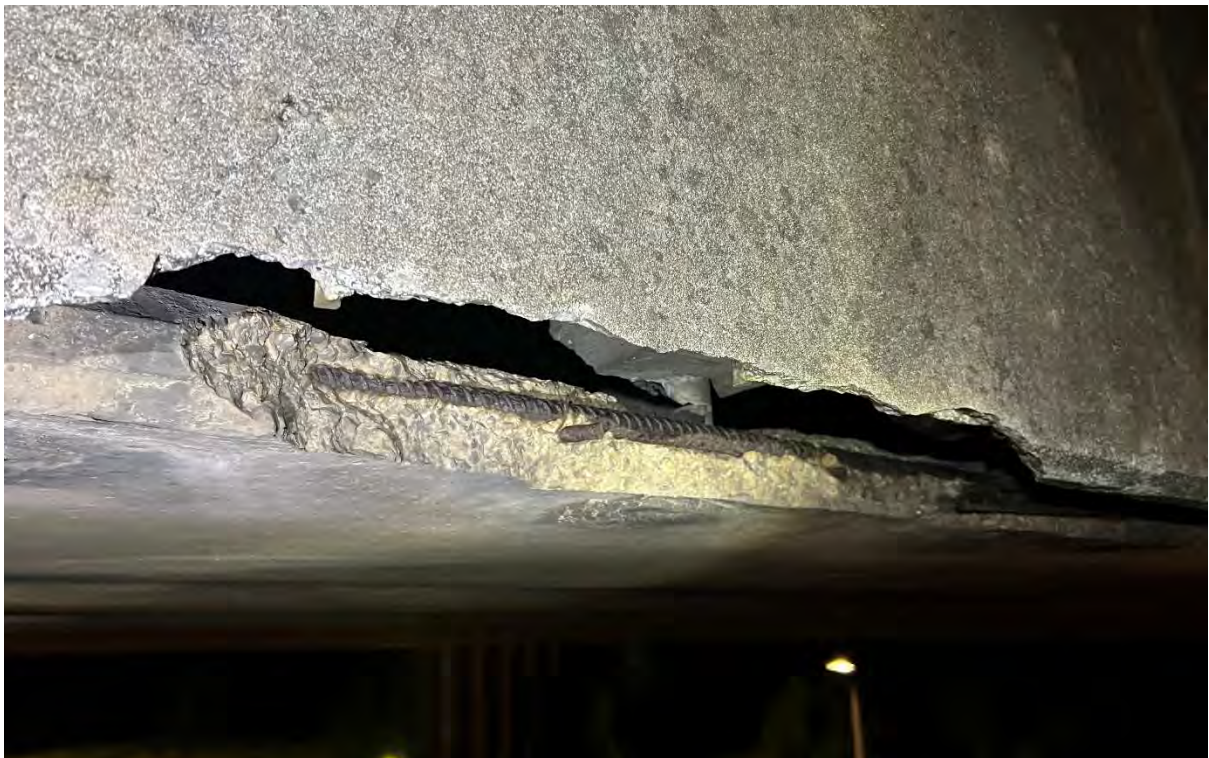
Photograph 18 - Span 2, W/B, beam 9. Area of spalling with exposed reinforcement exhibiting minor corrosion, measuring 2000x80x55mm.

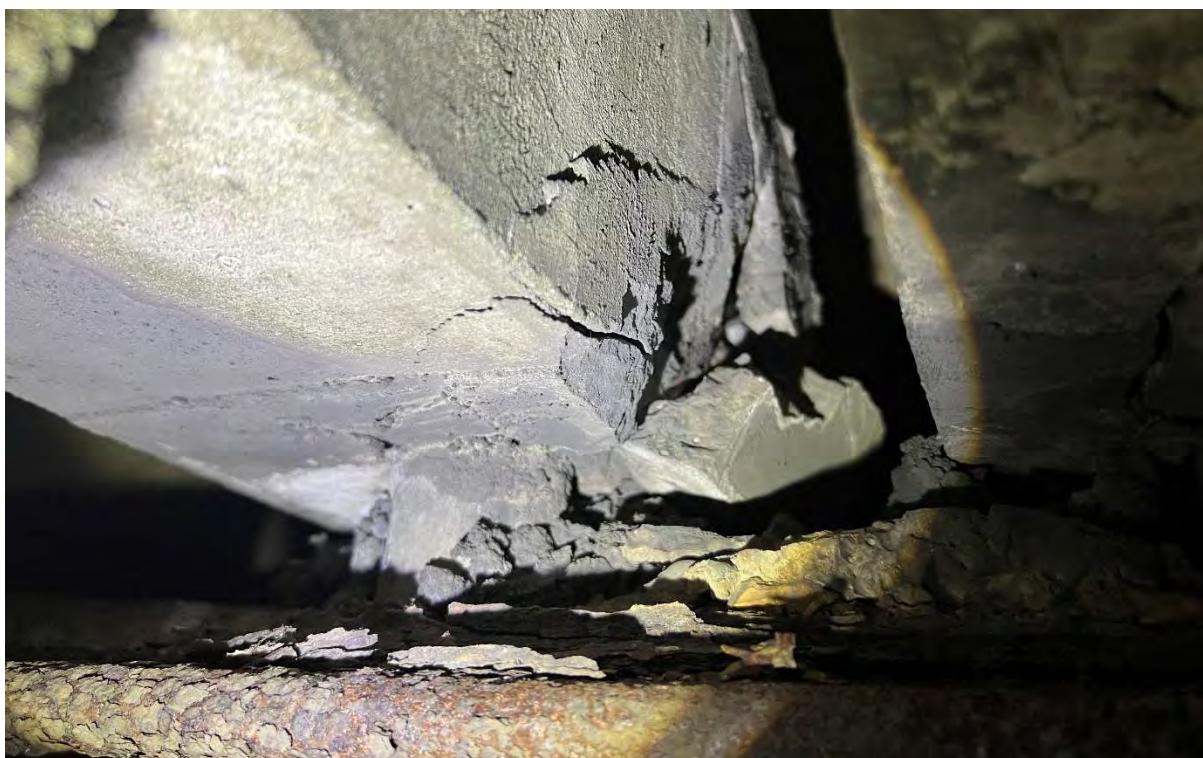
Photograph 19 - Span 2 W/B, beam 9. Area of spalling and loose concrete to edge unit connection.

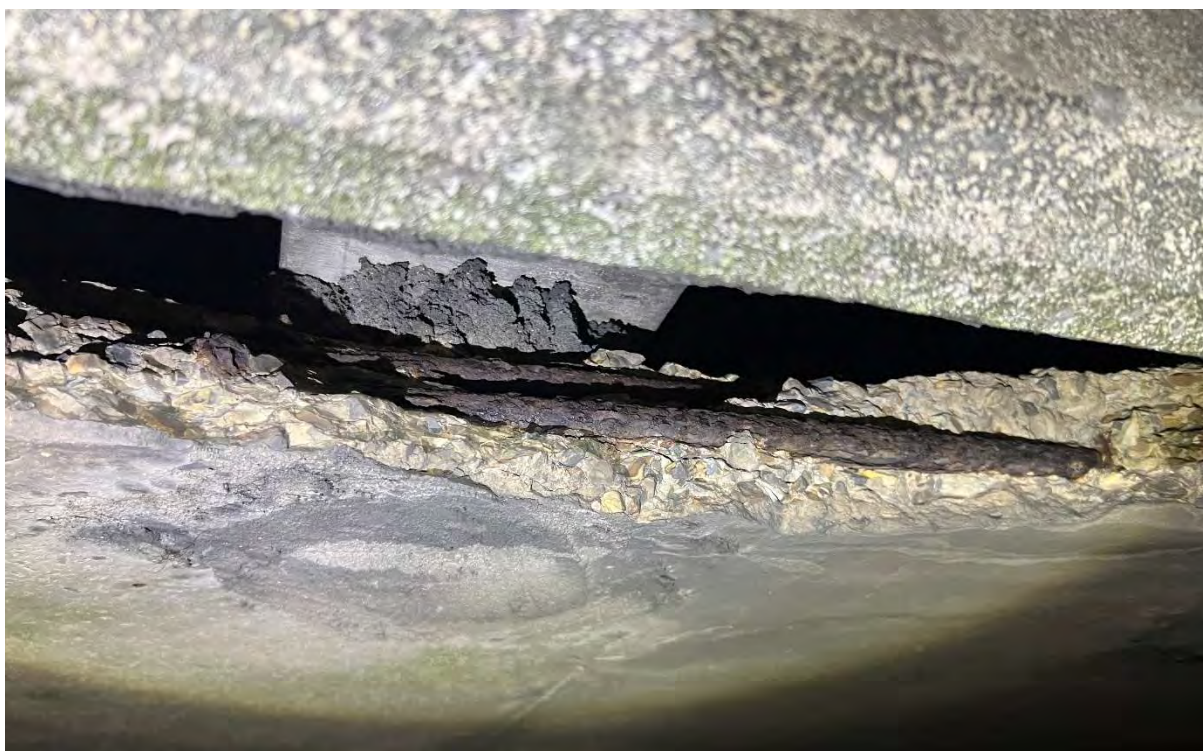
Photograph 20 - Span 2 W/B, beam 9. Area of spalling with exposed reinforcement exhibiting minor corrosion, measuring 700x80x50mm.

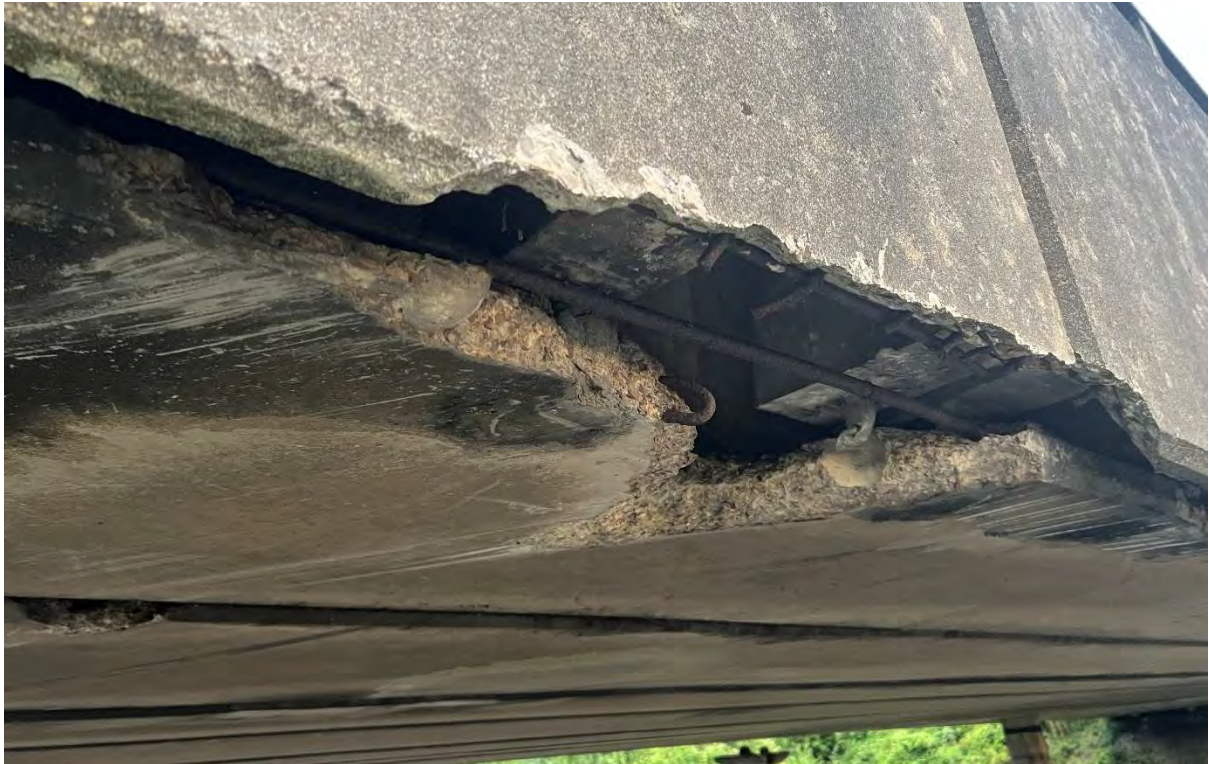
Photograph 21 - Span 2 E/B, beam 1. Area of spalling with exposed reinforcement exhibiting minor corrosion, measuring 1100x600x100mm.

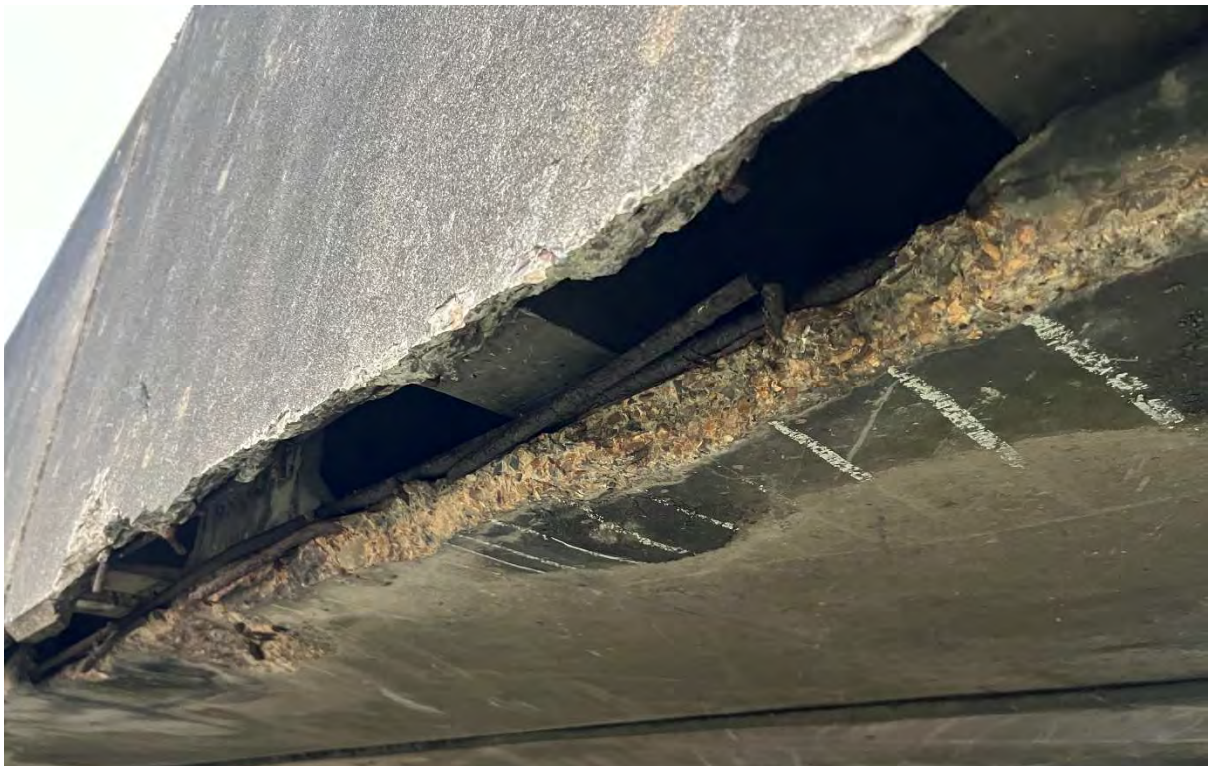
Photograph 22 - Span 2 E/B, beam 1. Area of spalling with exposed reinforcement exhibiting minor corrosion, measuring 3200x60x100mm.

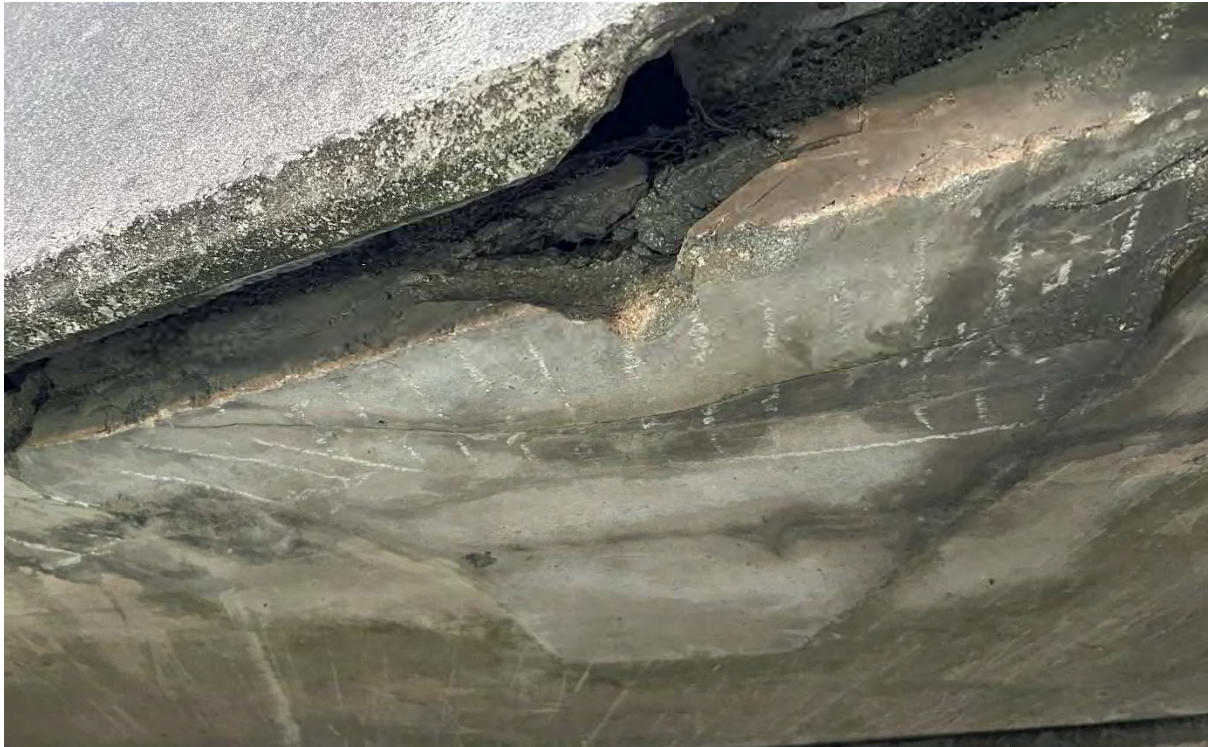
Photograph 23 - Span 2 E/B, beam 1. Area of delamination, measuring 800x150mm.

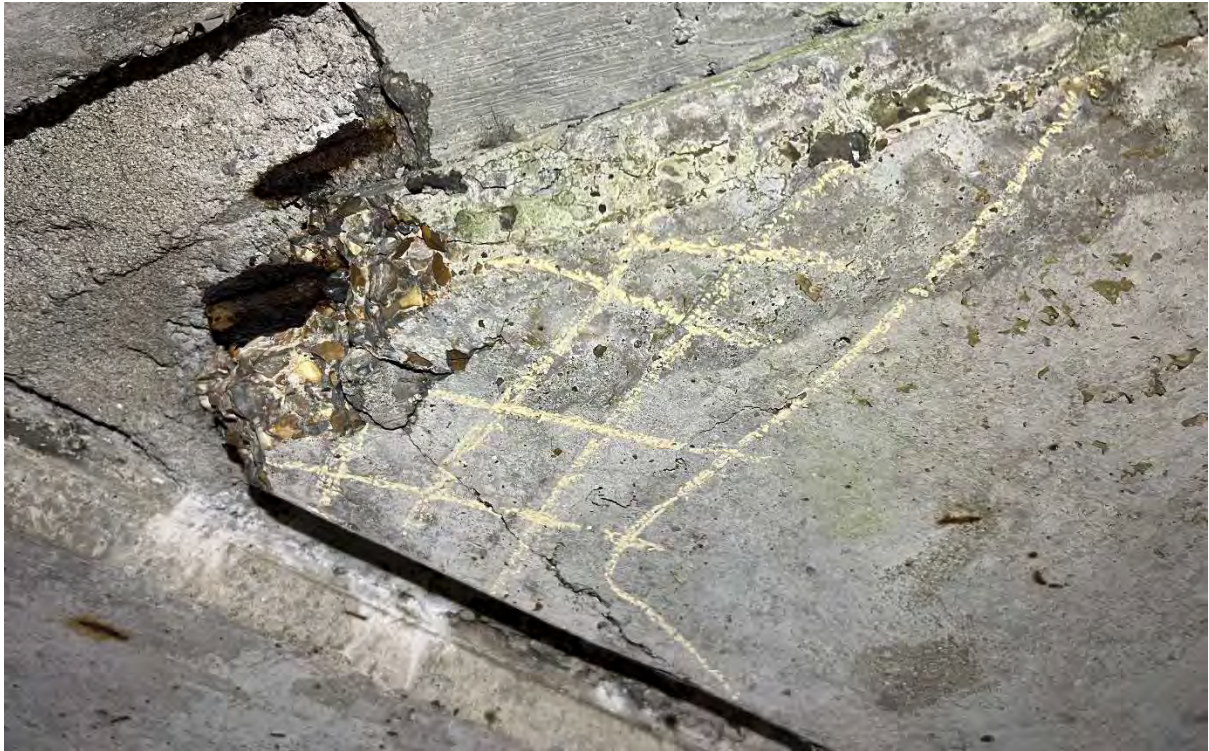
Photograph 25 - Span 2 E/B, beam 1. Area of spalling & delamination with exposed reinforcement exhibiting minor corrosion, measuring 300x200x40mm.

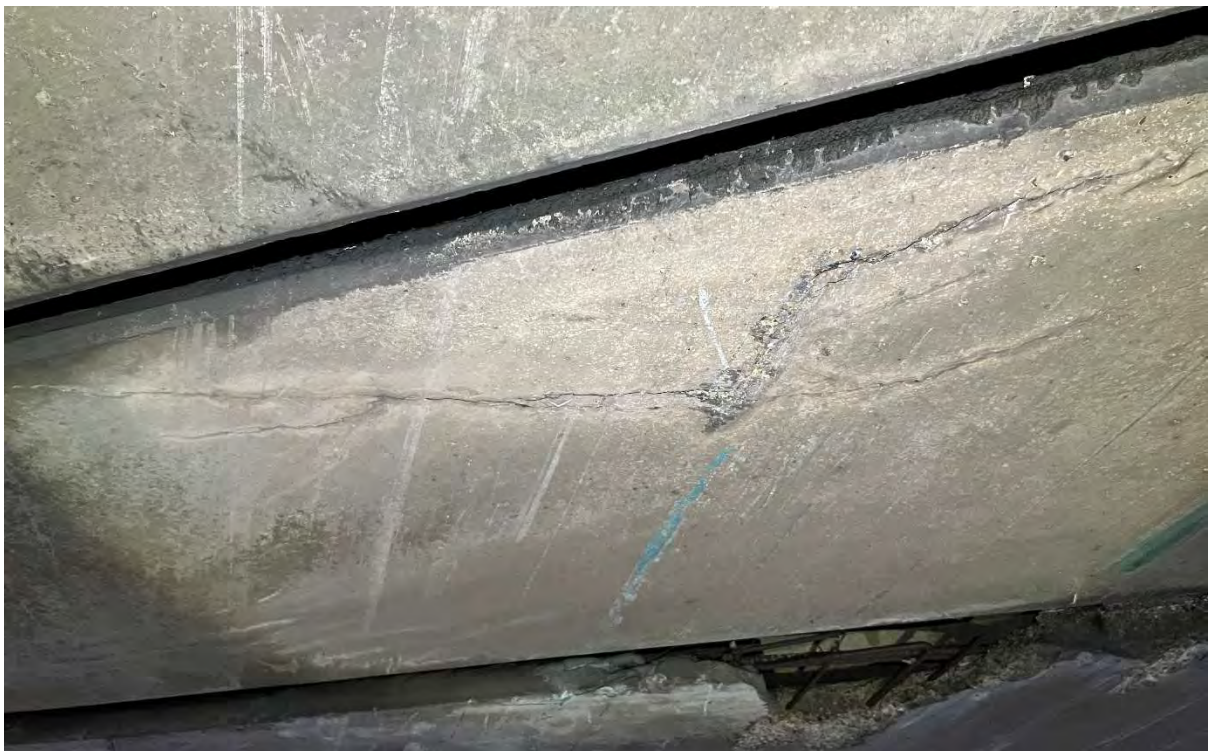
Photograph 26 - Span 2 E/B, beam 2. Longitudinal crack to beam soffit, measuring 2500mm in length and up to 0.9mm in width.

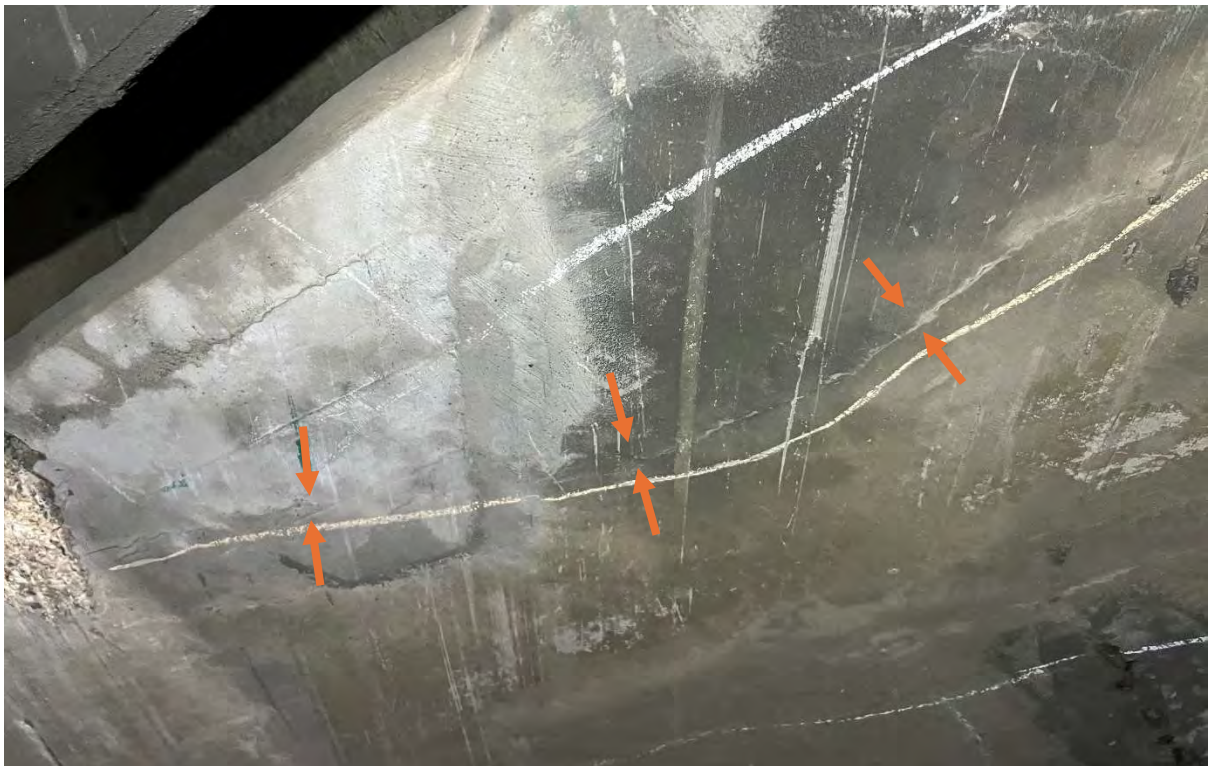
Photograph 28 - Span 2 E/B, beam 3. Longitudinal crack, measuring 1700mm in width and up to 0.2mm in width.

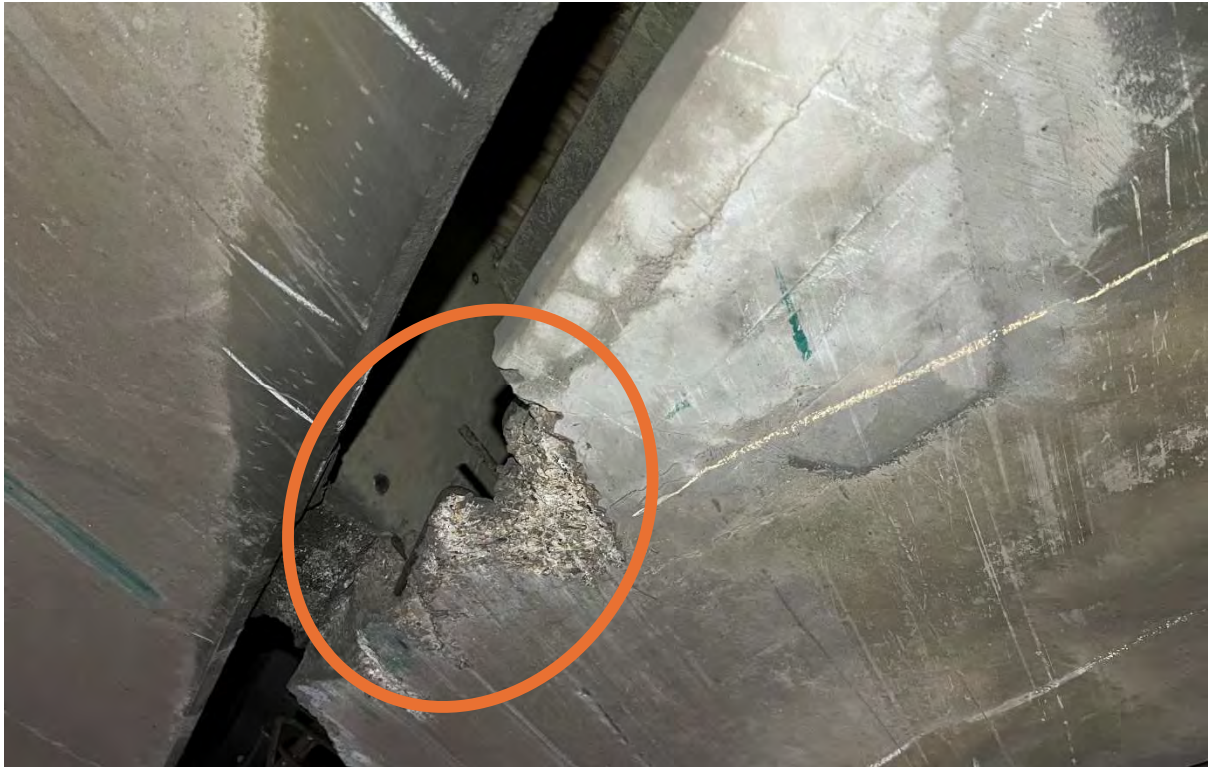
Photograph 29 - Span 2 E/B, beam 3. Area of spalling with exposed reinforcement exhibiting minor corrosion, measuring 900x120x100mm.

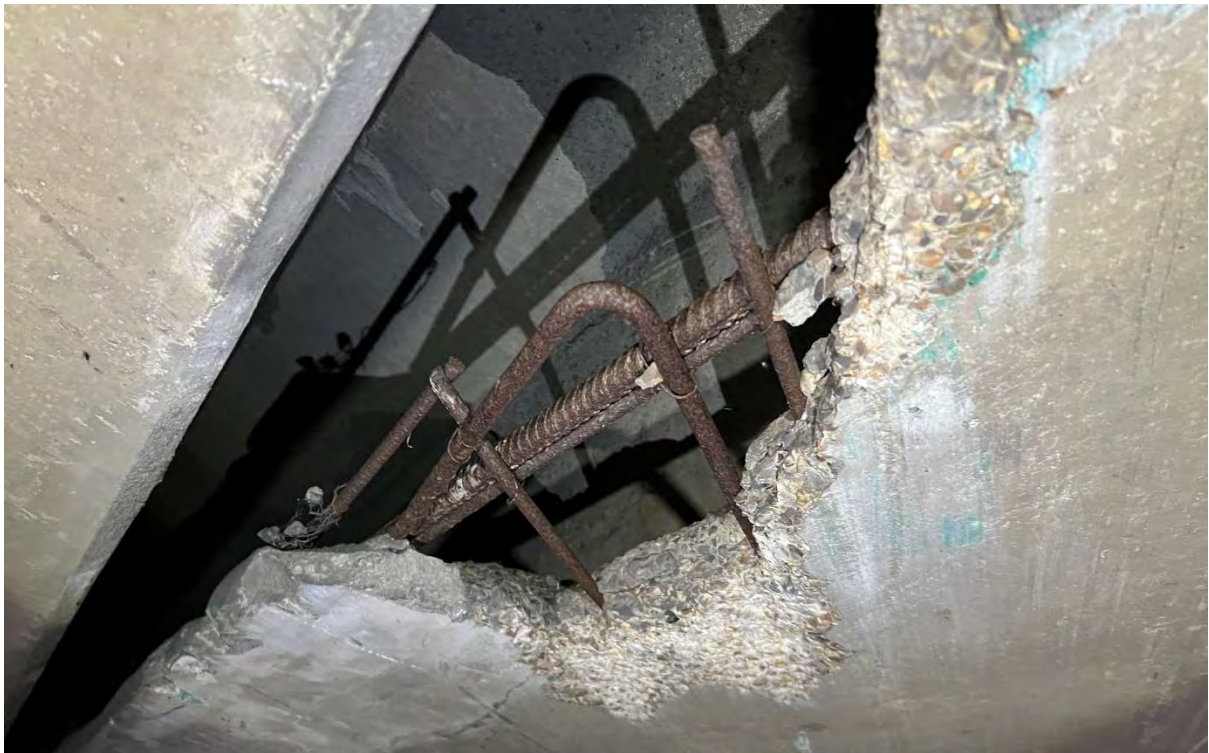
Photograph 30 - Span 2 E/B, beam 3. Area of spalling with exposed reinforcement exhibiting minor corrosion, measuring 700x600x100mm.

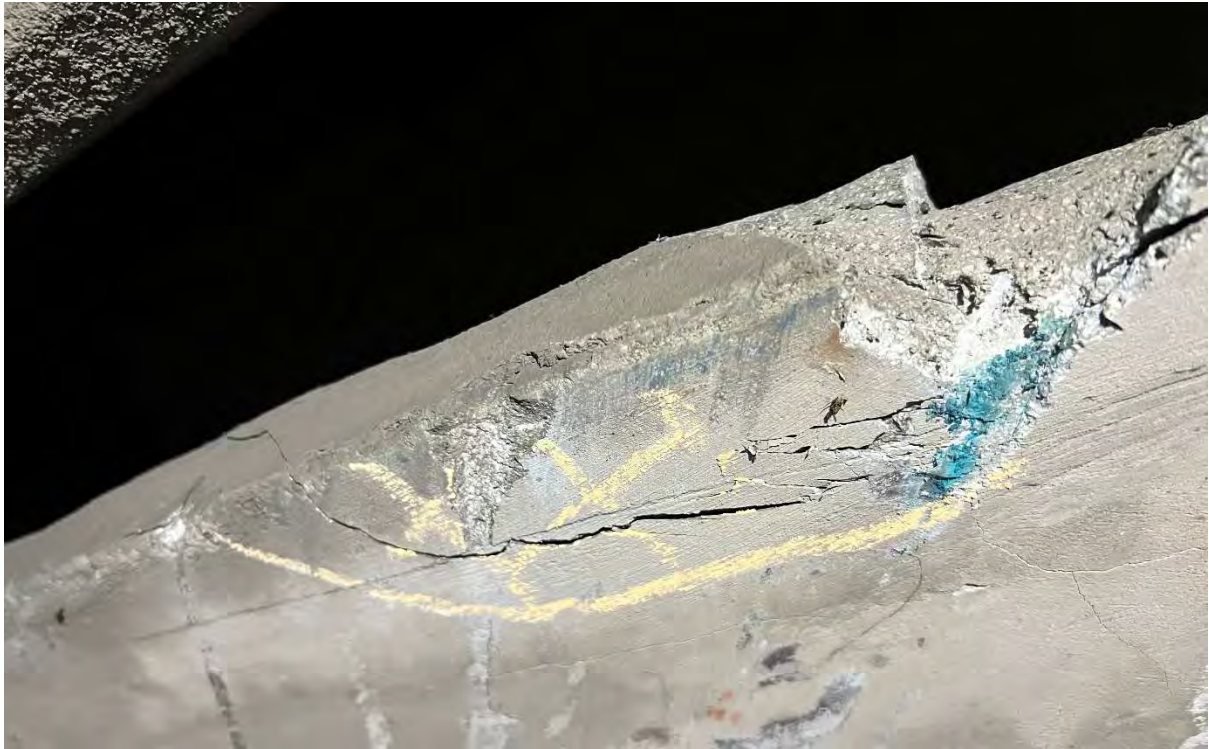
Photograph 31 – Span 2 E/B, beam 3. Area of delaminated concrete, measuring 250x75mm.

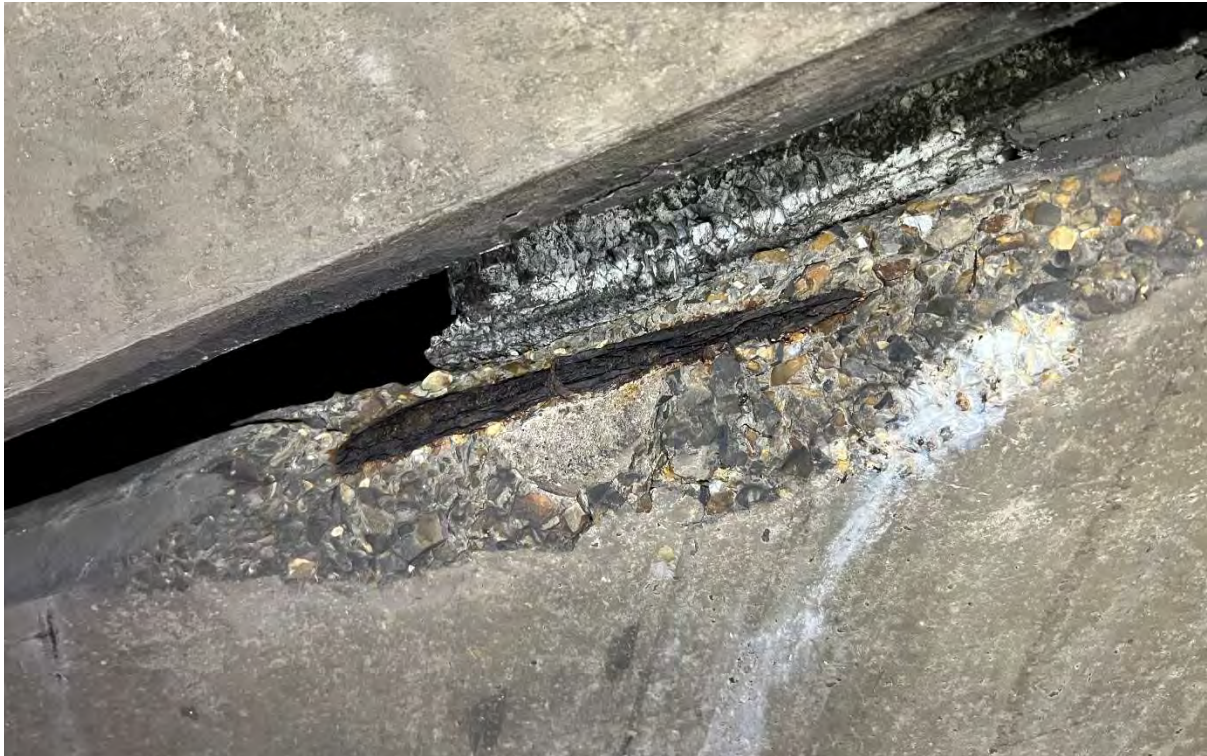
Photograph 33 - Span 2 E/B, beam 4. Area of spalling with exposed reinforcement exhibiting minor corrosion, measuring 400x40x75mm.

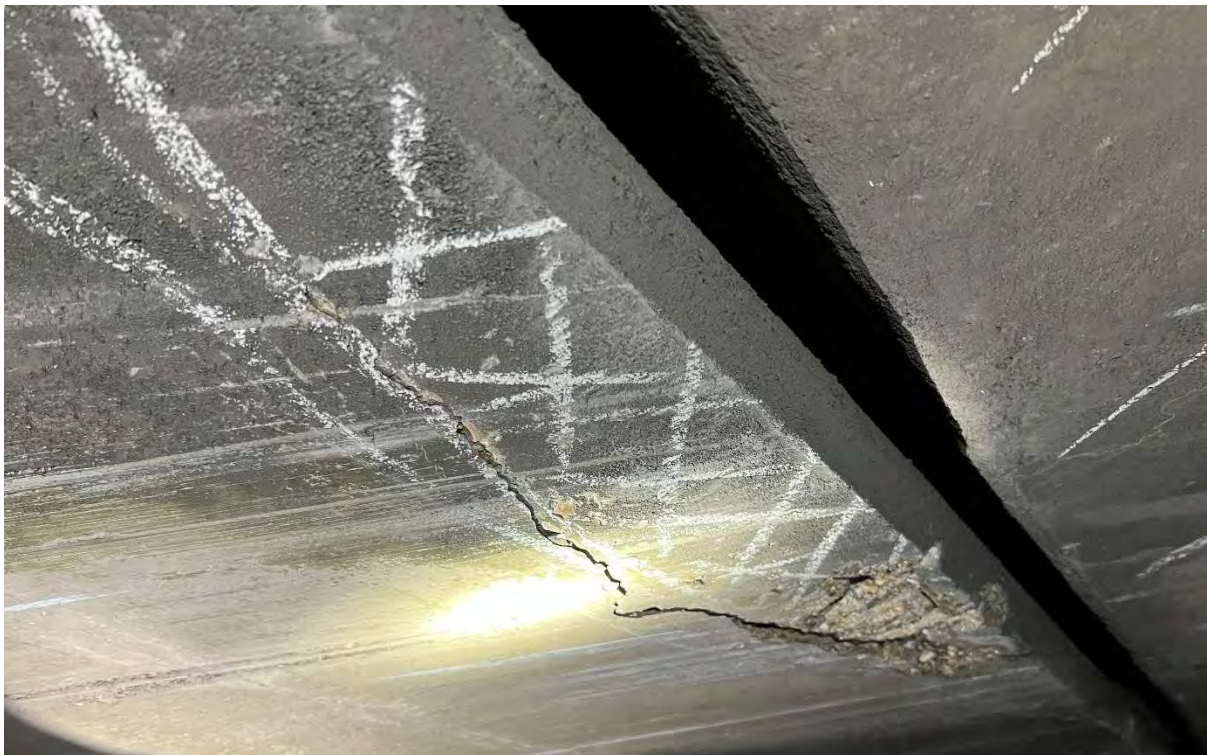
Photograph 34 - Span 2 E/B, beam 4. Area of spalling and delamination, measuring 1000x200mm.
