## Bishton-Llanmartin Overbridge M4 23A-24 51 Principal Inspection Report 2025/26

Service Provider/Consultant Name: Arcadis

Service Provider/Consultant Project Number: 30286543

T-WHIS Number: CTI/005

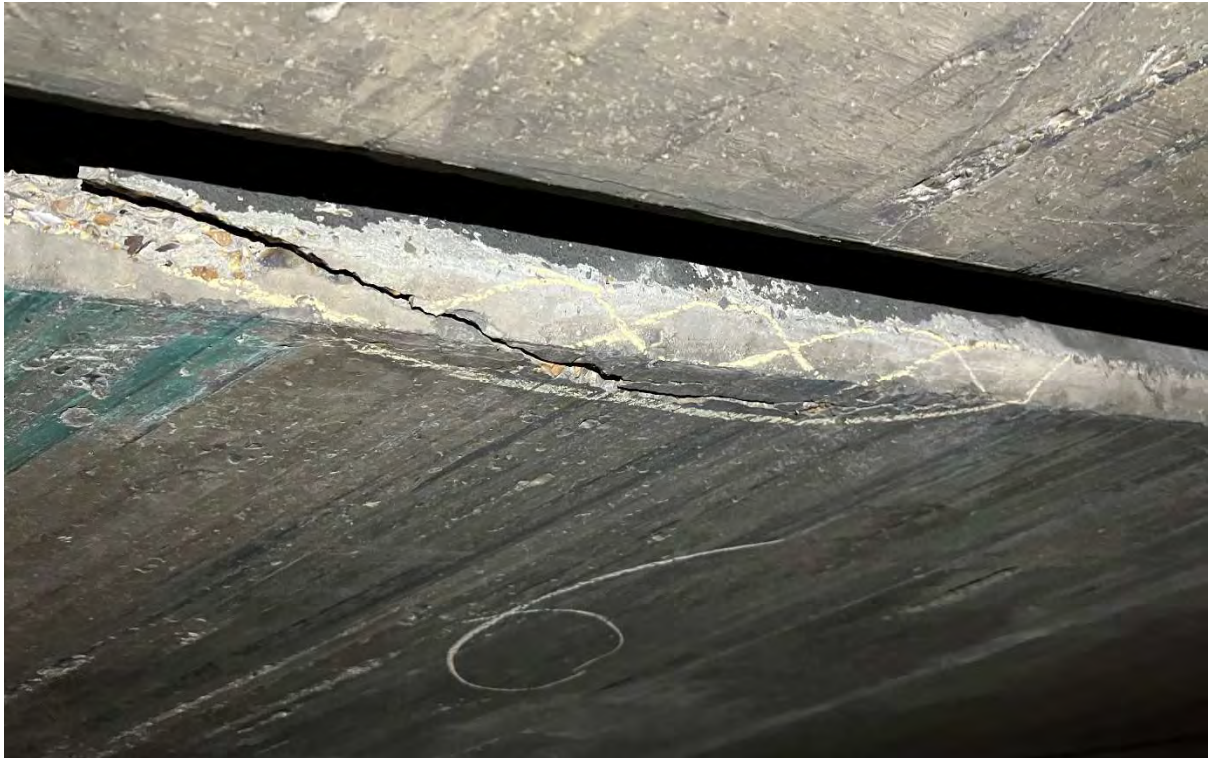
Overall, the span 2 deck soffit was in poor condition, with multiple areas in poor condition <sup>(5)</sup>. Multiple areas of spalled concrete, caused by vehicle strikes, with exposed, corroded reinforcement were observed to the bottom flanges of the beams. There is a significant loss of section to multiple beams with potential for loss of capacity. Additionally, longitudinal cracking was noted to the soffits of the beams.

Photograph 35 - Span 2 E/B, beam 4. Area of delamination to beam soffit, measuring 600x100mm.

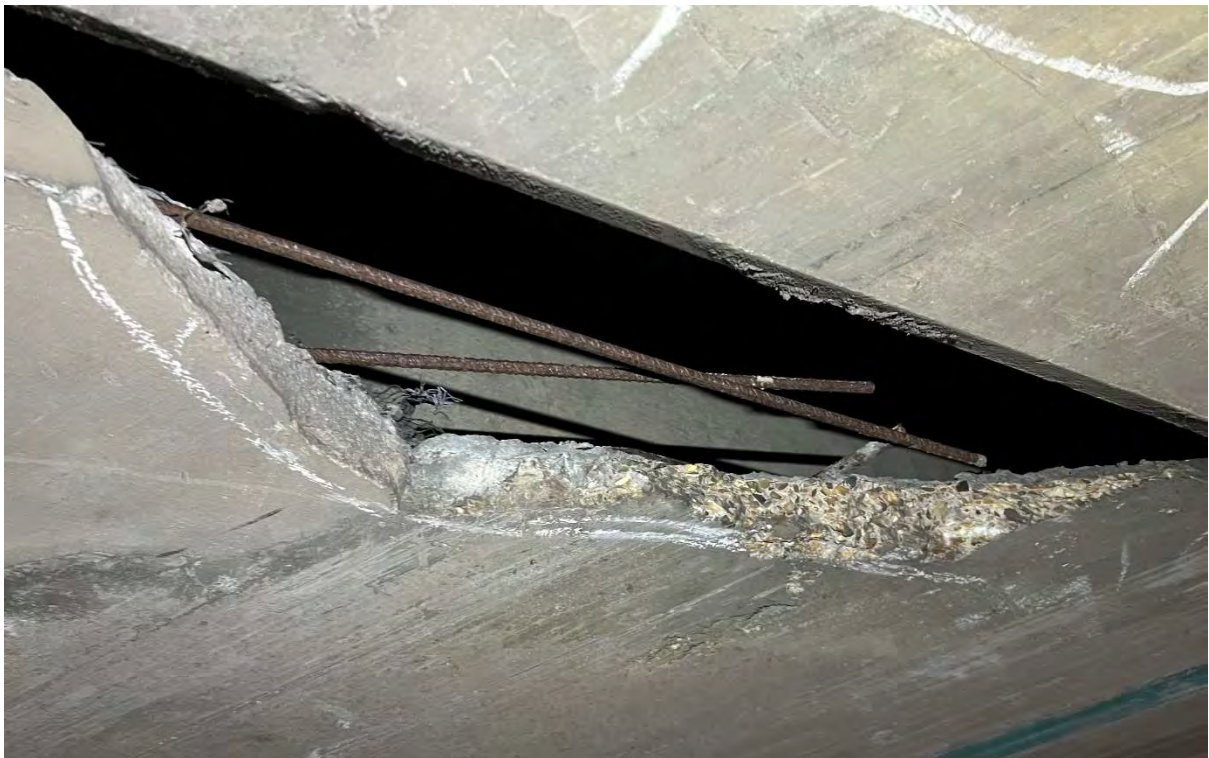
Photograph 36 - Span 2 E/B, beam 5. Area of spalling with exposed reinforcement exhibiting minor corrosion, measuring 800x200x100mm.

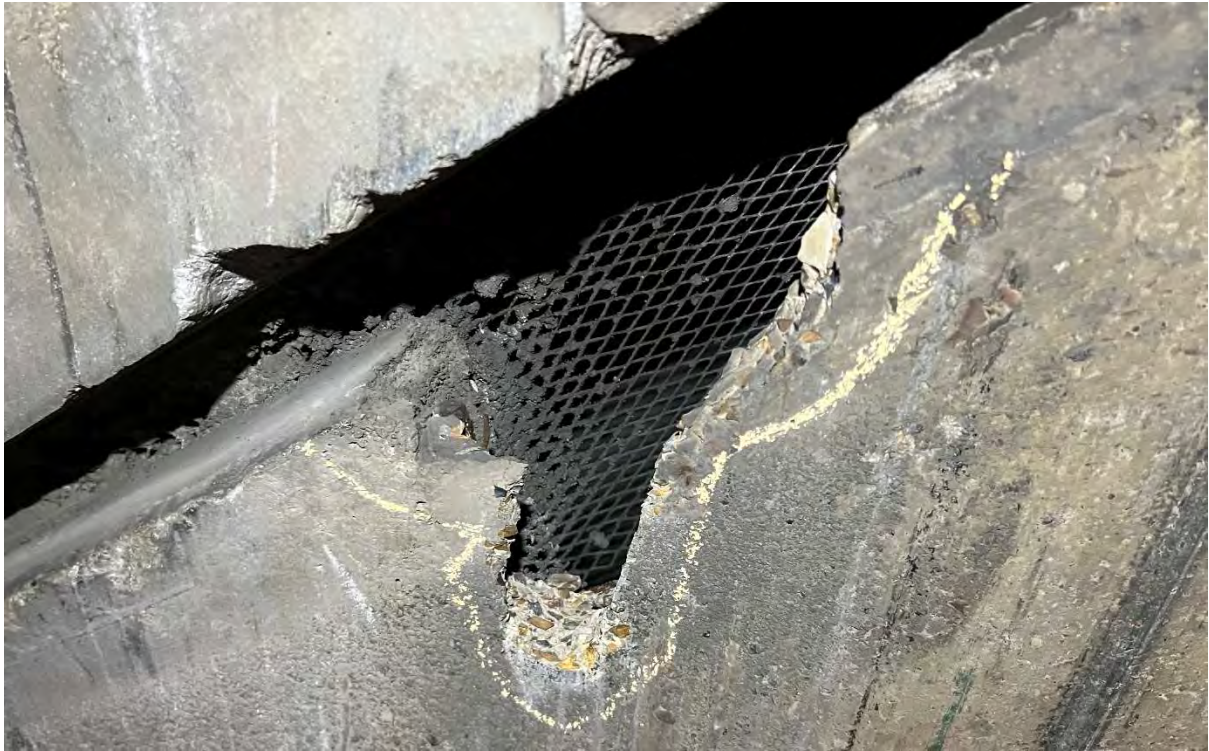
Photograph 37 - Span 2 E/B, beam 5. Area of spalling, measuring 300x400x100mm.

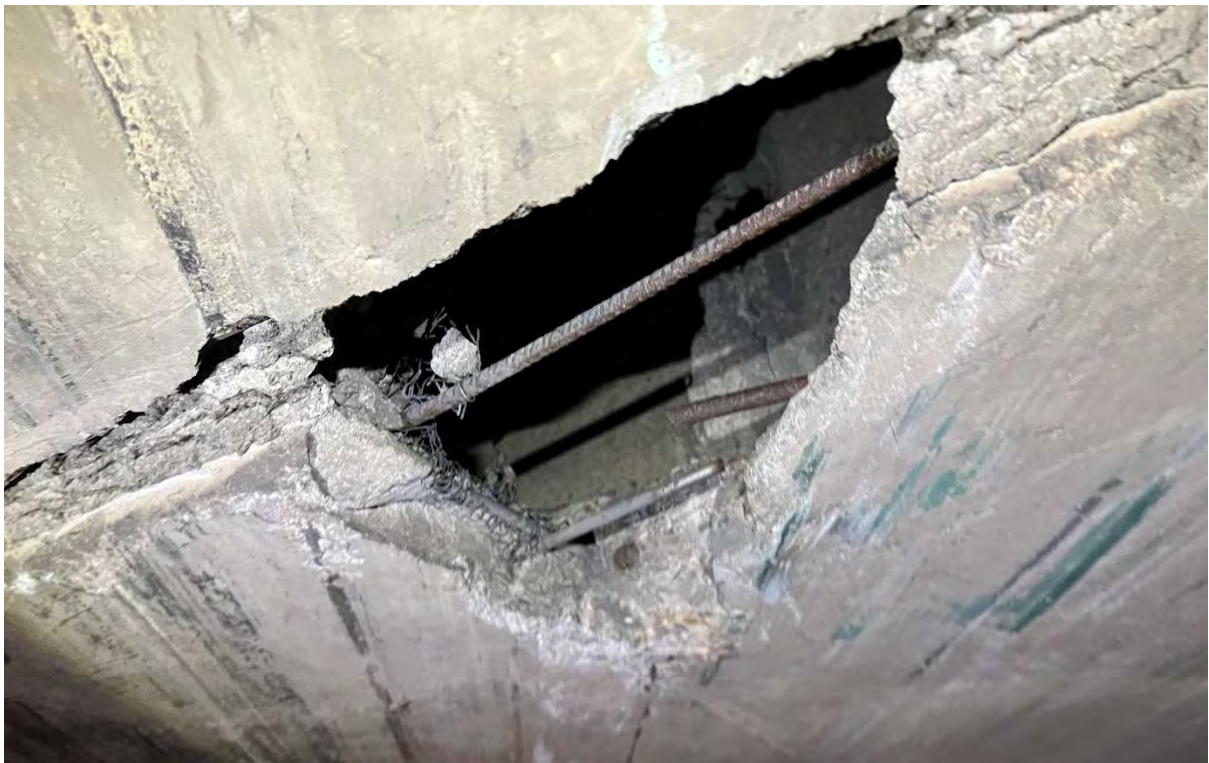
Photograph 38 - Span 2 E/B, beam 6. Area of spalling with exposed reinforcement exhibiting minor corrosion, measuring 300x400x100mm.

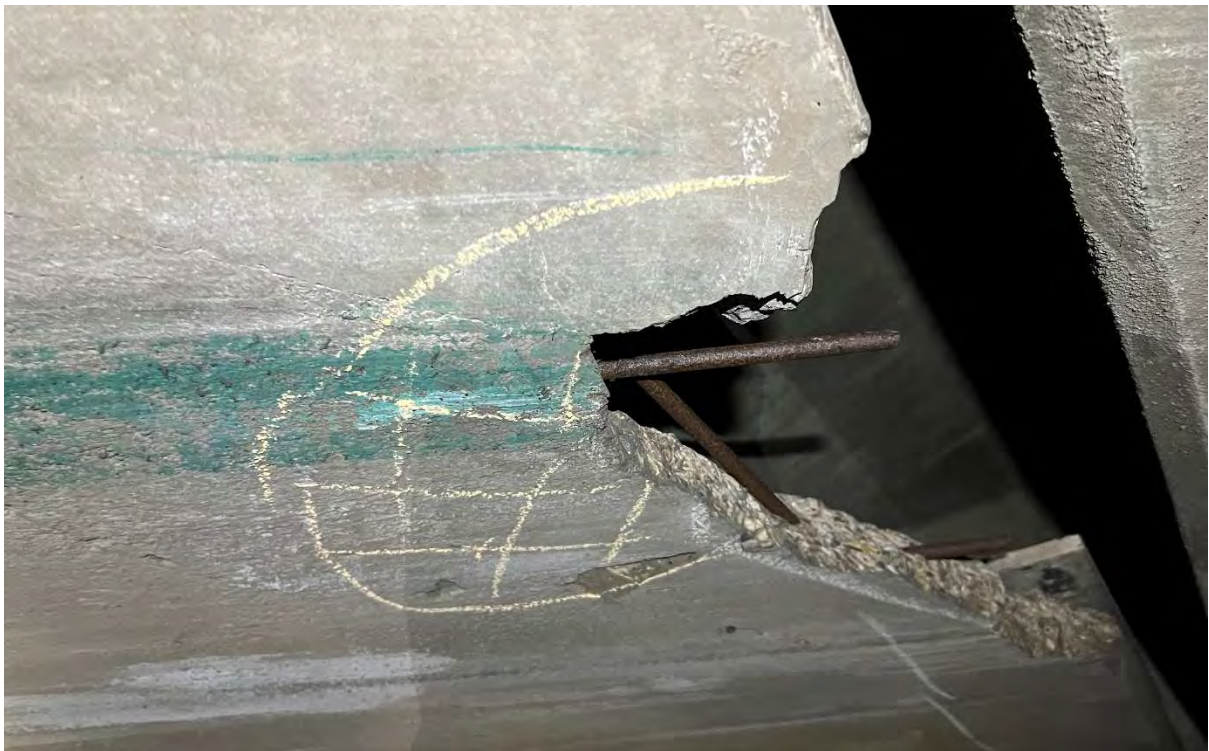
Photograph 40 - Span 2 E/B, beam 7. Area of spalling (700x200x100mm) & delamination (200x300mm) with exposed reinforcement exhibiting minor corrosion.

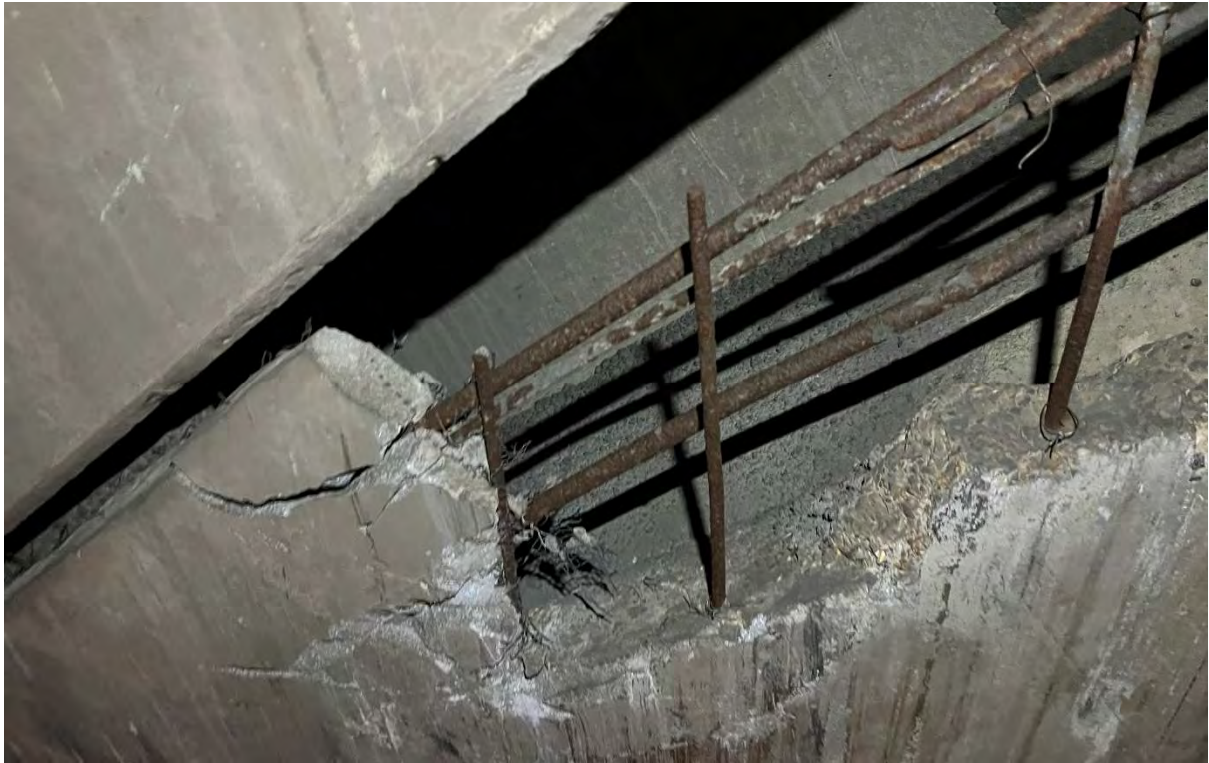
Photograph 41 - Span 2 E/B, beam 7. Area of spalling with exposed reinforcement exhibiting minor corrosion, measuring 1200x450x100mm.

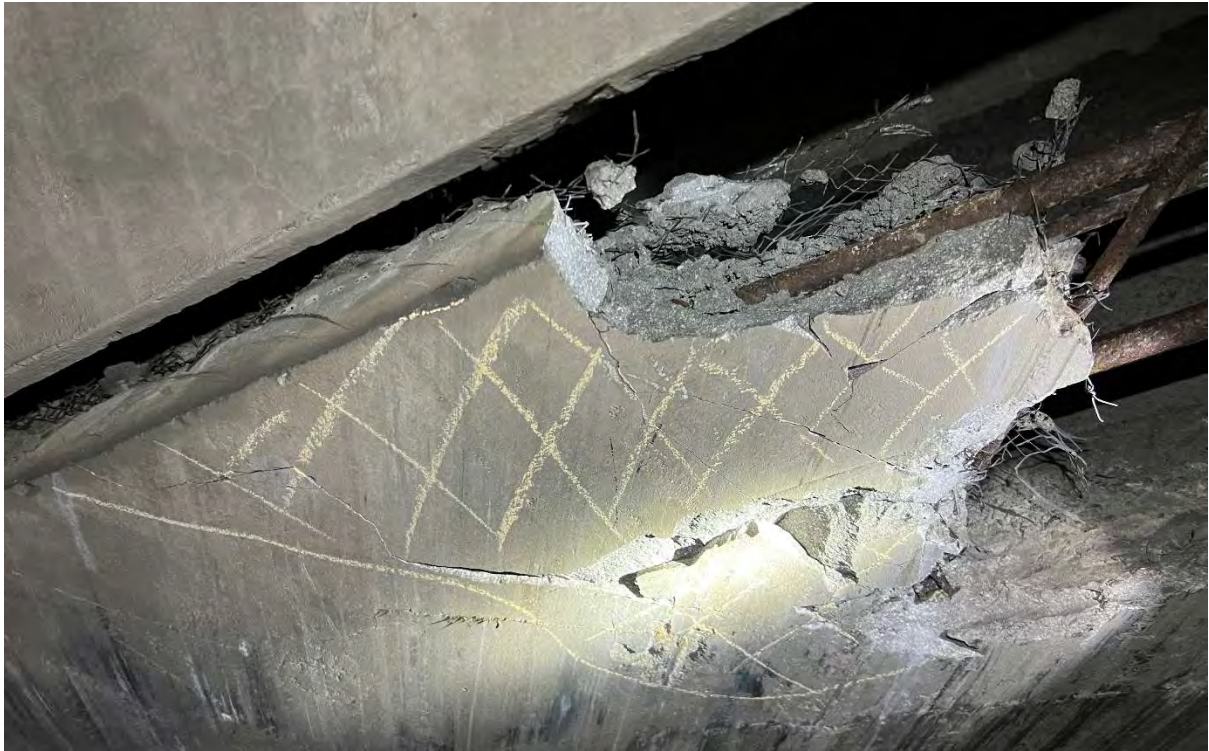
Photograph 42 - Span 2 E/B, beam 7. Area of delamination, measuring 700x500mm.

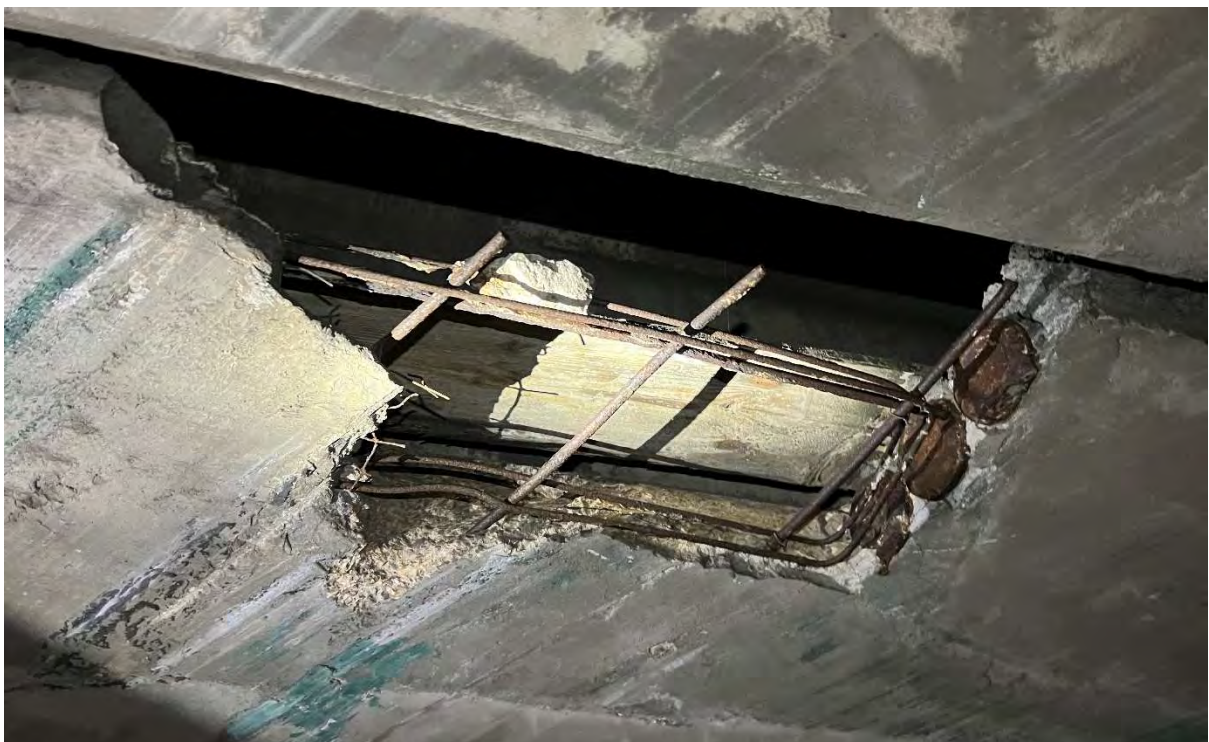
Photograph 44 - Span 2 E/B, beam 9. Area of spalling with exposed reinforcement exhibiting minor corrosion, measuring 900x500x100mm.

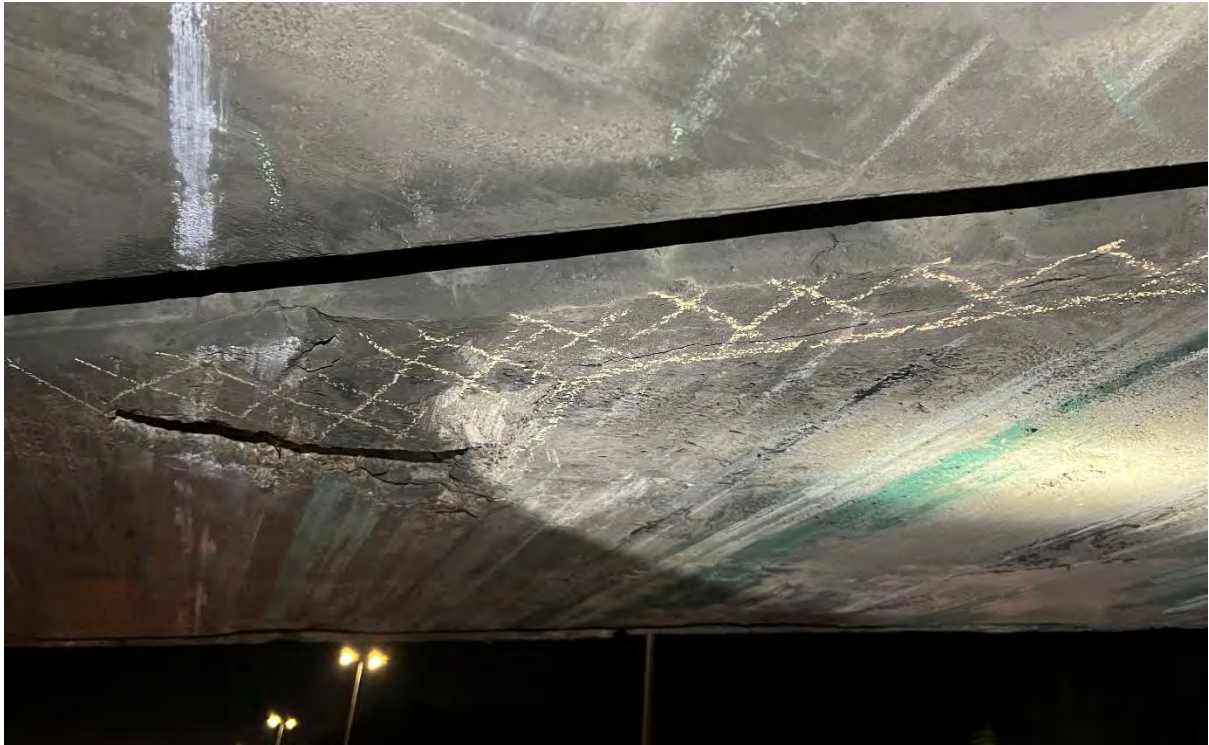
Photograph 45 - Span 2 E/B, beam 9. Area of spalling (400x200x35mm) and delamination (1100x250mm).

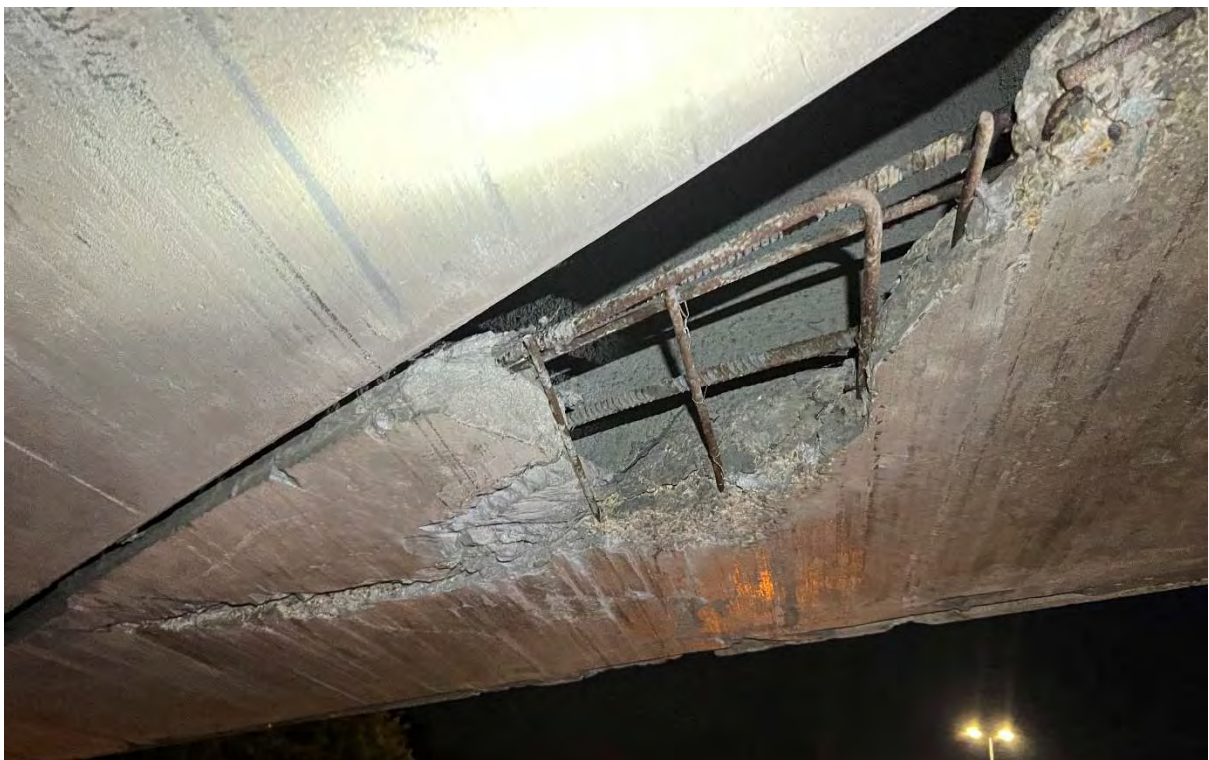
Photograph 46 - Span 2 E/B, beam 9. Area of delamination (2000x500mm) and spalling (1200x550x100mm) with exposed reinforcement exhibiting minor corrosion.

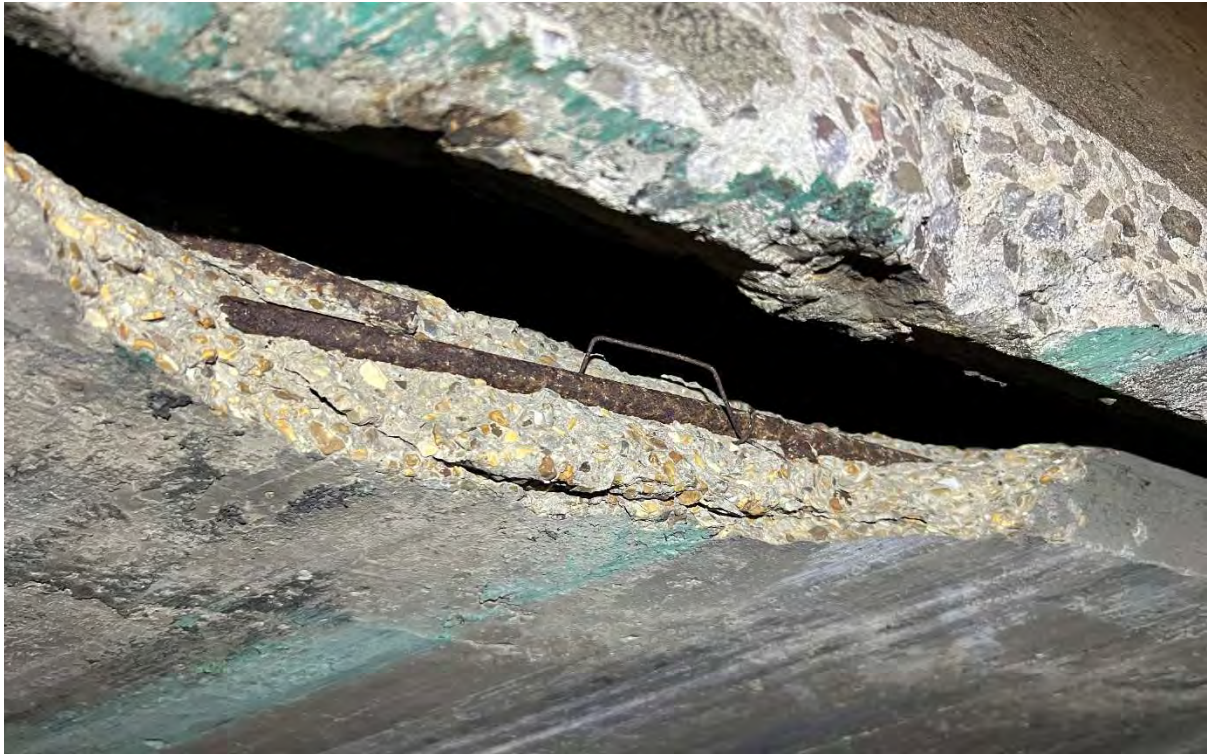
Photograph 47 - Span 2 E/B, beam 9. Area of spalling with exposed reinforcement exhibiting minor corrosion, measuring 500x200x100mm.

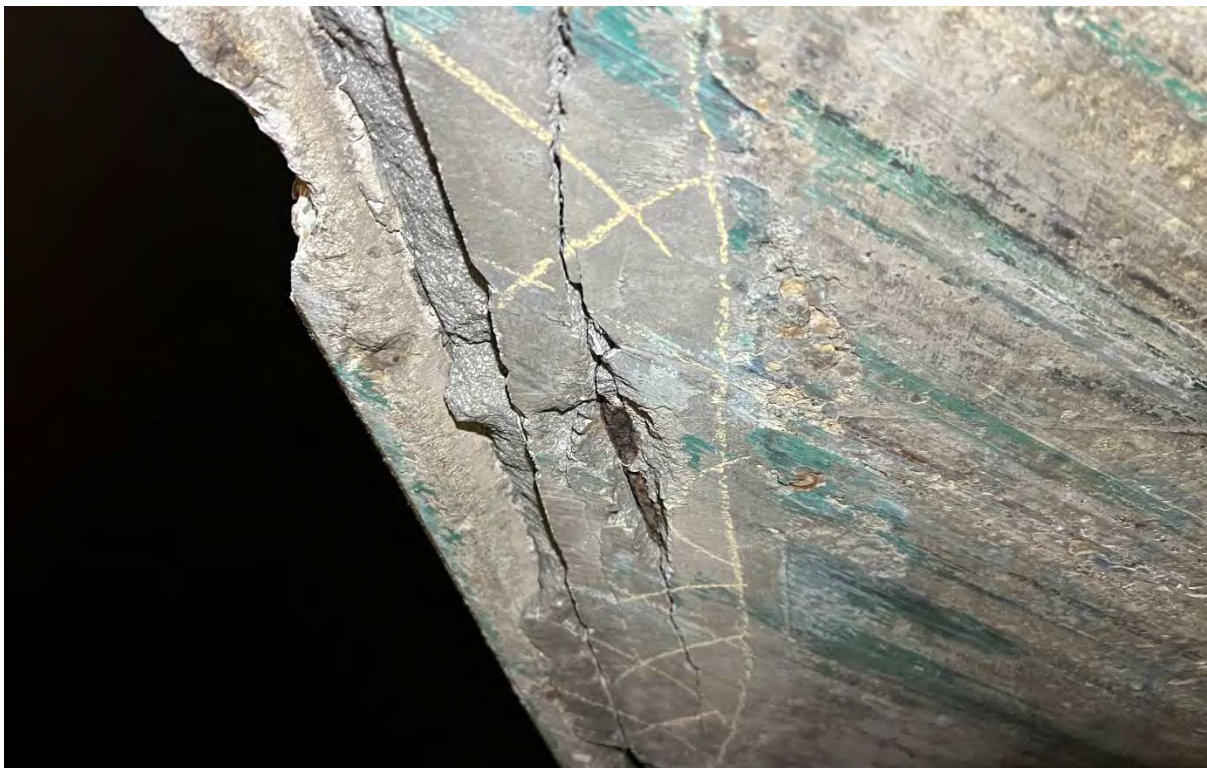
Photograph 48 - Span 2 E/B, beam 9. Area of delamination & spalling with exposed reinforcement exhibiting minor corrosion, measuring 2000x200x40mm.

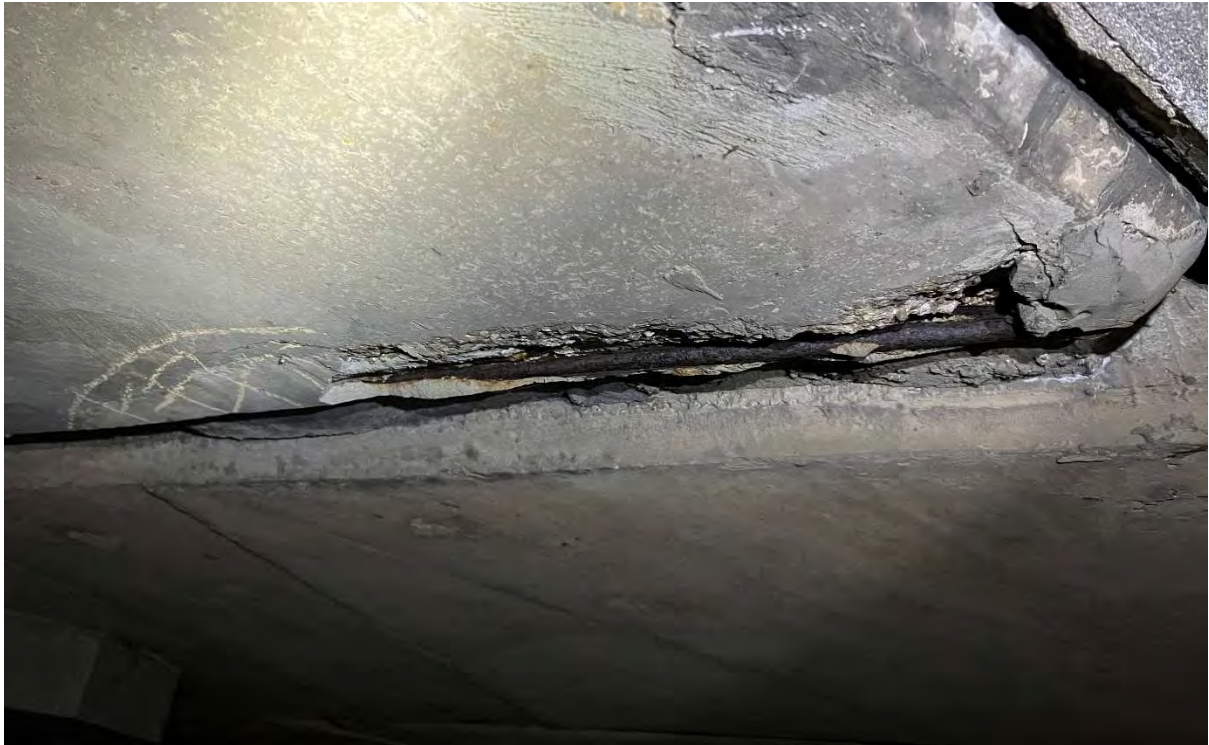
Photograph 49 - Span 2 E/B, beam 9. Area of delamination & spalling with exposed reinforcement exhibiting minor corrosion, measuring 1800x200x40mm.

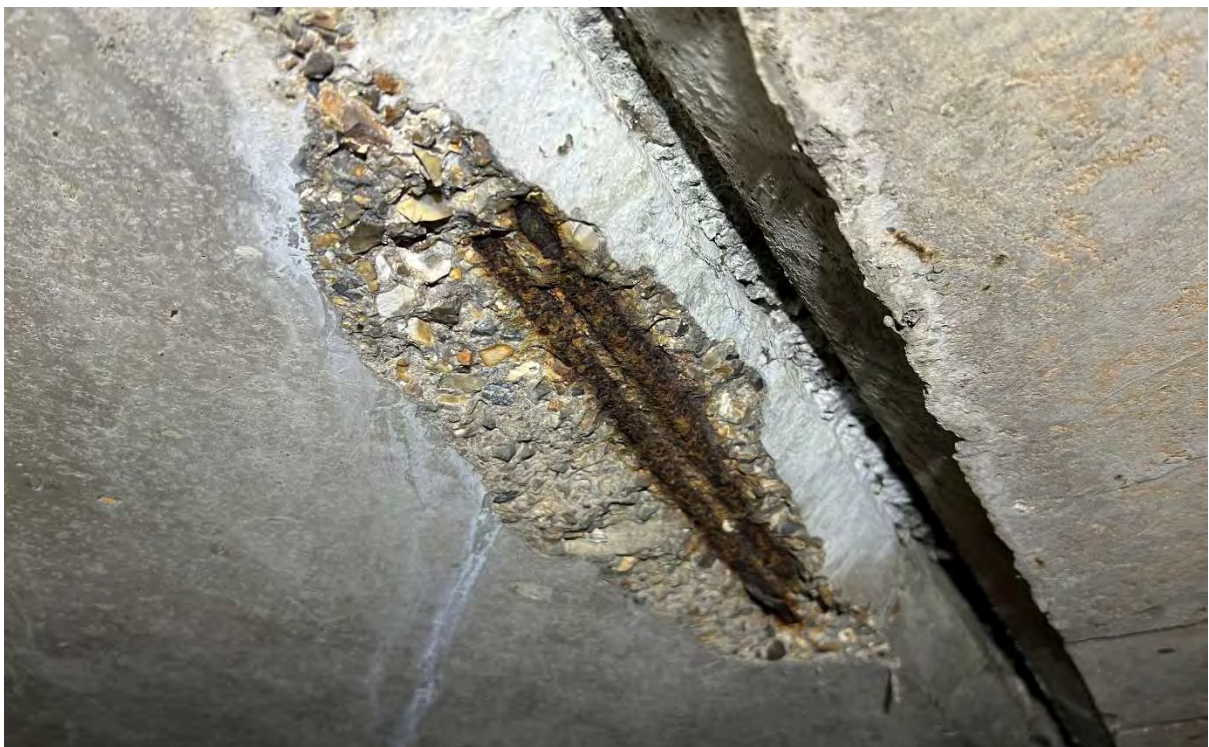
Overall, the span 3 deck soffit was in good to fair condition <sup>(6)</sup>. An area of spalled concrete with exposed, corroded reinforcement was noted to the bottom flange of beam 1. Further, calcite staining was noted to the soffit of beam 1. Since the previous Principal Inspection in 2019, the span 3 deck soffit does not appear to have deteriorated.

Photograph 50 - Span 3, beam 1. Area of spalling with exposed reinforcement exhibiting minor corrosion, measuring 500x120x30mm.

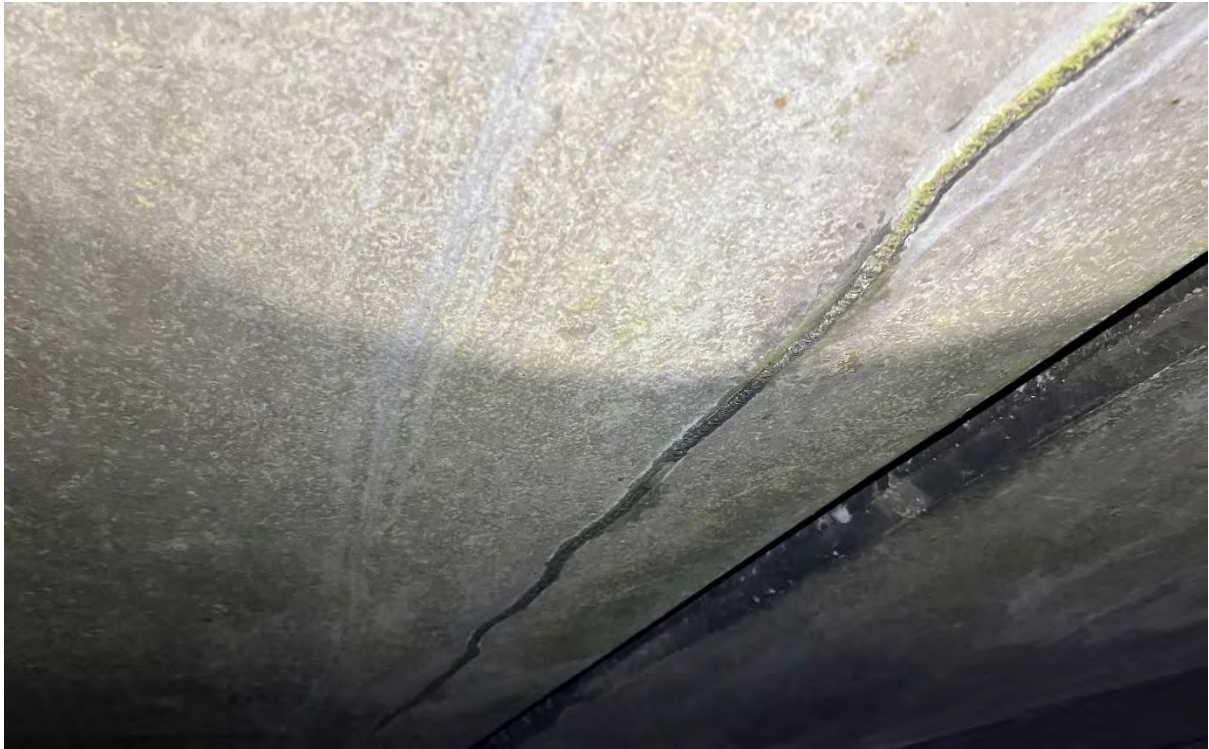
Photograph 51 - Span 3, beam 1. Calcite staining indicating water seepage through the deck.

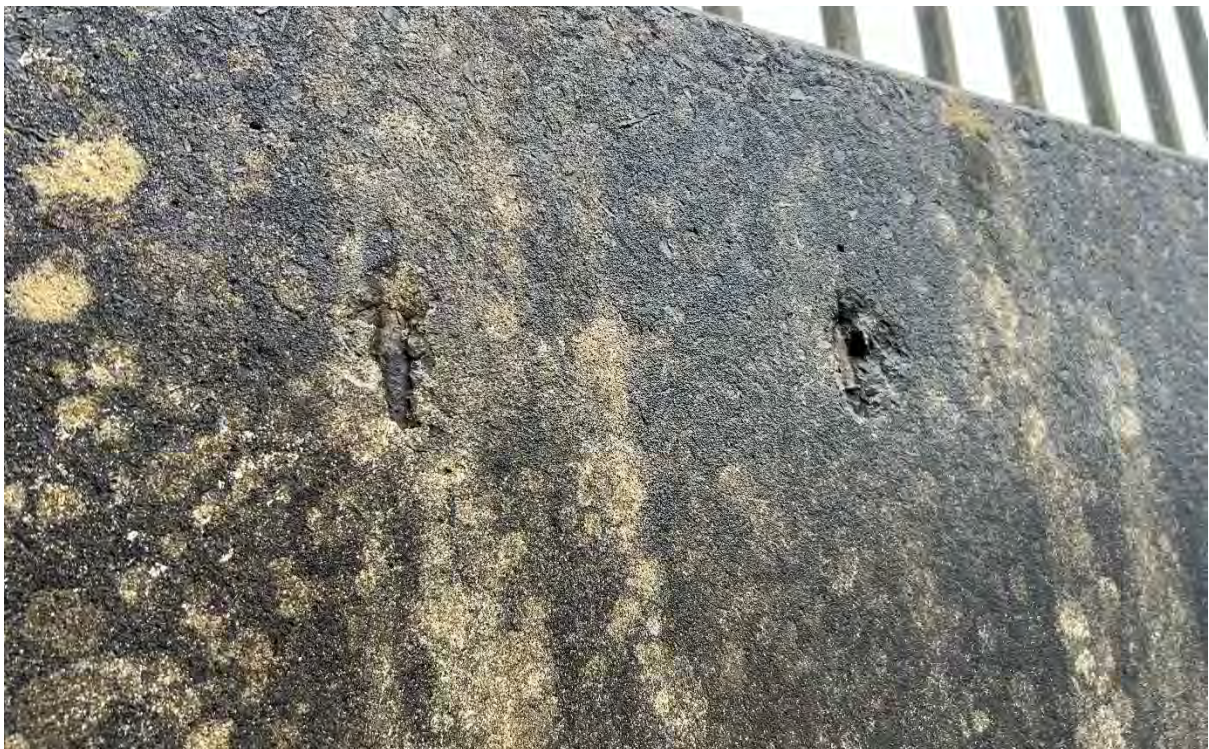
Multiple minor spalls, typically measuring 100x100x10mm, with exposed reinforcement exhibiting minor corrosion were observed to the southeast parapet fascia panels <sup>(52)</sup>.

Photograph 52 - Span 1. Multiple minor spalls with exposed reinforcement exhibiting minor corrosion to southeast parapet panels, measuring 100x100x10mm.

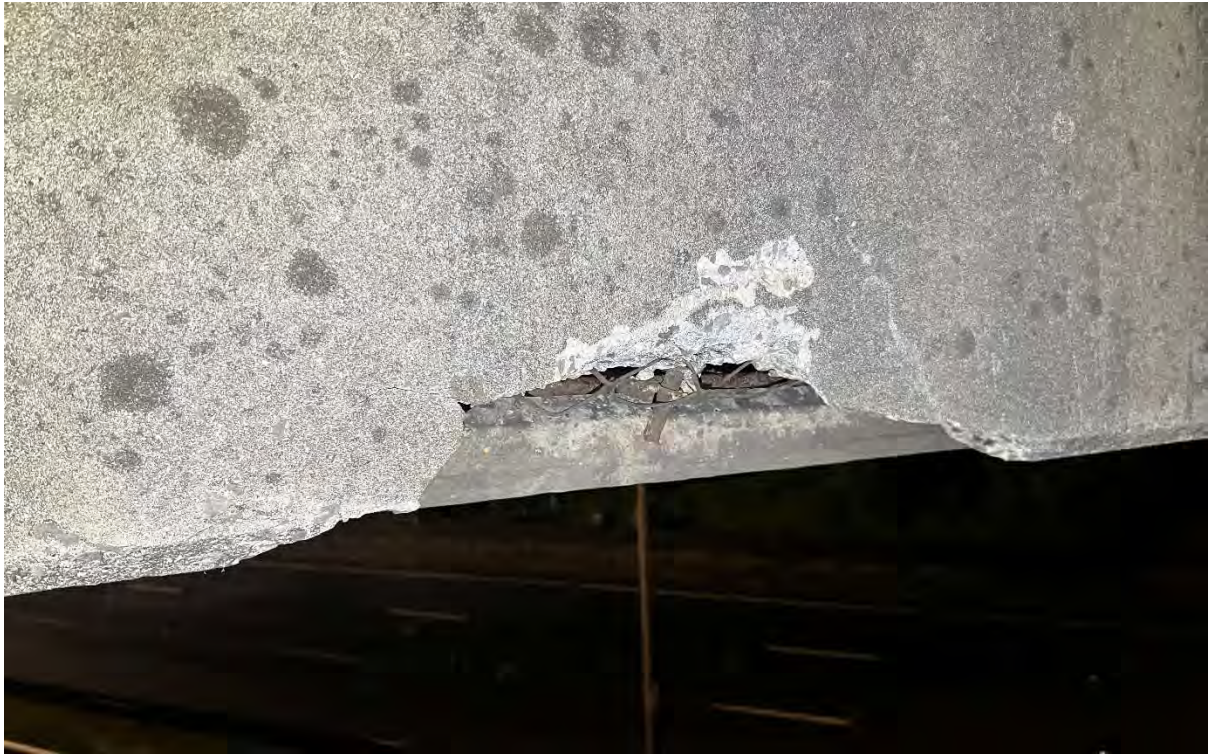
Within span 2, multiple areas of spalling with exposed, corroded reinforcement were observed to the parapet fascia panels <sup>(53-61)</sup>. Water ingress between the parapet fascia panels and beams was also noted <sup>(62)</sup>. This does not appear to be significantly worse than in the previous inspection.

Photograph 53 - Span 2 W/B, east parapet fascia panel. Area of spalling with exposed reinforcement exhibiting minor corrosion, measuring 600x120x75mm.

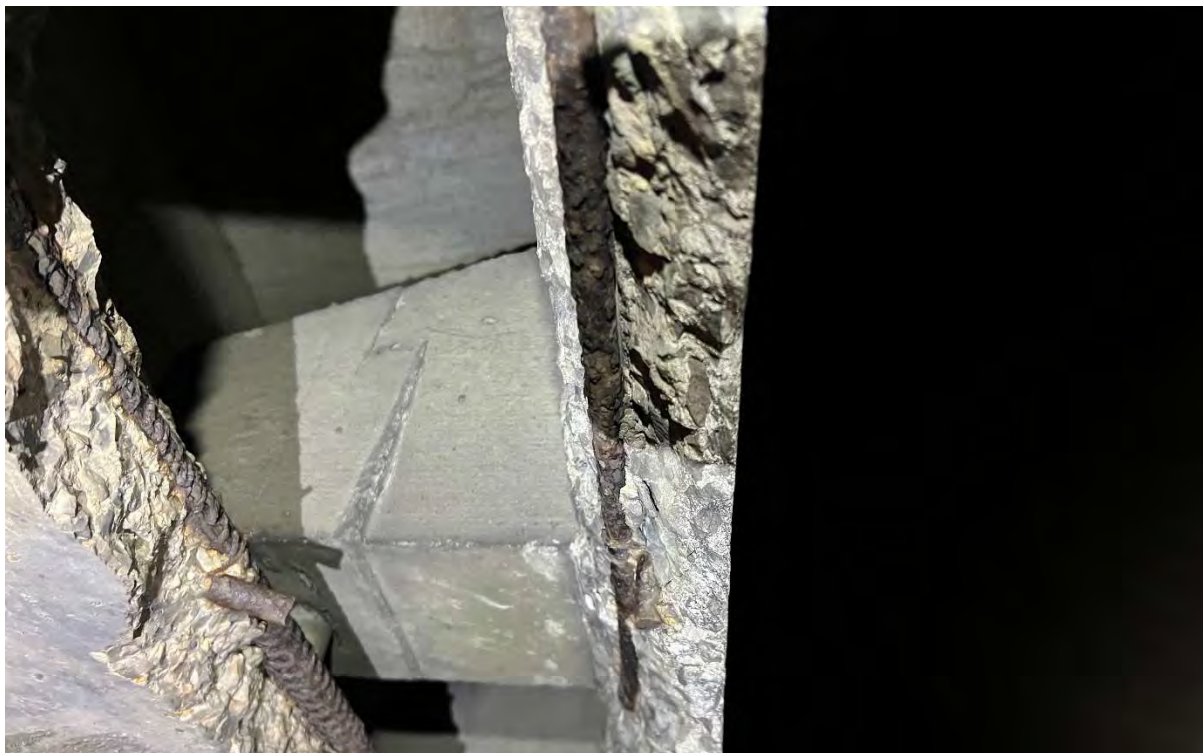
Photograph 55 - Span 2 W/B, east parapet fascia panel. Area of spalling with exposed reinforcement exhibiting minor corrosion, measuring 700x50x75mm.

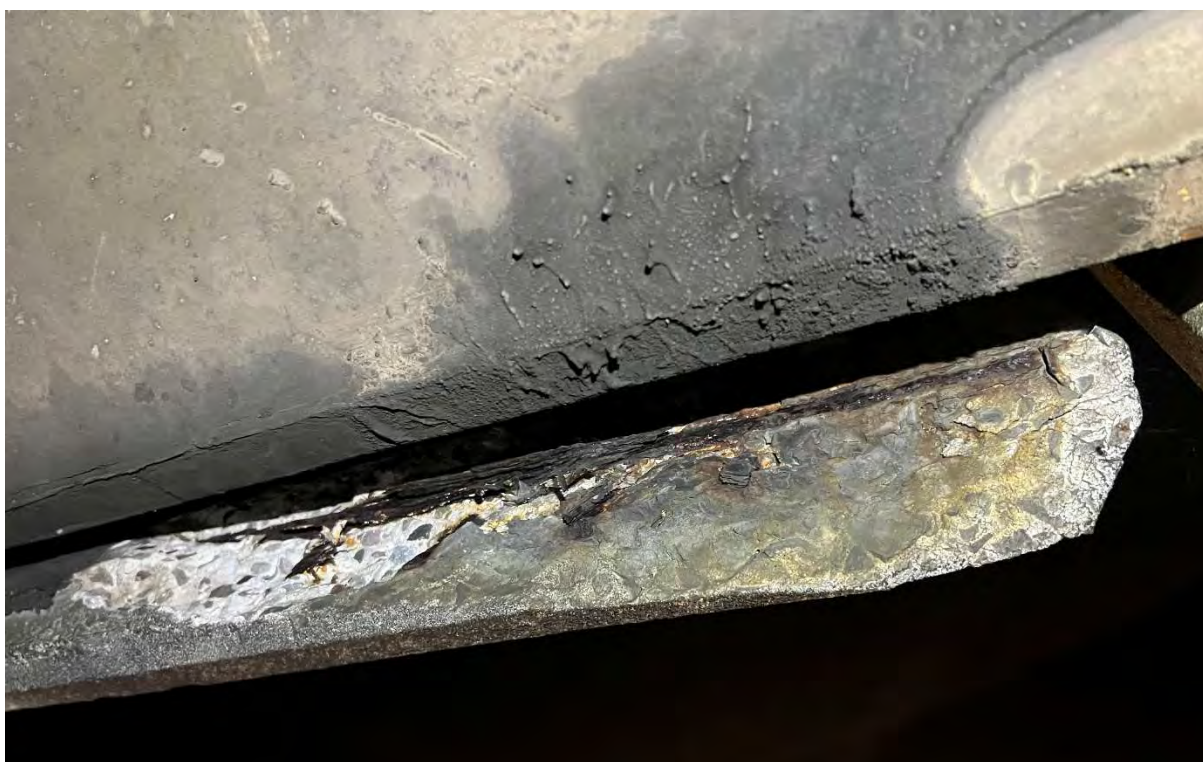
Photograph 56 - Span 2 W/B, west parapet fascia panel. Area of spalling with exposed reinforcement exhibiting minor corrosion, measuring 500x150x35mm.

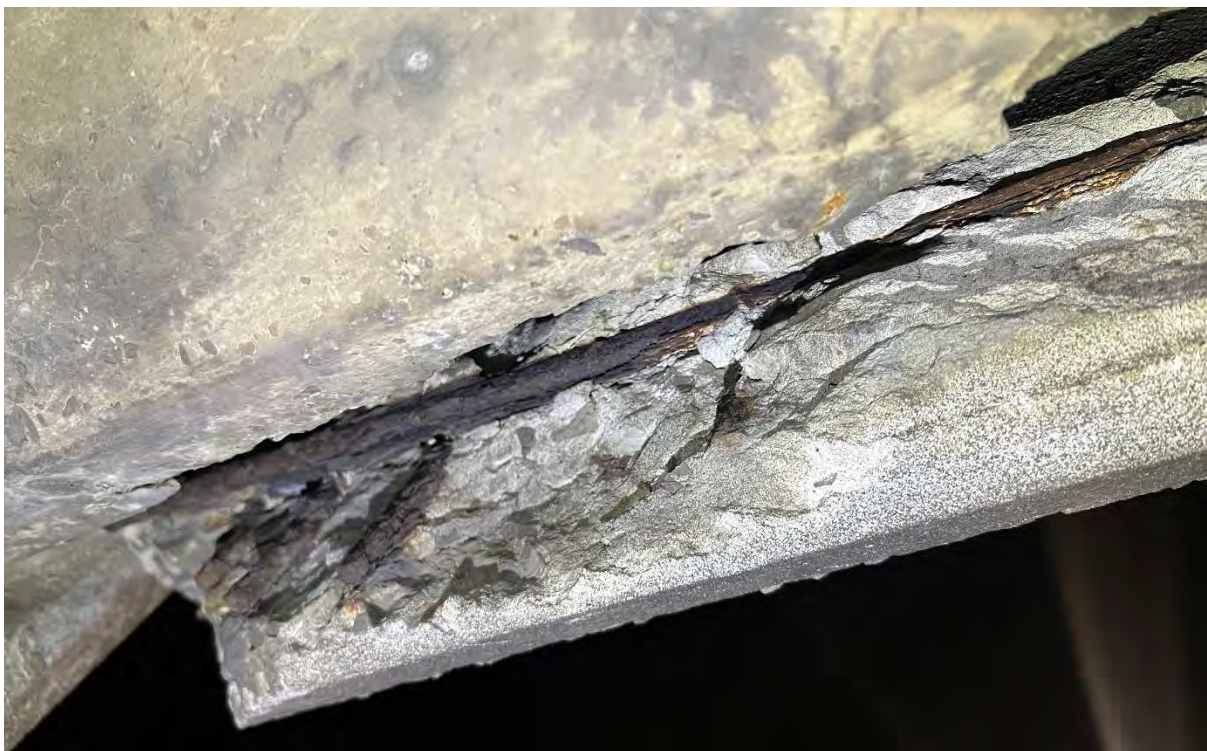
Photograph 58 - Span 2 W/B, west parapet fascia panel. Area of spalling with exposed reinforcement exhibiting minor corrosion, measuring 2600x300x20mm.

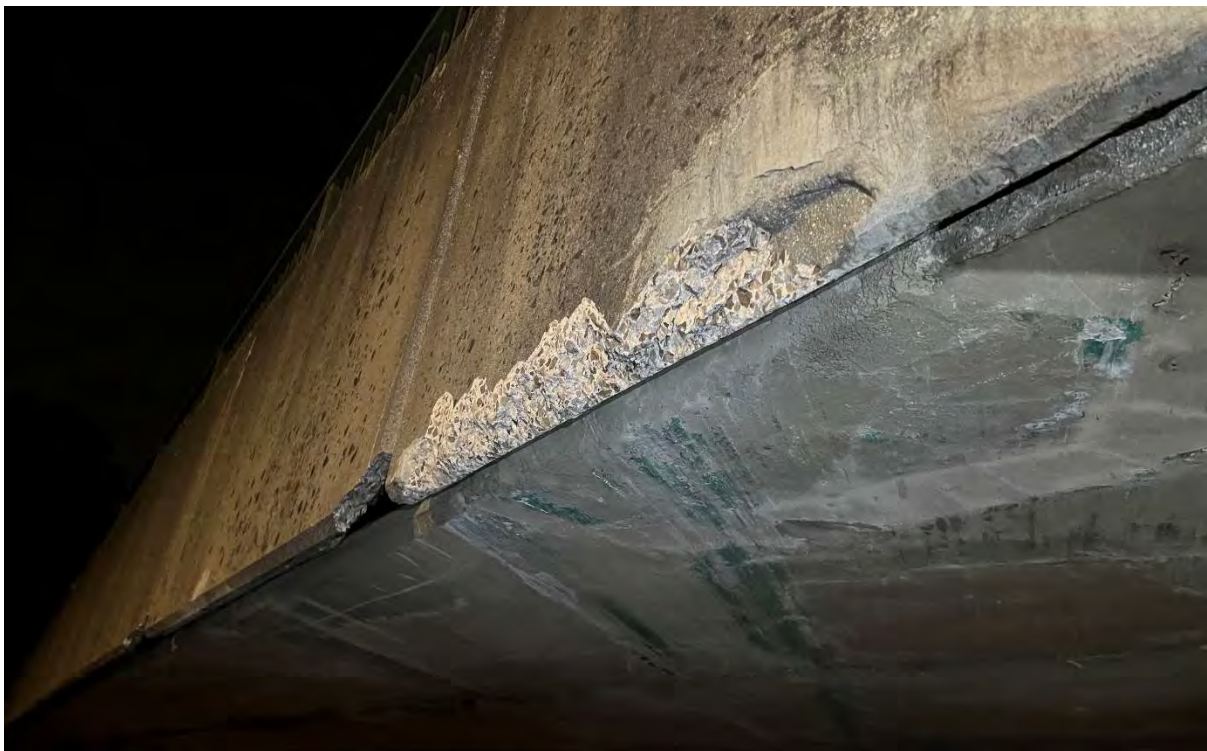
Photograph 60 - Span 2 E/B, east parapet fascia panel. Area of spalling measuring 1100x150x20mm.

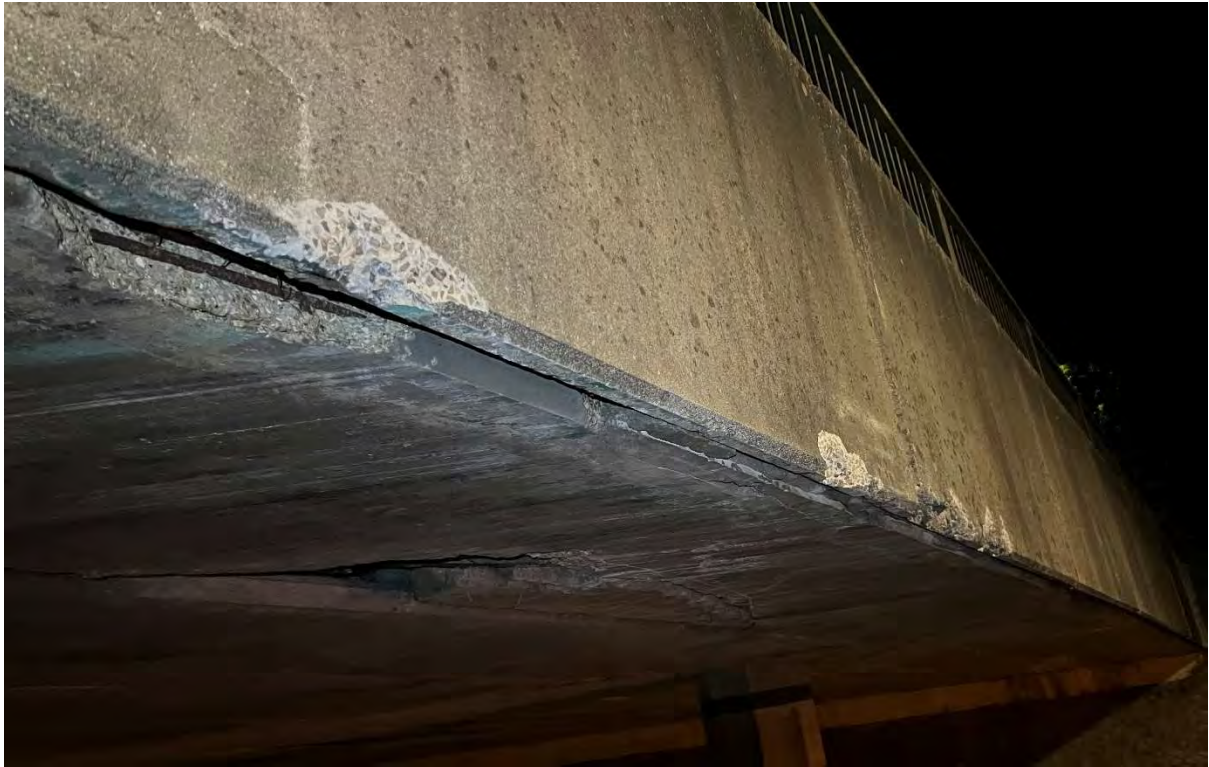
Photograph 61 - Span 2 E/B, east parapet fascia panel. Three minor spalls, all measuring 200x100x20mm.

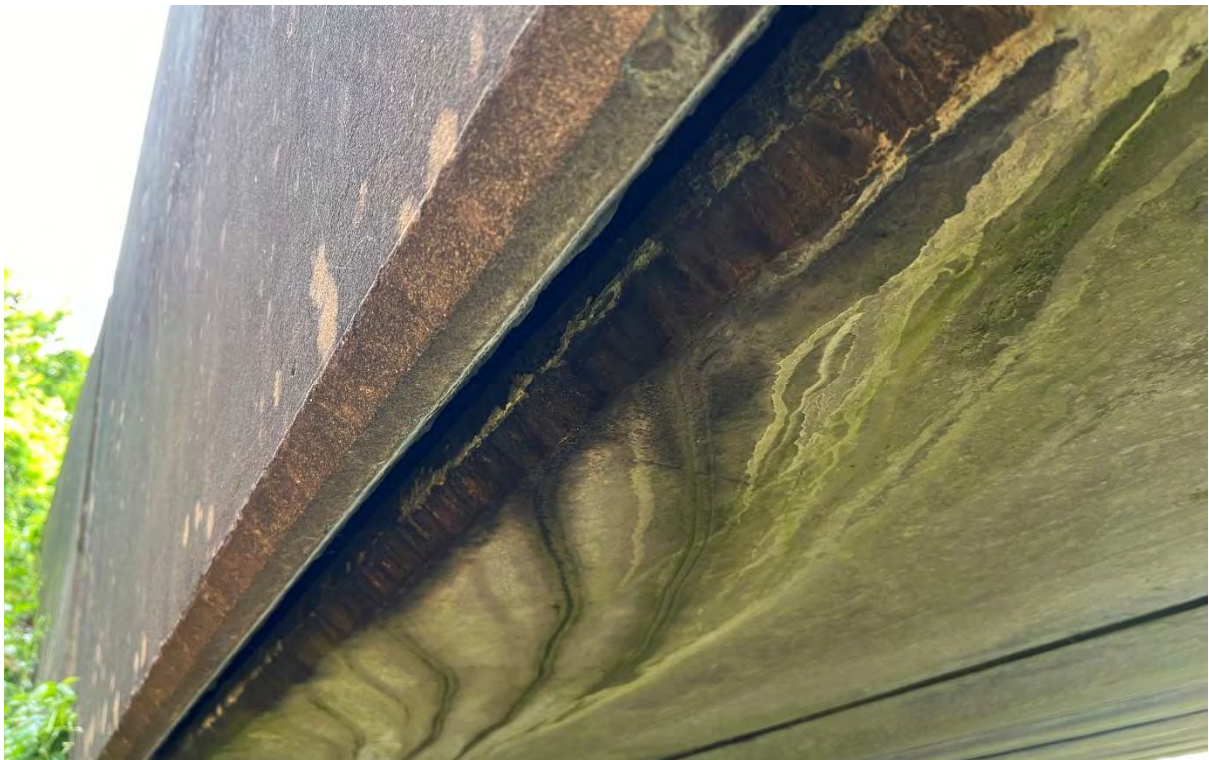
Photograph 62 - Water ingress between parapet fascia panels and deck beams.

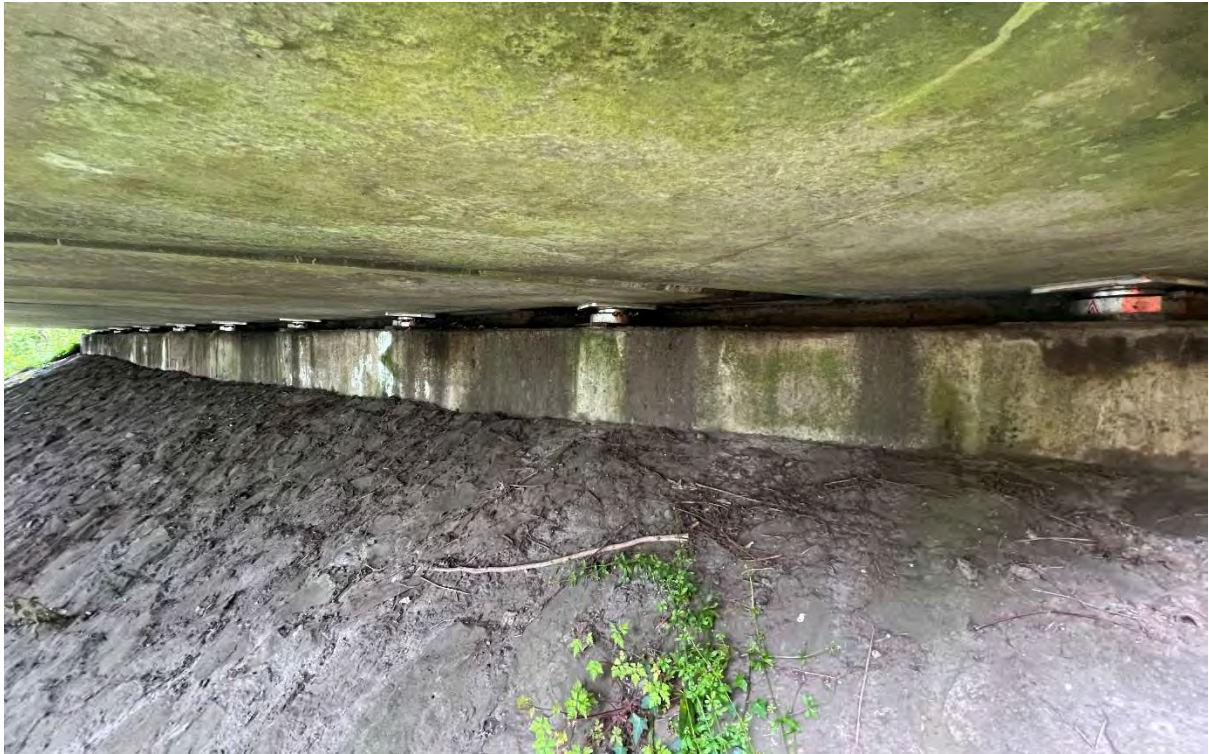
Overall, the abutments appeared to be in good condition. Historic water seepage and algae staining was observed to both abutments <sup>(63-64)</sup>.

Photograph 63 - Span 1. Historic water seepage & algae staining to south abutment.
