## Bishton-Llanmartin Overbridge M4 23A-24 51 Principal Inspection Report 2025/26

Service Provider/Consultant Name: Arcadis

Service Provider/Consultant Project Number: 30286543

T-WHIS Number: CTI/005

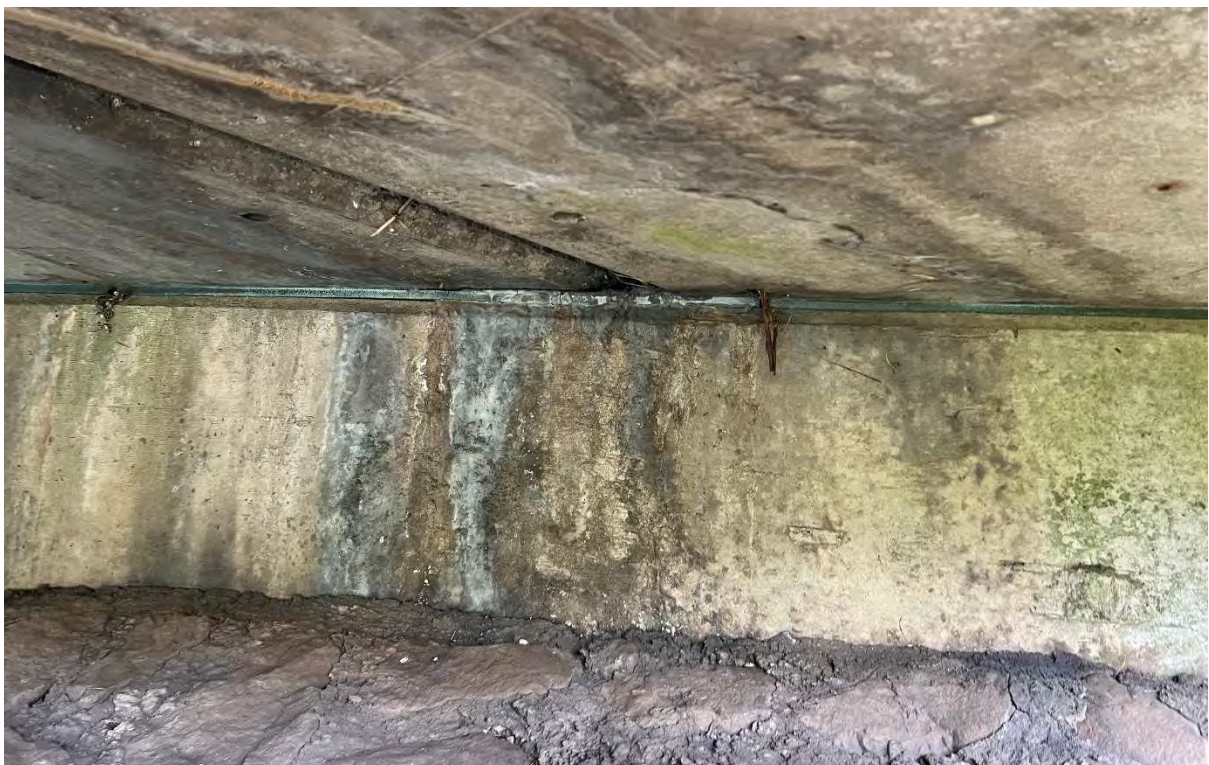
Overall, the abutments appeared to be in good condition. Historic water seepage and algae staining was observed to both abutments <sup>(63-64)</sup>.

Photograph 64 - Span 3. Historic water seepage & algae staining to north abutment.

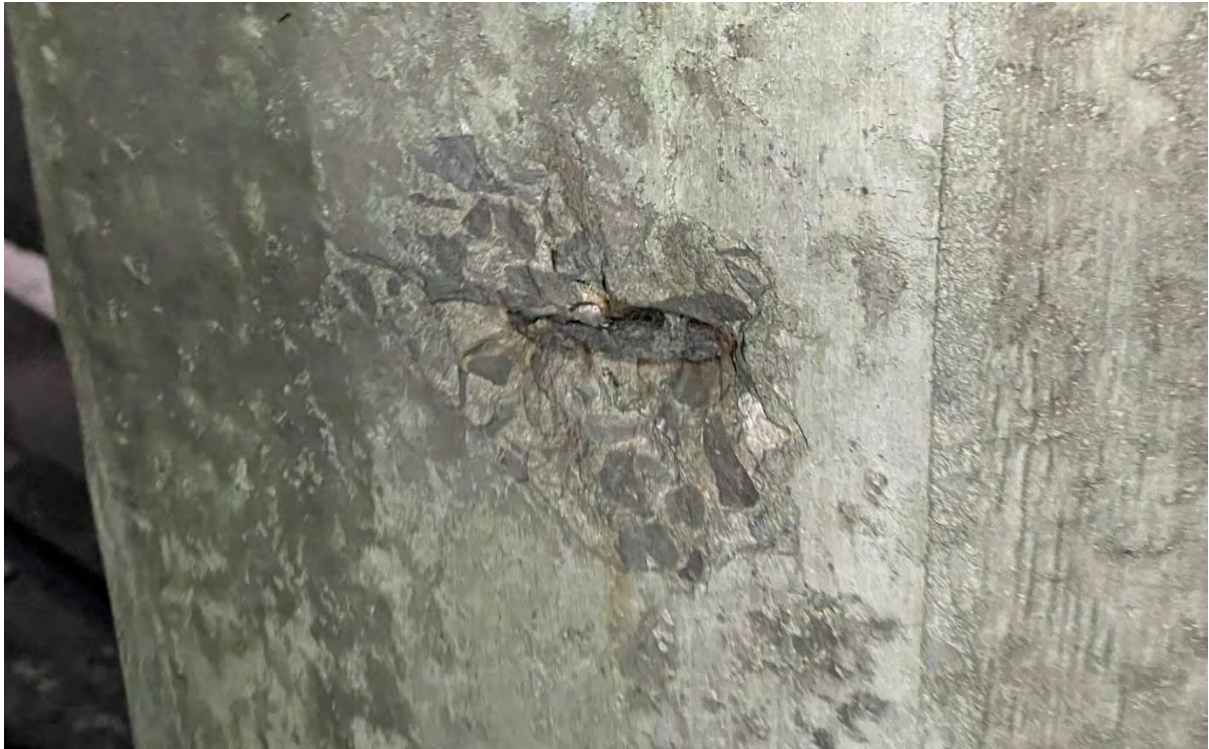
Overall, the north intermediate piers were in good condition. A minor spall with exposed reinforcement exhibiting minor corrosion was noted to the northeast column, measuring 200x200x25mm <sup>(65)</sup>.

Photograph 65 – Span 2, northeast column. Minor spall with exposed reinforcement exhibiting minor corrosion, measuring 200x200x25mm.

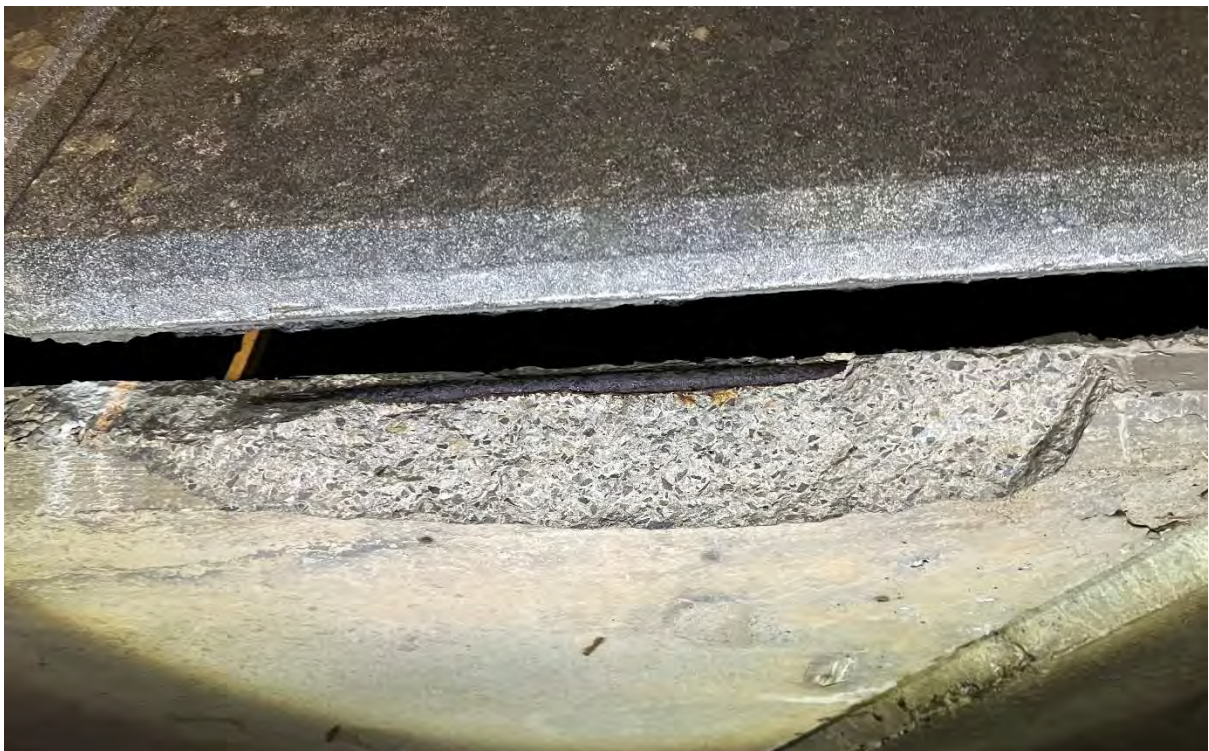
Overall, the south crosshead was in fair condition. An area of spalling, measuring 650x150x80mm, with exposed reinforcement exhibiting minor corrosion was noted to the west edge of the south crosshead <sup>(66)</sup>.

Photograph 66 - Span 1, west edge of south crosshead. Area of spalling with exposed reinforcement exhibiting minor corrosion, measuring 650x150x80mm.

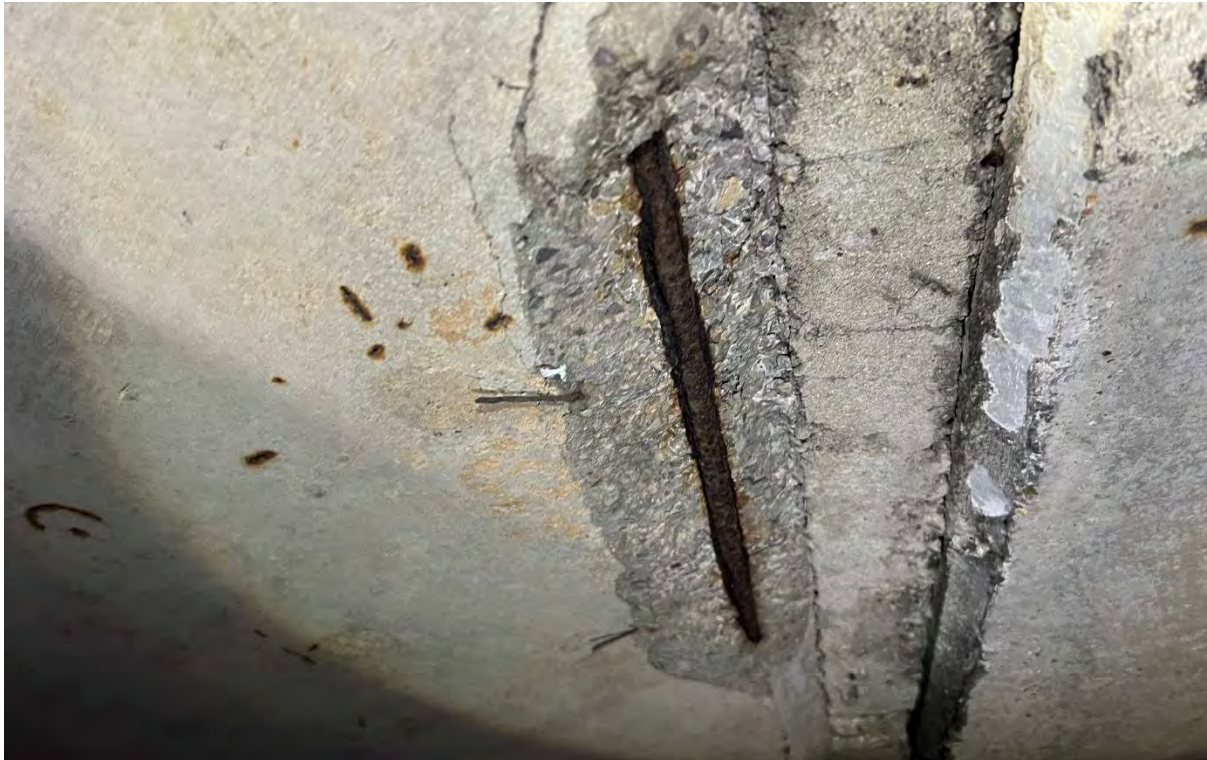
Overall, the north crosshead was in fair condition. An area of spalling, measuring 600x100x30mm, with exposed reinforcement exhibiting minor corrosion was noted to the north crosshead <sup>(67)</sup>.

Photograph 67 - Span 2, north crosshead. Area of spalling with exposed reinforcement exhibiting minor corrosion, measuring 600x100x30mm.

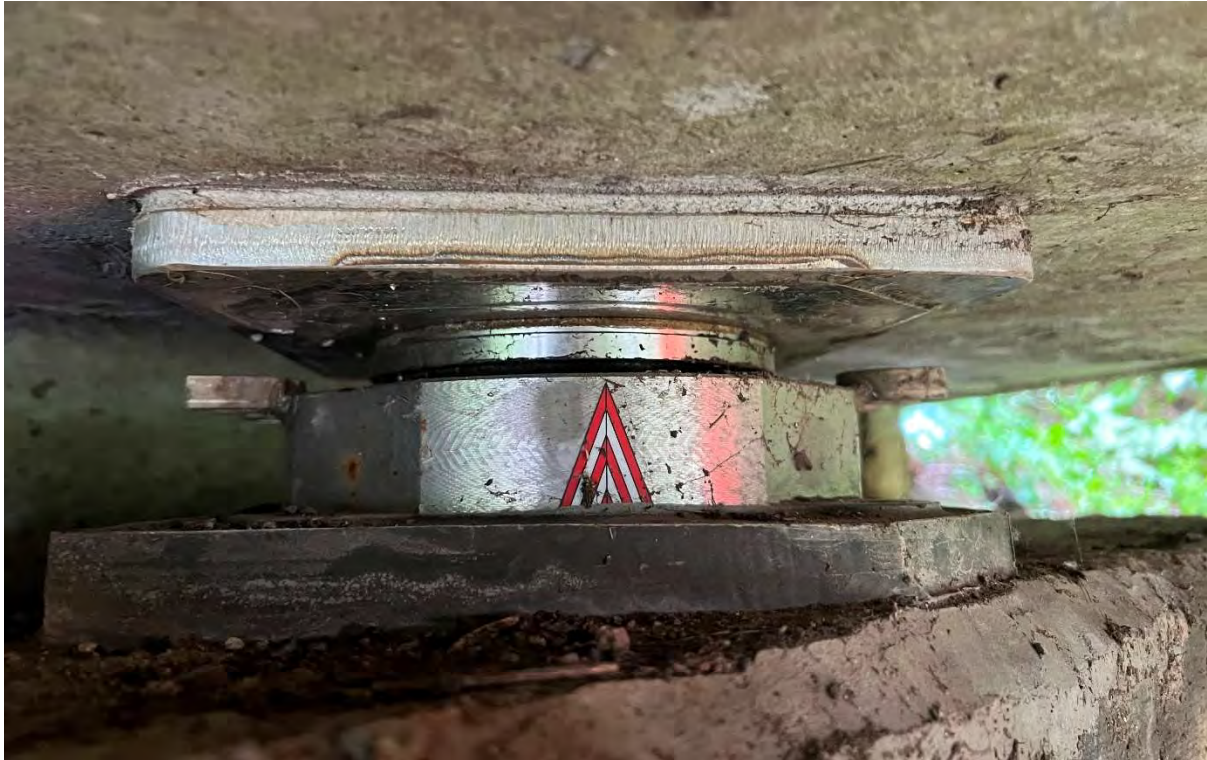
Overall, the south abutment bearings were in good condition. Isolated surface corrosion was noted to the pot bearings <sup>(68)</sup>. Since the previous Principal Inspection in 2019, the abutment bearings have been replaced.

Photograph 68 - Span 1, south abutment. Isolated surface corrosion to bearings.

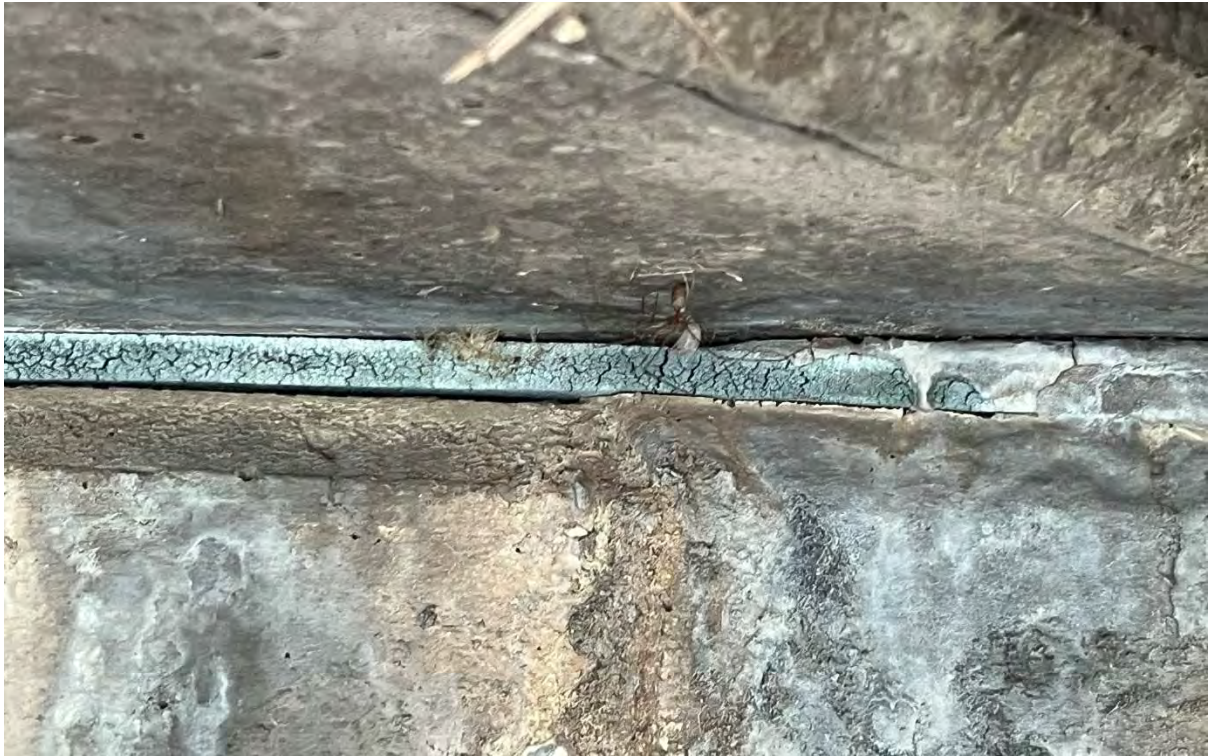
The north bearing strip material is cracking <sup>(69)</sup>.

Photograph 69 - Span 3, north abutment. Minor cracking to strip bearings.

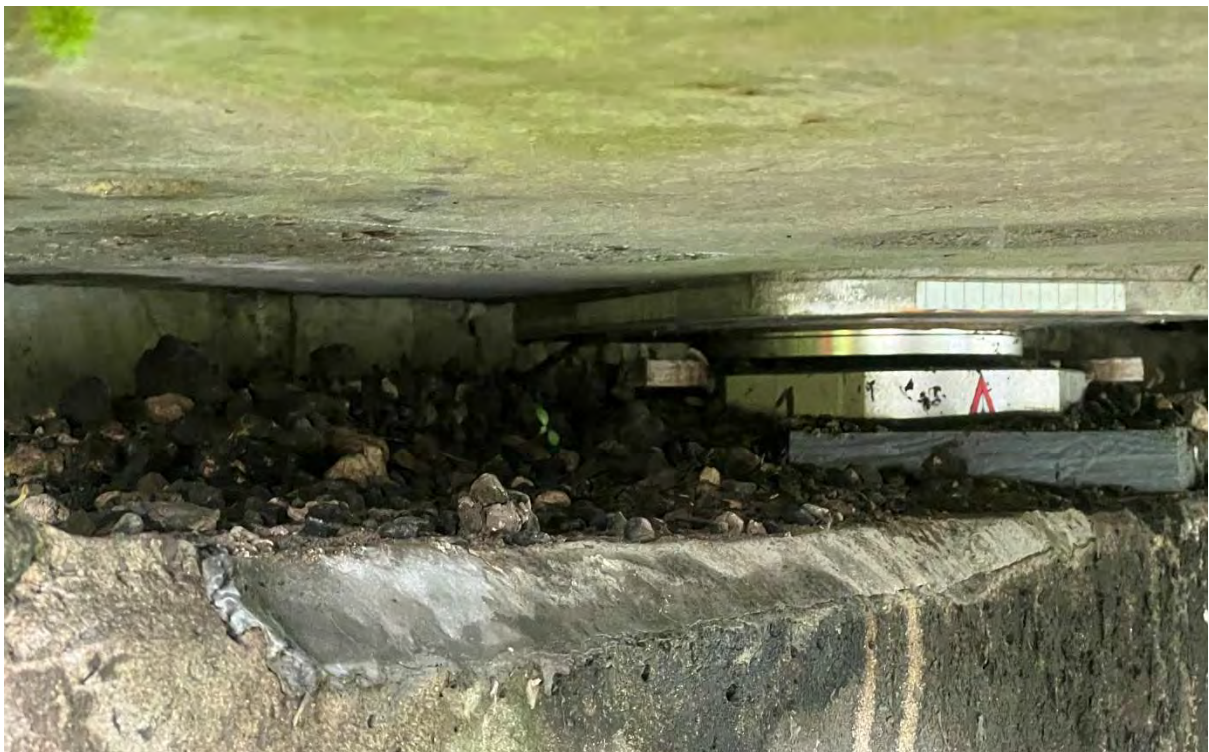
The south abutment bearing shelf appeared to be in good condition. However, a build-up of dirt and debris prevented the full inspection of the bearing shelf <sup>(70)</sup>.

Photograph 70 - Span 1. Build-up of dirt and debris to south bearing shelf.

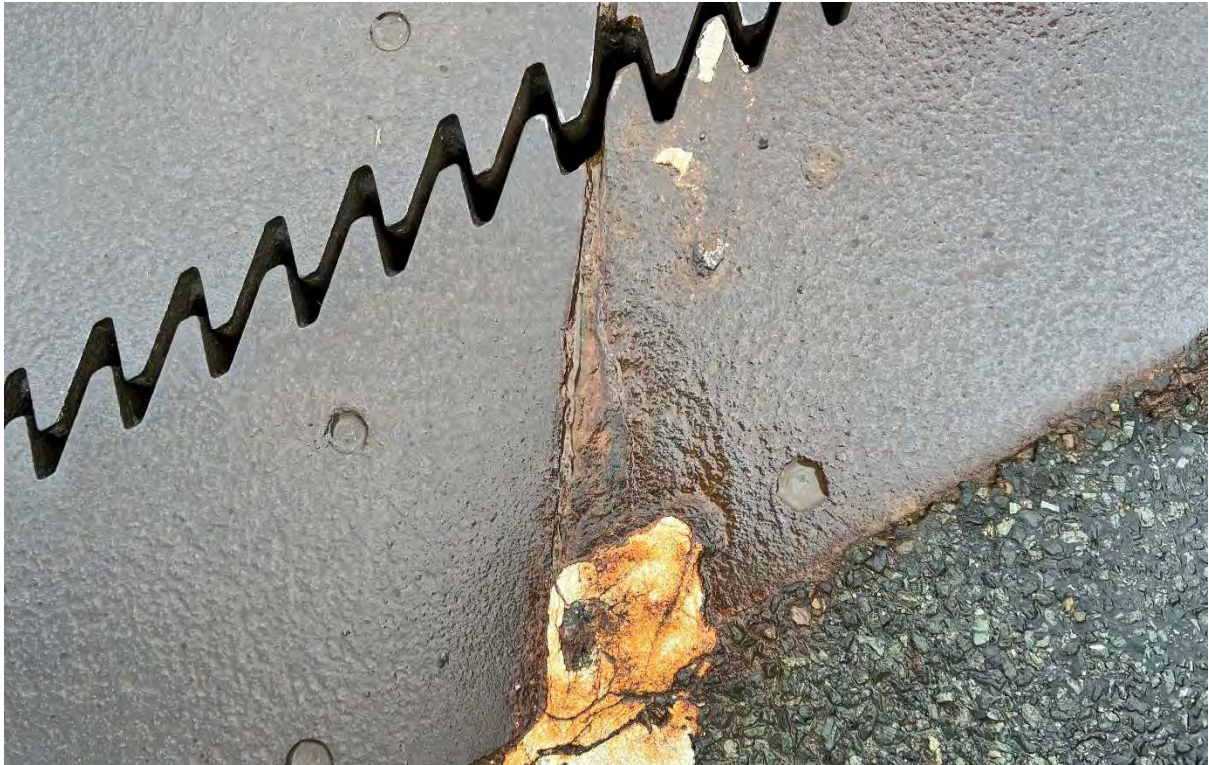
Overall, the south expansion joint was in good condition <sup>(72)</sup>. Isolated, minor corrosion was observed to the south expansion joint <sup>(73)</sup>. Further, a build-up of dirt and debris was noted within the footway expansion joints <sup>(74)</sup>.

Photograph 73 - Span 1. Isolated minor corrosion to south expansion joint.

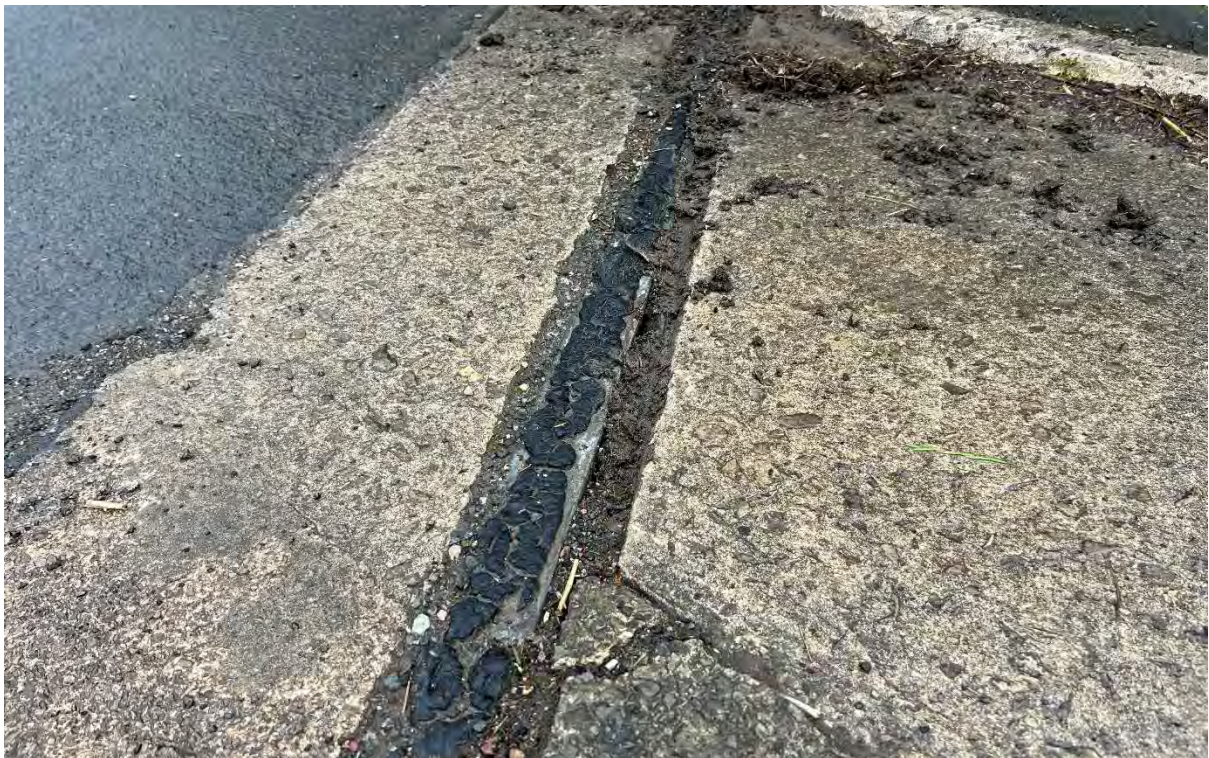
Photograph 74 - Span 1. Build-up of dirt and debris to expansion joint in footways, southwest shown.

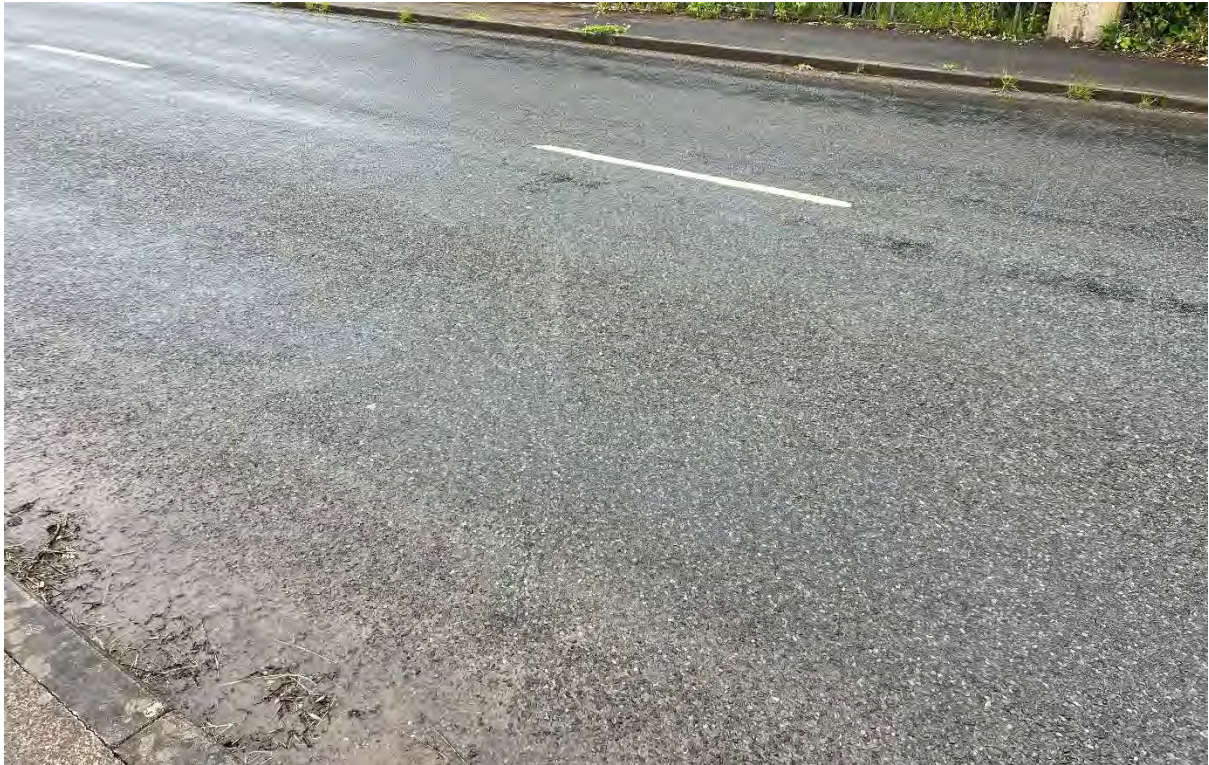
Overall, the northern buried expansion joint was in good condition. However, no crack inducer was present within the carriageway surfacing <sup>(75)</sup>. Vegetation growth was also noted to the joint between the parapet panel and northeast wing wall <sup>(76)</sup>.

Photograph 75 - Span 3. No crack inducer to north expansion joint.

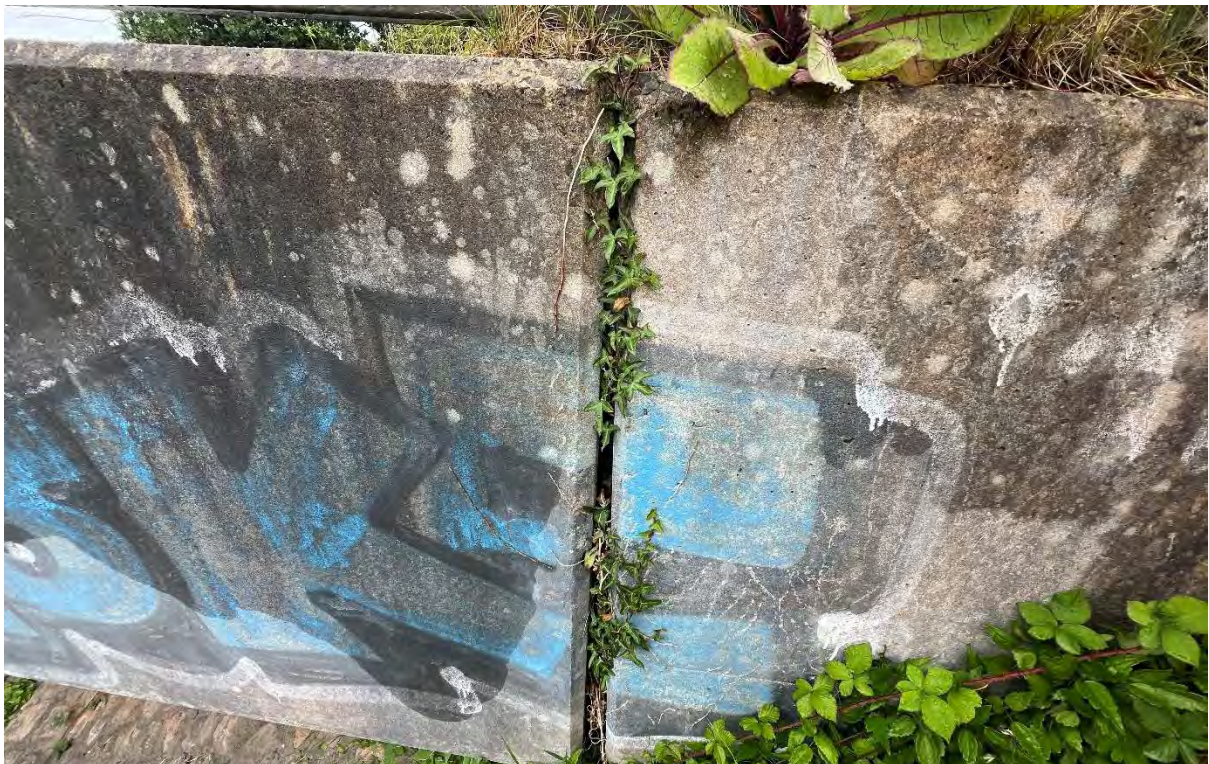
Photograph 76 - Span 3. Vegetation growth to joint between parapet panel and northeast wing wall.

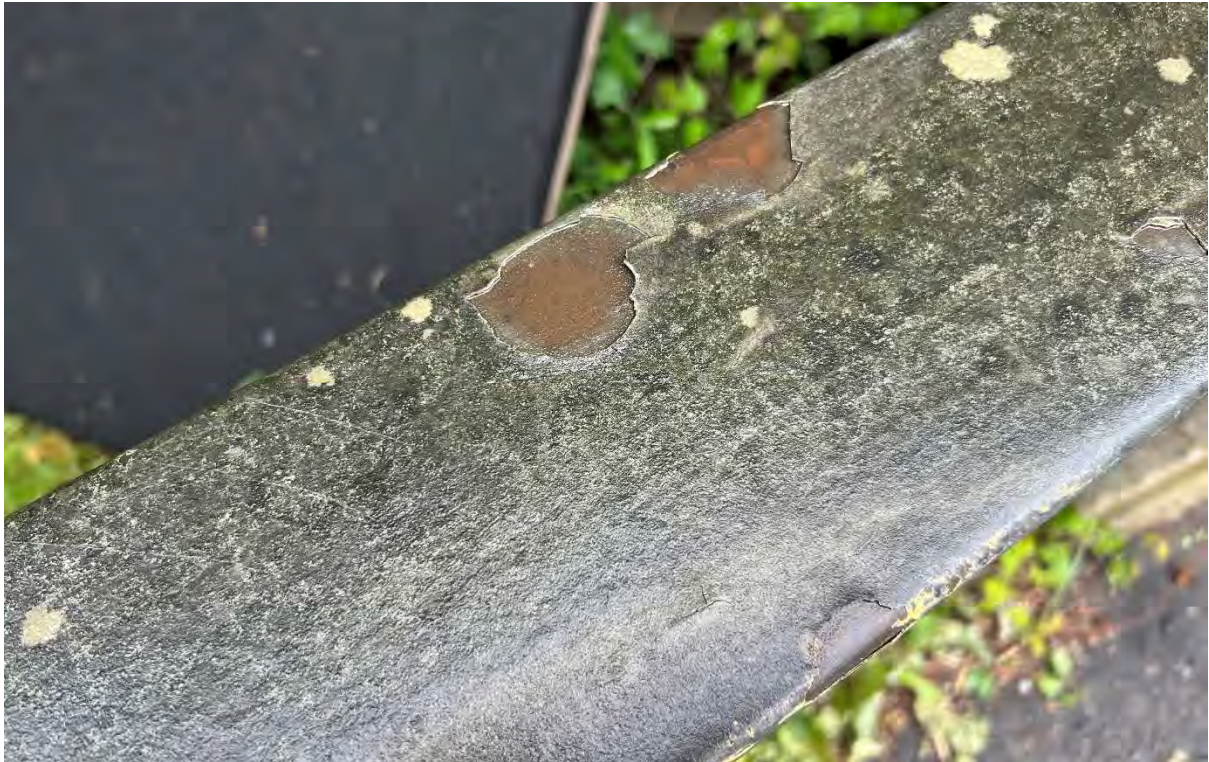
Overall, the parapet paint system was in fair condition. Isolated breakdown of the paint system was noted to the parapet rails, infill bars, base plate, holding down bolts and welded connections <sup>(77-80)</sup>.

Overall, the parapets were in fair condition. Isolated minor corrosion was noted to the parapets where the paint system had broken down <sup>(77-80)</sup>.

Photograph 77 - Isolated minor corrosion to parapet rails where the paint system had failed.

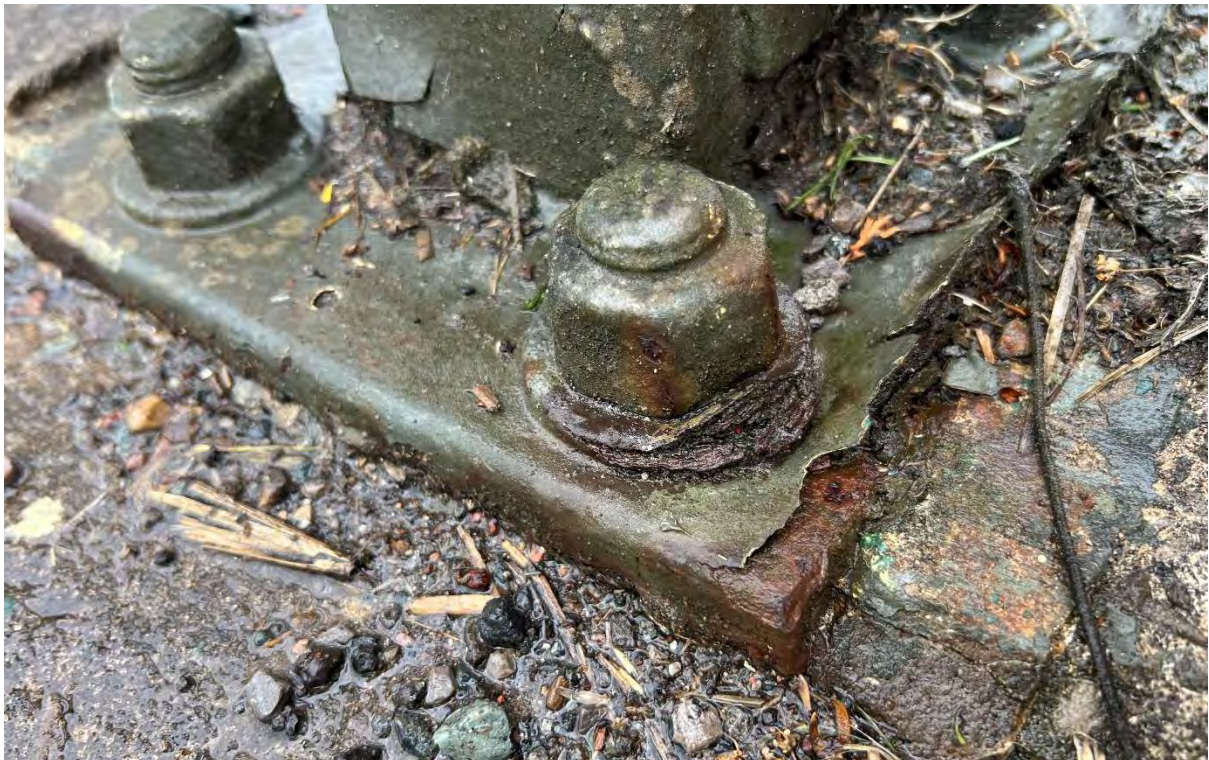
Photograph 78 - Isolated minor corrosion to parapet base plates and holding down bolts.

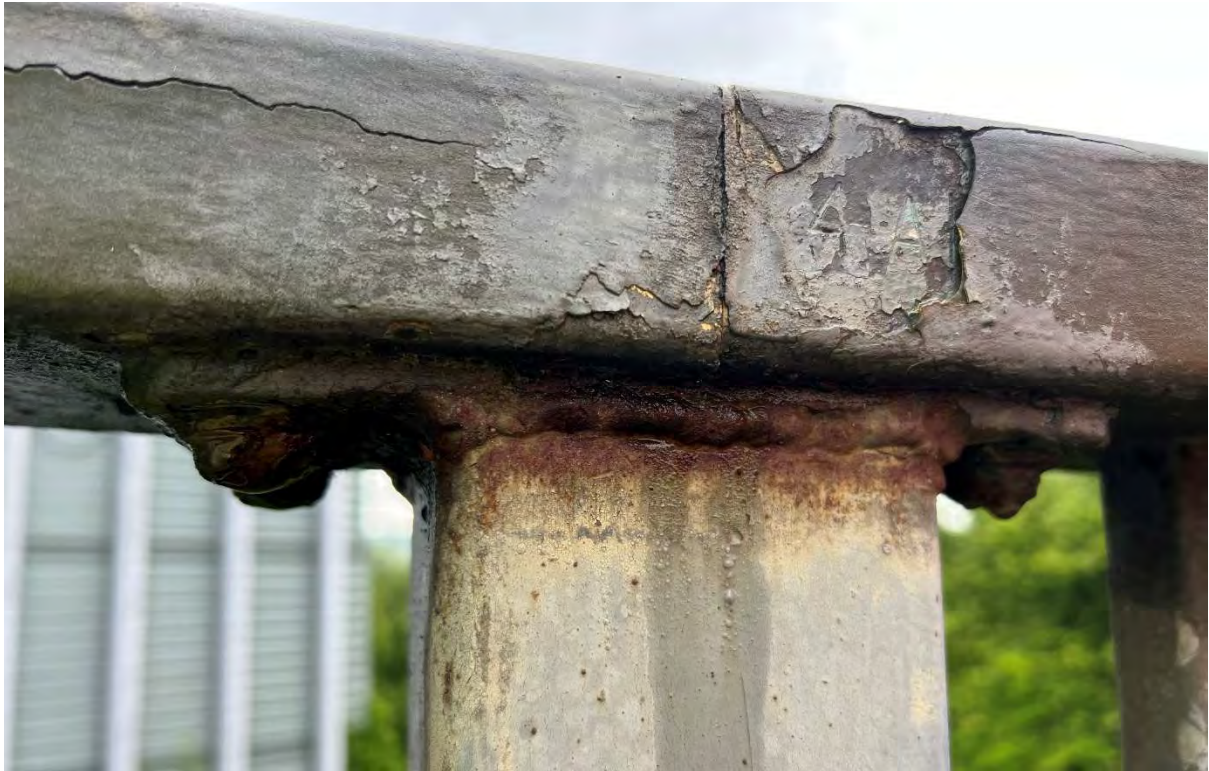
Photograph 79 - Isolated minor corrosion to parapet welded connections.

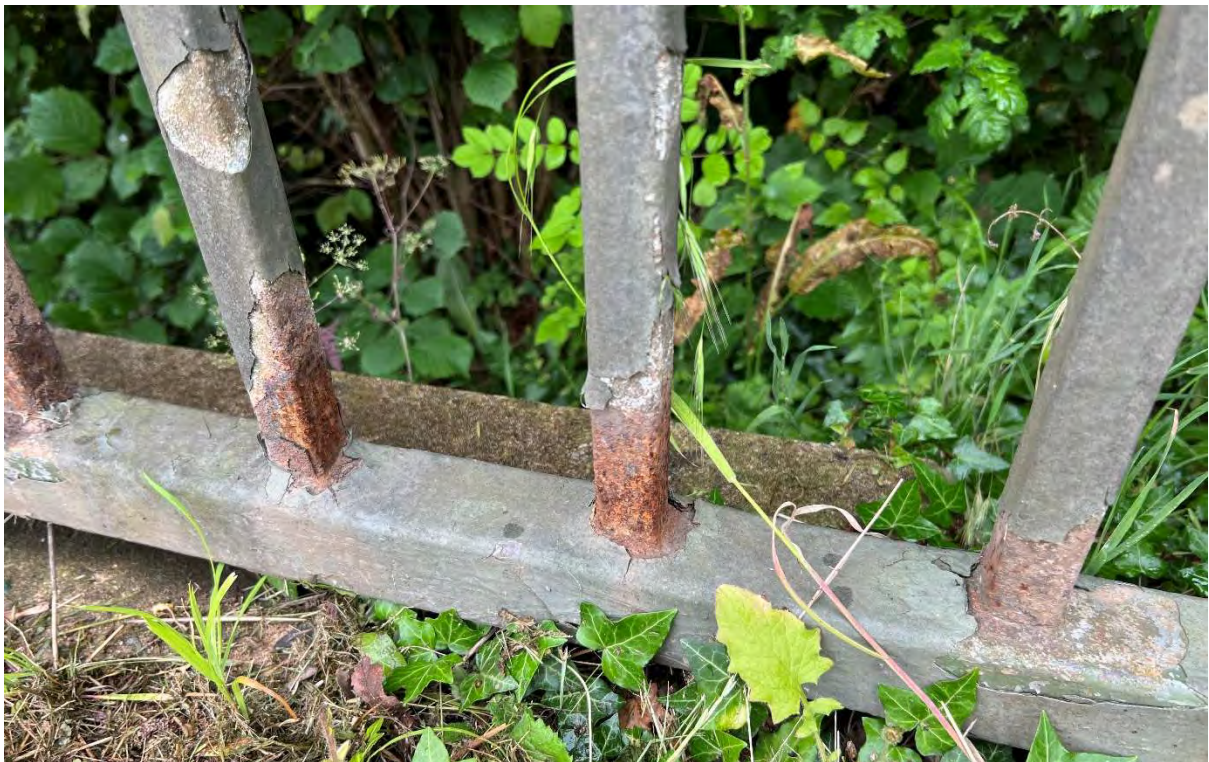
Photograph 80 - Span 1. Minor surface corrosion to southeast parapet infill bars.

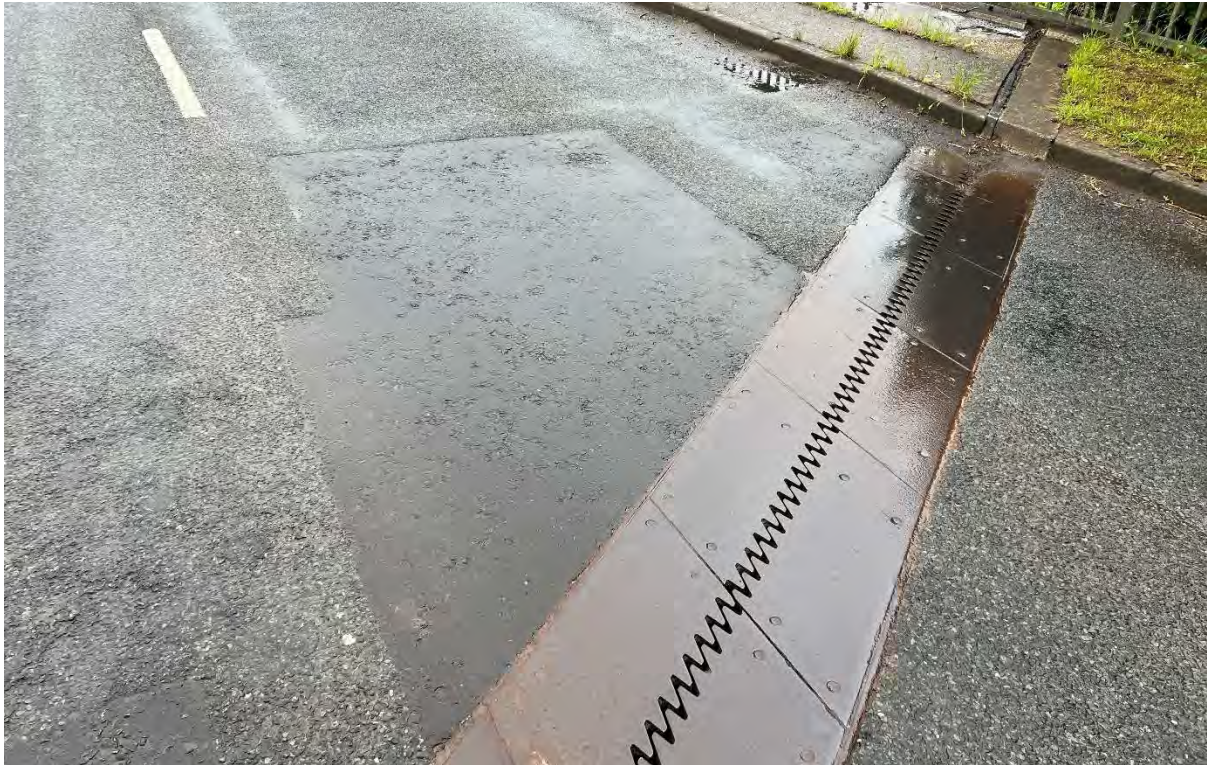
Overall, Waltwood Road carriageway surfacing was in good condition. A surfacing repair at the north edge of the southern expansion joint was noted <sup>(81)</sup>. Minor vegetation growth was also observed at the edges of the carriageway <sup>(82)</sup>. No defects were noted to the M4 carriageway.

Photograph 81 - Span 2. Surfacing repair at north edge of southern expansion joint.

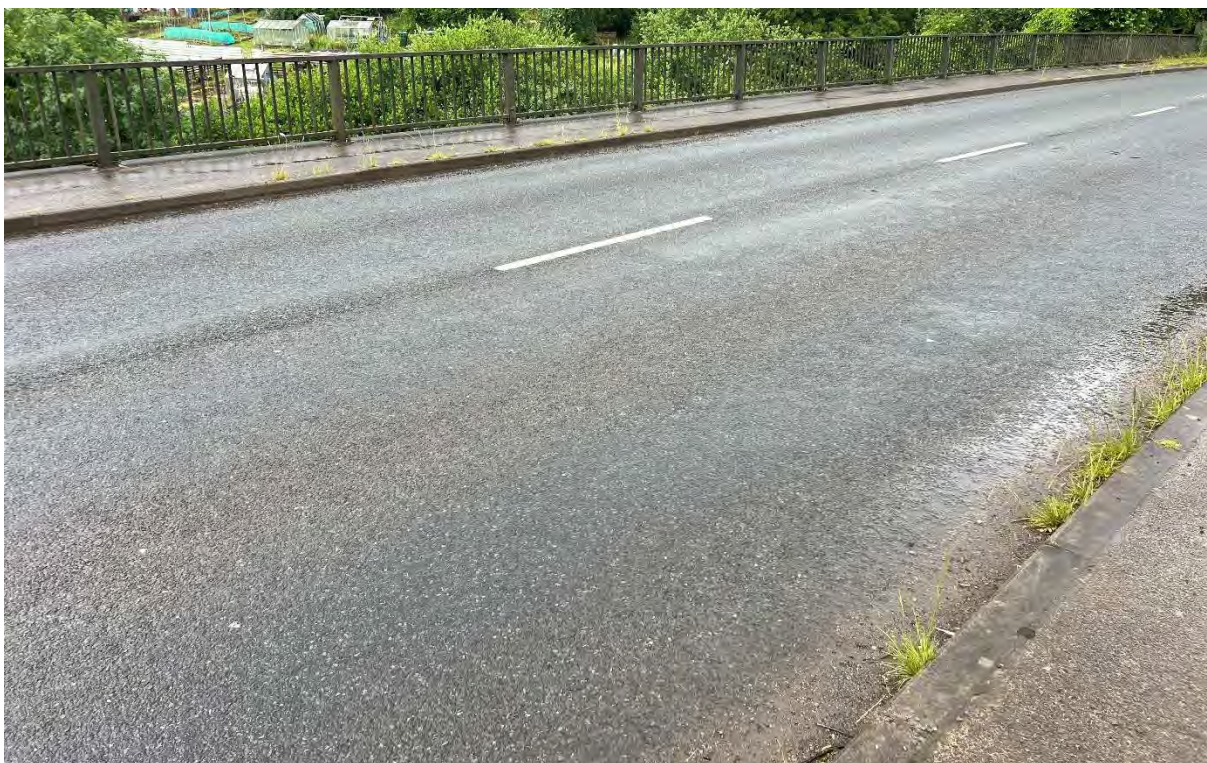
Photograph 82 - Minor vegetation growth to edges of carriageway.

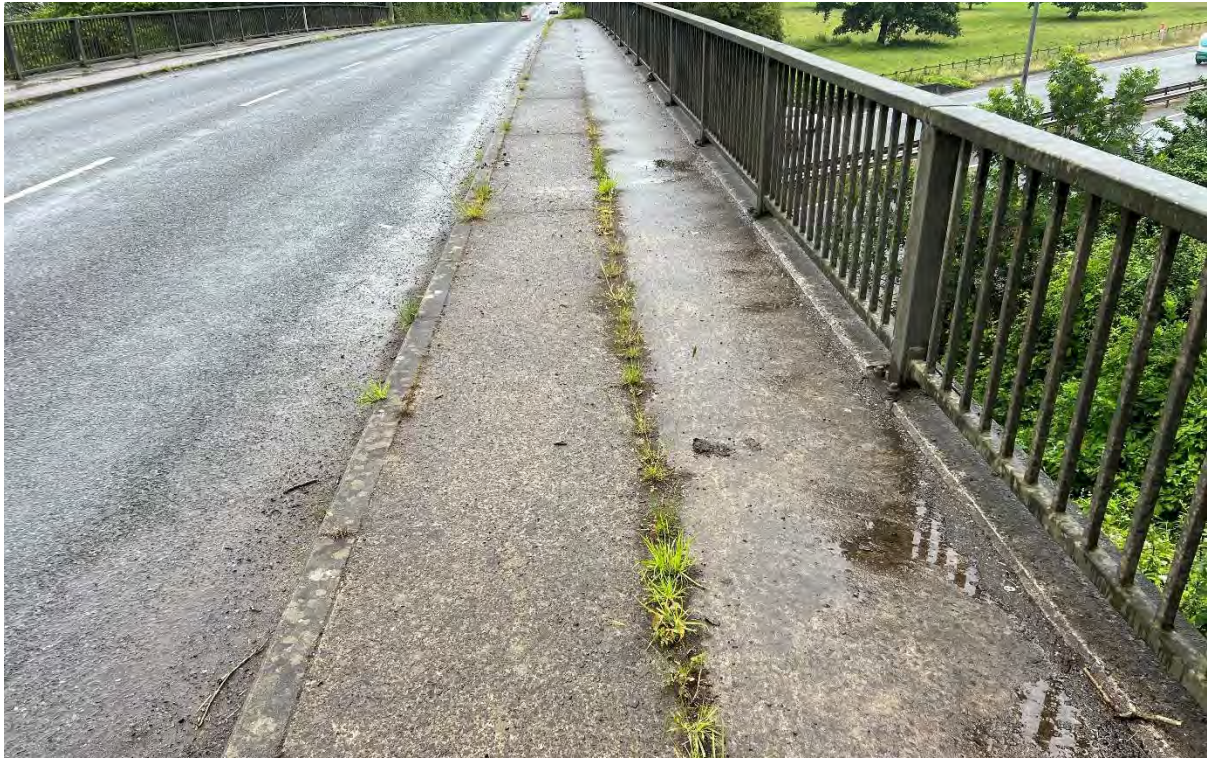
Photograph 83 - Vegetation growth and cracking to footway surfacing.

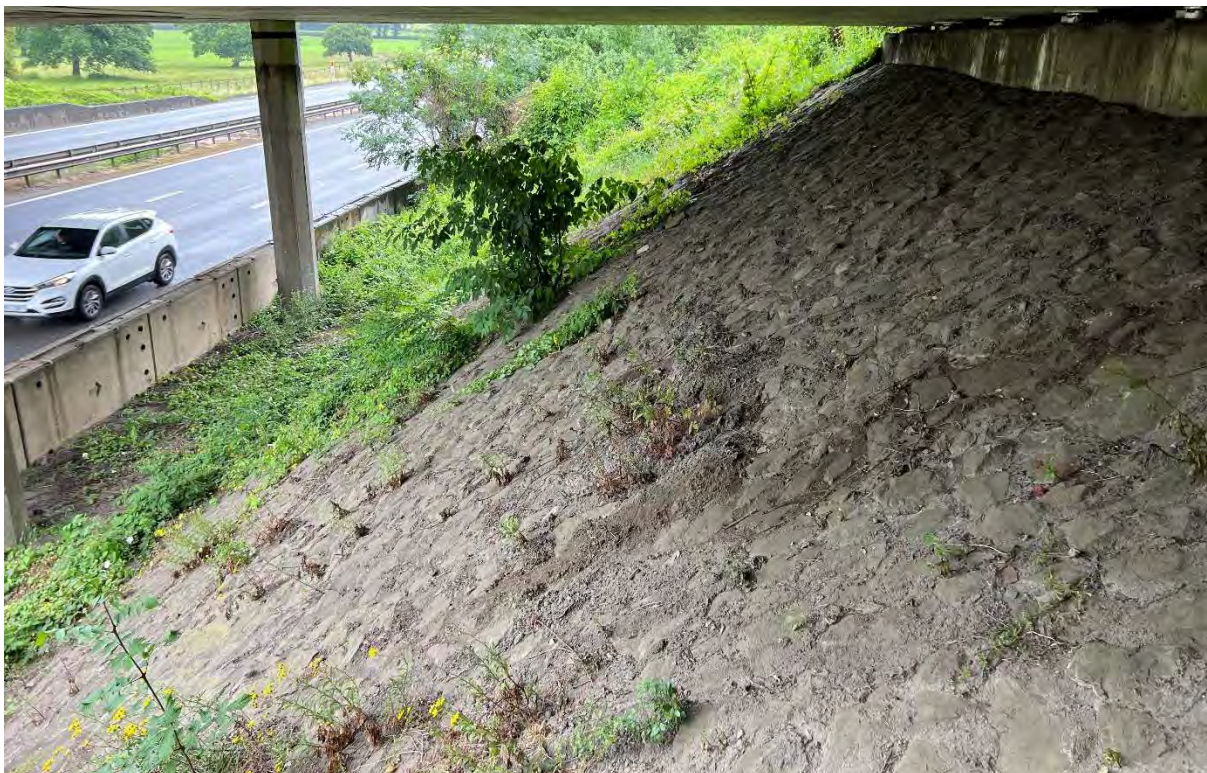
Photograph 84 - Span 1. Moderate vegetation growth to south revetment.

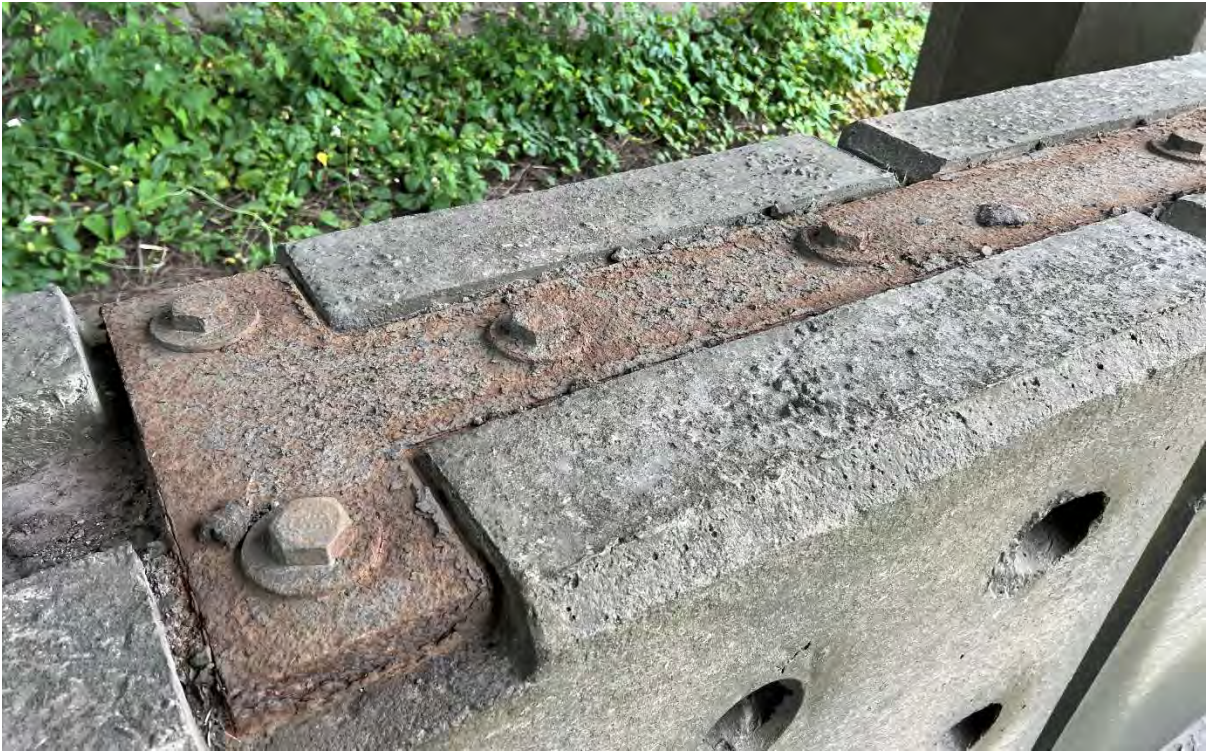
Photograph 87 - Span 2. Minor surface corrosion to the TVCB connections.

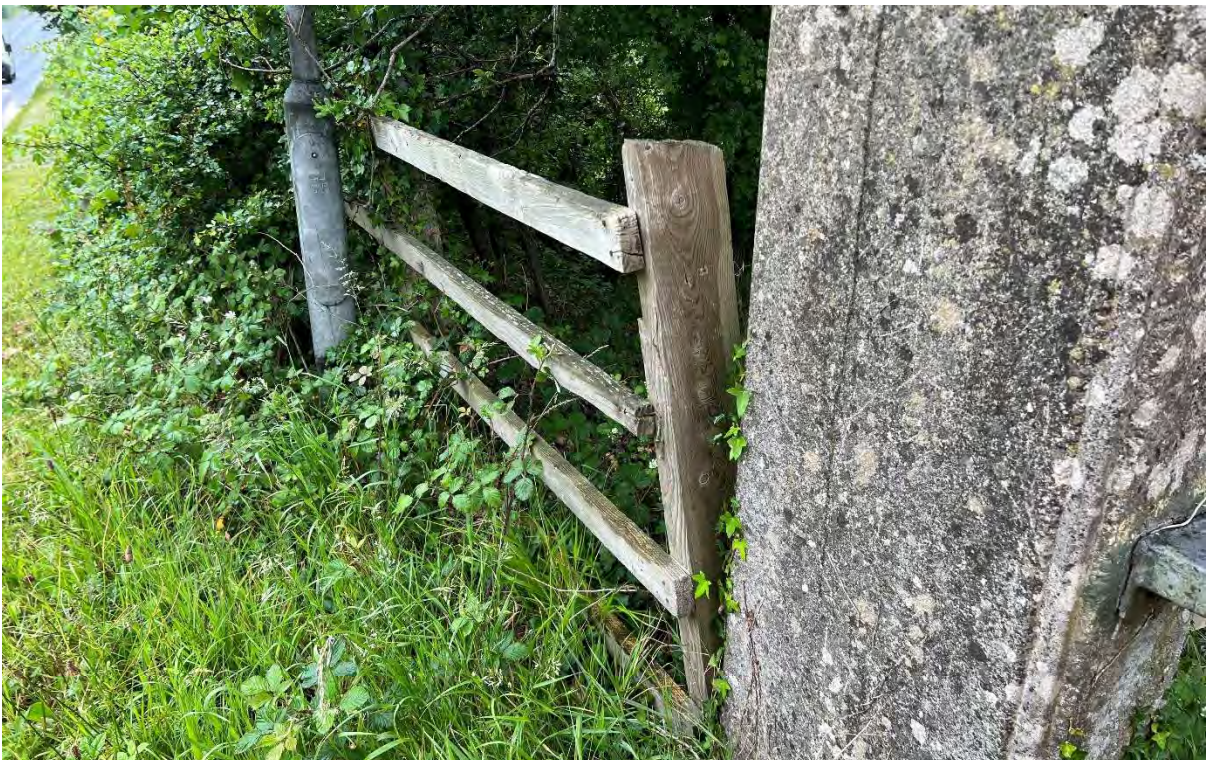
Photograph 88 - Span 3. Moderate timber decay to northeast approach fencing.
