## M4 23A-24 51 Bishton Llanmartin Overbridge CS 470 Management of Sub-standard Highway Structures

**M4 23A-24 51**  
**Bishton Llanmartin Overbridge**

**CS 470 Management of Sub-standard Highway Structures**

**March 2026**

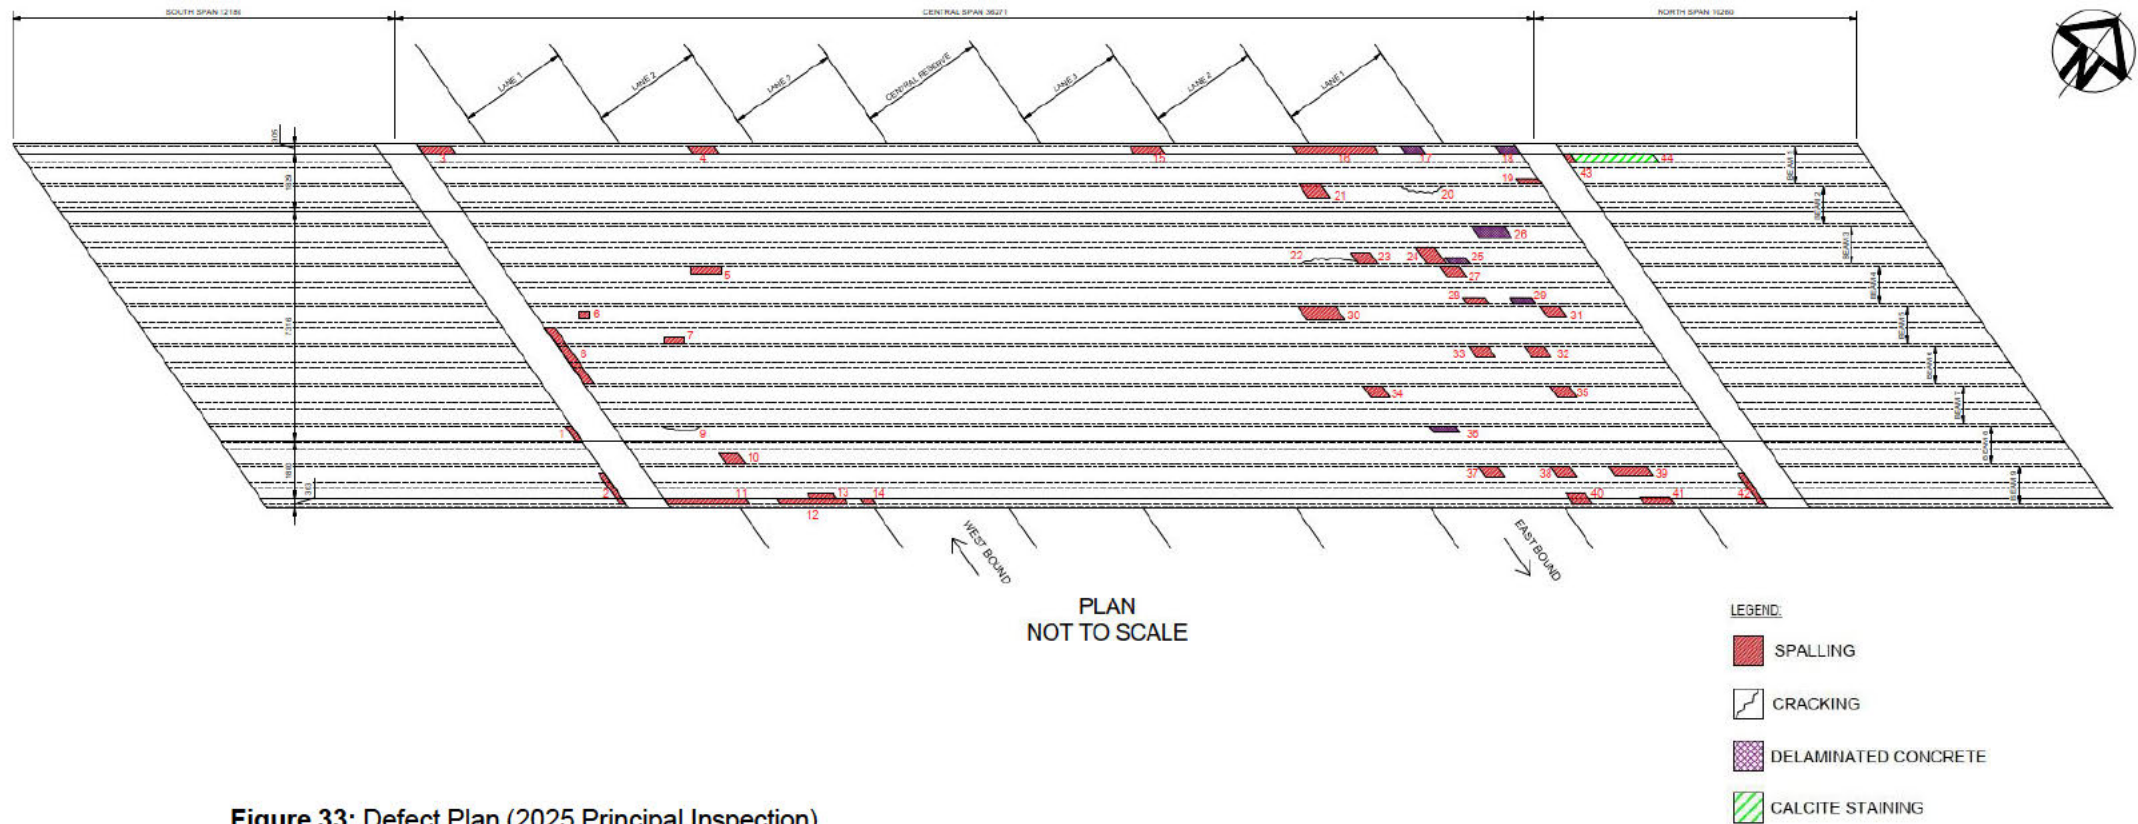
**Figure 33: Defect Plan (2025 Principal Inspection)**

The most recent 2025 PI found the structure to be in overall fair to poor condition, however Span 2 (the main span over the M4) was in poor condition. The PI recommended new assessment and PTSI works to be undertaken, as well as the investigation of interim measures. The defect plan is presented in Figure 3 Figure 33.

flexural or shear cracking) albeit records significant deterioration/ further defects since the previous 2019/20 PI. The 2025/26 PI report recorded the overall condition of the bottom flange of the precast beams in Span 2 as poor, particularly above Lane 1 and 2 of the eastbound M4 carriageway. As discussed in the previous section, further impact strikes could lead to distress and failure.

It is recommended that **Option L1: Lane Closure on Waltwood Road** is implemented. It is recommended that the northbound lane of Waltwood Road is closed given that is where the majority of the defects have been reported within the 2025/26 PI report.

Closure to be on northbound lane on Waltwood Road as this is directly above the highest quantity of defects on the soffit below. Traffic management to be employed through contraflow or similar system designed by a competent contractor.
