A487 New Dyfi Bridge

Environmental Statement –
Volume 3: Appendix 10.1

Preliminary Sources Study Report

900237-ARP-ZZ-ZZ-RP-CG-00002

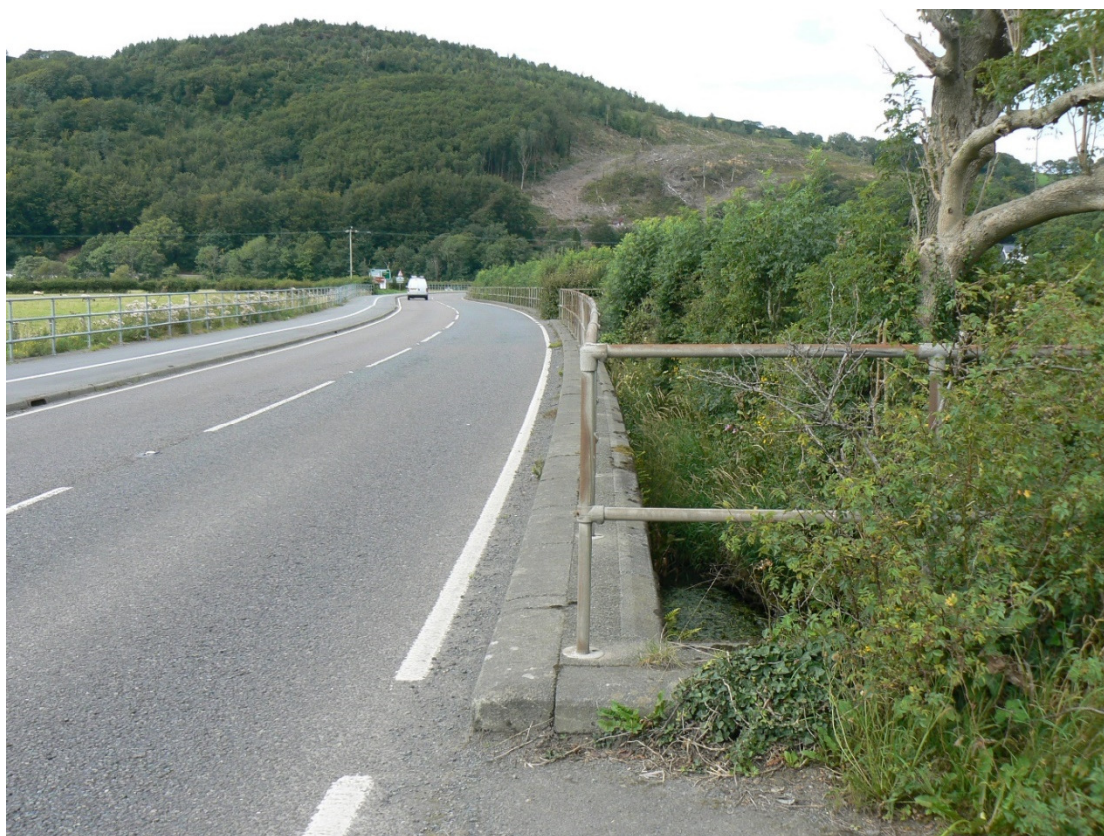
At around Ch. 0+250m, the proposed route crosses over the existing A487. Drainage channels run along both sides of the existing A487 and are culverted under the access to the fields; see Photograph 1. Services also cross the A487 at this location including a high pressure gas main; see Photograph 2. Overhead power lines cross the A487 and run across the site in a north easterly direction; see Photograph 3.

Photograph 1 – Culvert passing under A487 at Ch. 0+250m

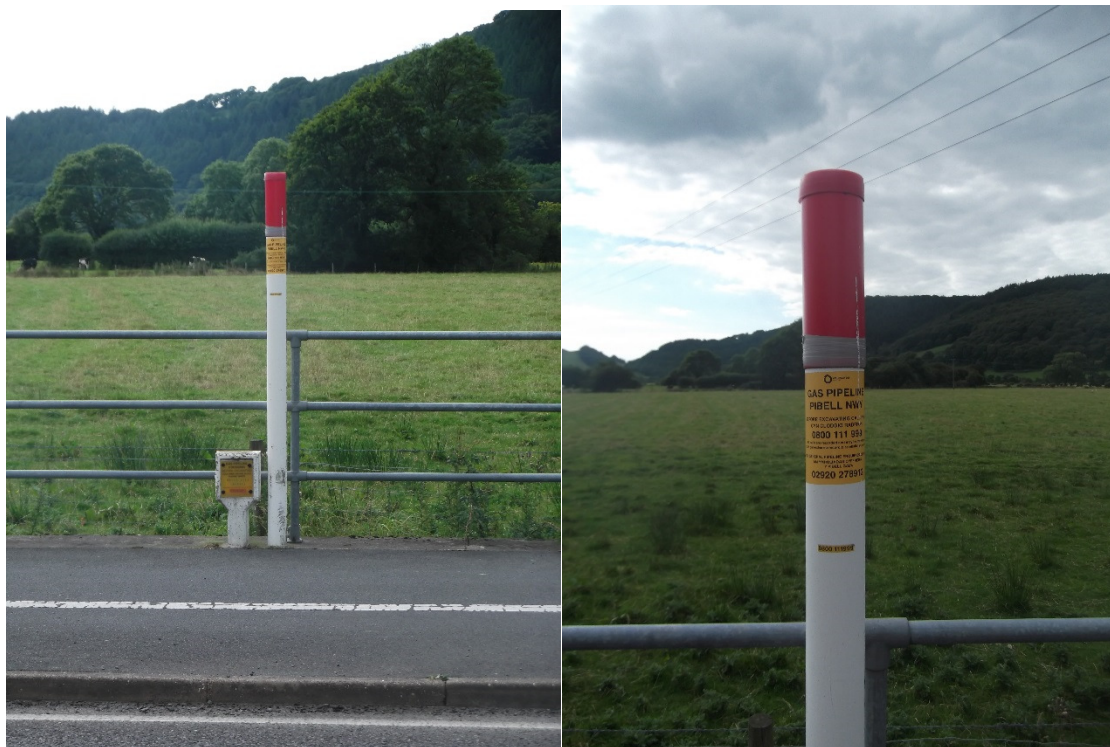
Photograph 2 – High pressure gas mains crossing the road.

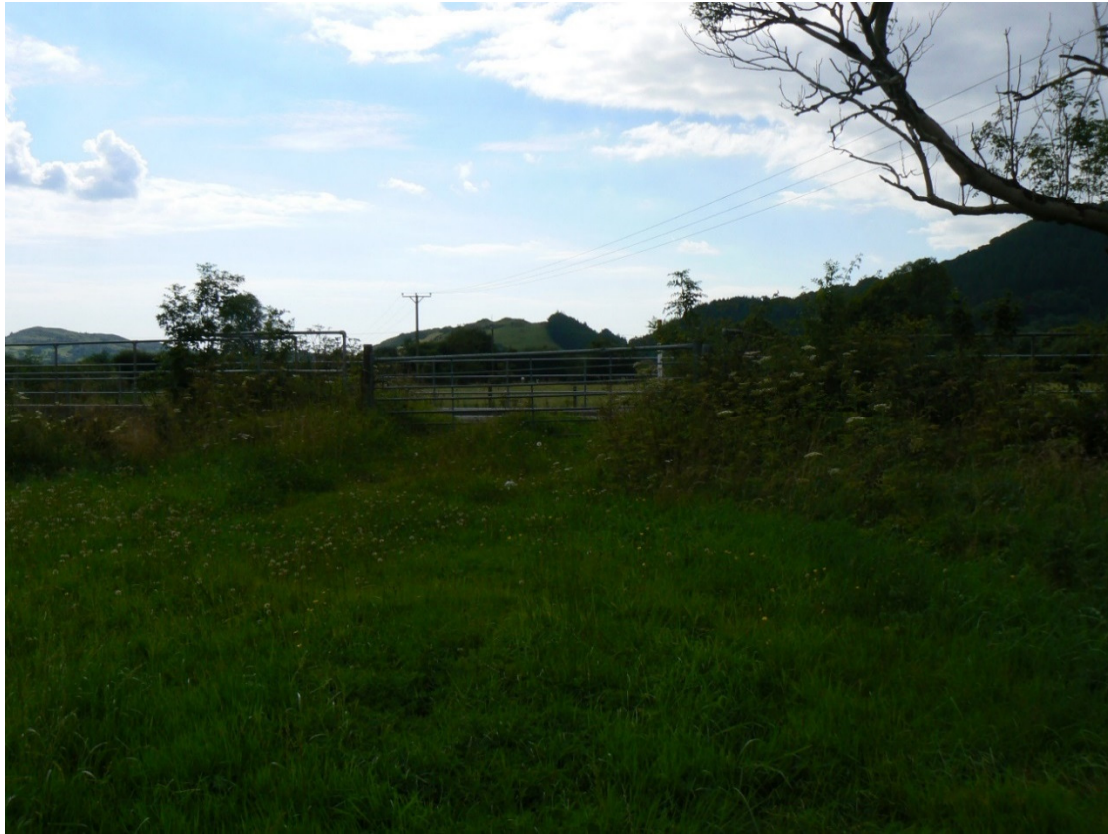
Photograph 3 – Overhead power lines crossing A487

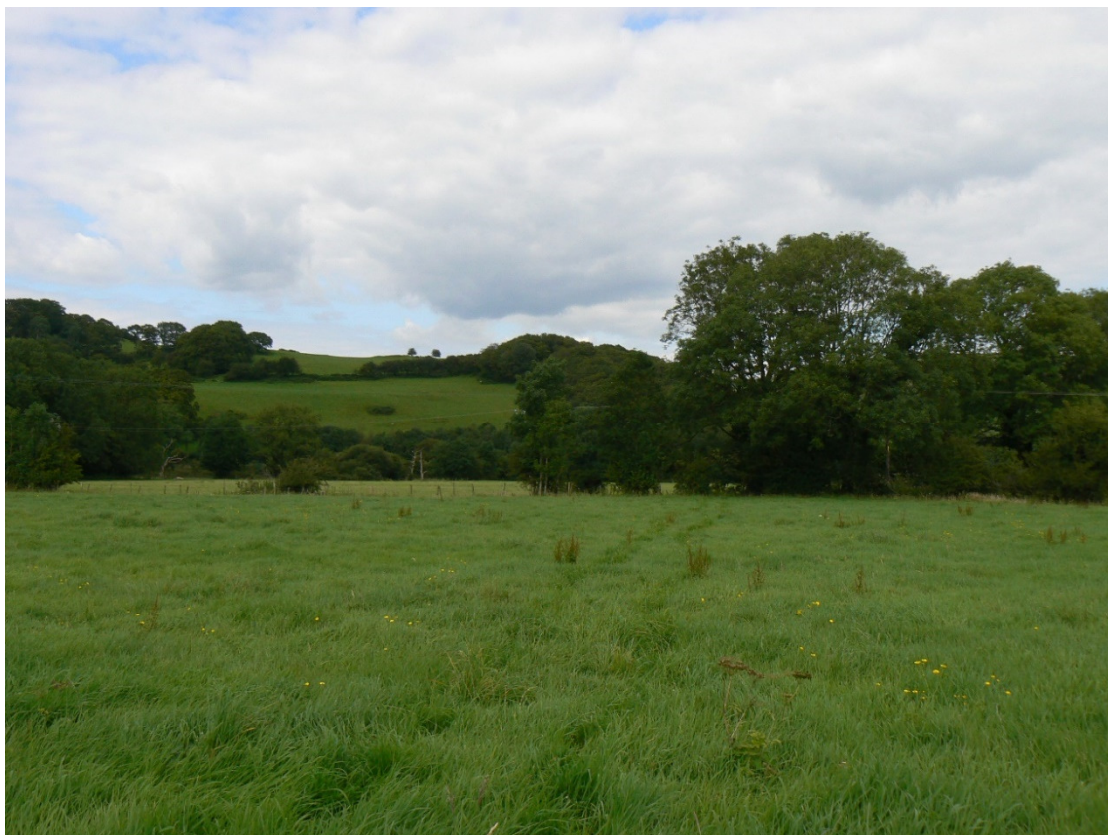
Between Ch. 0+250m and Ch. 0+820m, the proposed alignment crosses fields and hedgerows; see Photograph 4. At around Ch. 0+290m the field is very marshy in places indicating impeded drainage; see Photograph 5. Marshy ground is also present between Ch. 0+450m and Ch. 0+480m; see Photograph 6, and around Ch. 0+765m to Ch. 0+795m; see Photograph 7. Also a number of ponds are present, see Photograph 8.

Photograph 4 – Ch. 0+420m looking north along the proposed alignment

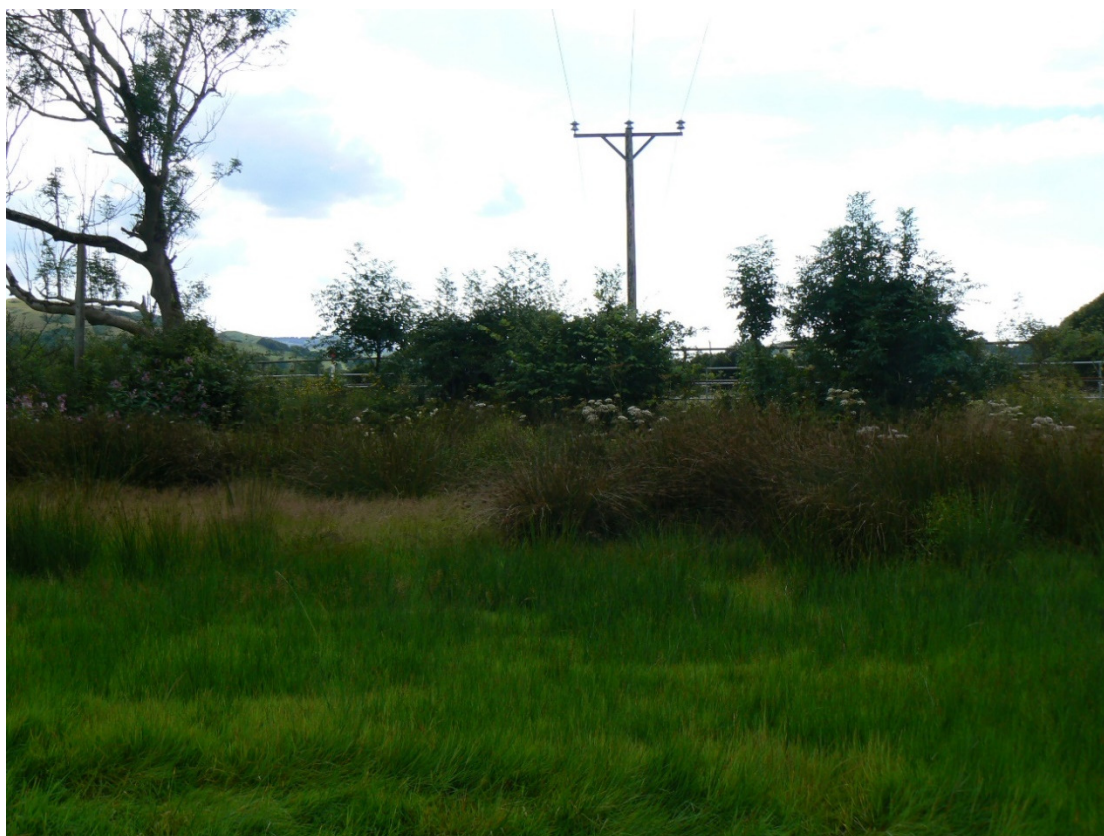
Photograph 5 – Marshy ground at Ch. 0+290m, also showing overhead cables

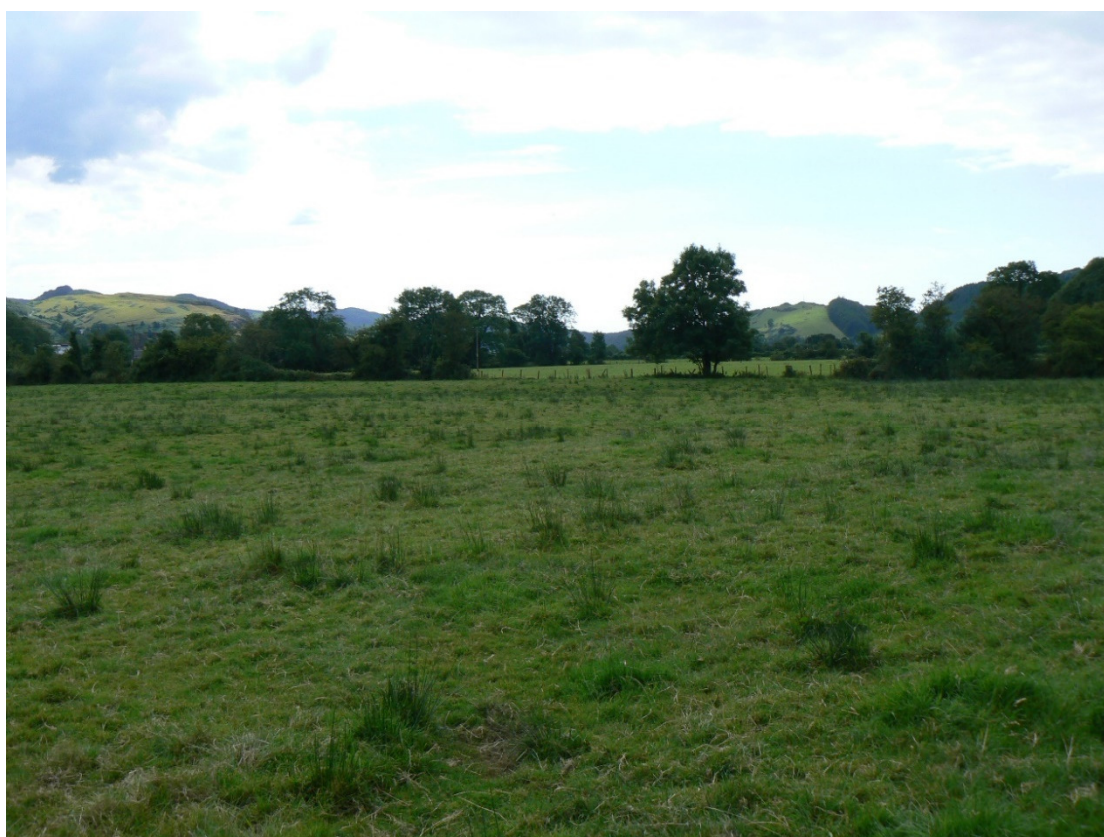
Photograph 6 – Marshy field at Ch. 0+450m to Ch. 0+480m.

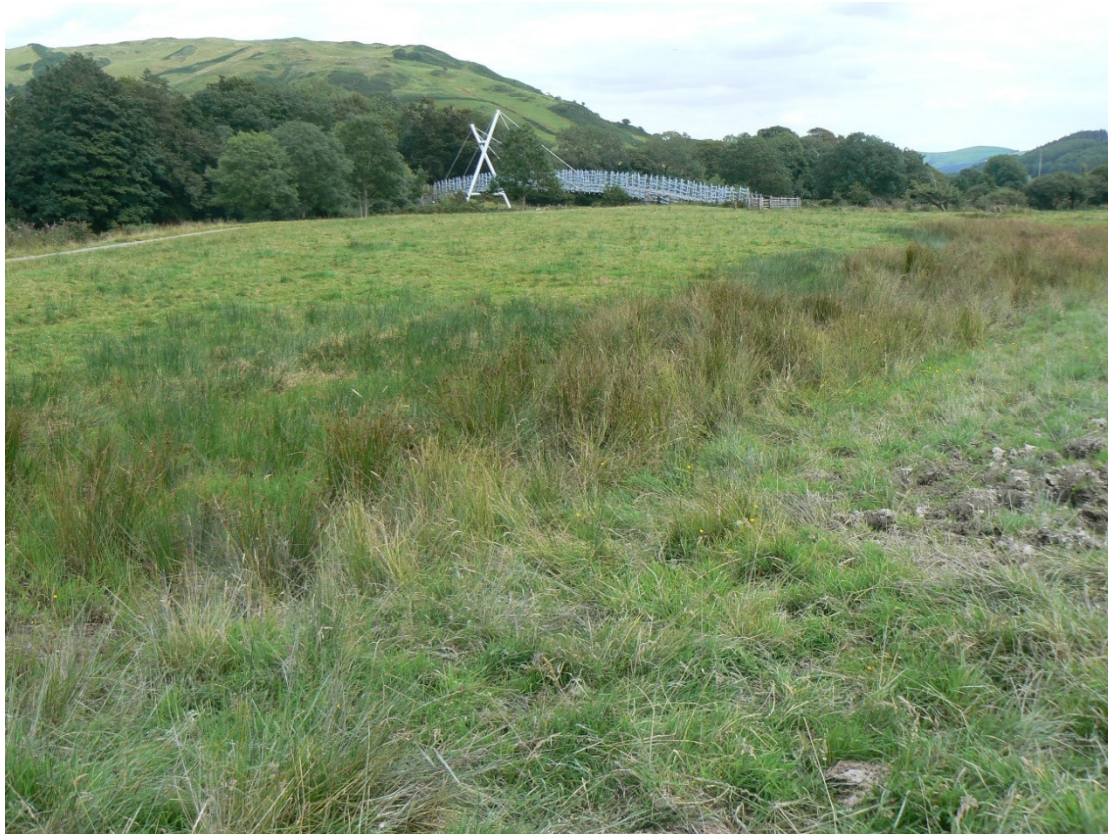
Photograph 7 – Marshy area between Ch. 0+765 to Ch. 0+795m, possible spring present.

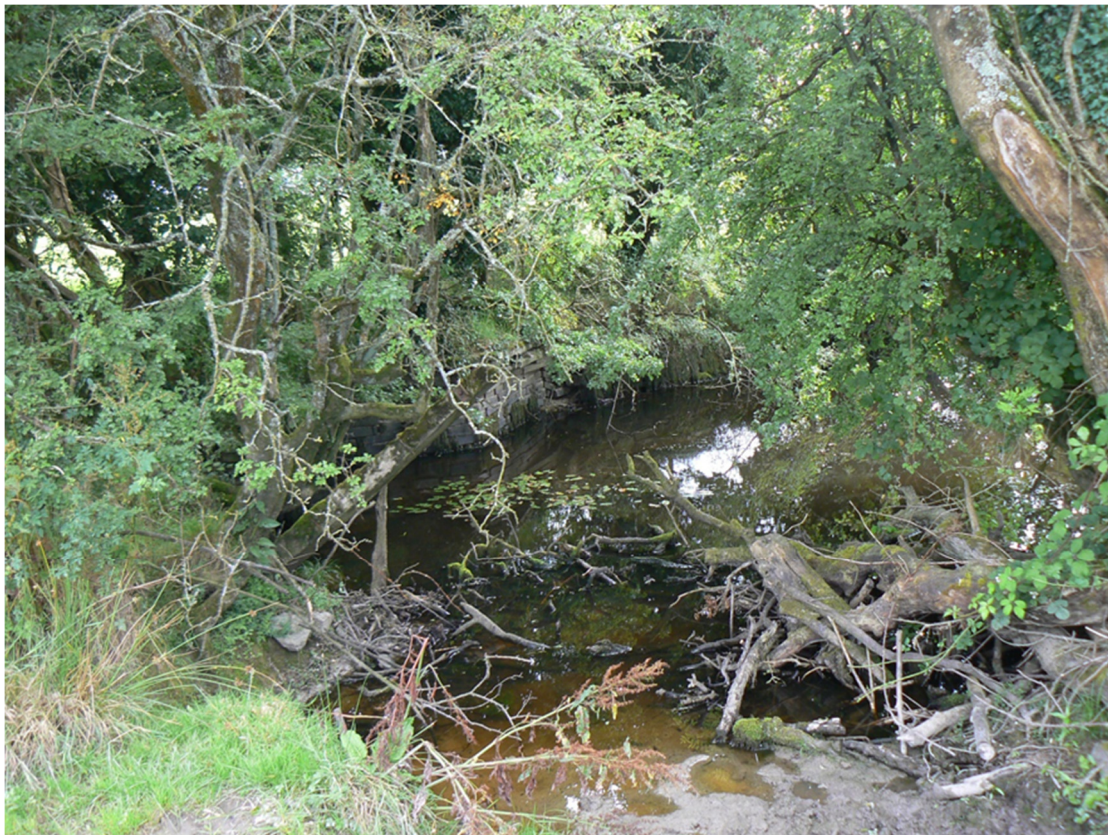
Photograph 8 – Pond east of Ch. 0+620m

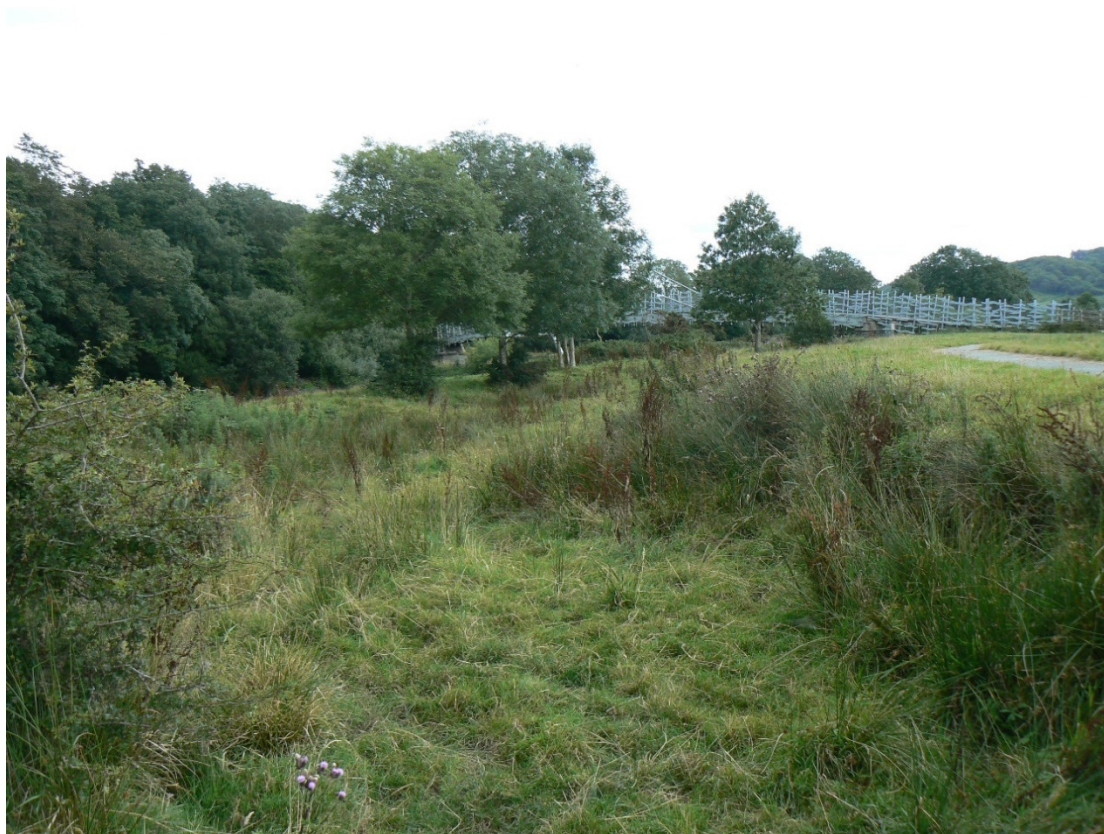
At Ch. 0+830m, the alignment crosses the existing footpath; see Photograph 9. It then crosses very uneven grassed area between Ch. 0+830m to Ch. 0+880m, potentially as a result of historic fill from the construction of the Millennium Bridge, which crosses the River Dyfi to the east of the proposed alignment.

Photograph 9 – Uneven ground on the western side of the footpath at Ch. 0+830m to Ch. 0+830m

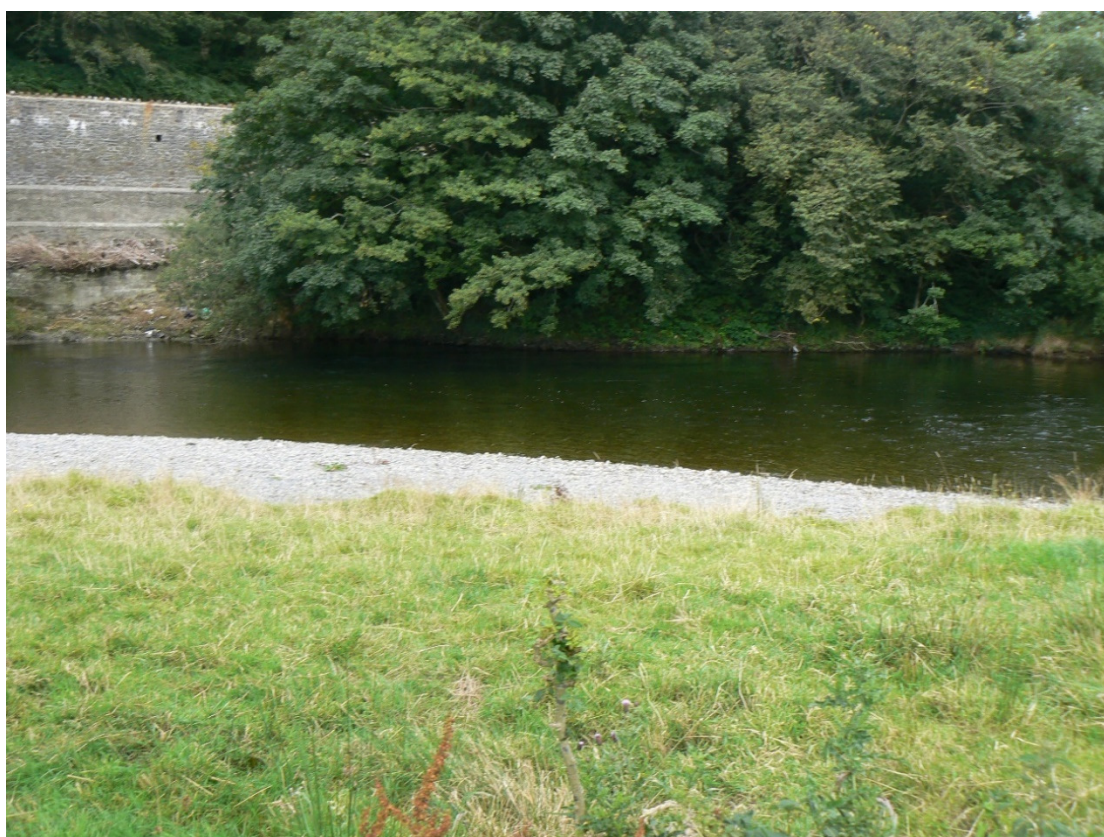
Between Ch. 0+880m and Ch. 0+895m, the alignment crosses a gravel bank, associated with deposition within the River Dyfi; see Photograph 10. Downstream of the alignment stiff, grey brown, clayey silt over river terrace deposits comprising rounded gravels were exposed in the river bank; see Photograph 11. There also appeared to be some evidence of an old masonry wall, possibly historic river edge protection; see Photograph 12. Upstream of the Millennium Bridge, on the southern river bank, there were signs of significant instability with localised slumping; see Photograph 13.

Photograph 10 – Gravel bank associated with River Dyfi

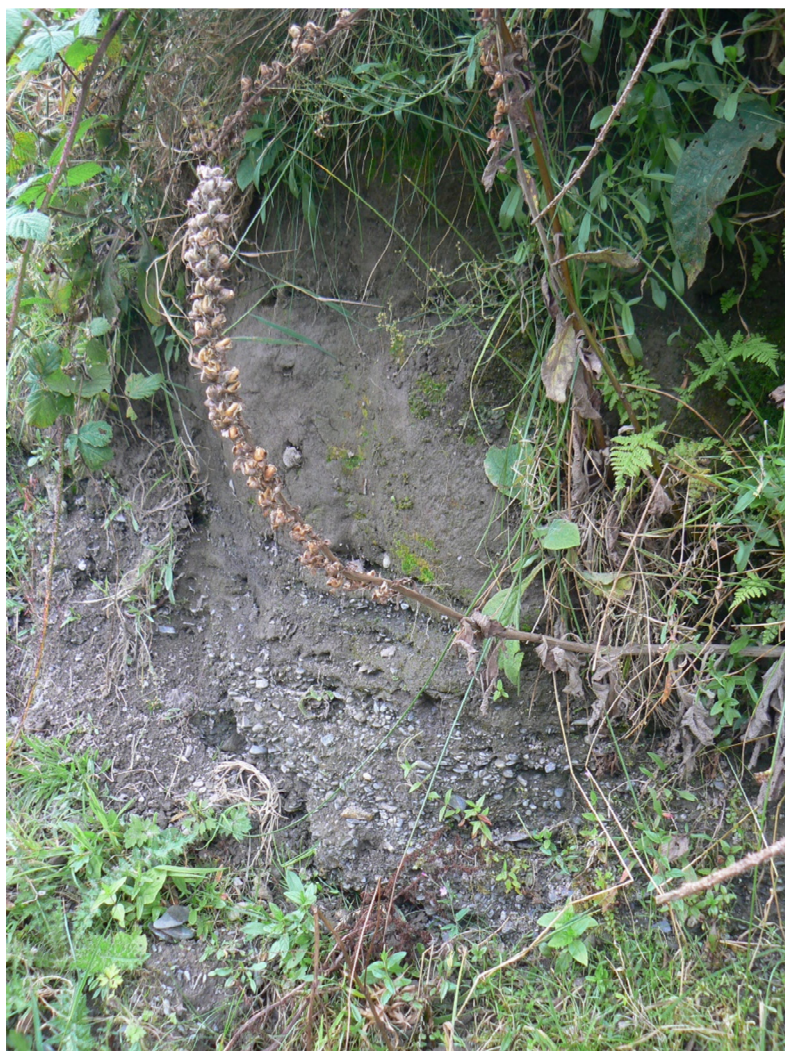
Valley-fill and mixed alluvium of the floodplain include coarse to fine-grained gravels with impersistent interbedded sandy clays, clays and silts; see Photograph 11. River terrace deposits up to a few metres high are recorded elsewhere in the Dyfi valley and consist mainly of gravels; see Photograph 10. The flat tract of the floodplain is criss-crossed by historic river courses (palaeochannels) although these features have been greatly suppressed by successive cultivation.

Photograph 11 – Exposure in the riverbank downstream of the alignment

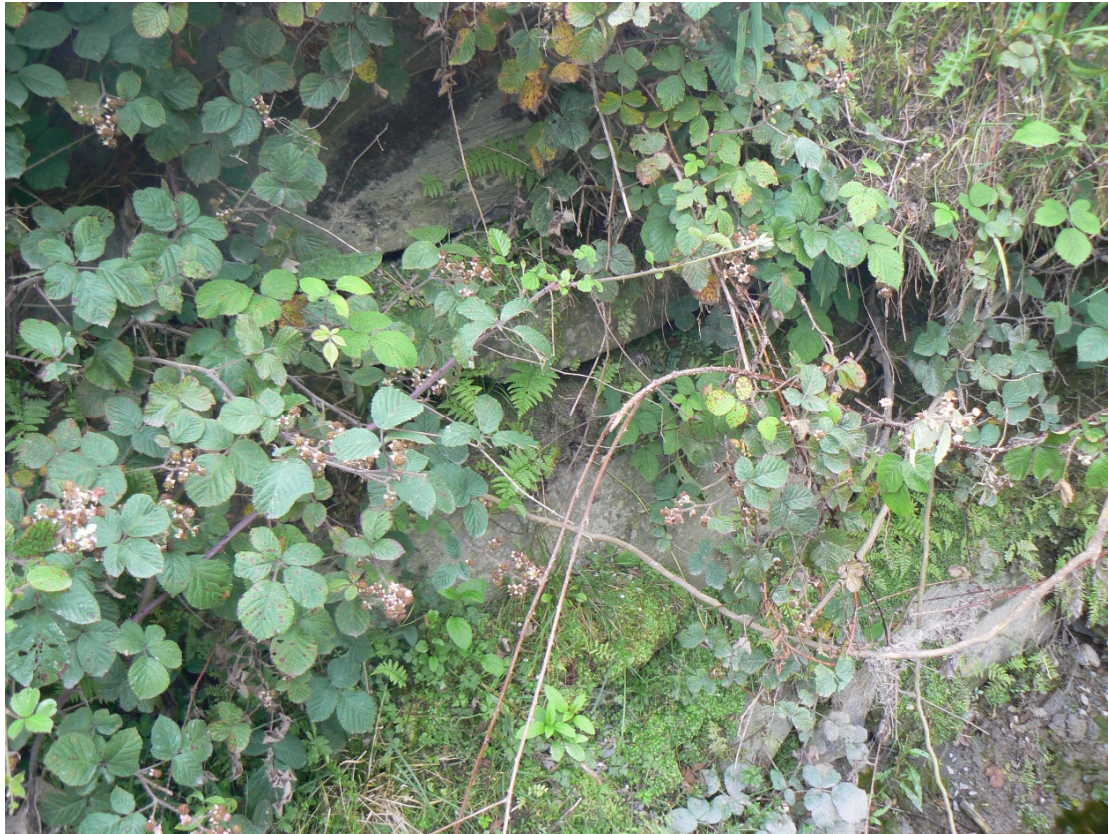
Photograph 12 – Historic river edge protection works

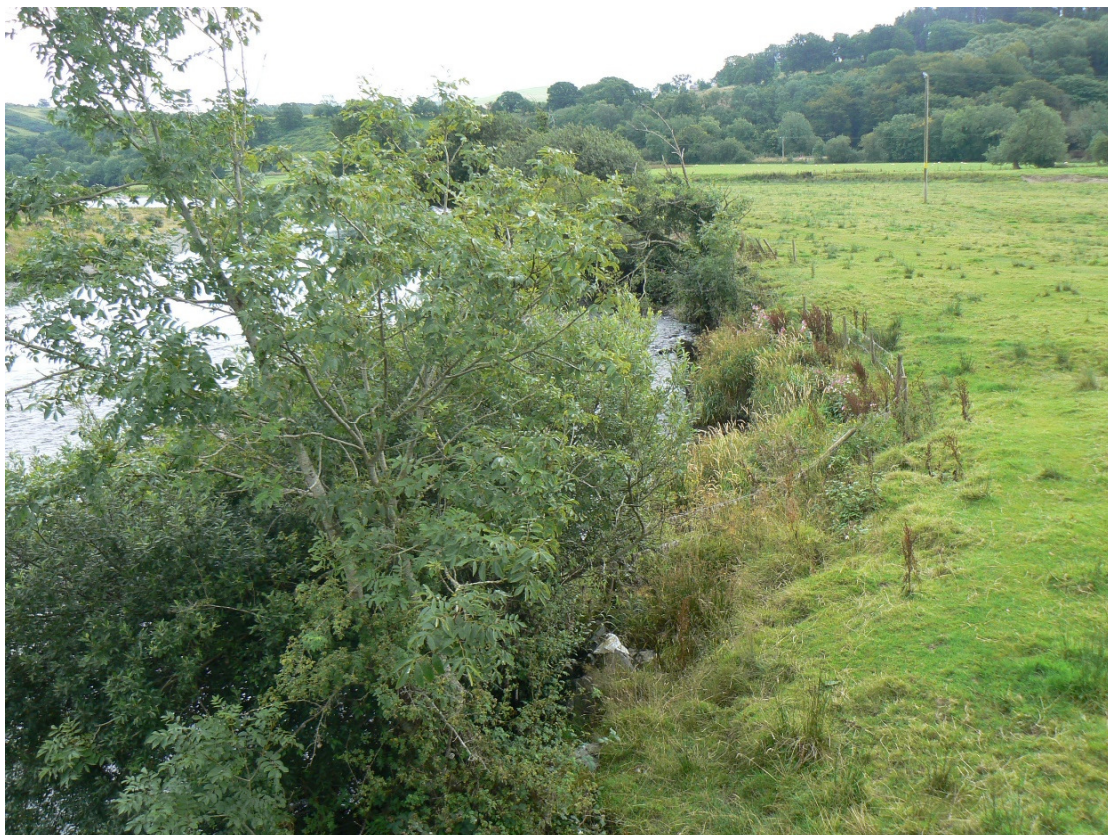
Photograph 13 – Showing instability upstream of the Millennium Footbridge

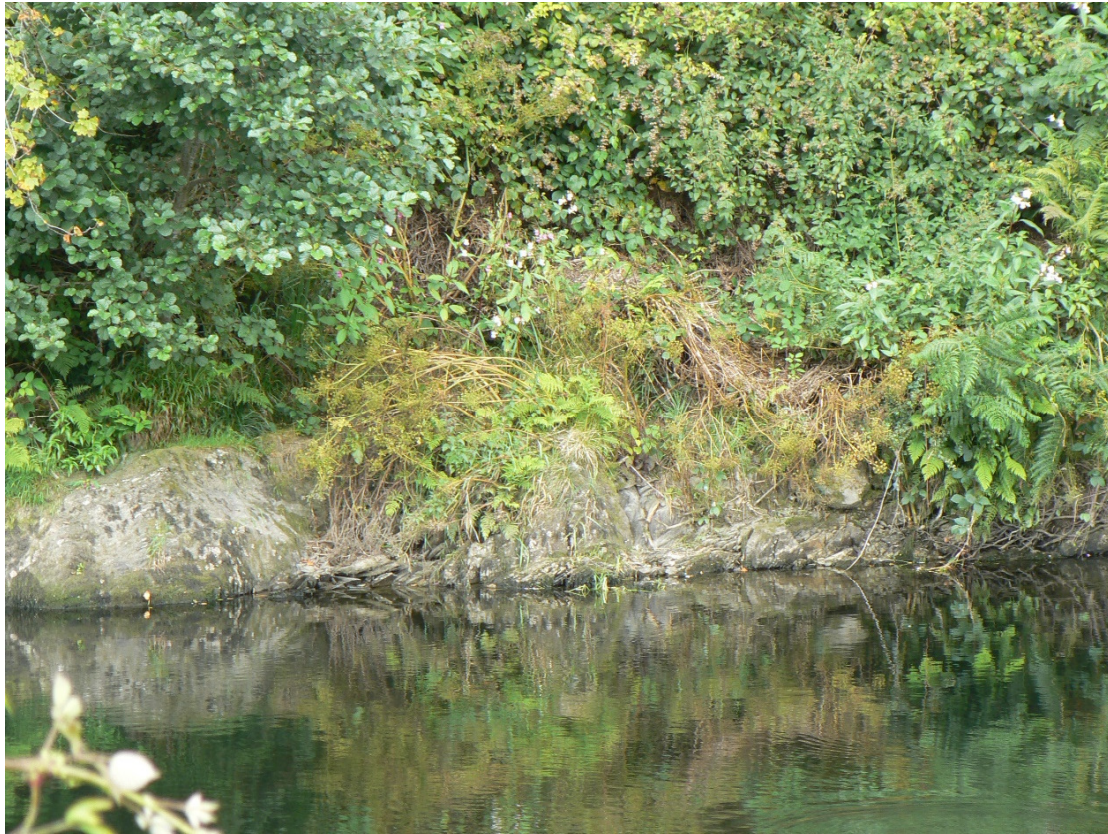
On the northern bank of the river, between Ch. 0+780m and Ch. 0+800m, rock was shown outcropping; see Photograph 14. However just upstream, a retaining structure is present which supports the existing A487; see Photograph 15.

Photograph 14 – Rock outcropping on the opposite bank at about Ch. 0+790m

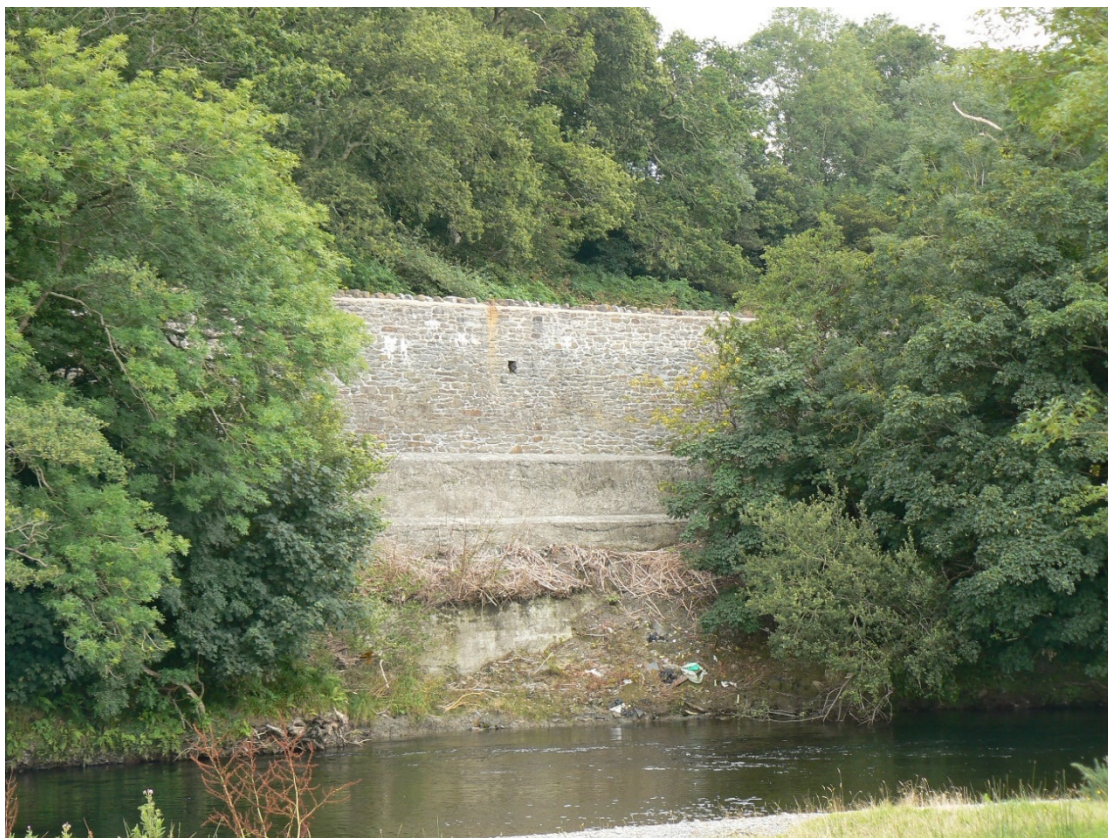
Photograph 15 – Retaining structure supporting the existing A487

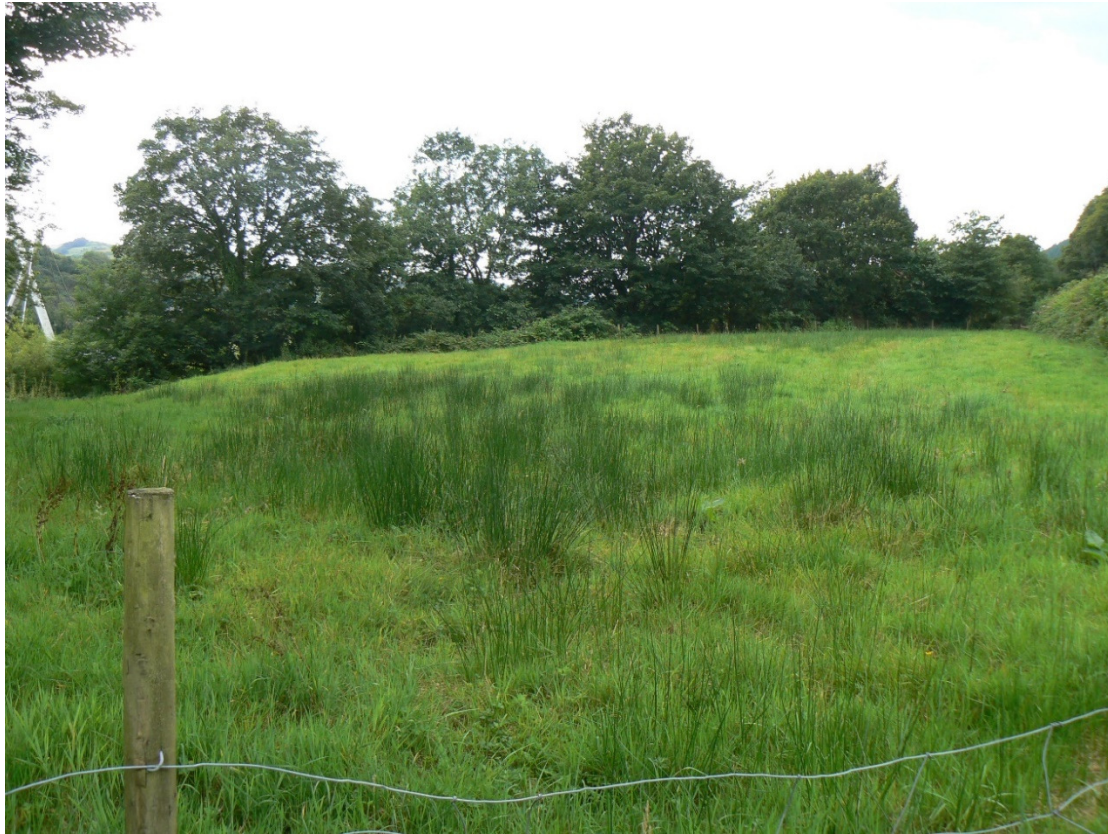
Photograph 16 – From Ch. 1+000m looking along the alignment towards Ch. 0+940m

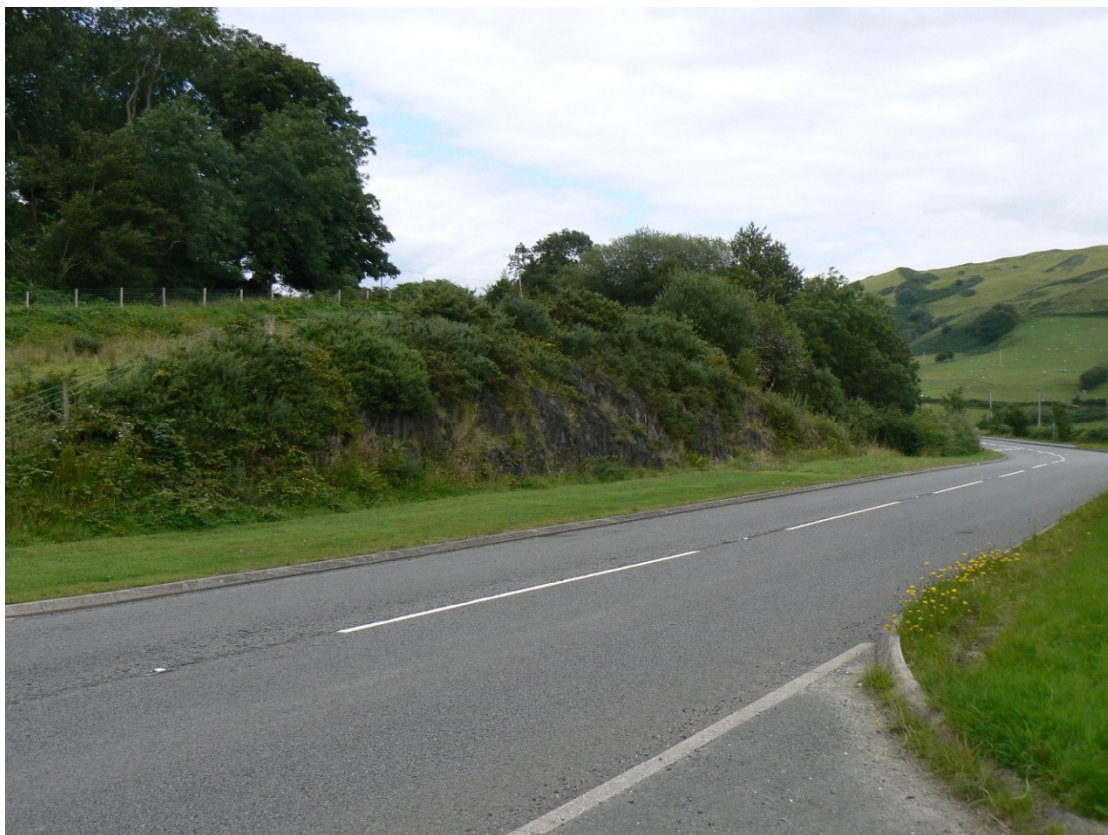
Photograph 17 – Ch. 1+010m where the proposed alignment rejoins the existing A487

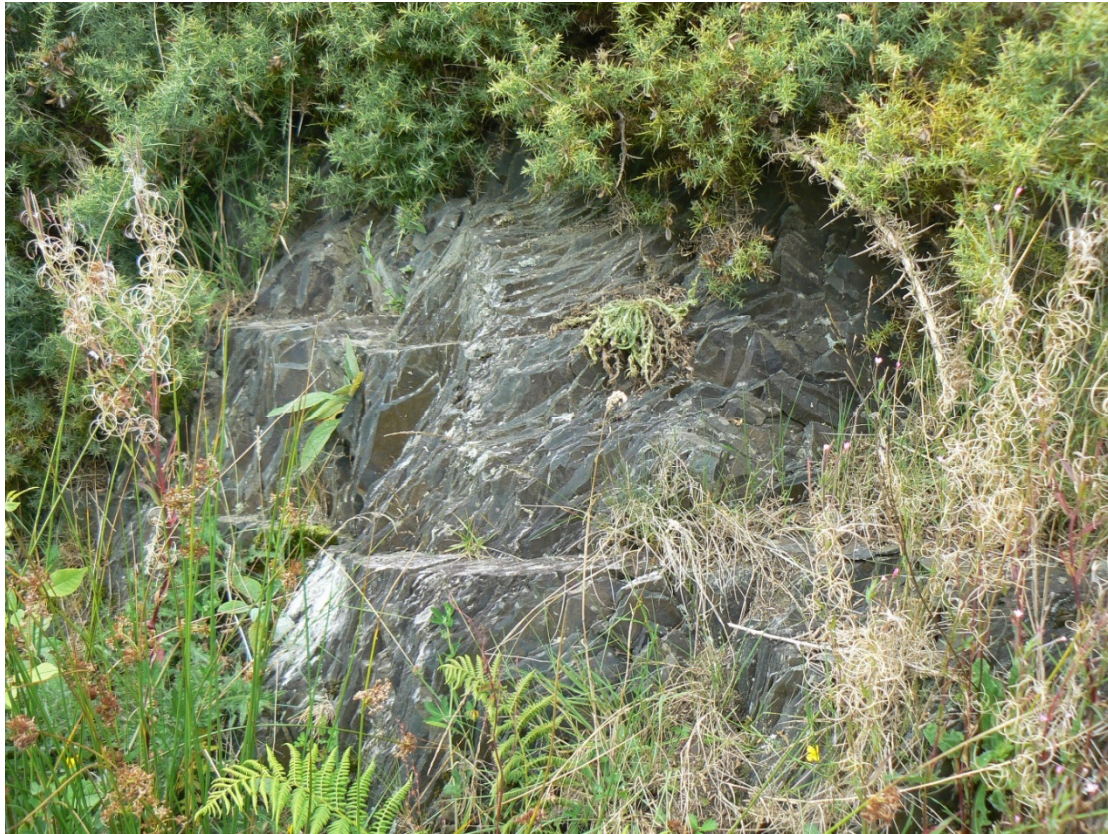
Photograph 18 – Vertical discontinuities in the rock cutting at around Ch. 1+100m

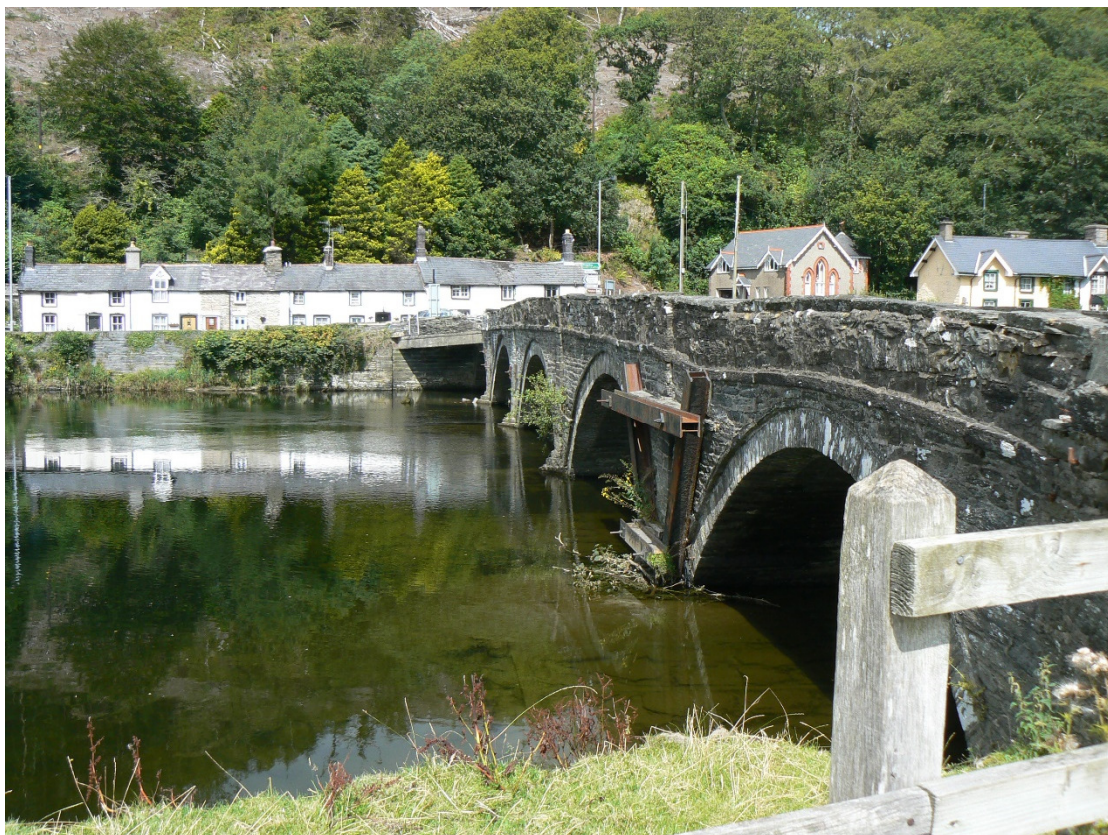
The existing Dyfi Bridge is a Grade II listed road bridge. It was built in 1533, repaired in 1681 and rebuilt in 1805. It is a 5-arch rubble bridge, featuring rounded arches with arch rings, voussoirs, thin pilaster buttresses between each arch and very low pointed cutwaters. Modern reinforcements have also been added and numerous repairs are evident (see Photograph 19).

The bridge has been repeatedly damaged over the years by vehicle impacts leading to lengthy closures for repairs. Closures have also been triggered by flooding. These closures have been problematic as alternative routes to cross River Dyfi involve long detours.

Photograph 19 – Showing repairs to existing Dyfi Bridge
