Appendix C.1
Gazetteer of Cultural
Heritage Sites

Newtown Bypass, Powys Archaeological walkover survey

Newtown Bypass, Powys

Archaeological Evaluation and Watching Brief

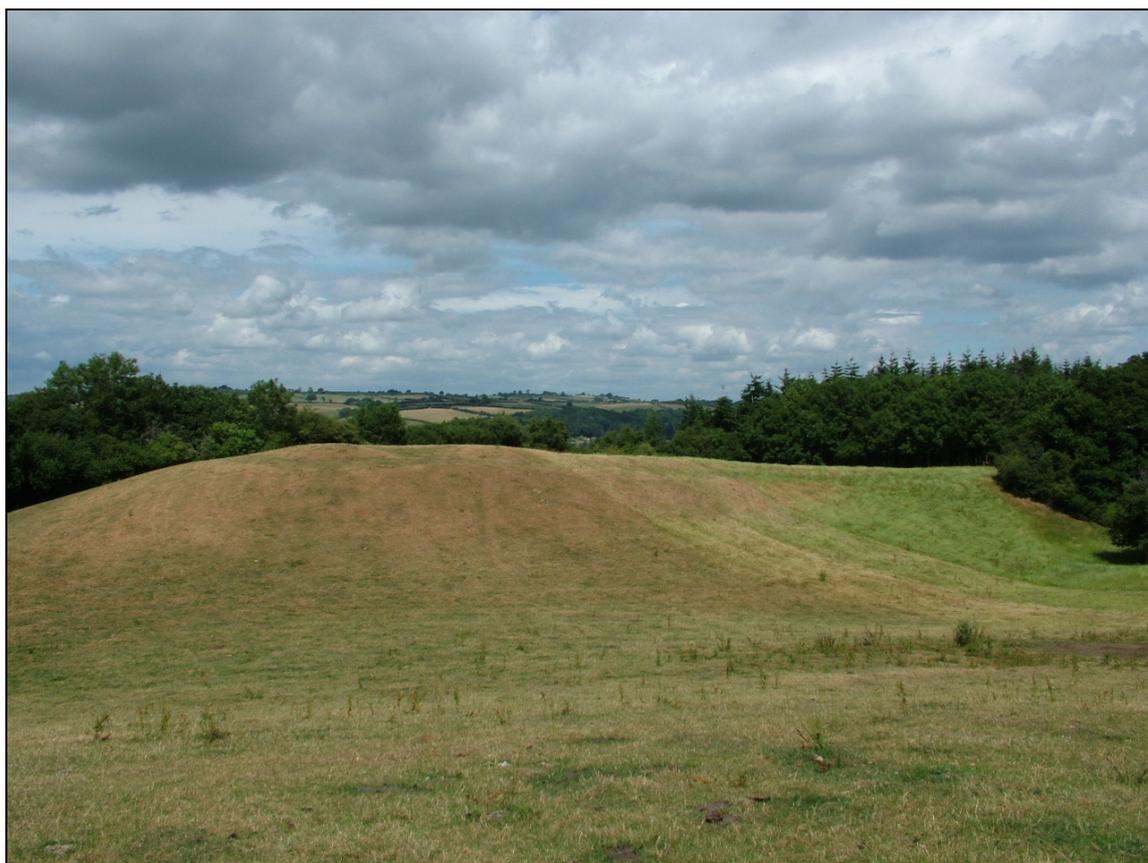
Fig. 1 Castell-y-dail hillfort, this extends into the forestry on the right (CPAT 3663-0008)

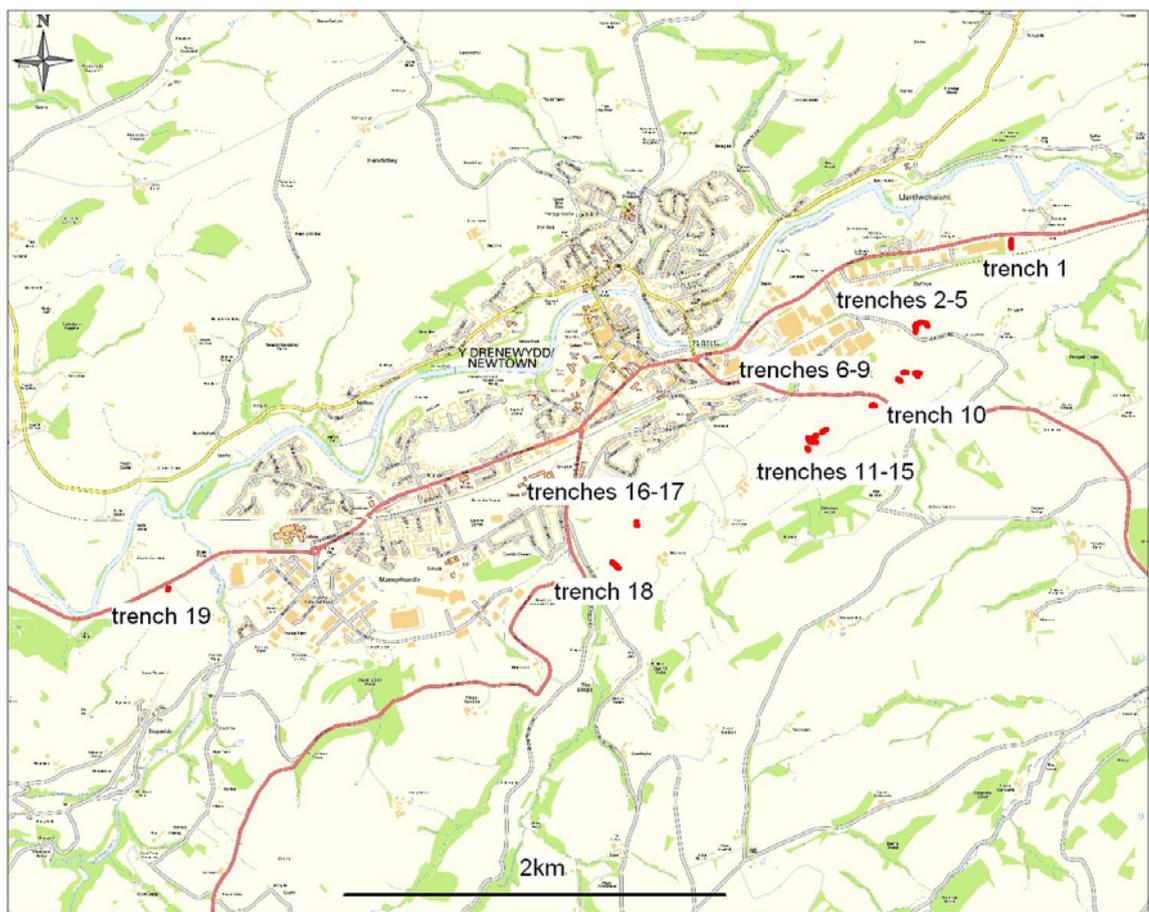
Fig. 5 The location of the evaluation trenches

- 3.2 In each trench the modern overburden was removed by machine under close archaeological supervision down to the surface of the undisturbed natural subsoil or the first recognisable archaeological horizon. Thereafter all excavation was undertaken by hand. A written, drawn and photographic record was maintained during all excavations, a summary of which is provided in Appendix 1. All trenches measured 1.5m in width and were located with respect to the Ordnance Survey national grid using a Global Positioning System (GPS) with sub-metre accuracy. The numbers in brackets in the following text refer to individual context records that form part of the site archive, which will be deposited with the regional Historic Environment Record in Welshpool in due course. Detailed plans of the individual trenches are provided in A3 format at the end of the report.

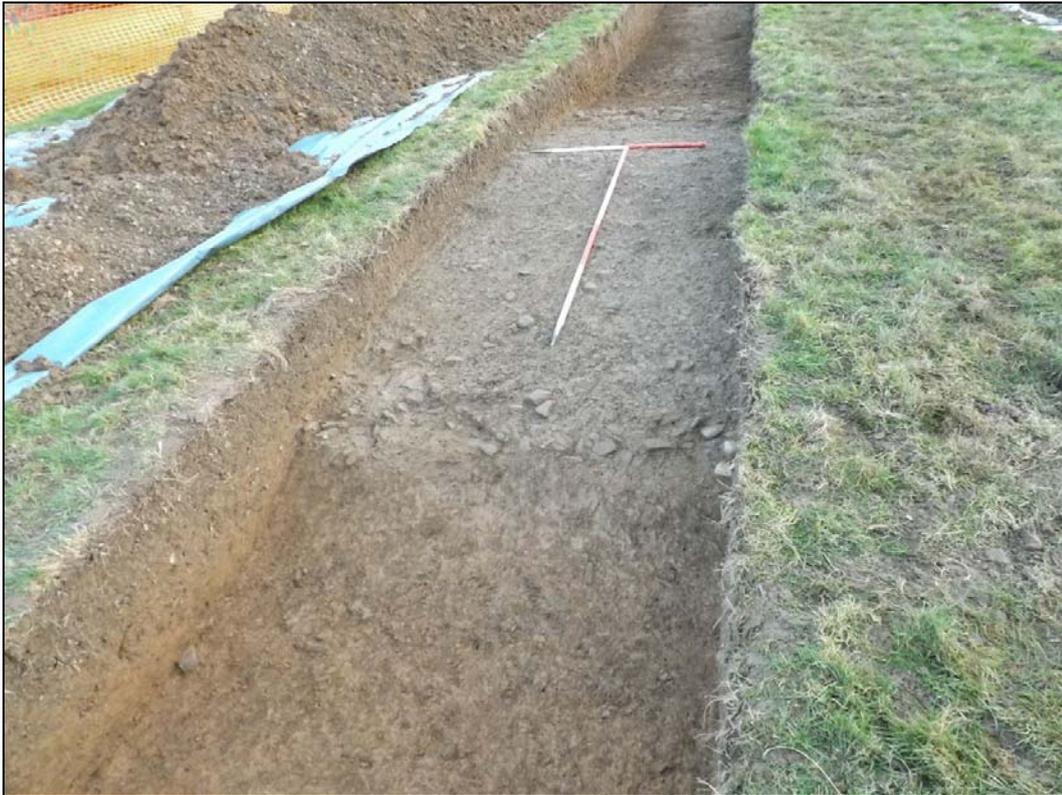
Fig. 7 The Roman road (01-004), viewed from the west. Photo CPAT 3717-0184

- 3.5 Although the road was not subject to any excavation beyond the initial hand cleaning three phases of construction, or at least resurfacing, were apparent, each consisting of compacted gravel and river cobbles. The uppermost surface (01-006) was relatively well preserved, within which four wheel ruts (01-007) were identified. Earlier surfaces were visible on either side of the road, beneath the extents of the latest surface, the earliest of which consisted of context 01-015 on the north side and a presumably equivalent layer, context 01-008, on the south side. Similarly, the second phase consisted of context 01-019 on the north side and 01-005 on the south side. The maximum surviving width of the road metalling was around 6.2m.

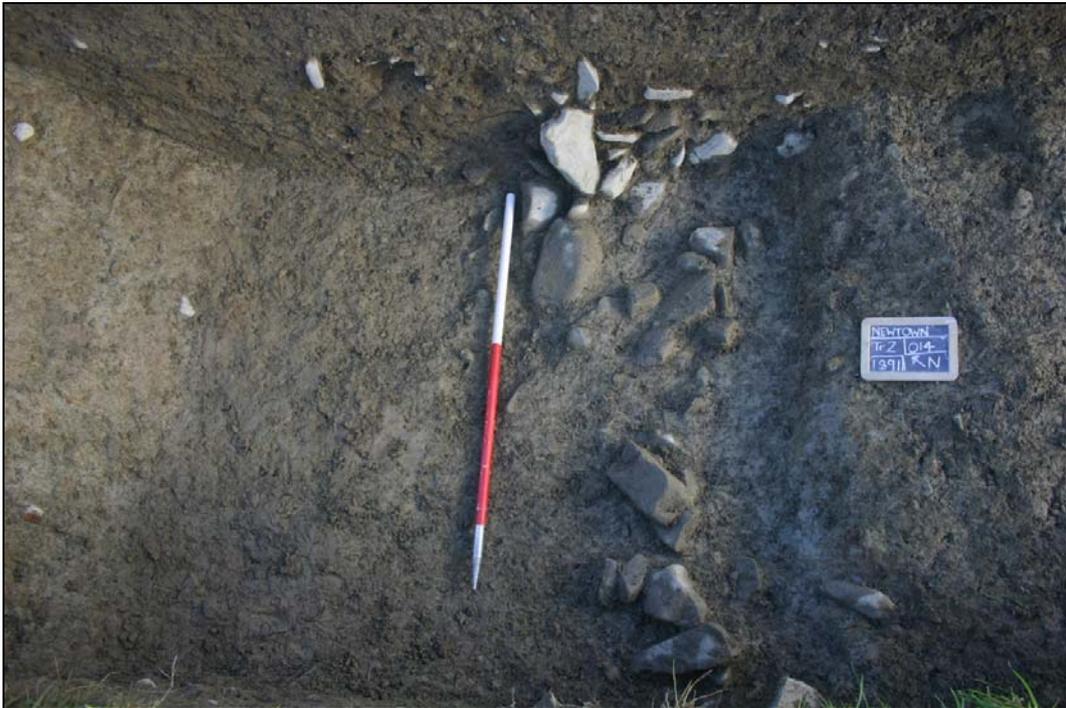
Fig. 9 Enclosure ditch 02-008 partly excavated, showing stone deposit 02-014, viewed from the south-west. Photo CPAT 3716-0124

of brown silty clay (02-007). Bulk soil samples were taken from two of the fills (02-014 and 016).

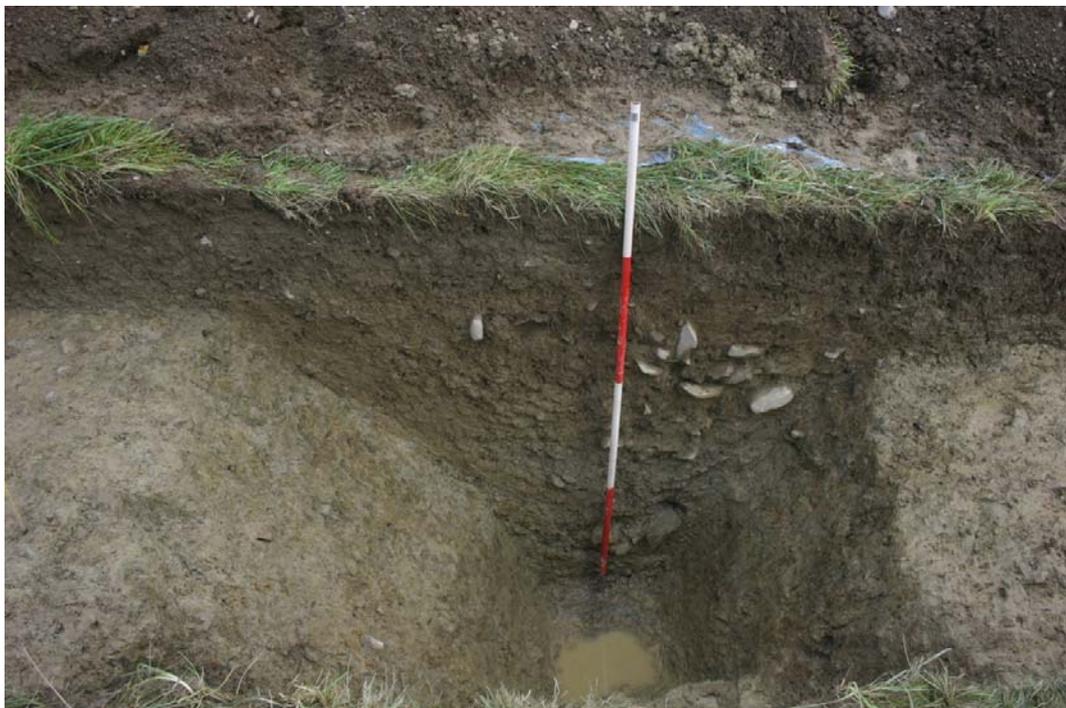
Fig. 10 Enclosure ditch 02-008 viewed from the south-west. Photo CPAT 3716-0170-0117

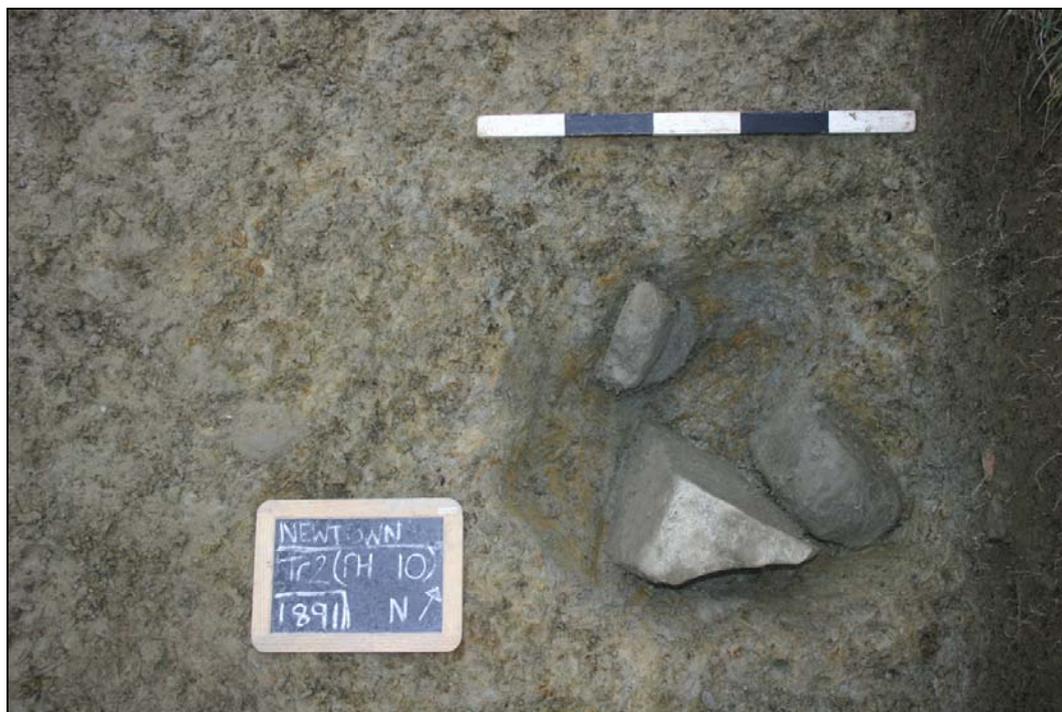
Fig. 11 Post-hole 10-010 showing stone packers, viewed from the south-east.
Photo CPAT 3716

- 3.10 A post-hole (02-010) with stone packing was identified 0.5m from the inner edge of the enclosure ditch, measuring 0.48m by 0.4m and 0.3m deep (Fig. 11). The position of the post-hole is likely to correspond with enclosure bank, which it has been assumed lay on the inside of the ditch. Given the lack of surviving stratigraphy it is not possible to determine its relationship with the enclosure, but if contemporary the post-hole must have been dug before the bank was constructed, perhaps to hold a post which was later embedded within the bank and could have been part of a palisade.

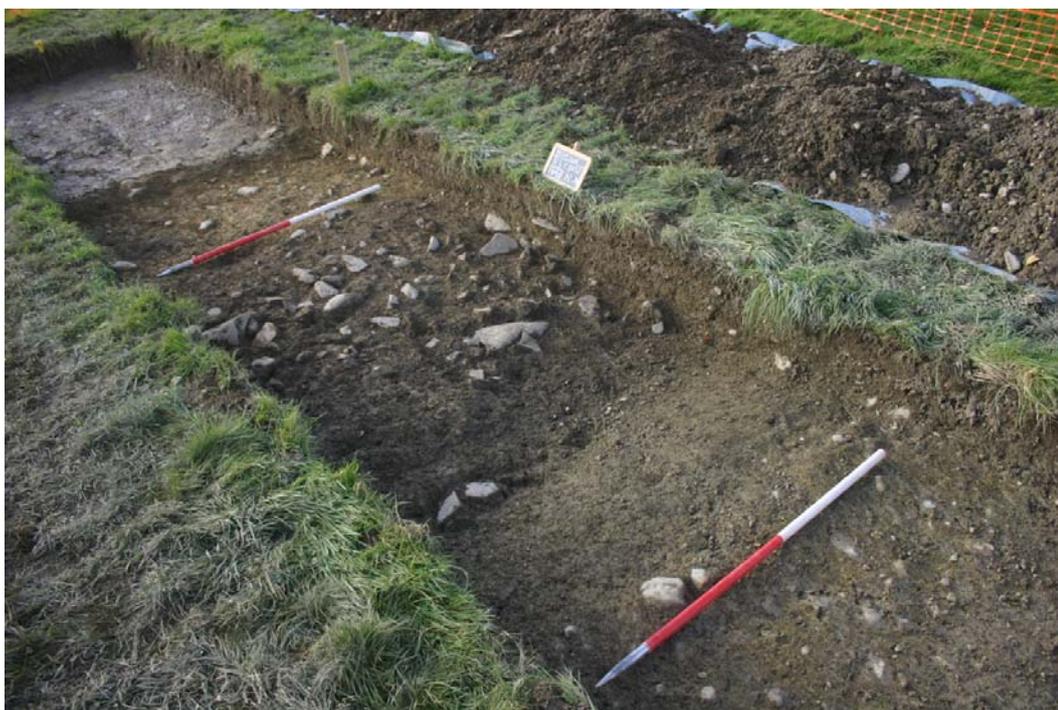
Fig. 12 The enclosure ditch (03-005) in trench 3, viewed from the east. Photo CPAT 3716-0148

- 3.14 A 2.5m-wide ditch (03-005) was identified towards the south-western end of the trench (Fig. 12), corresponding with that revealed by the geophysics and representing the south-western side of the enclosure. The ditch was not excavated, although a single sherd of Roman greyware was recovered from the upper fill (03-003), which partly overlay an earlier fill (03-019) which was visible against the inner edge of the ditch. The ditch was slightly narrower than its counterpart in trench 2 which may be due in part to truncation of the upper levels by cultivation.

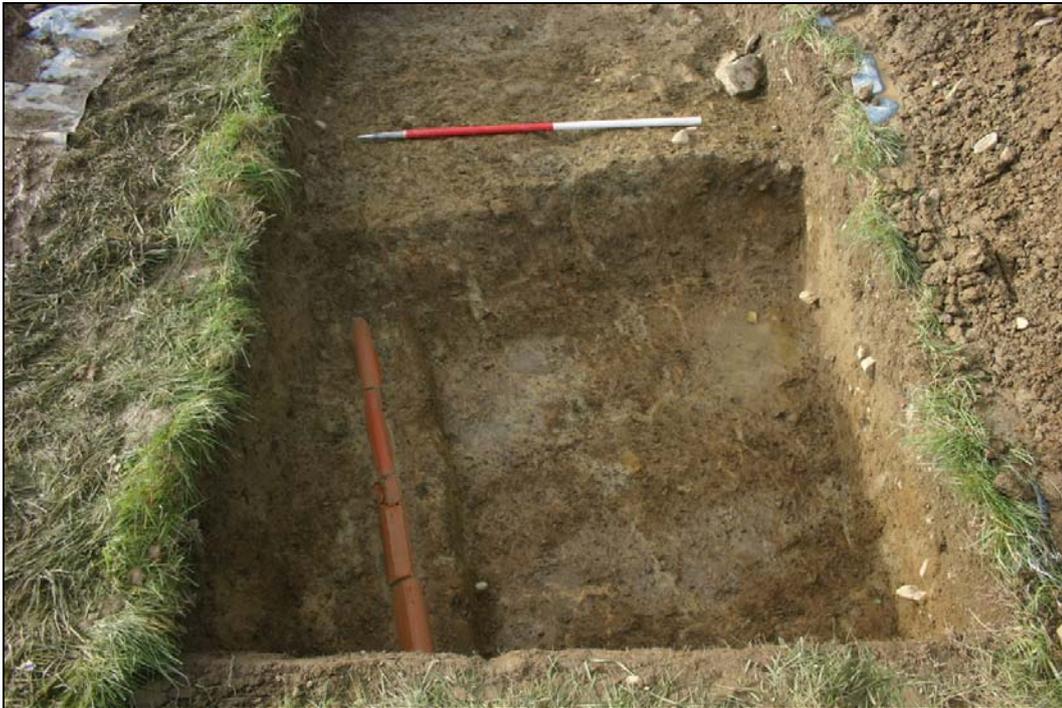
Fig. 13 Ditch (03-006) viewed from the north-east. Photo CPAT 3716-0137

enclosure its date remains unproven, although the relationship with the land drain demonstrates that it is likely to pre-date the 19th century at least.

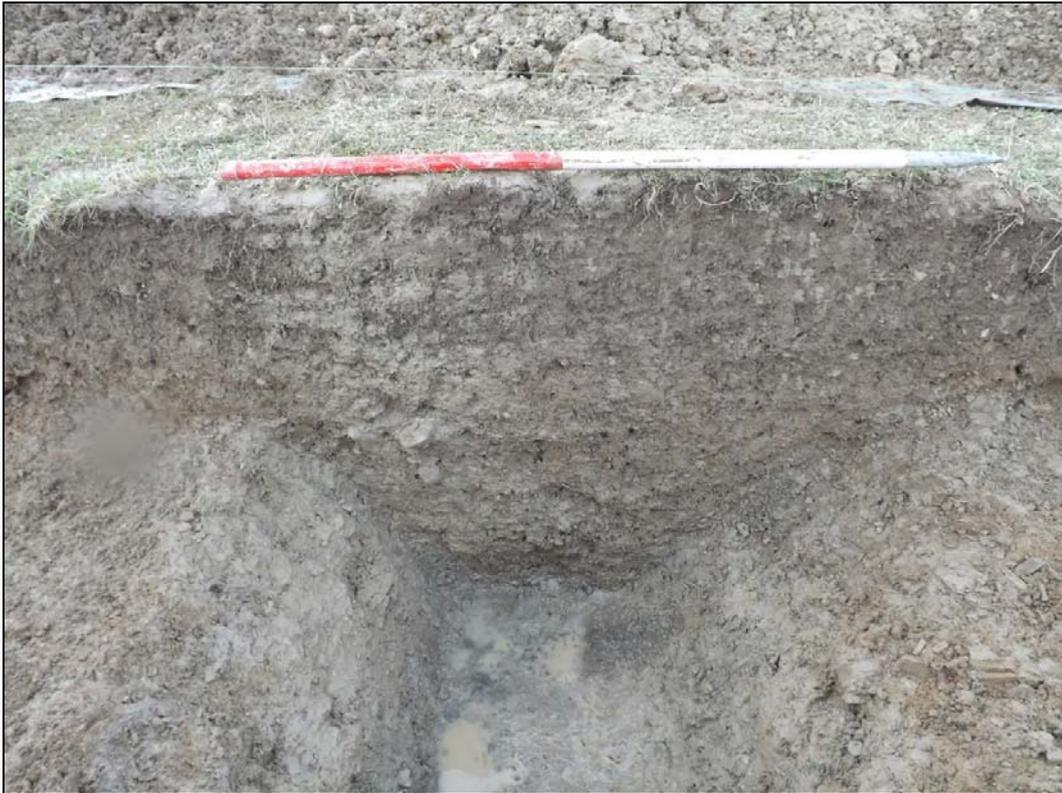
Fig. 15 Trench 6, ditch 06-005 viewed from the east. Photo CPAT 3717-0160

- 3.20 The surface of the natural subsoil was notably different on either side of the ditch, being more disturbed on the south side and perhaps reflecting differing land-use, suggesting that the ditch may be part of a field system which pre-dates the present arrangement of fields.

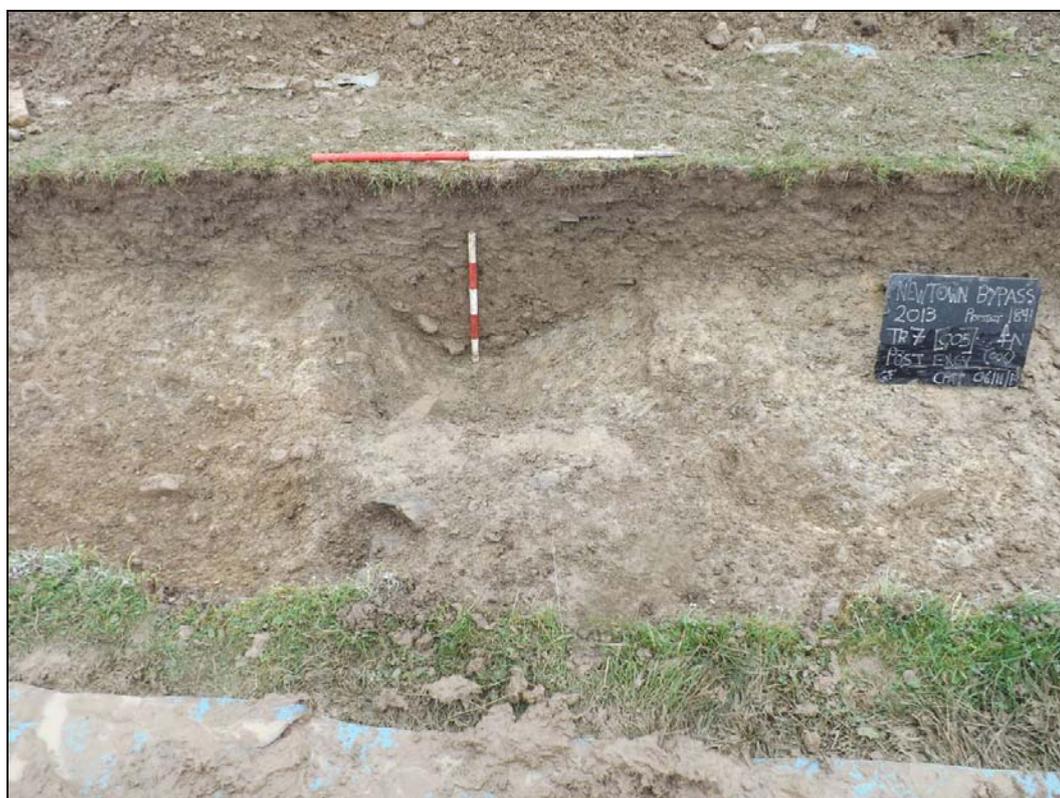
Fig. 16 Trench 7 ditch 07-005 viewed from the south. Photo CPAT 3717-0152

- 3.24 The results from the geophysical survey had suggested that a second ditch might be present within the western half of the trench, which, together with ditch 07-005, could have defined the southern part of a rectilinear enclosure. However, the evaluation failed to provide any evidence for a ditch in this area, although owing to waterlogging of the trench during the excavation there remains an element of uncertainty.

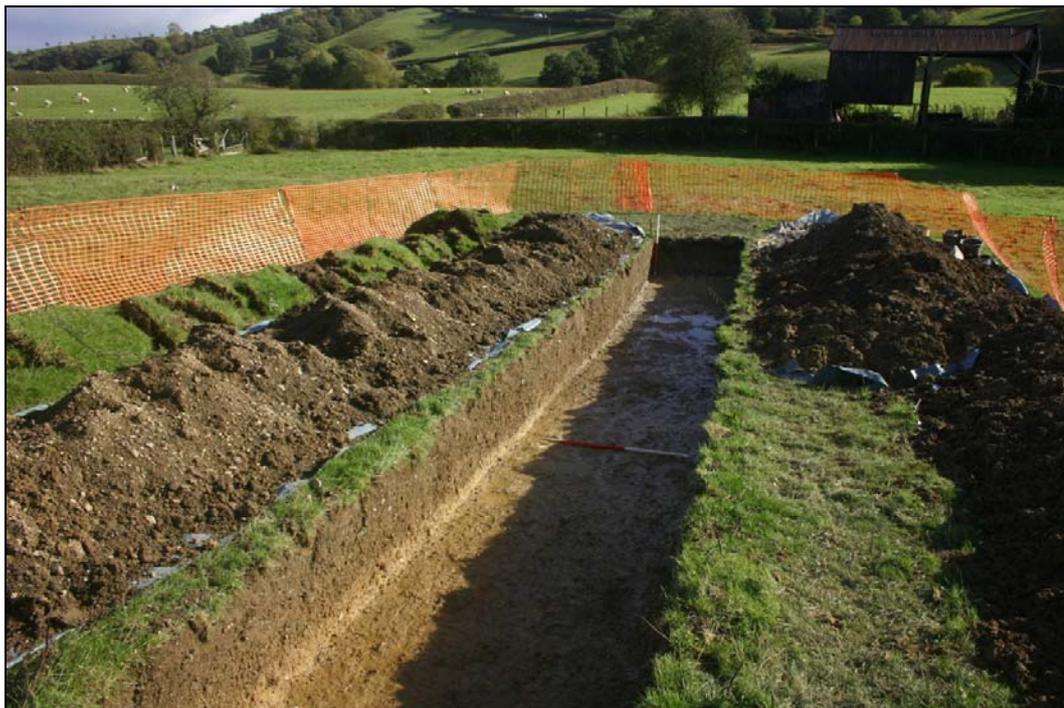
Fig. 17 Trench 9 viewed from the west. Photo CPAT 3716-0063

- 3.29 Trench 9 was positioned to investigate a curving ditched feature identified by the geophysical survey and thought to represent part of a possible enclosure or field system (Roseveare 2013; feature 37). The trench measured 20m in length, aligned north-west/south-east and centred at SO 12332 91387 (Figs 17 and 41).

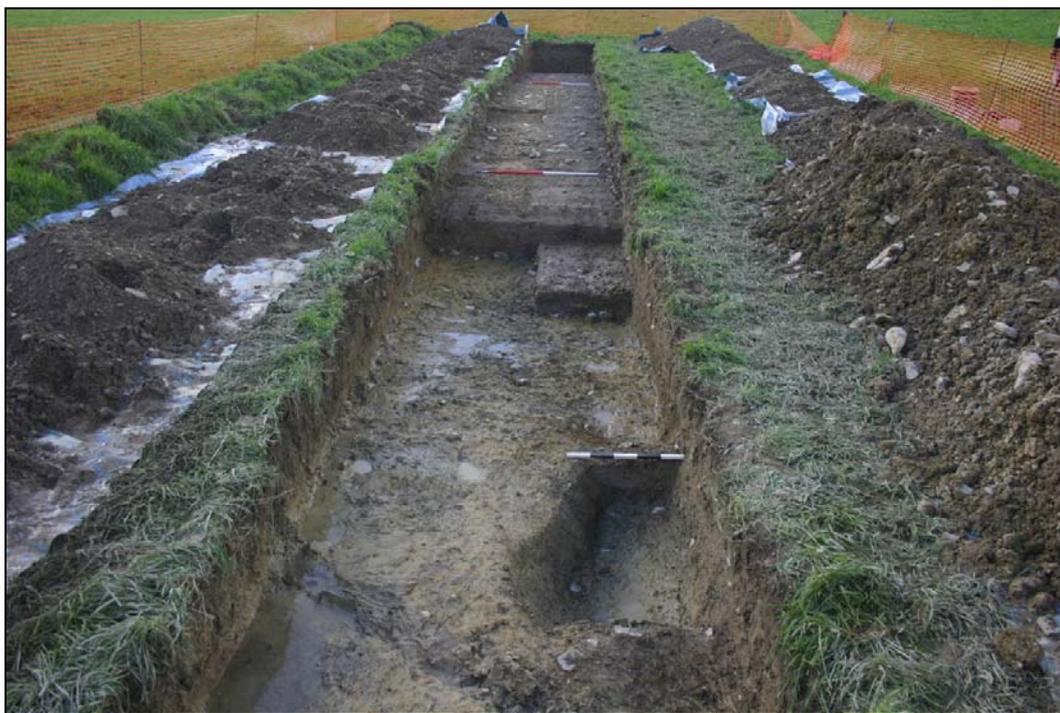
Fig. 19 Trench 10 viewed from the east showing the position of the metal surface (10-003 and 10-011) between the furthest two scales and the surface of the natural subsoil (10-008) in the foreground, cut by a pit or gully (10-014) and a land drain (10-007).

Photo CPAT 3716-0043).

- 3.34 A probable gully (10-014) at the eastern end of the trench cut into the natural subsoil (10-008). The feature was up to 0.2m deep and at least 0.54m wide with a basal fill (10-013) similar to deposit 10-010 and an upper fill (10-012) similar to deposit 10-006. At the western end of the trench a possible pit (10-015), around 1.1m across, was identified, perhaps cutting through deposit 10-010, but not investigated owing to waterlogging.

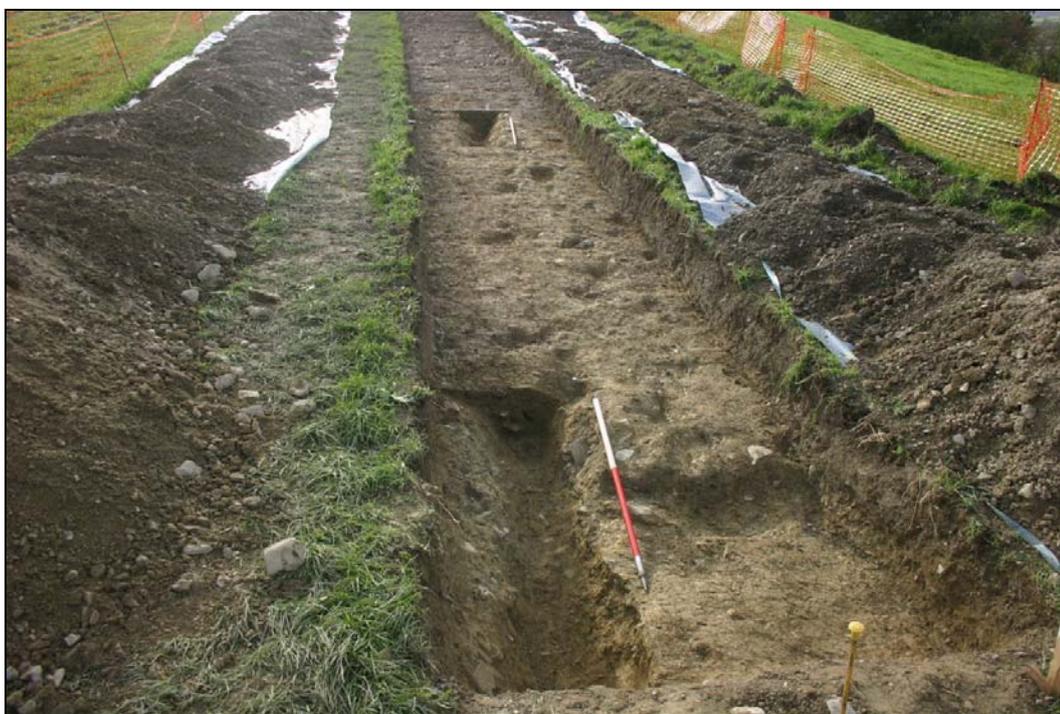
Fig. 21 Trench 12 viewed from the north-east, showing gully 12-006. Photo CPAT 3716-0025

- 3.39 There was no evidence for the potential features identified by the geophysical survey which may therefore be related to changes in the underlying geology.

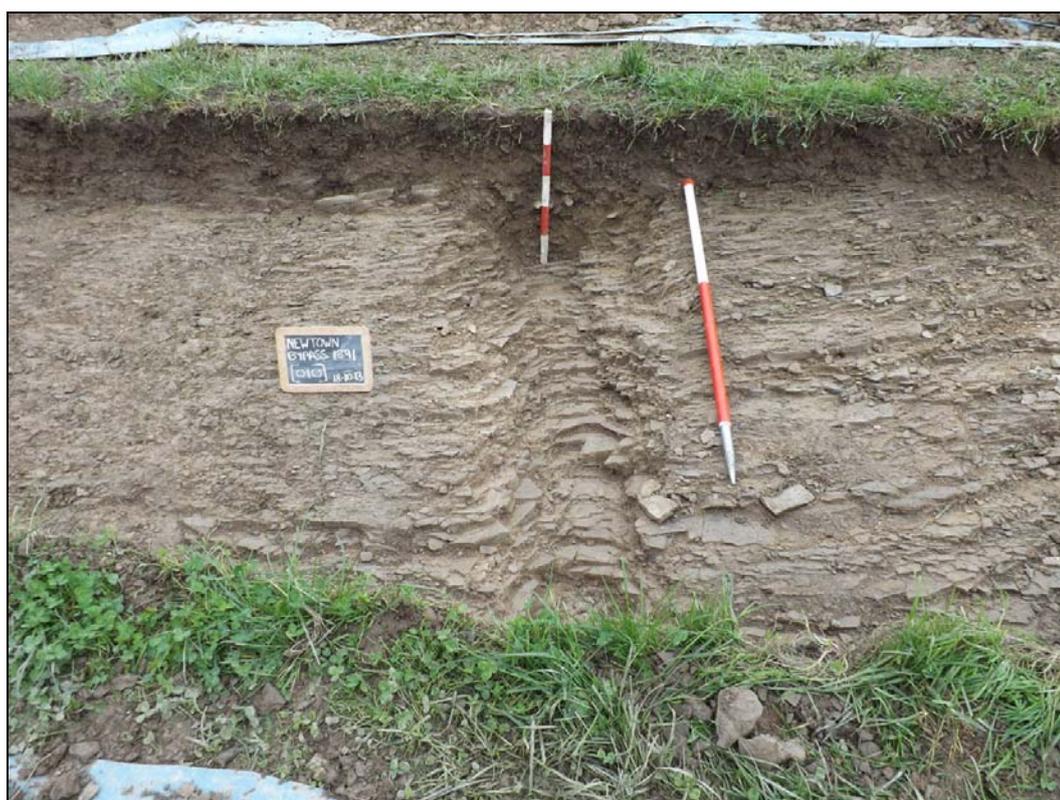
Fig. 22 Trench 13 viewed from the south, showing gully 13-010. Photo CPAT 3716-0026

- 3.42 Three narrow, rock-cut gullies were identified cutting into the subsoil and bedrock which, from their position and orientation, are likely to equate to some of the cropmarks which have been recorded in this area. Unfortunately, the aerial photograph (RCAHMW 95-cs-1316) in question is at an oblique angle with insufficient fixed control points to allow for accurate rectification, given the sloping nature of the terrain.

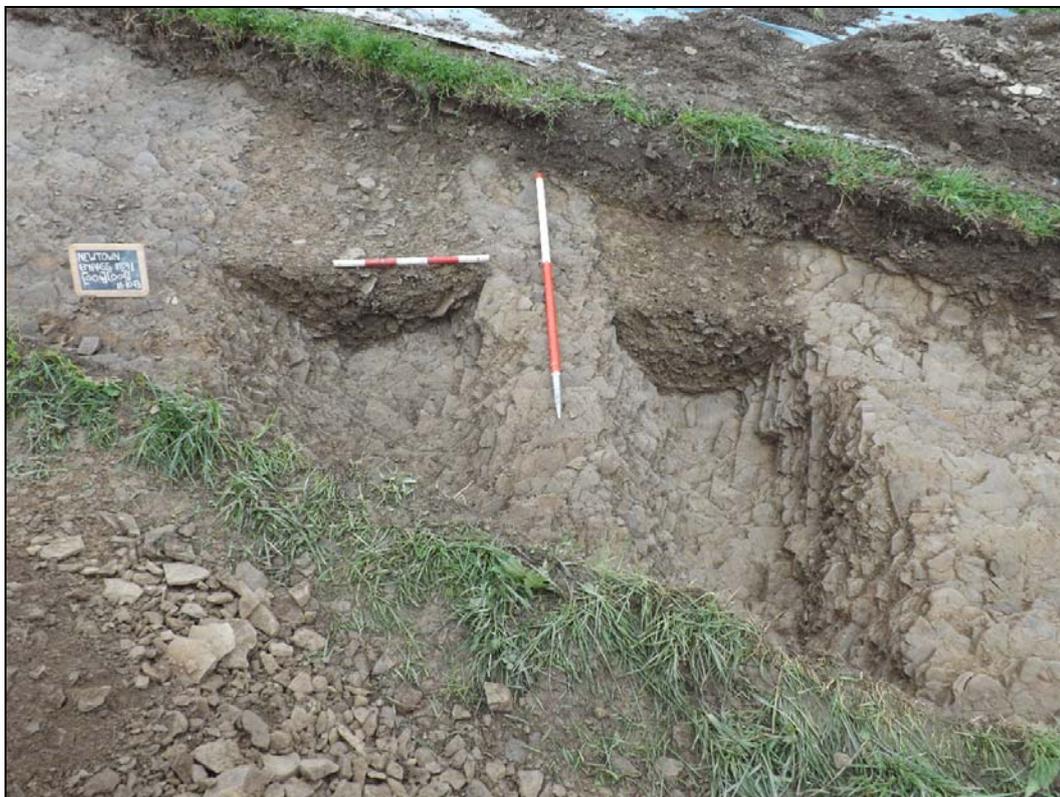
Fig. 23 Trench 13 viewed from the south-east, showing gullies 13-004 and 006.
Photo CPAT 3716-0024

greater proportion of stone. The western gully (13-004) measured up to 0.85m in width and 0.23m deep, with similar lower and upper fills (13-005 and 012 respectively) to those in the adjacent gully. The only artefactual evidence was a very small sherd of undiagnostic redware pottery (Find no. 13-103) from the lower fill (13-005) of the western gully (13-004).

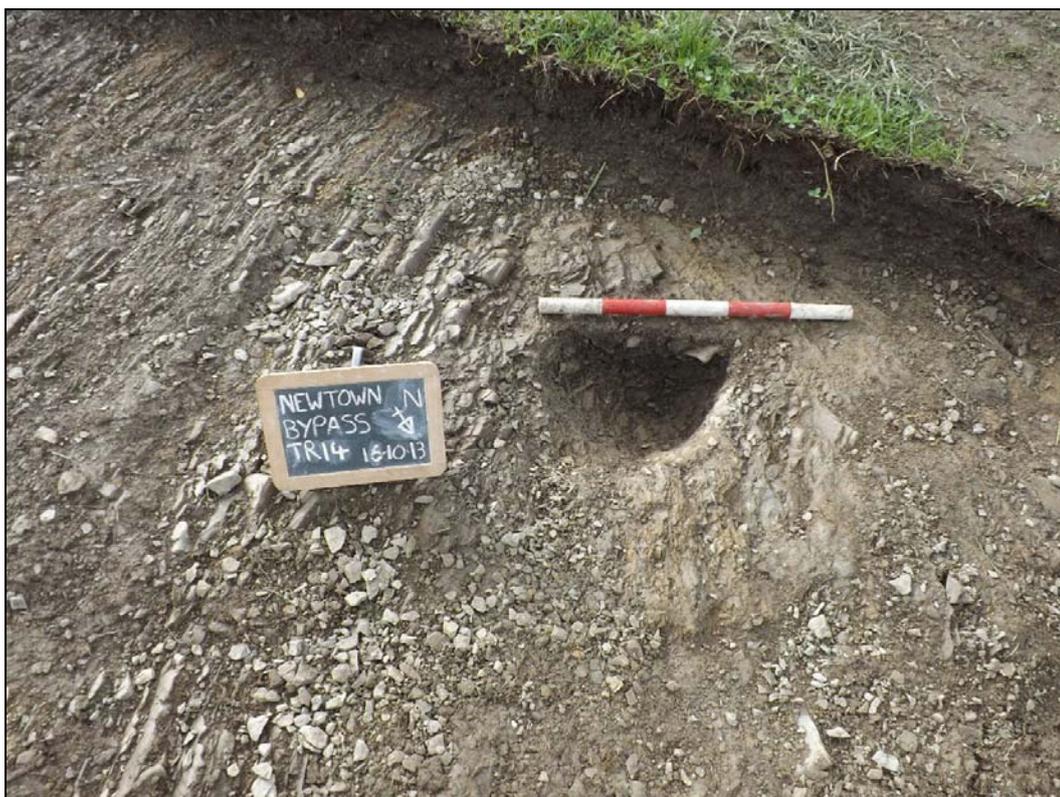
Fig. 24 Trench 14 viewed from the north-east, showing post-hole 14-004.
Photo CPAT 3717-0022

- 3.45 Trench 14 was positioned to investigate the northern side of a possible later prehistoric hilltop enclosure in an area not covered by the geophysical survey, and where no cropmarks had been recorded. The trench measured 20m in length, aligned north/south and centred at SO 11850 91072 (Figs 20 and 45).
- 3.46 The removal of the topsoil (14-001) and modern ploughsoil (14-002), with a combined thickness of 0.18m revealed the underlying bedrock (14-003) across the entire trench, within which ploughscarring was evident. The only feature was a small, undated, rock-cut post-hole (14-004; Fig. 24), measuring 0.34m by 0.28m and up to 0.15m deep (Fig. 24). The fill (14-005), a bluish-grey sandy-silt, contained flecks of charcoal but produced no cultural material.

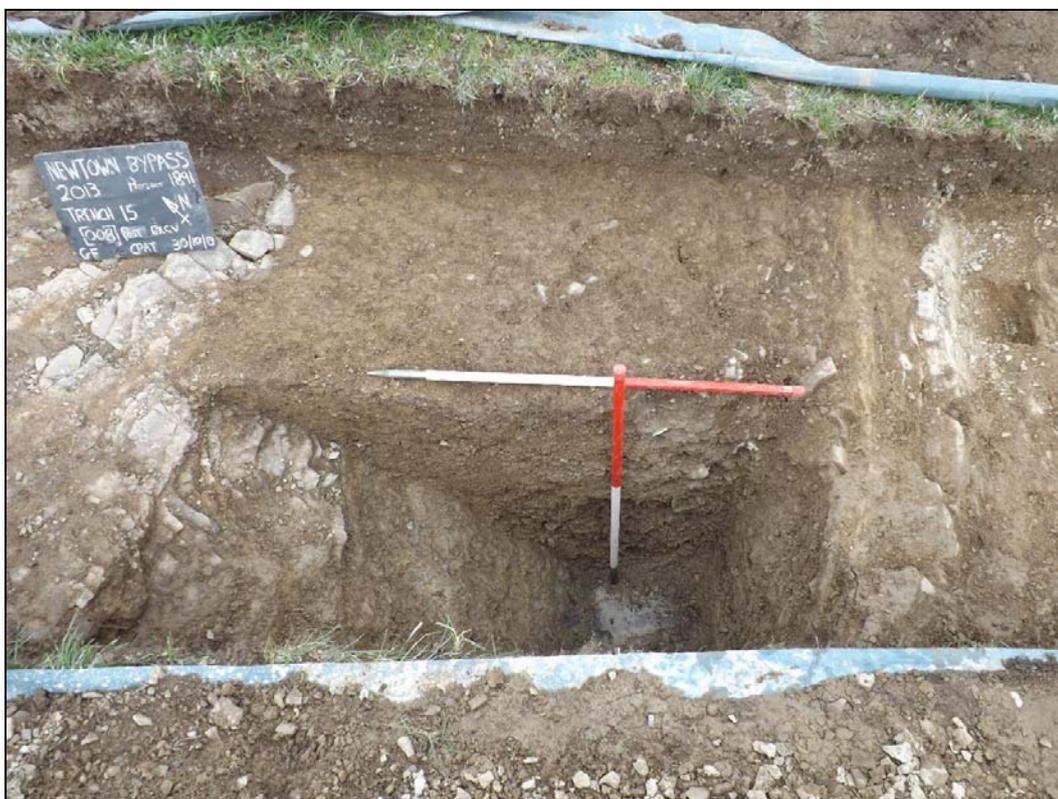
Fig. 25 Ditch 15-008 viewed from the south-west.
Photo CPAT 3717-0079

- 3.49 A rock-cut ditch (15-008) was identified which corresponded with the cropmark evidence and may be part of a small hilltop enclosure. This was up to 1.72m wide and 0.95m deep with a steeply-sloping outer edge and more gradual slope to the inner edge (Fig. 25). Initial weathering of the ditch had formed a thin primary silt (15-018) in the base and against the inner edge of the ditch, while the main fill was a uniform deposit of yellow brown clay silt (15-017).

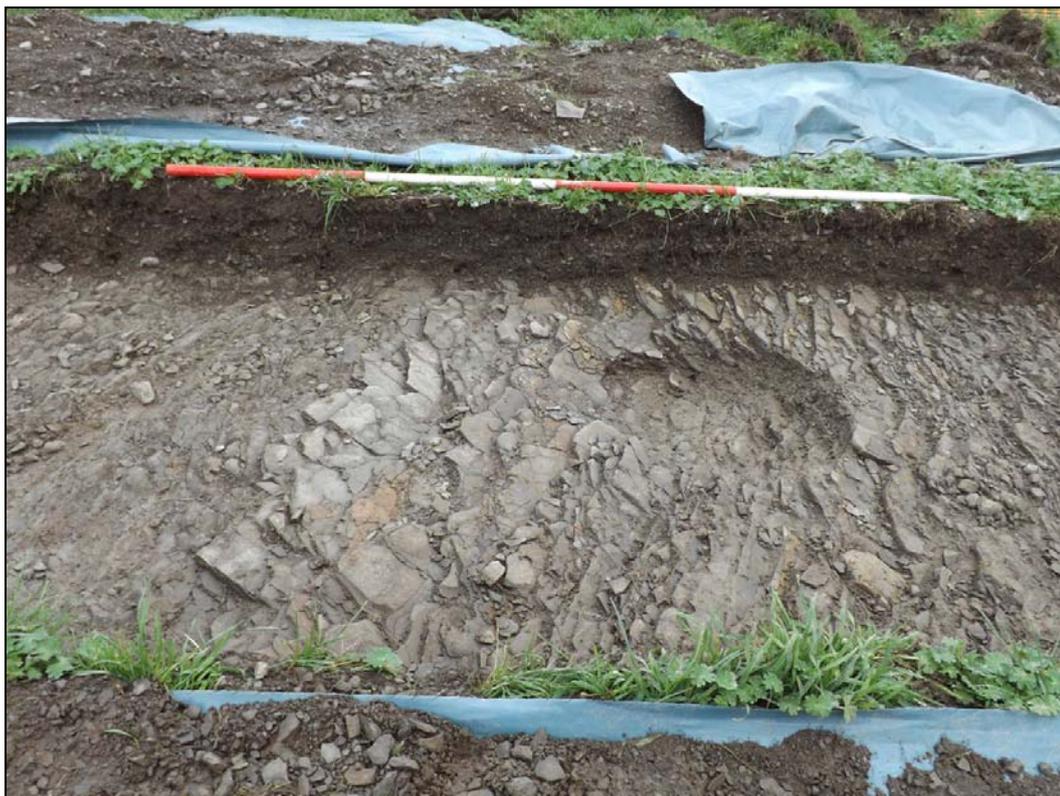
Fig. 26 Post-hole 15-004 viewed from the south-west.
Photo CPAT 3717-0097

- 3.50 Two features were identified in the interior of the possible enclosure, consisting of an elongated pit, or perhaps the butt-end of a gully (15-006) and a small post-hole (15-004). The former was around 1.55m wide and up to 0.5m deep, filled by a basal deposit of stony clay silt (15-016) and a main fill consisting of grey brown clay silt (15-007). The post-hole measured 0.7m in diameter and 0.5m deep, with a fill of yellowish brown clay silt (15-005) (Fig. 26). No artefacts were recovered from either feature.

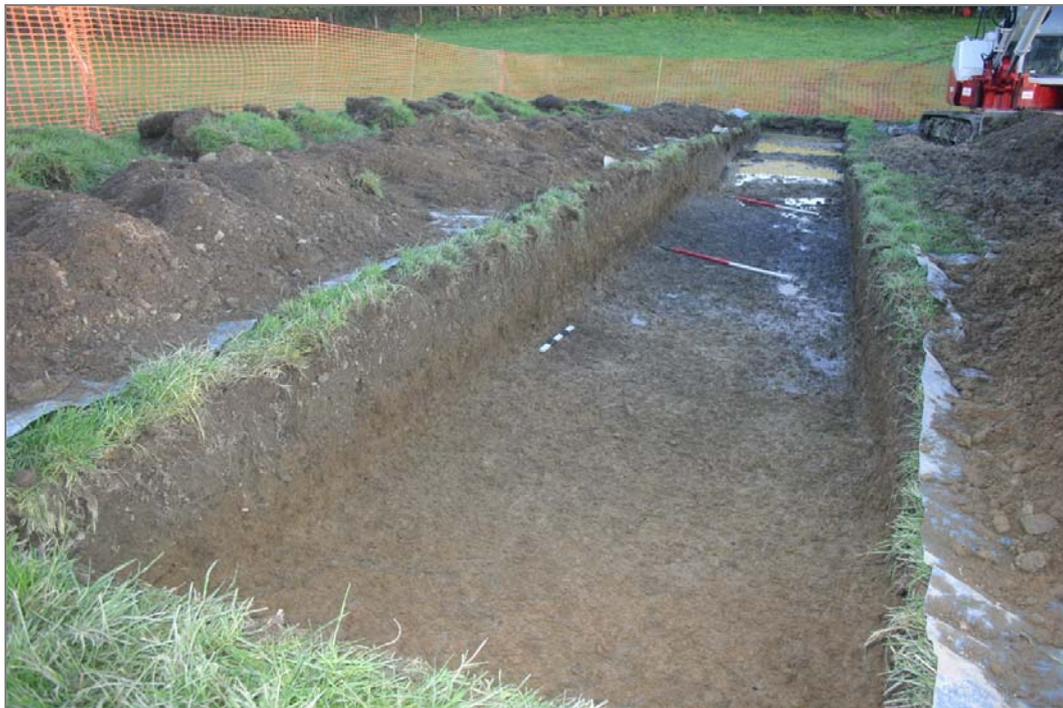
Fig. 28 Trench 18 viewed from the north-west, showing pit 18-007 adjacent to the short scale and ditch 18-009 between the larger scales. Photo CPAT 3717-0097

sealed beneath layer 18-005. Although the ditch was not excavated owing to waterlogging a sherd of Neolithic pottery (find 18-005) was recovered from the surface upper part of the fill.

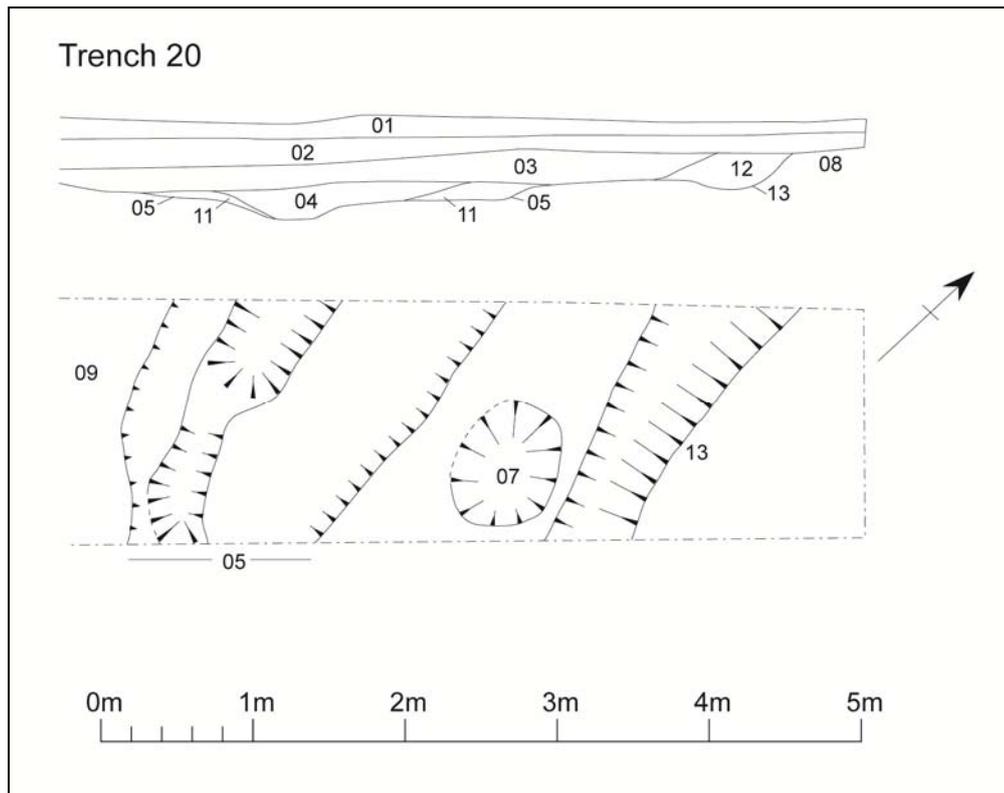
Fig. 31 Plan and section of the north-eastern end of trench 20

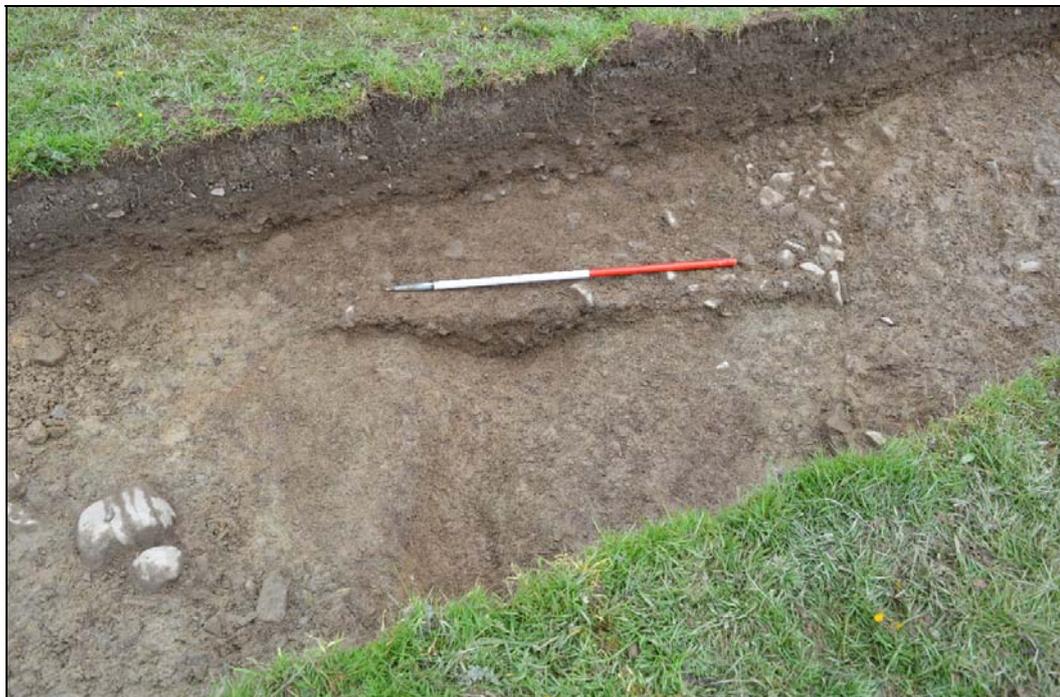
Fig. 32 Trench 20 – the base of the depression (05) viewed from the south-east, showing the stony material against either side. Photo CPAT 3835-0020

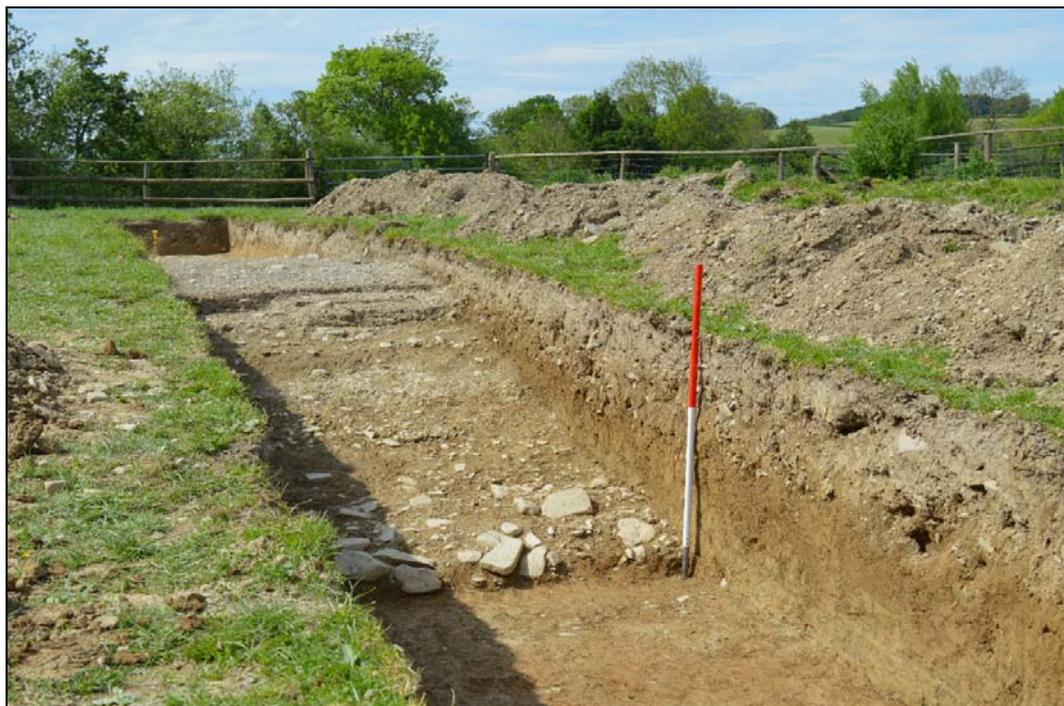
Fig. 34 The Roman road surfaces in Trench 21 and construction deposits on the south-eastern side of the road. Photo CPAT 3842-0055

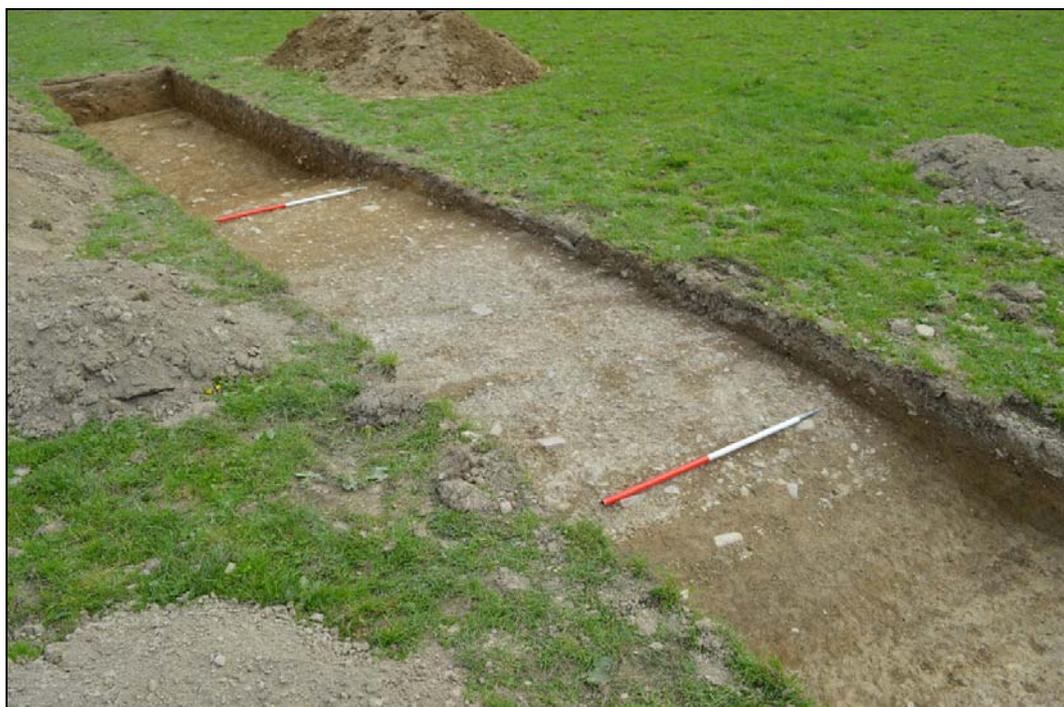
Fig. 35 Trench 21 showing the latest road surface (21-007), viewed from the south. Photo CPAT 3842-0005
