Appendix C.1
Gazetteer of Cultural
Heritage Sites

Newtown Bypass, Powys Archaeological walkover survey

Newtown Bypass, Powys

Archaeological Evaluation and Watching Brief

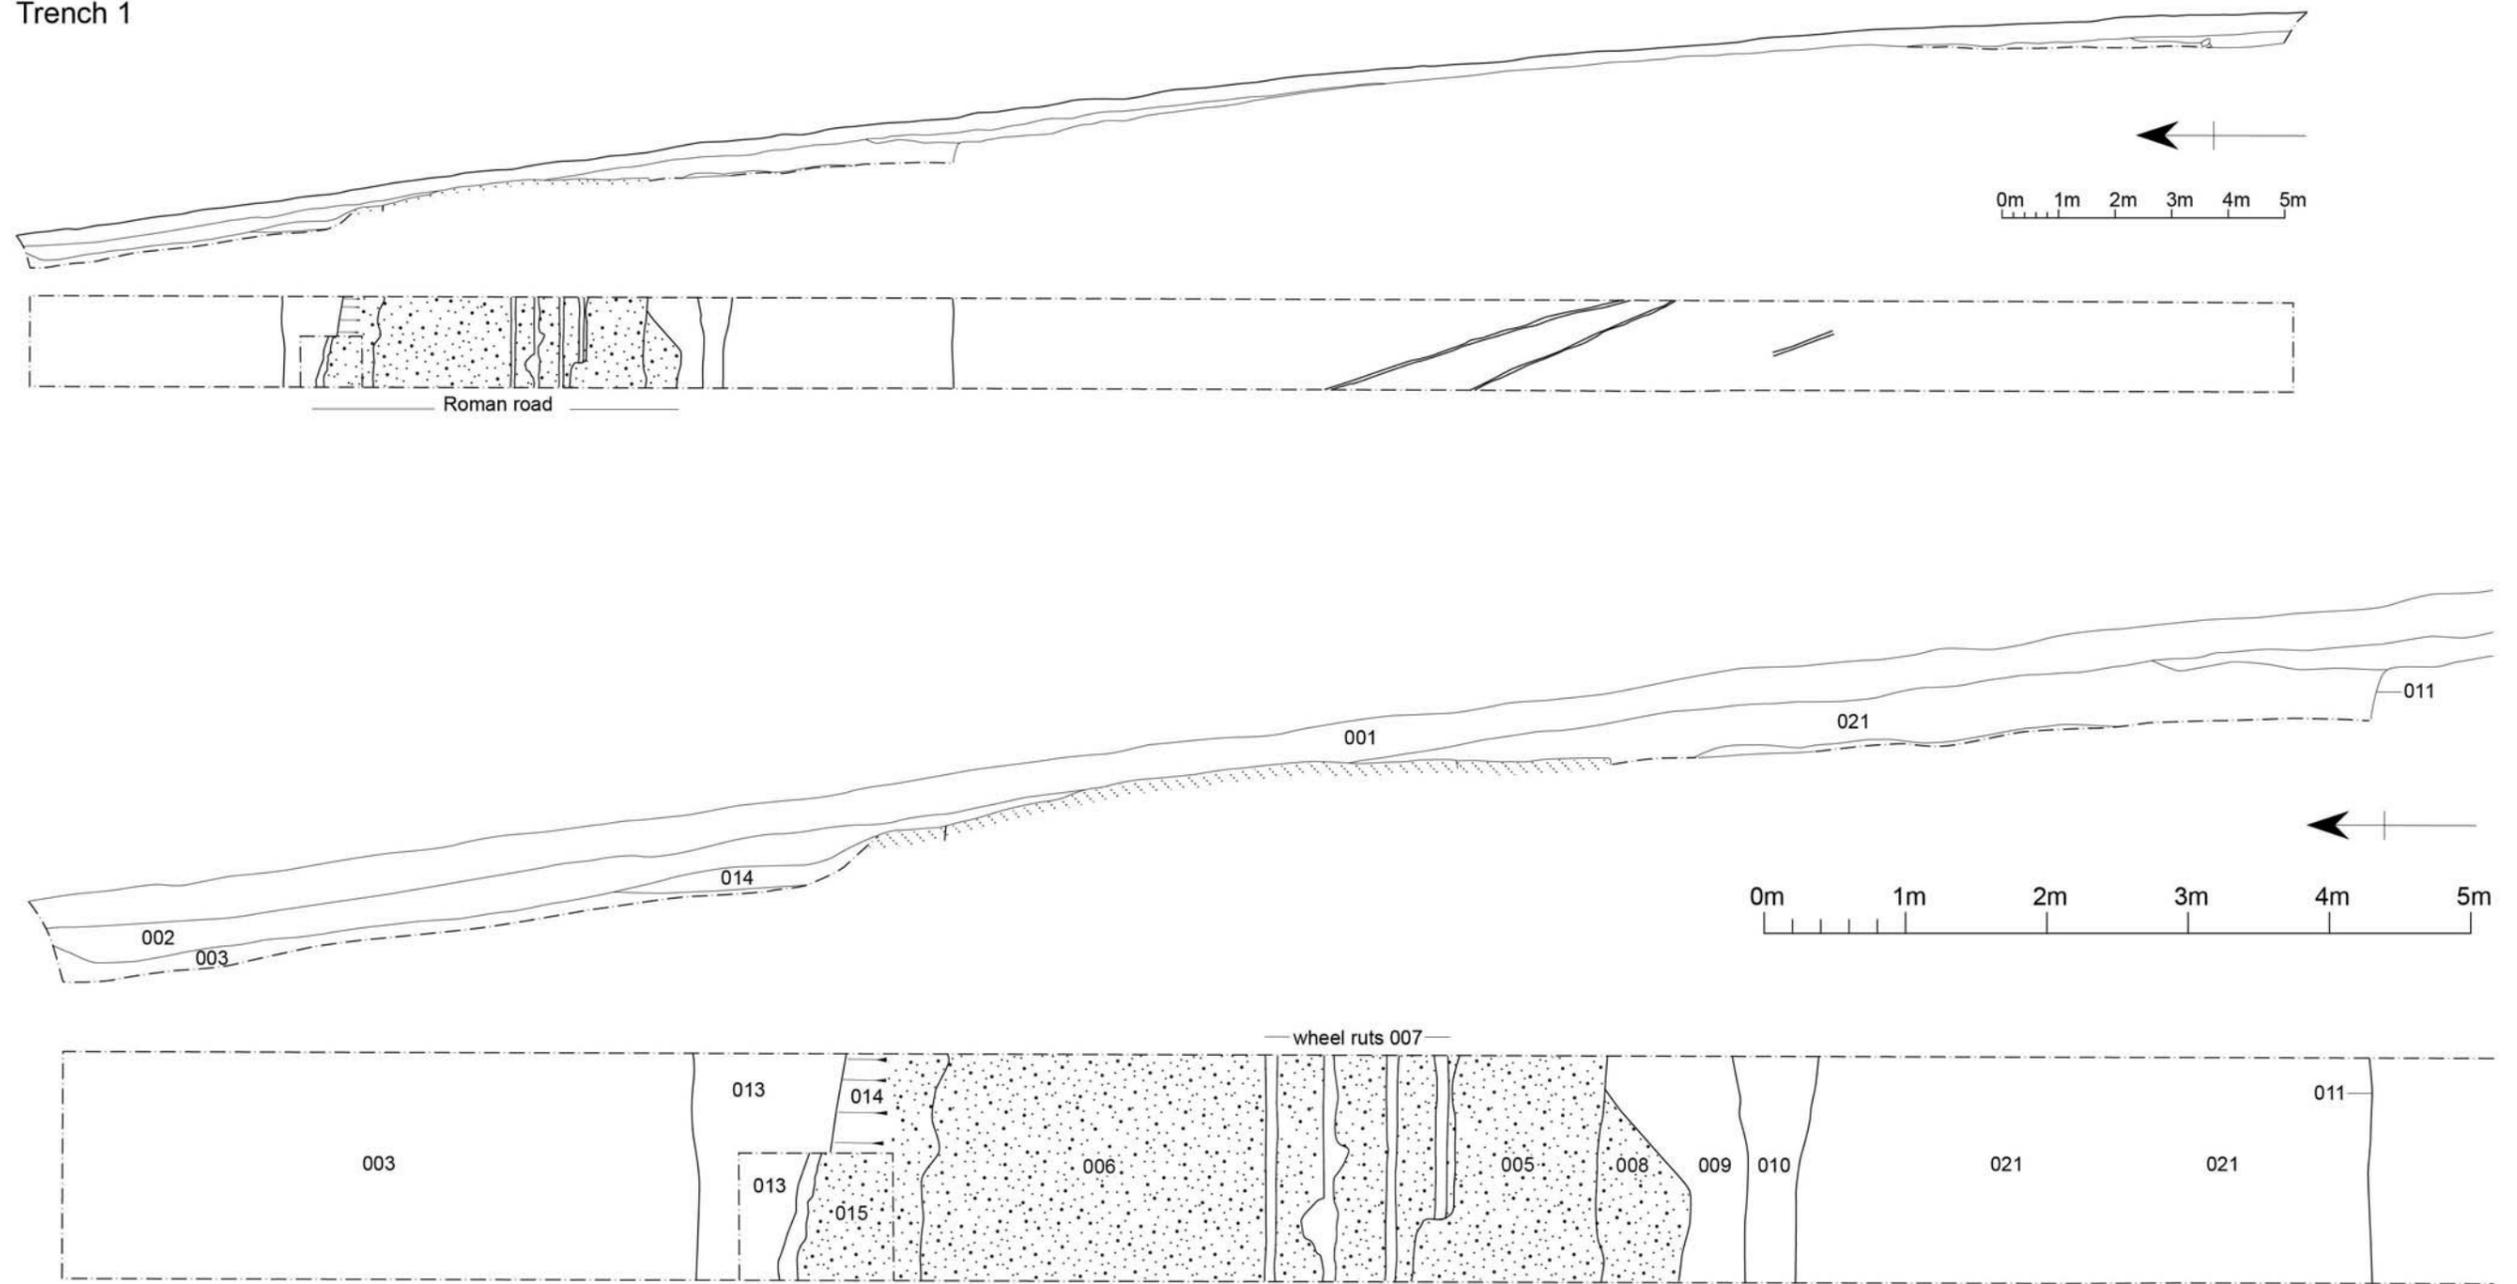
Fig. 36 Plan and section of Trench 1, showing detail of the Roman road

- 3.3 Trench 1 was positioned to investigate the Roman road between the forts at Forden Gaer and Caersws (Roseveare 2013; feature 34). The trench measured 40m in length, aligned north/south and centred at SO 12922 92088 (Fig. 6).

- 3.5 Although the road was not subject to any excavation beyond the initial hand cleaning three phases of construction, or at least resurfacing, were apparent, each consisting of compacted gravel and river cobbles. The uppermost surface (01-006) was relatively well preserved, within which four wheel ruts (01-007) were identified. Earlier surfaces were visible on either side of the road, beneath the extents of the latest surface, the earliest of which consisted of context 01-015 on the north side and a presumably equivalent layer, context 01-008, on the south side. Similarly, the second phase consisted of context 01-019 on the north side and 01-005 on the south side. The maximum surviving width of the road metalling was around 6.2m.

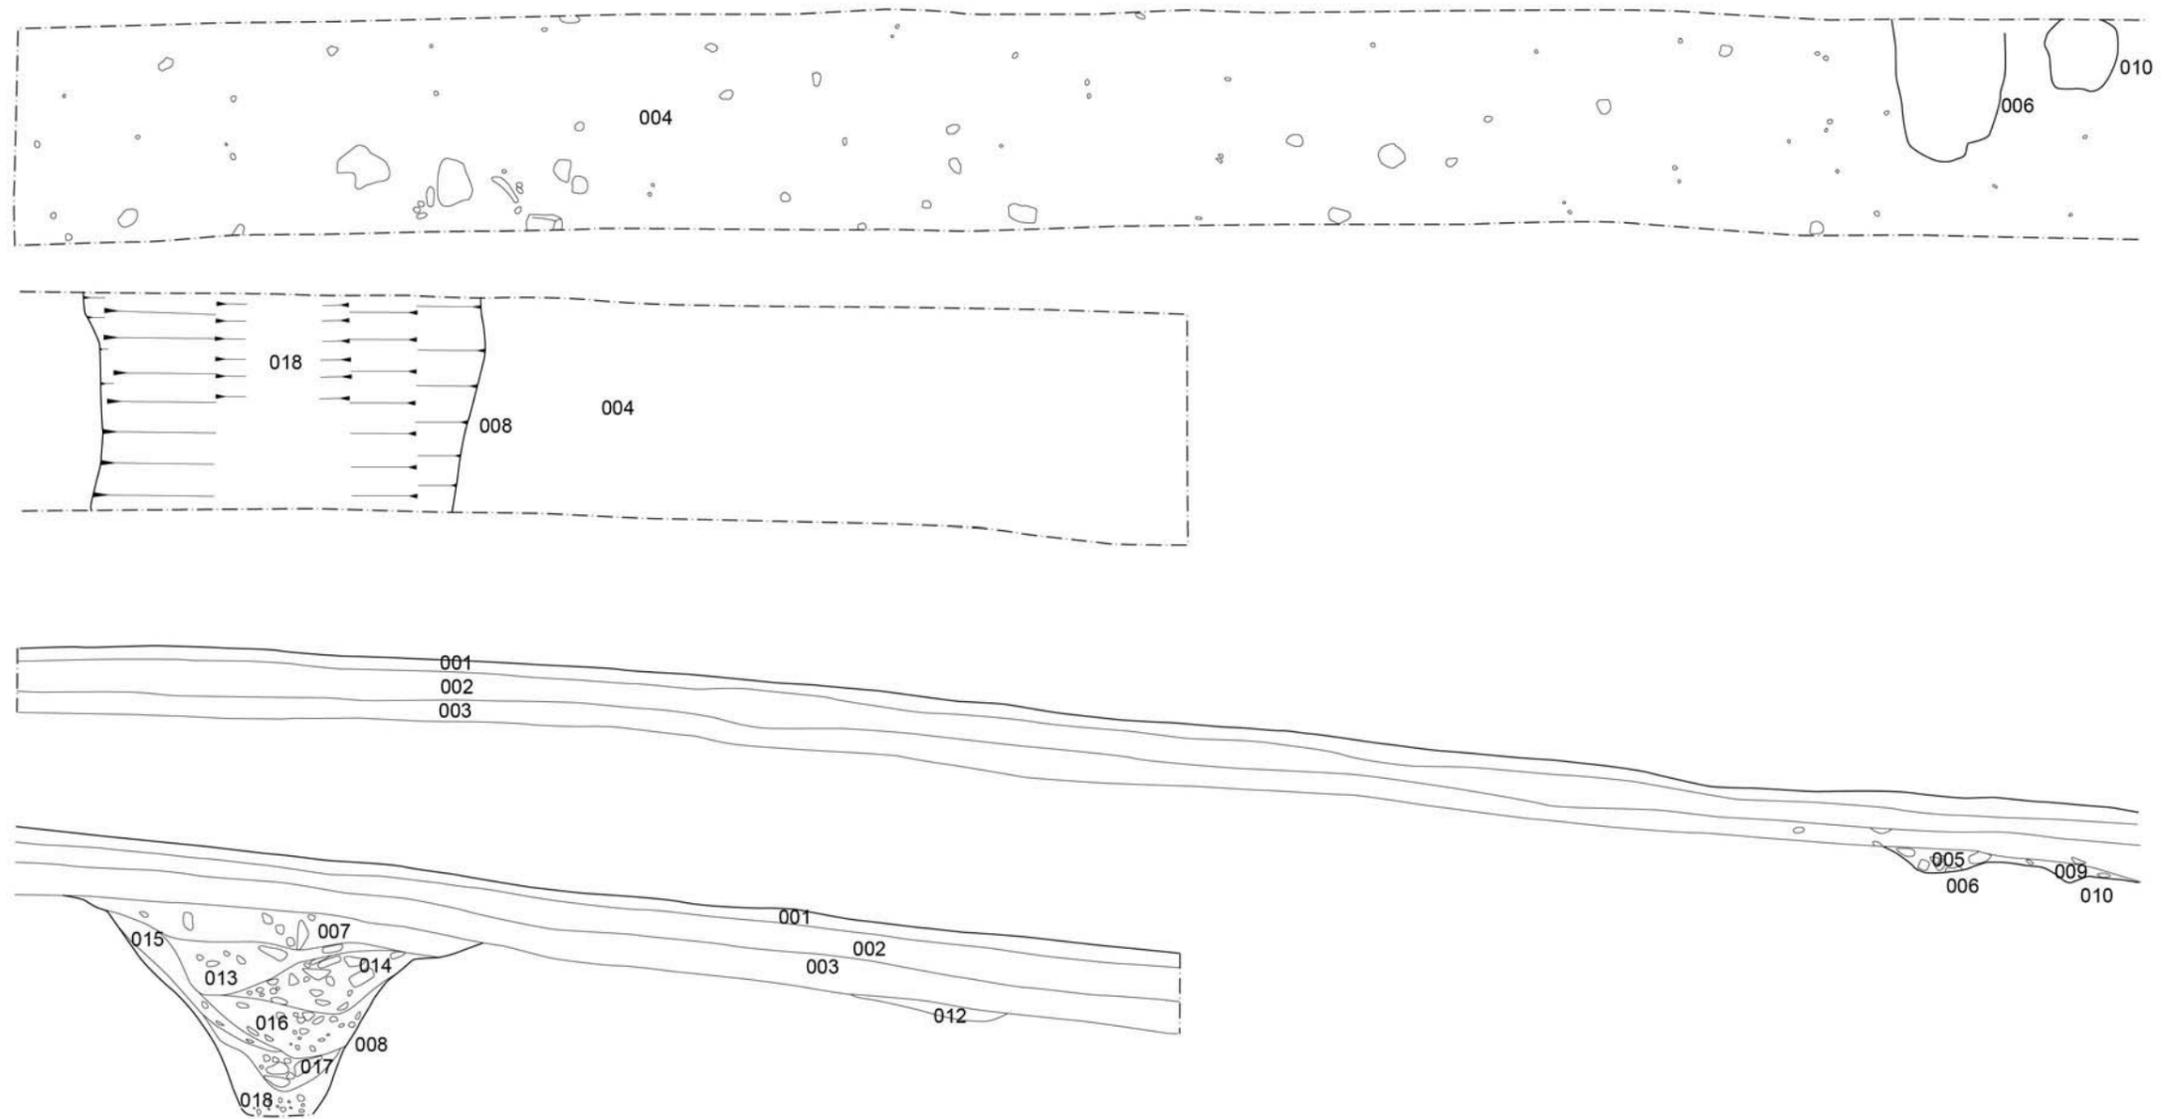
Fig. 37 Plan and section of Trench 2

- 3.8 Trench 2 was positioned to investigate the south-eastern side of an enclosure identified by the geophysical survey (Roseveare 2013; feature 28). The trench measured 23m in length, aligned north-west/south-east and centred at SO 12478 91681 (Fig. 8).

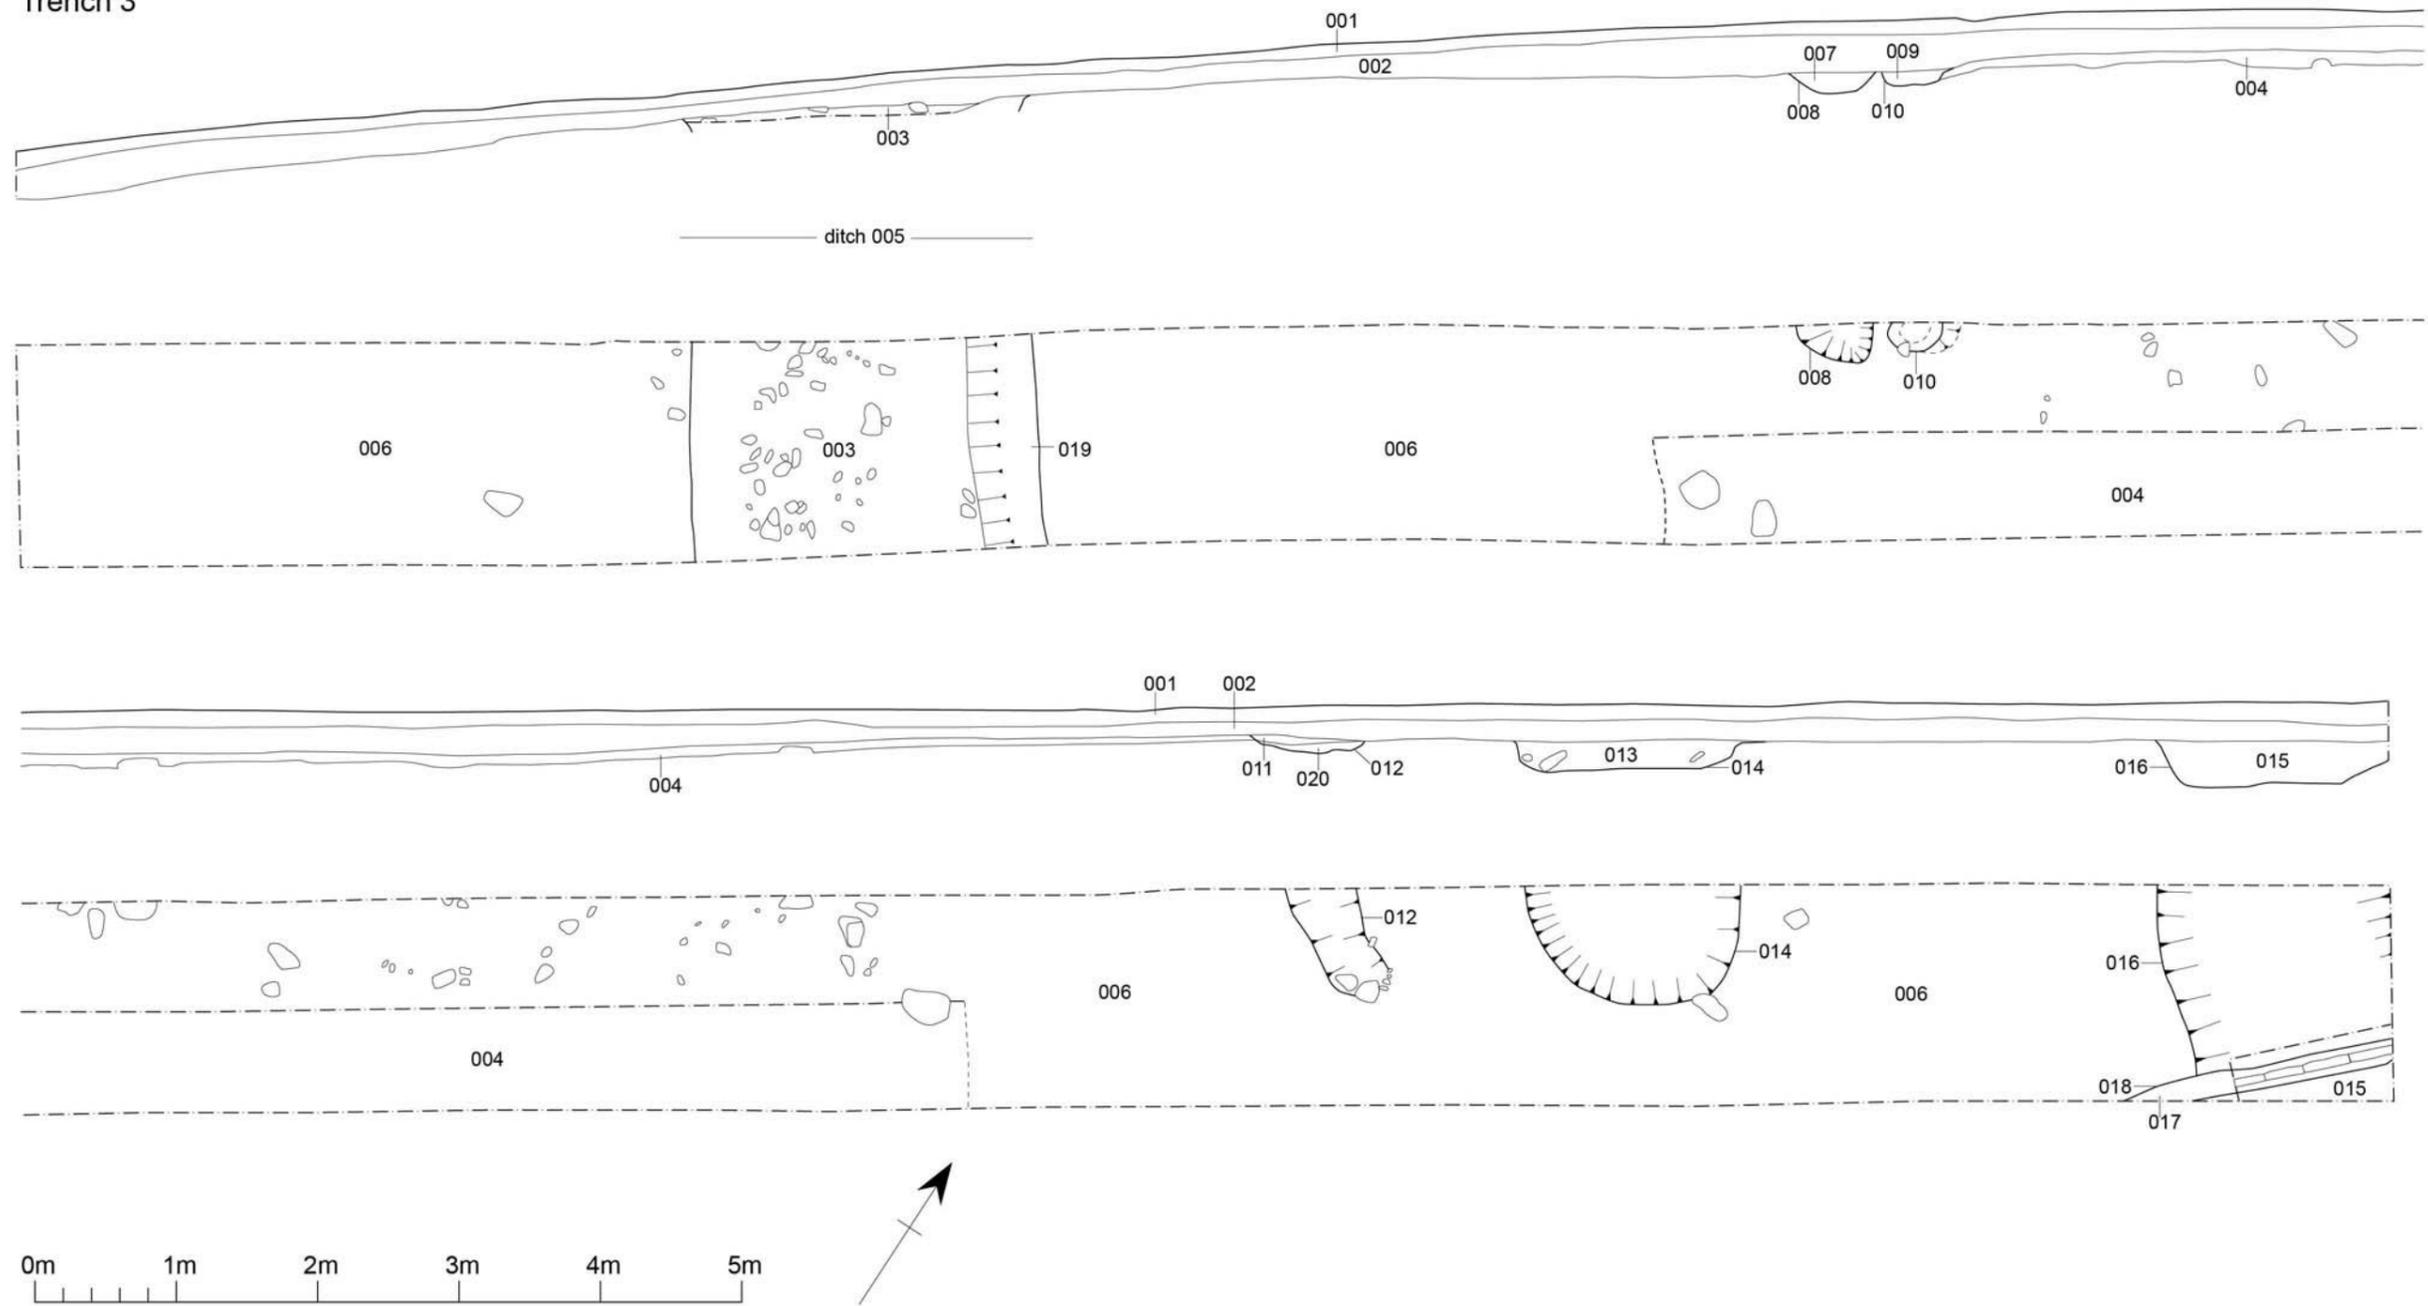
Fig. 38 Plan and section of Trench 3

- 3.14 A 2.5m-wide ditch (03-005) was identified towards the south-western end of the trench (Fig. 12), corresponding with that revealed by the geophysics and representing the south-western side of the enclosure. The ditch was not excavated, although a single sherd of Roman greyware was recovered from the upper fill (03-003), which partly overlay an earlier fill (03-019) which was visible against the inner edge of the ditch. The ditch was slightly narrower than its counterpart in trench 2 which may be due in part to truncation of the upper levels by cultivation.

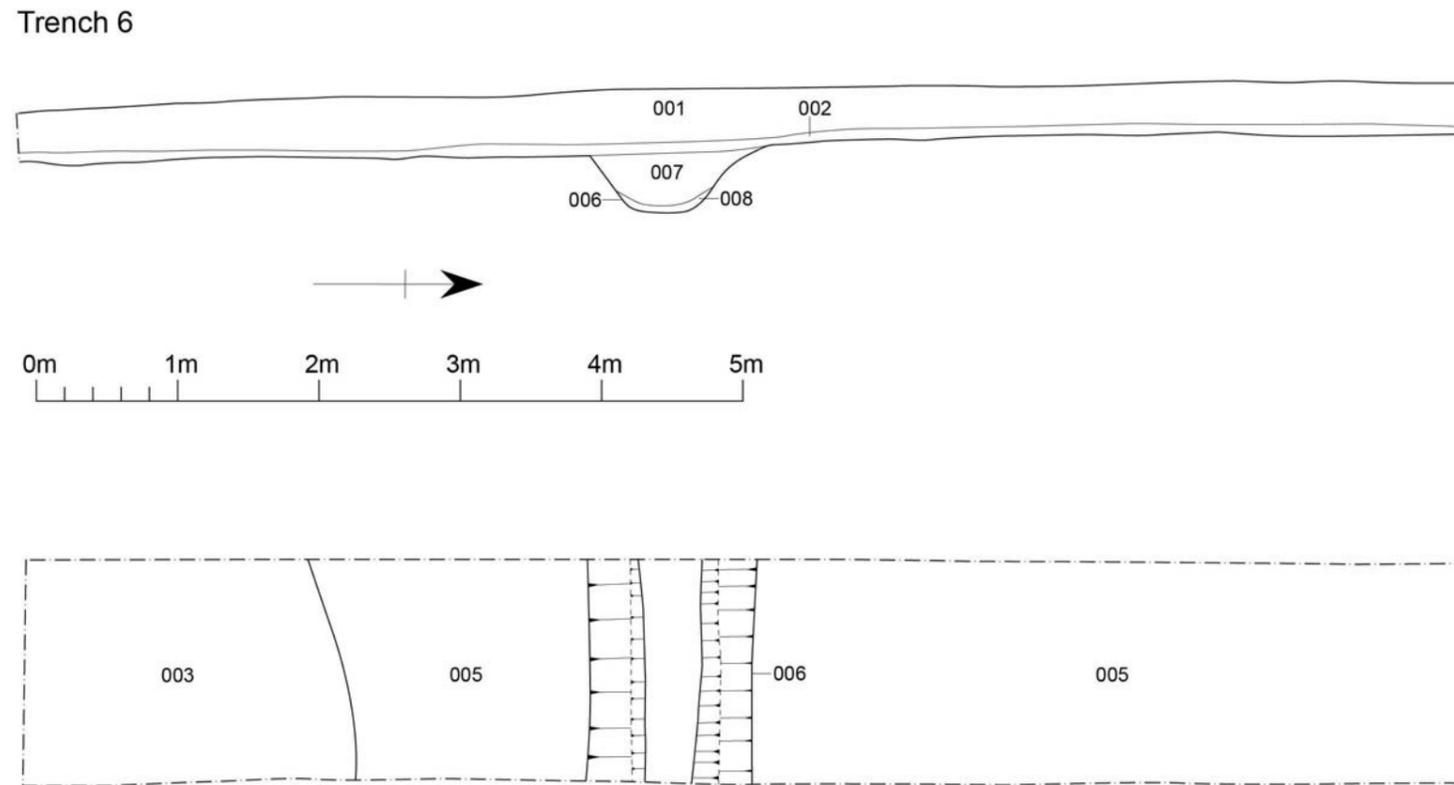
Fig. 39 Plan and section of Trench 6

- 3.18 Trench 6 was positioned to investigate a narrow ditched feature identified by the geophysical survey and thought to represent part of a possible enclosure (Roseveare 2013; feature 34). The trench measured 10m in length, aligned north/south and centred at SO 12432 91410 (Fig. 14).

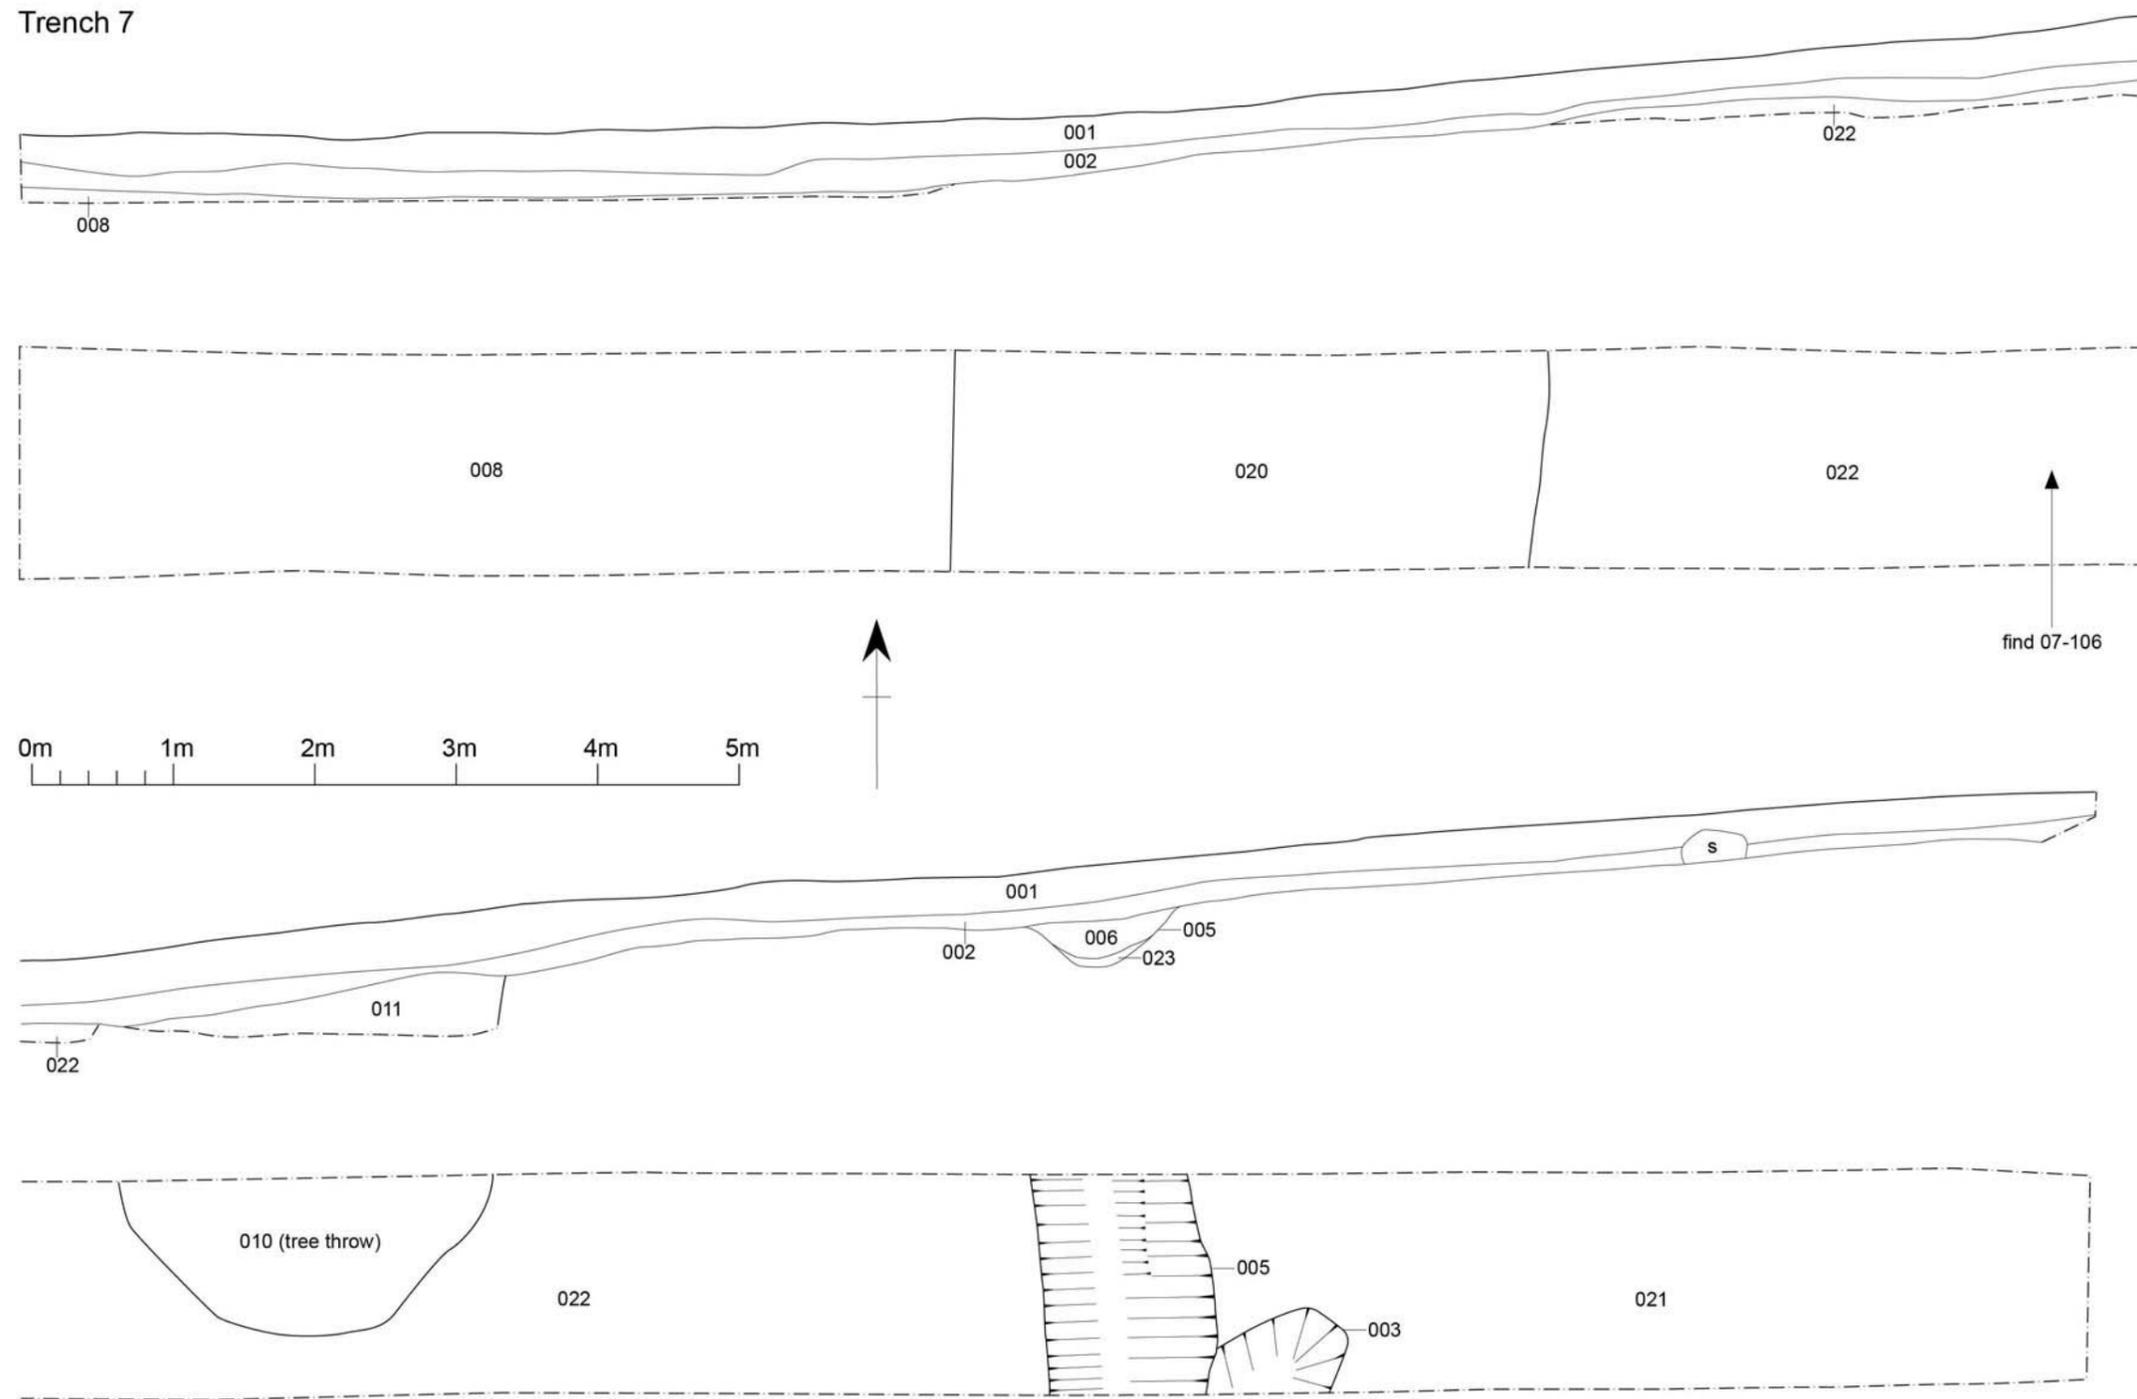
Fig. 40 Plan and section of Trench 7

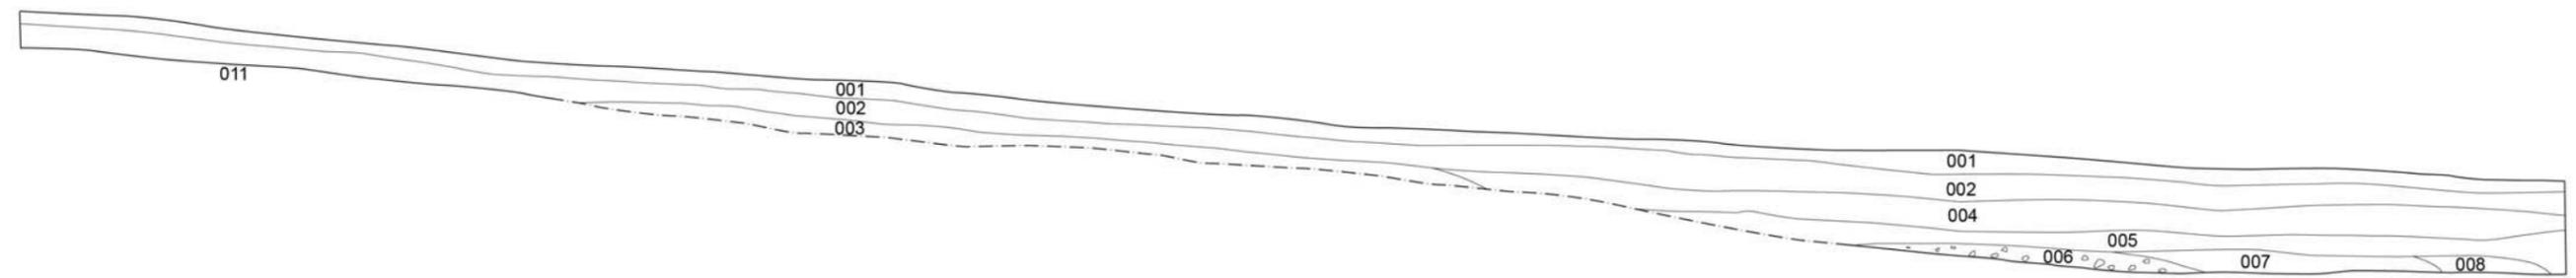
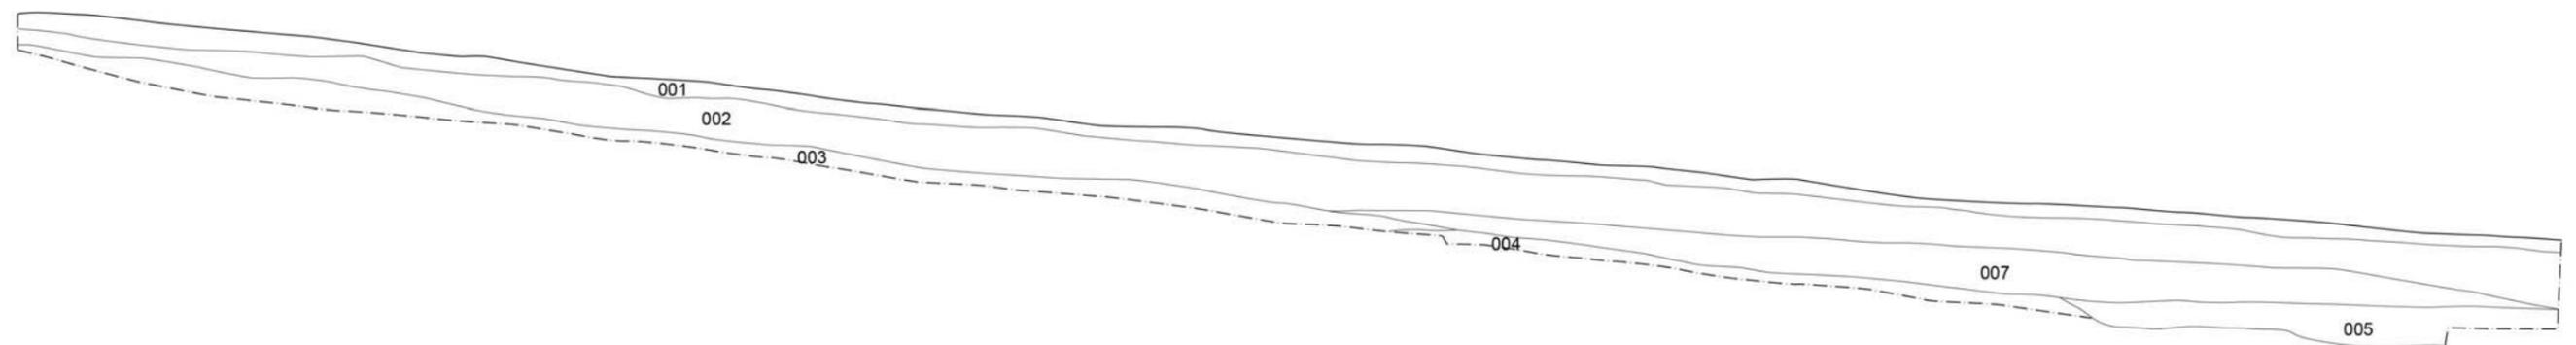
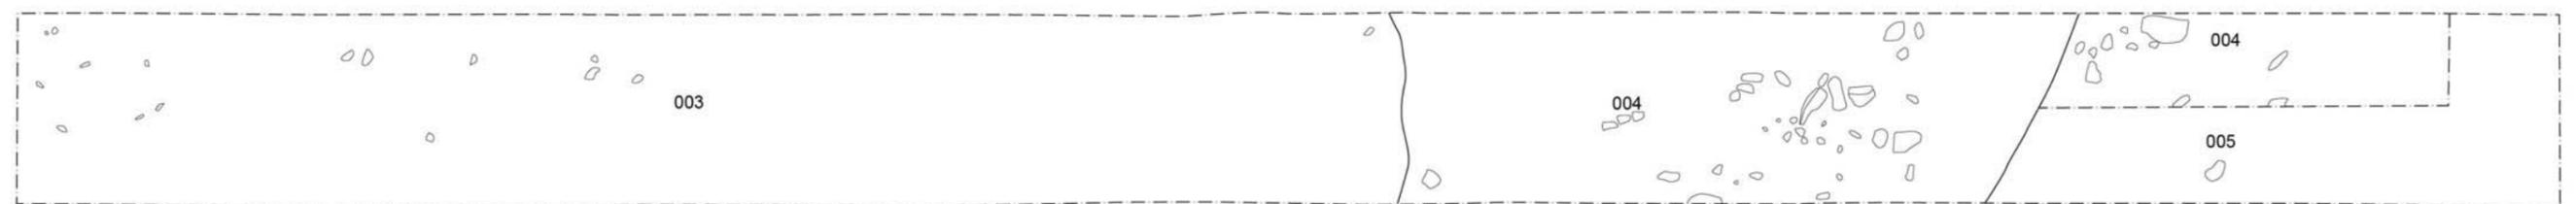
Fig. 41 Plan and section of Trench 9 and section of Trench 8

- 3.29 Trench 9 was positioned to investigate a curving ditched feature identified by the geophysical survey and thought to represent part of a possible enclosure or field system (Roseveare 2013; feature 37). The trench measured 20m in length, aligned north-west/south-east and centred at SO 12332 91387 (Figs 17 and 41).

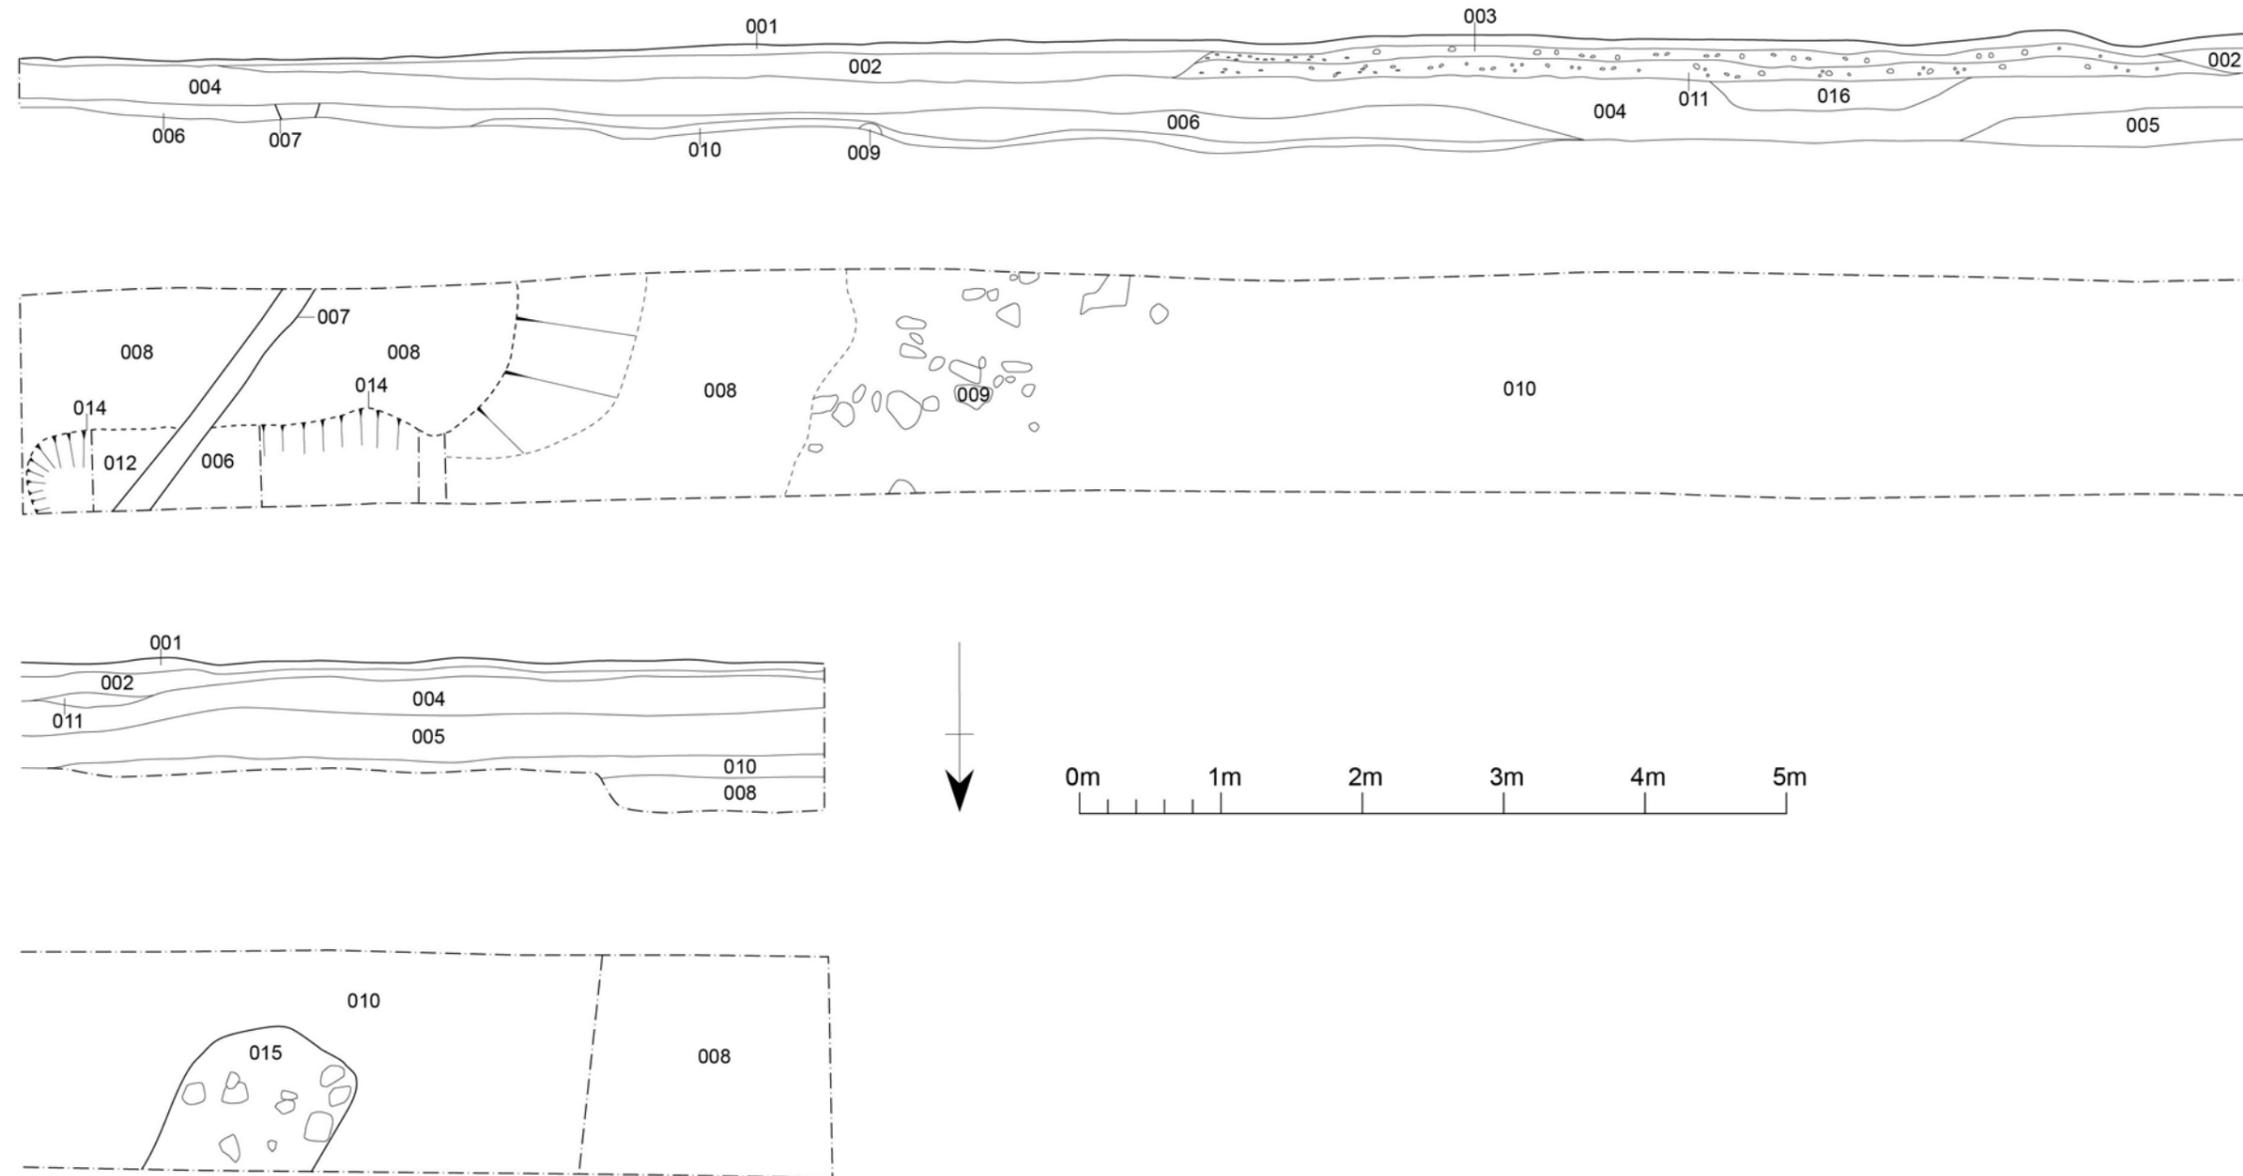
Fig. 42 Plan and section of Trench 10

- 3.31 Trench 10 was positioned to investigate a Y-shaped cropmark thought to represent part of a possible field system (PRN 4650). The trench measured 20m in length, aligned east/west and centred at SO 12200 91250 (Figs 18 and 42).

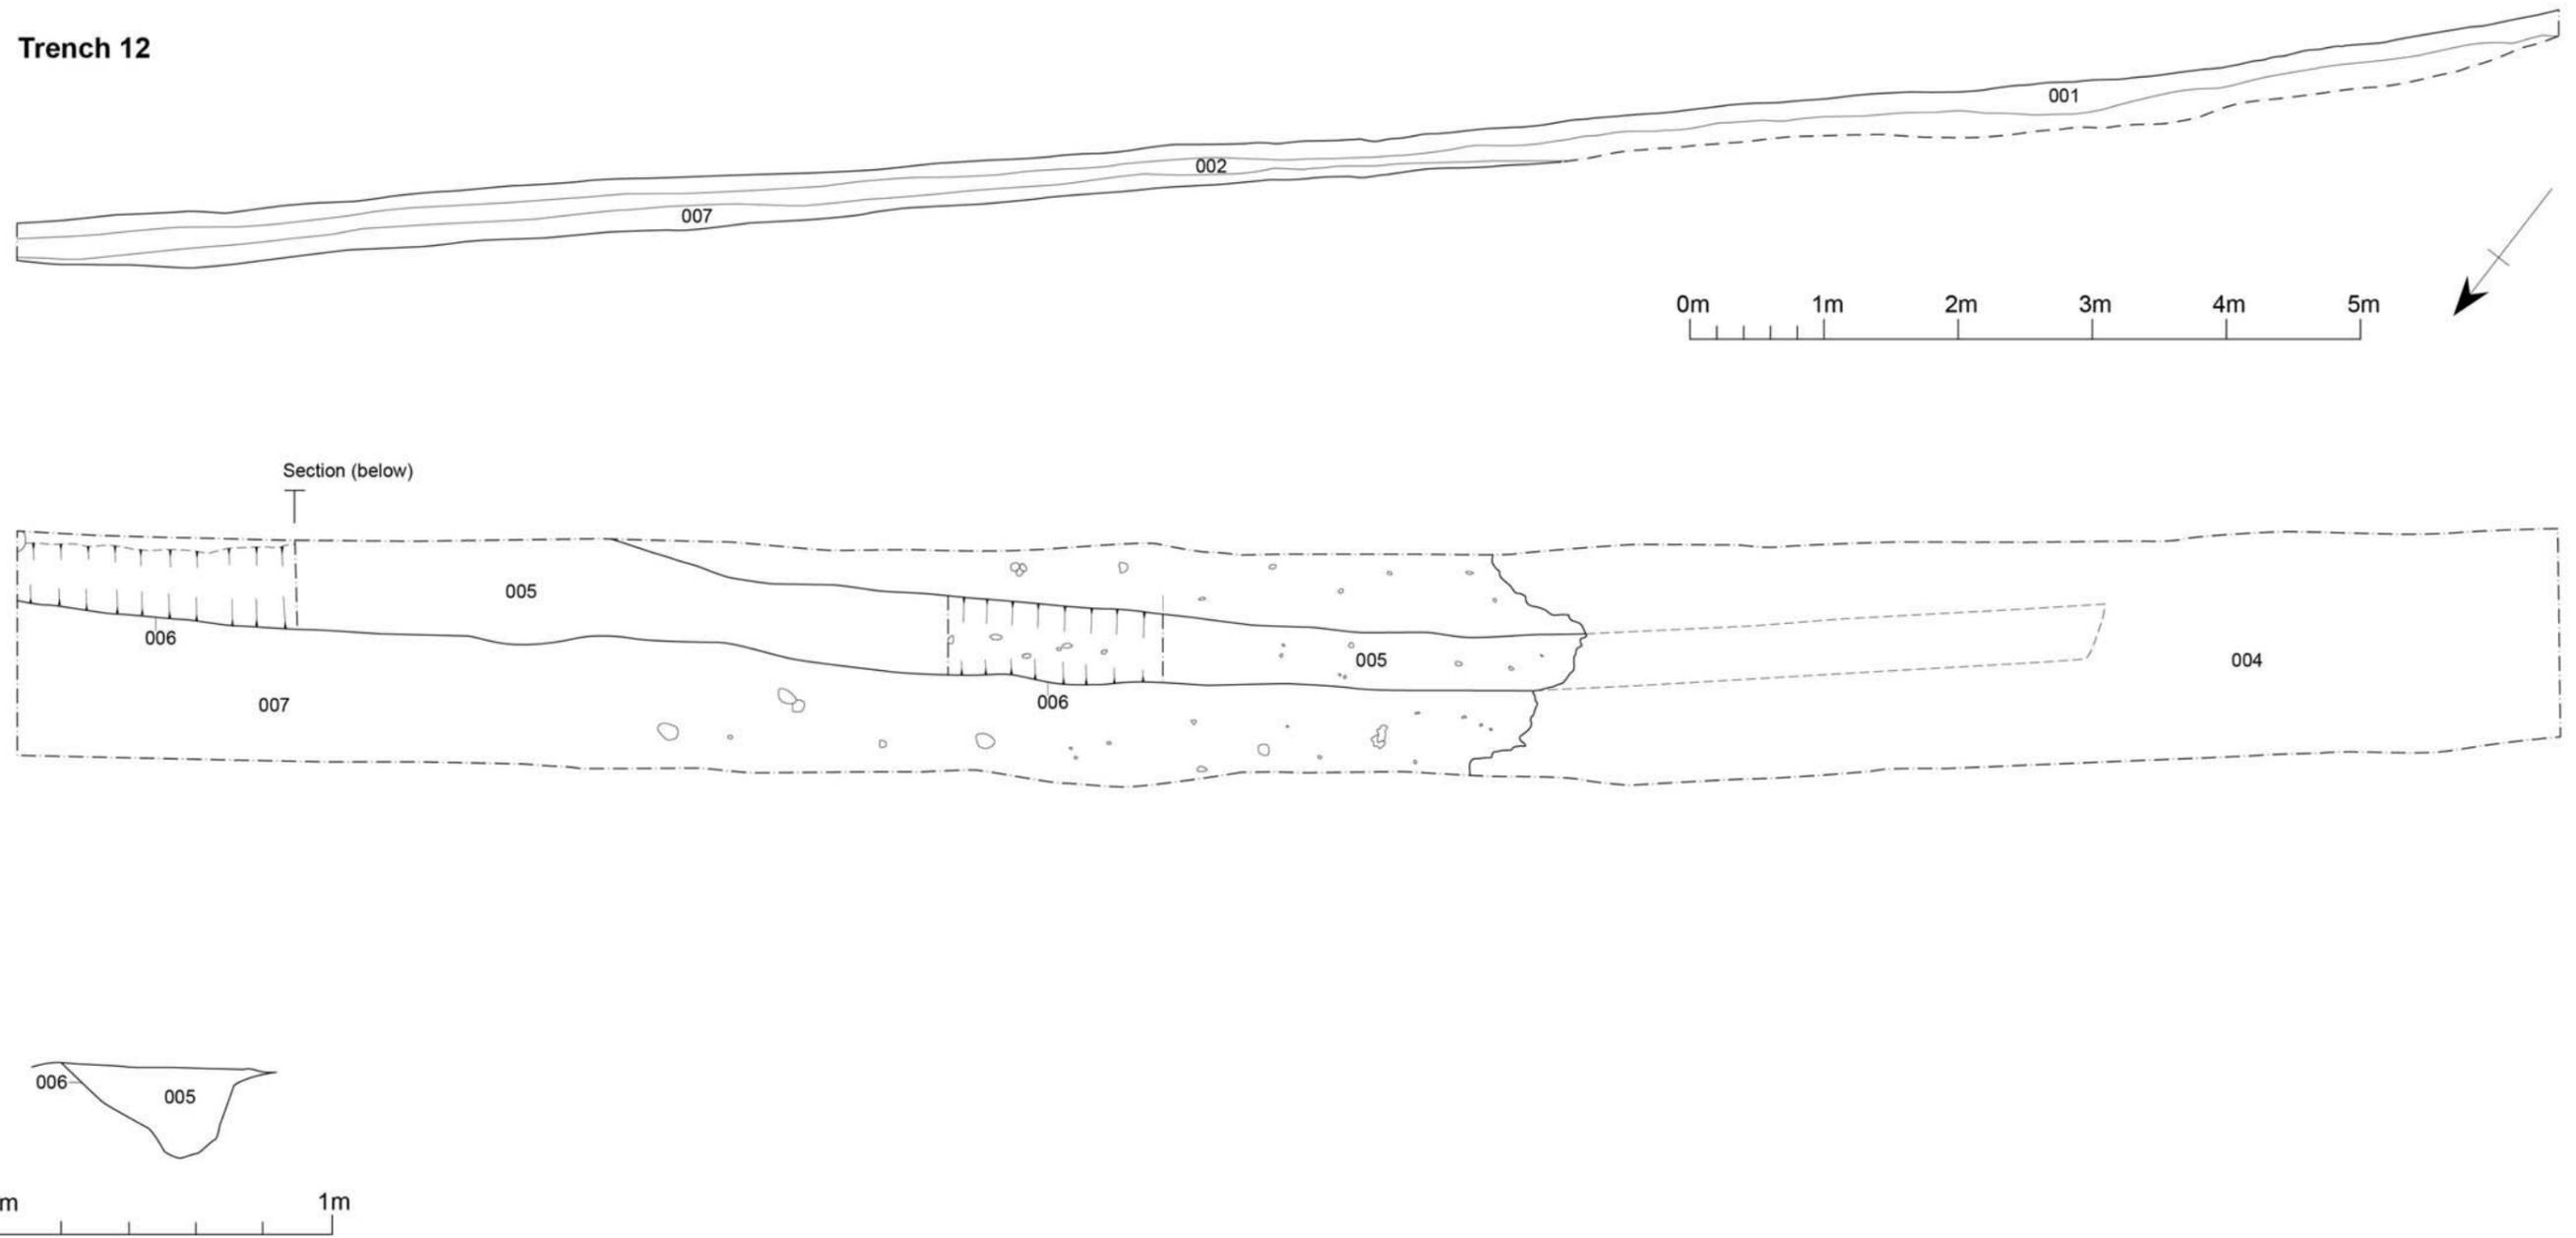
Fig. 43 Plan and section of Trench 12
