Appendix C.1
Gazetteer of Cultural
Heritage Sites

Newtown Bypass, Powys Archaeological walkover survey

Newtown Bypass, Powys

Archaeological Evaluation and Watching Brief

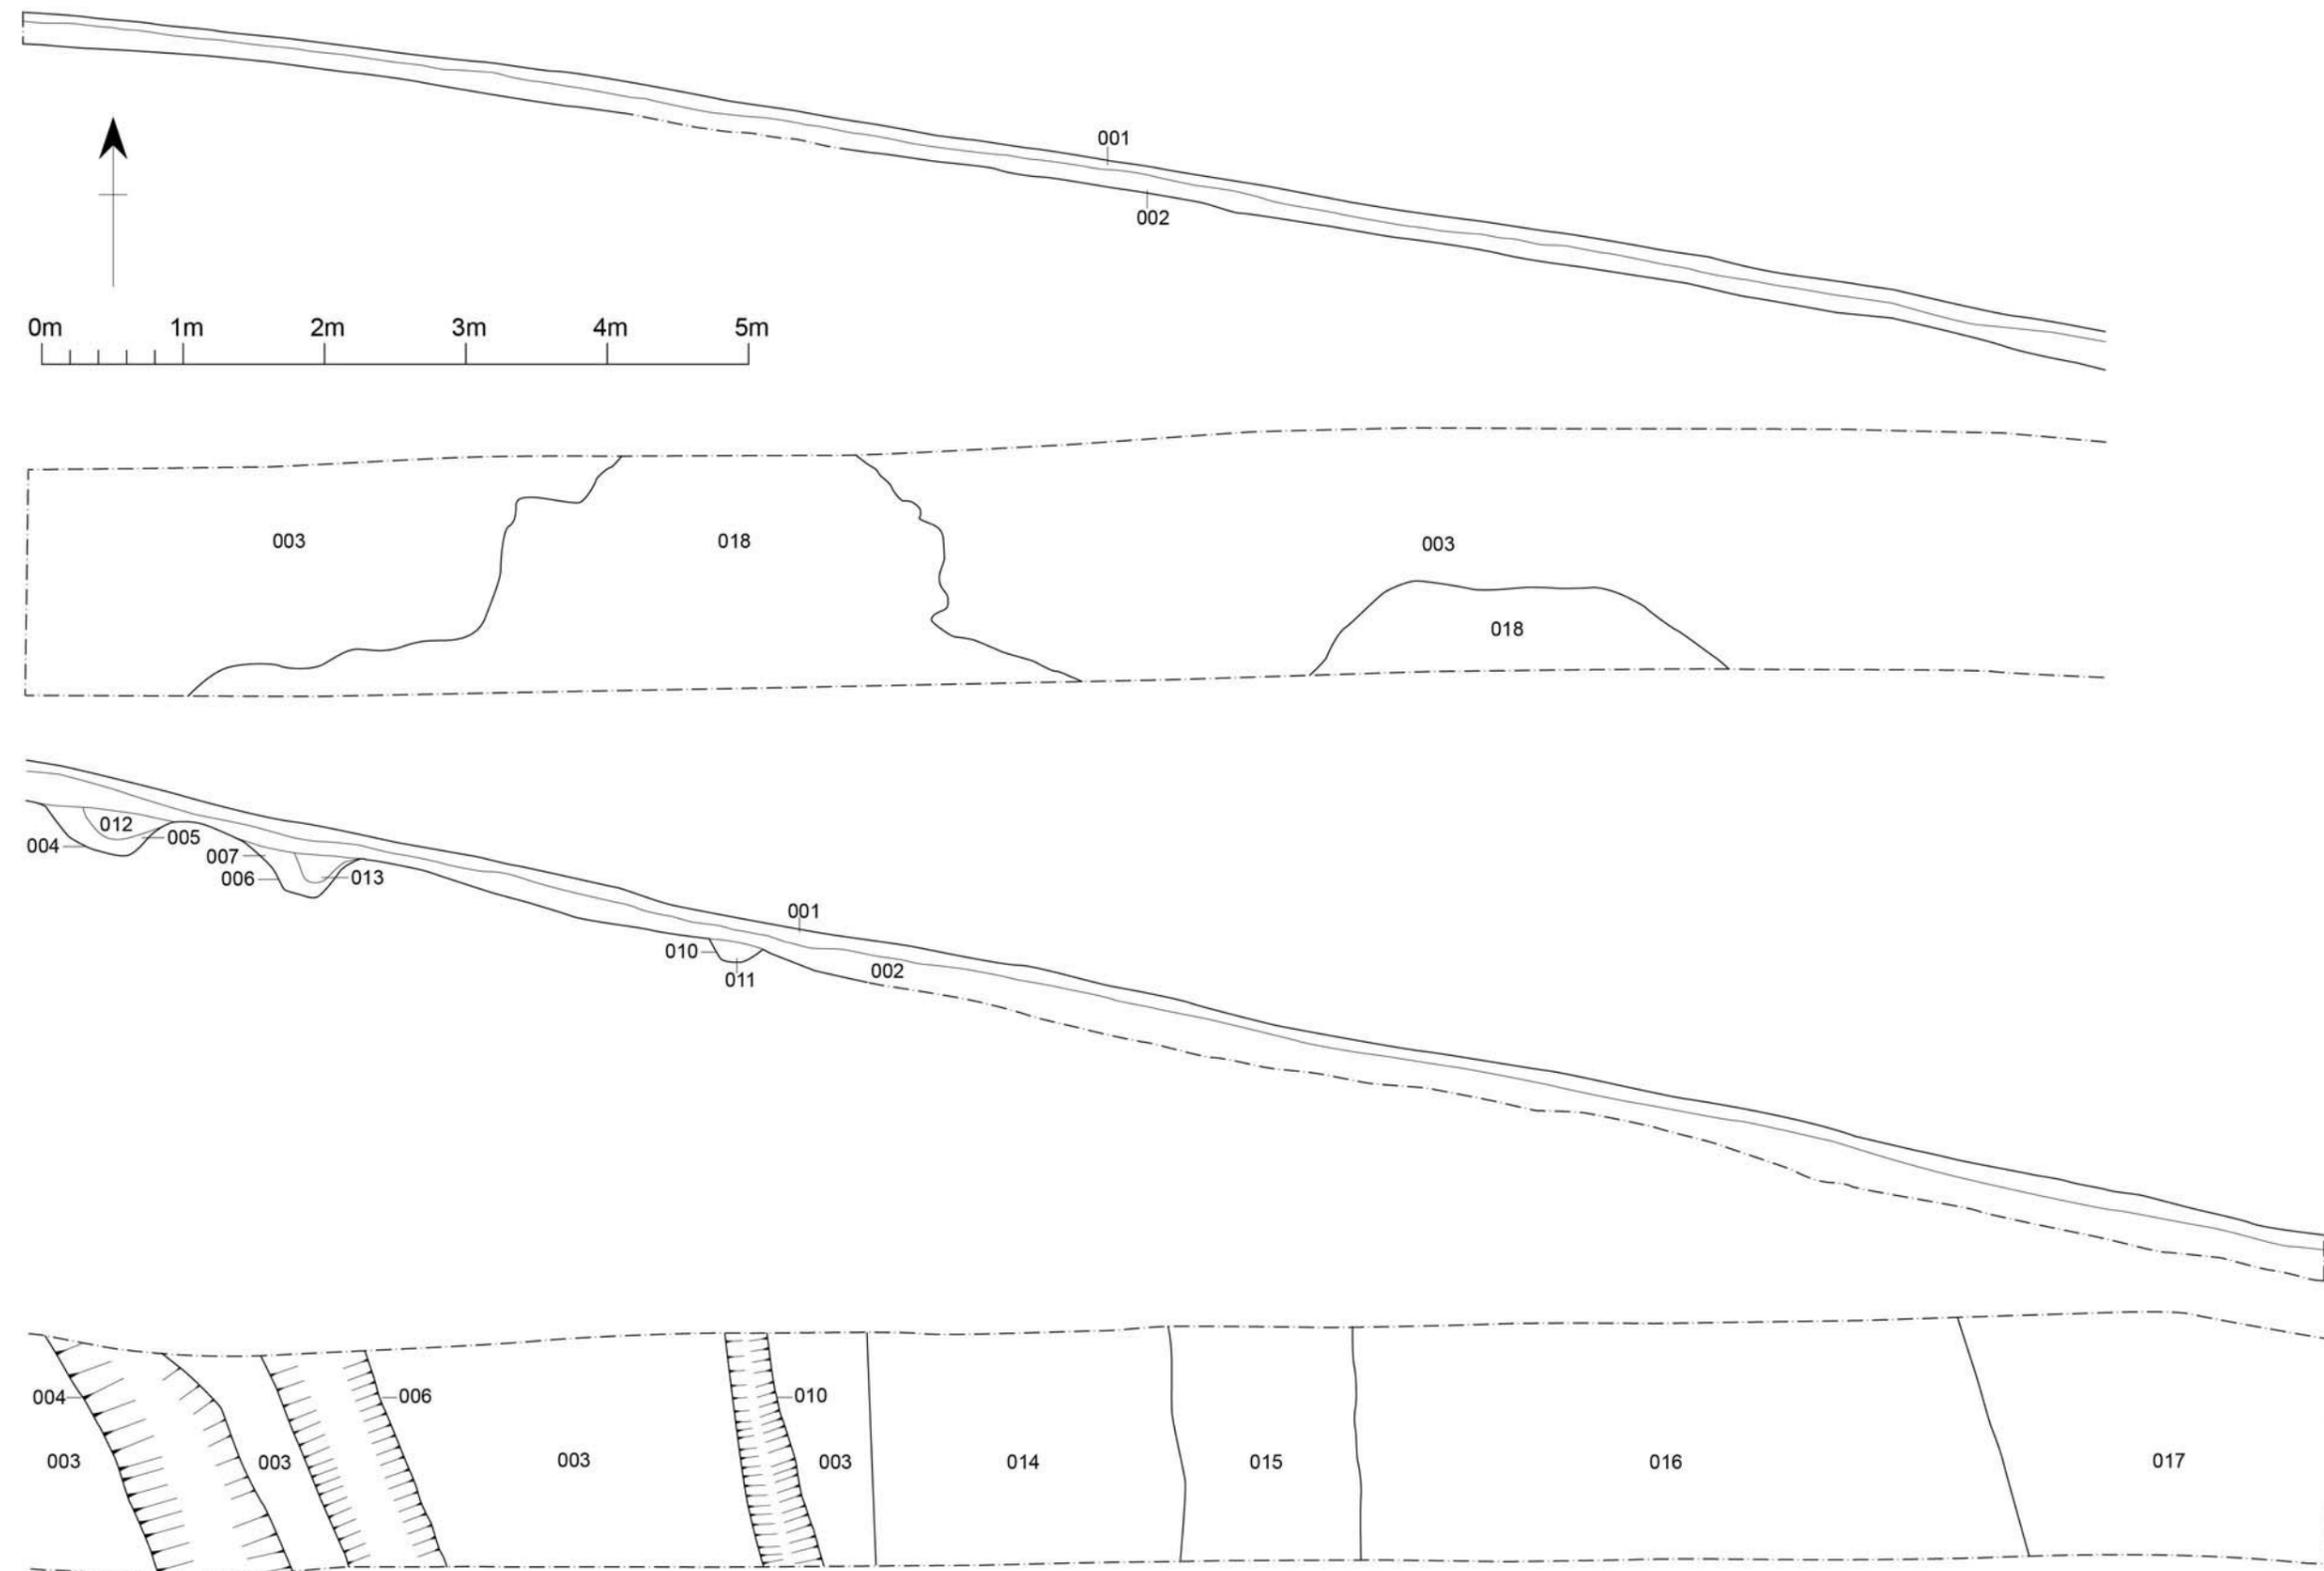
Fig. 44 Plan and section of Trench 13

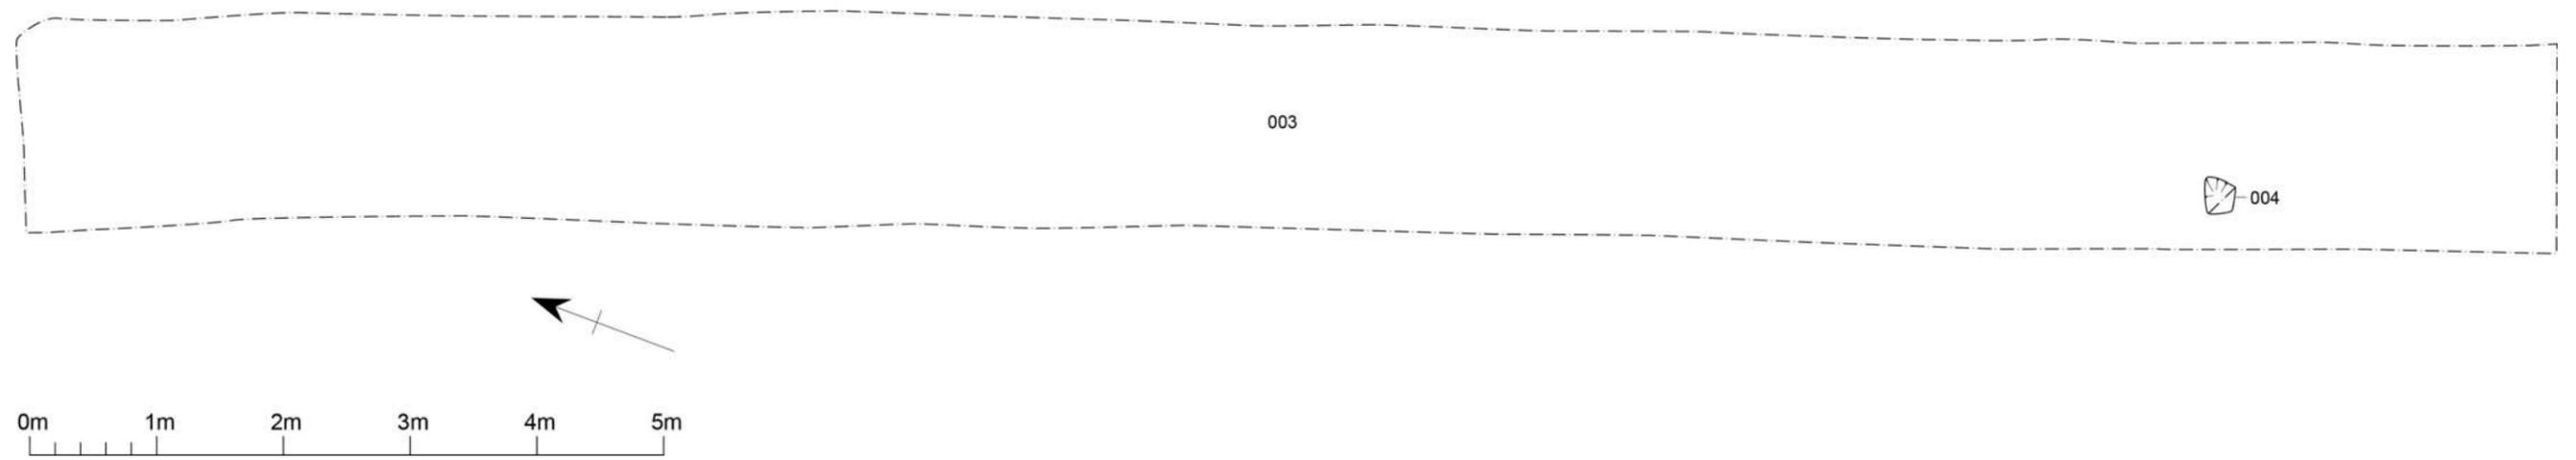
Fig. 45 Plan and section of Trench 14

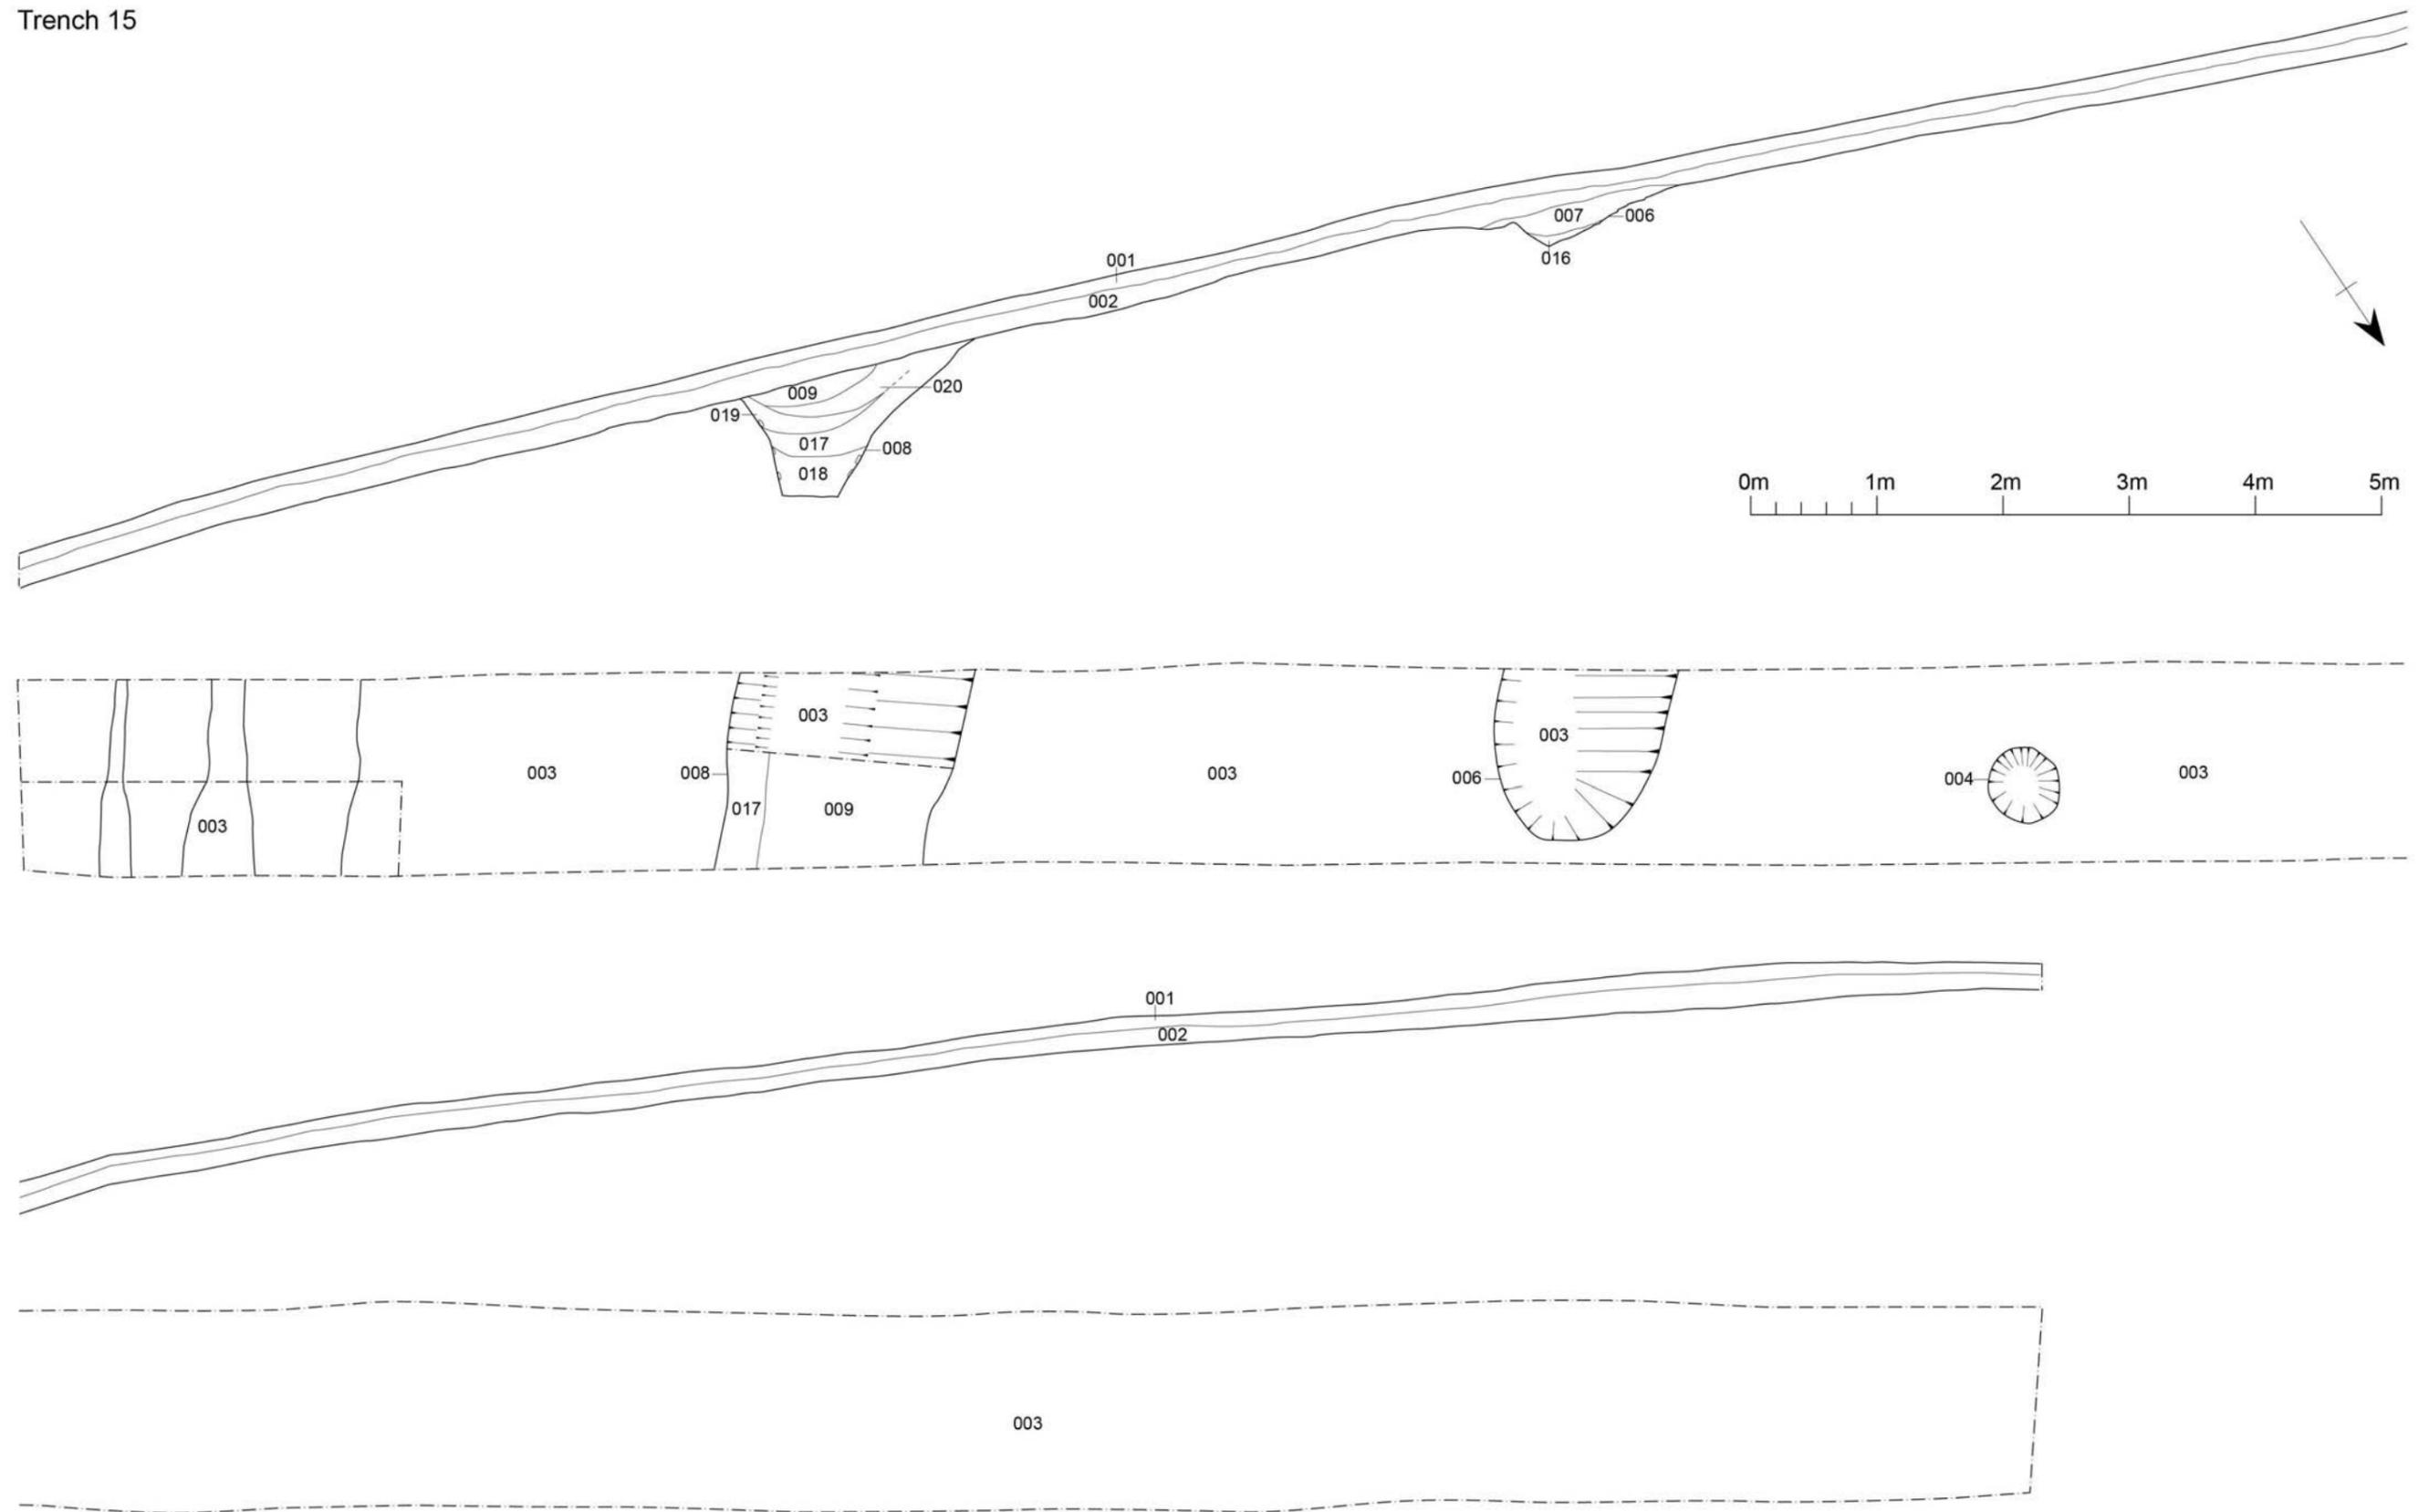
Fig. 46 Plan and section of Trench 15

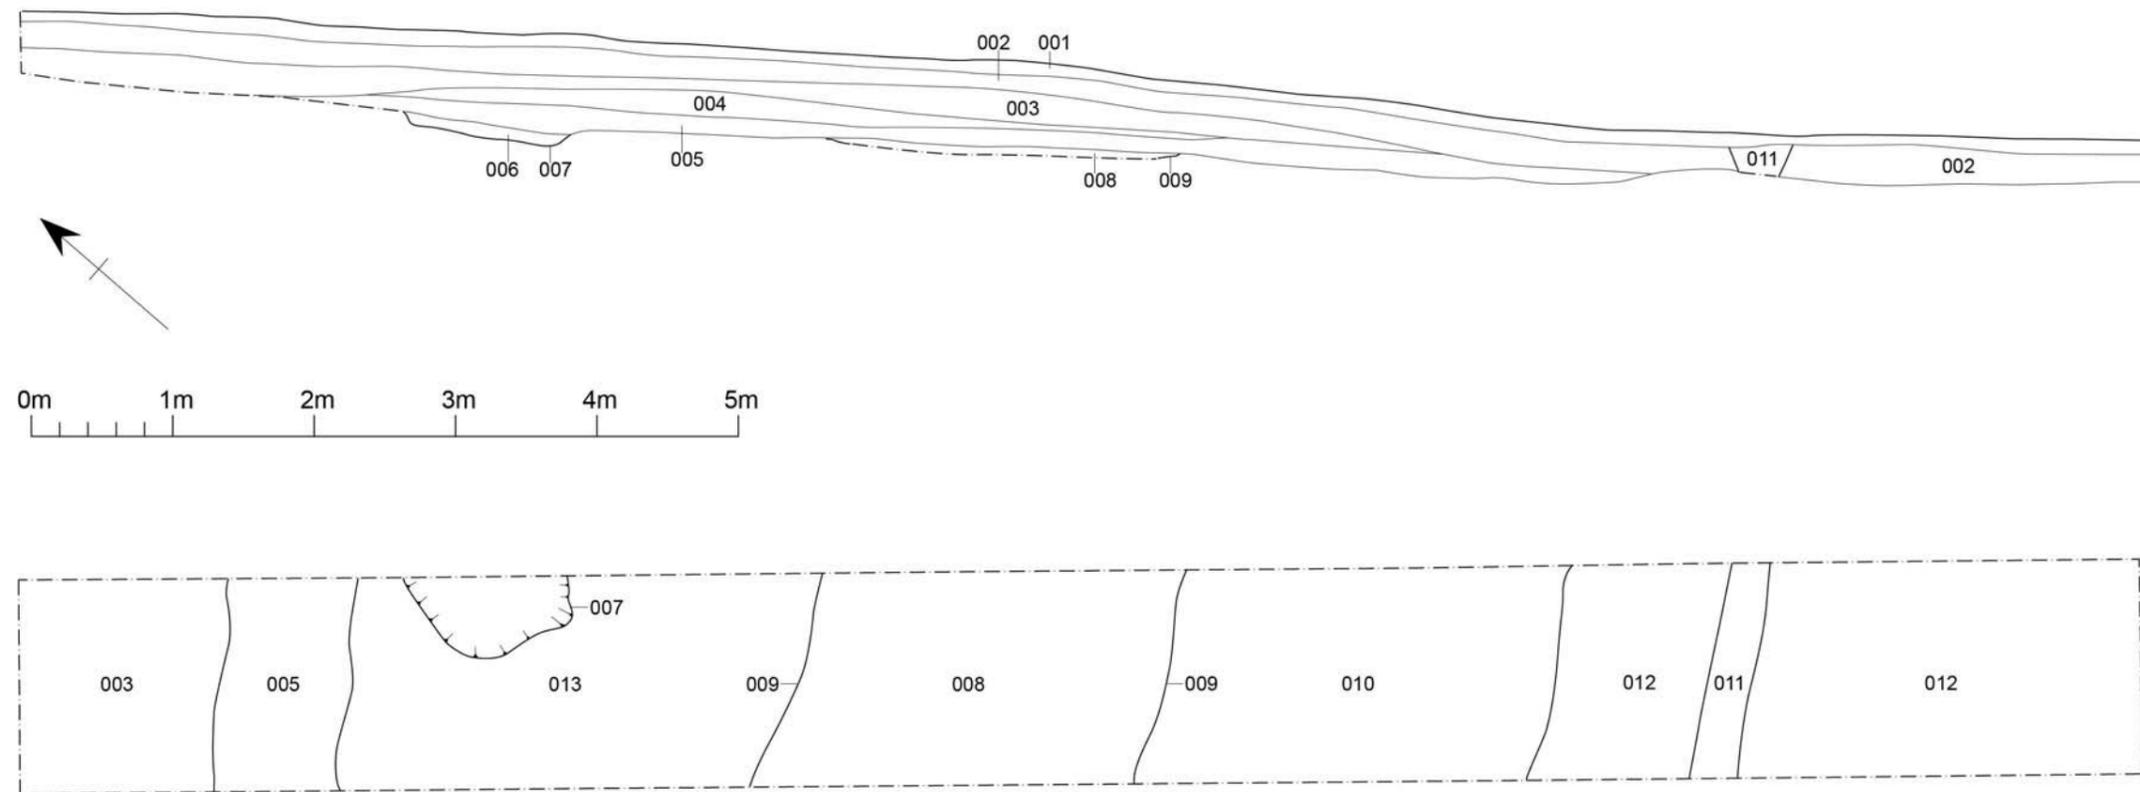
Fig. 47 Plan and section of Trench 18

- 3.52 Trench 18 was positioned to investigate a possible enclosure or geological feature identified by the geophysical survey (Roseveare 2013; feature 68). The trench measured 15m in length, aligned north-west/south-east and centred at SO 10860 90400 (Figs 27 and 47).

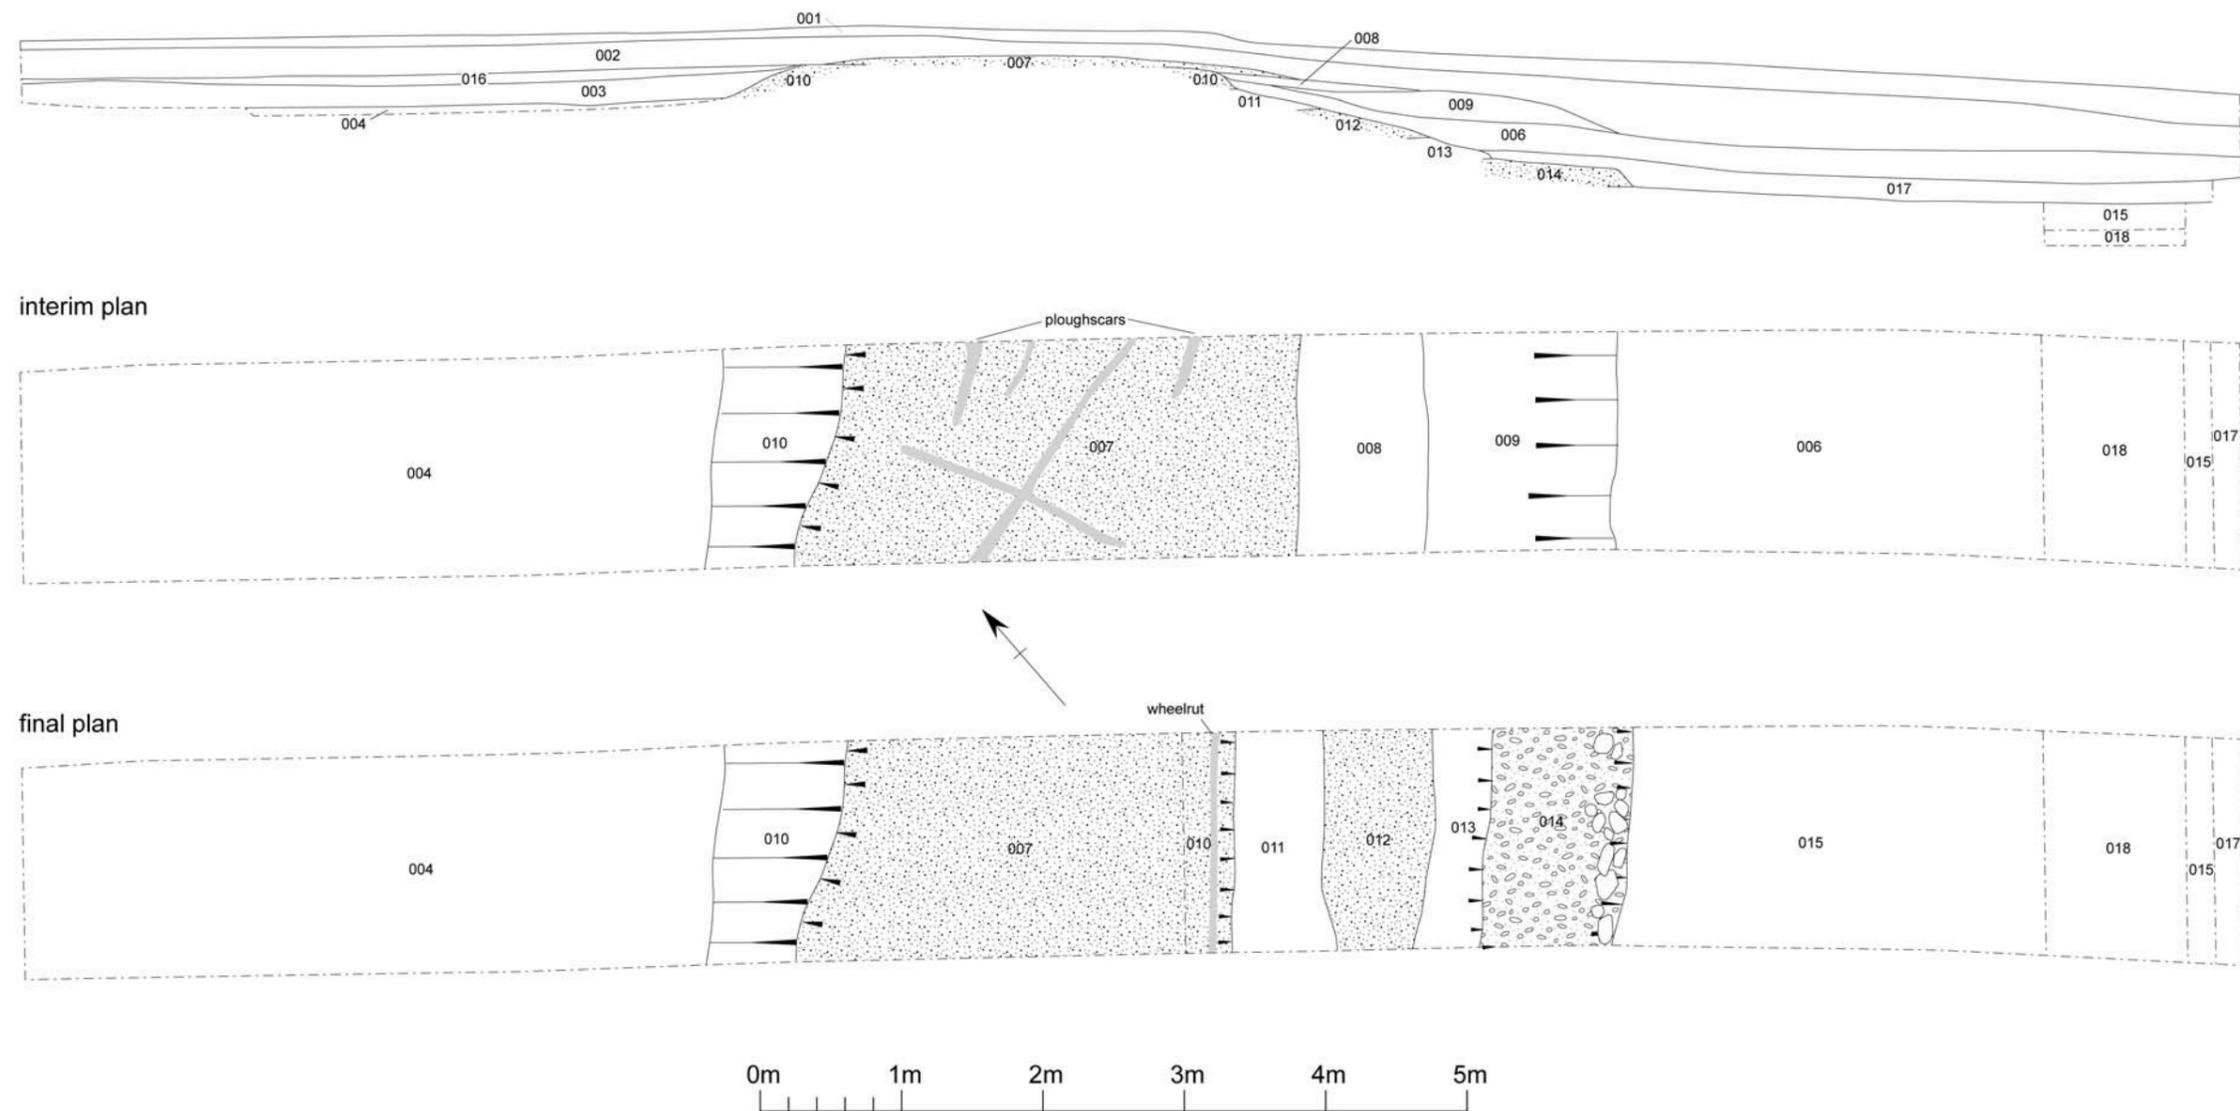
Fig. 48 Plan and section of Trench 21
