## 9025 - M4 J23a Magor Interchange Temporary Signals

25/SW/CSI/005

### Stage 3 Road Safety Audit Brief

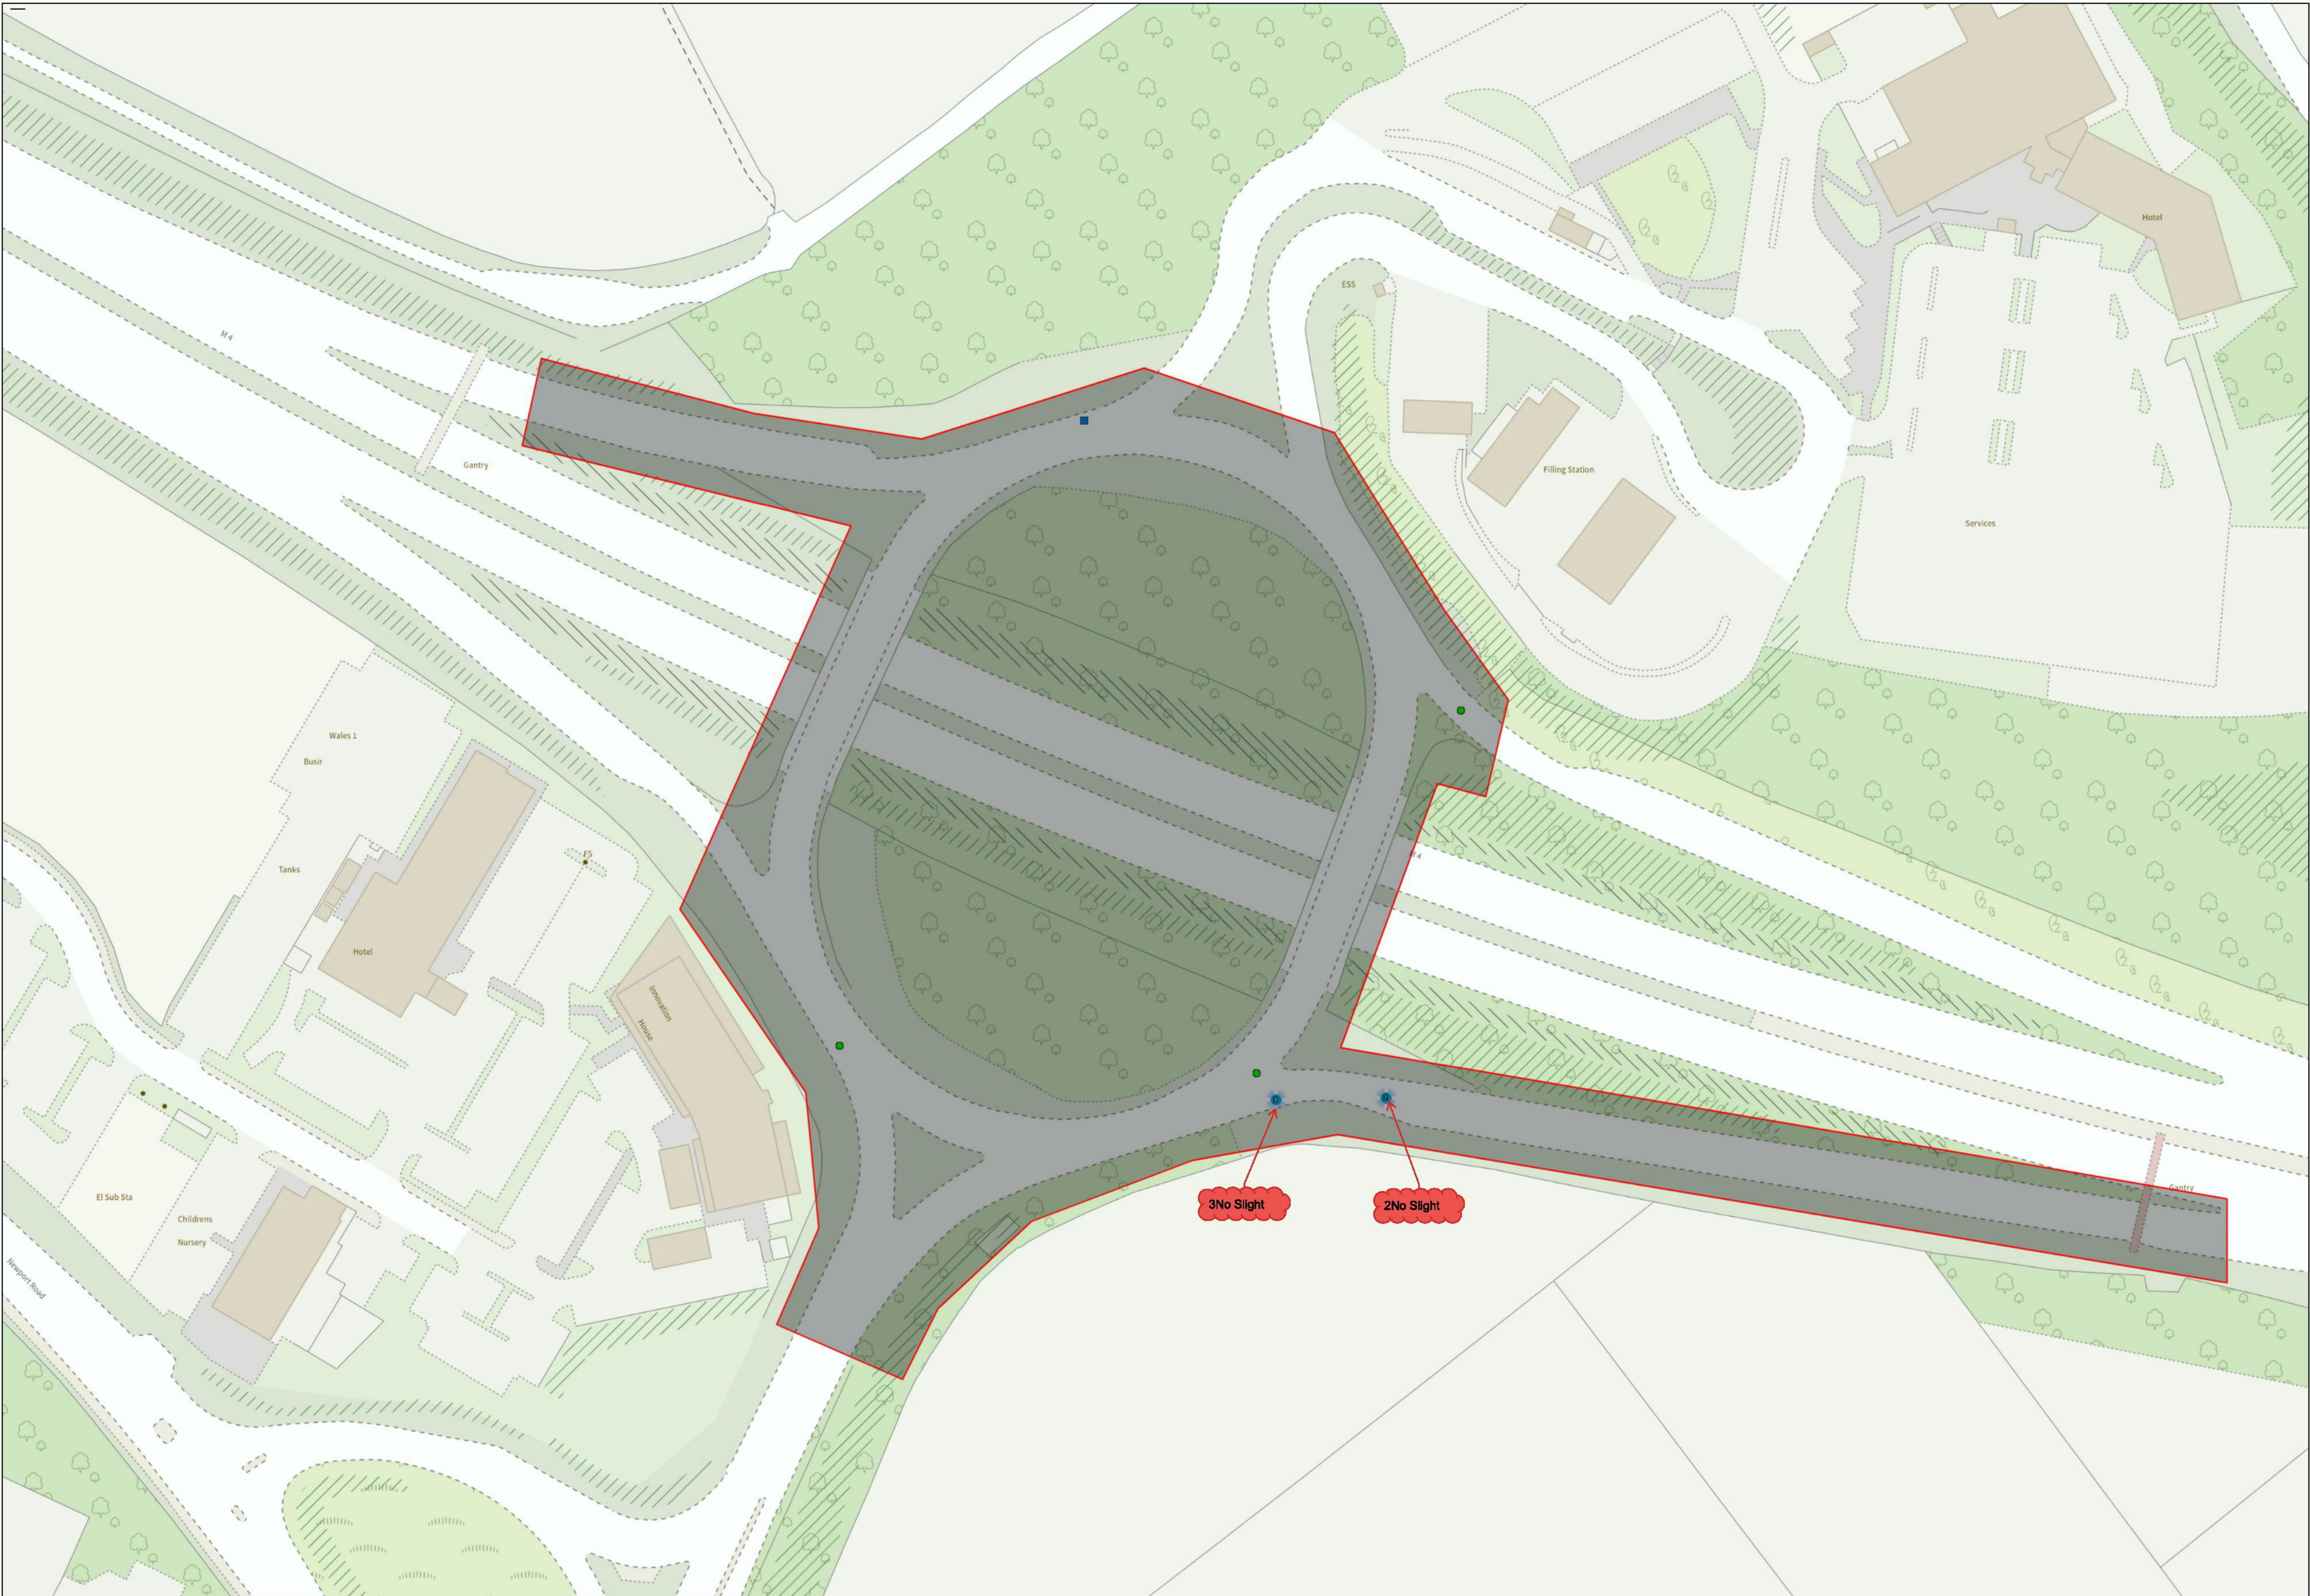
### Personal Injury Collision Location Plan

A location plan of the recorded collisions is contained in Appendix B.
