## **9025 - M4 J23a Magor Interchange Temporary Signals Combined Stage 1 & 2 Road Safety Audit**

| Document Reference: | UK0029359.3987-ROAD SAFETY AUDIT1-2 | | |
| Scheme Reference: | 25/SW/CSI/005 | Programme: | CSI |

WSP has been commissioned by the South Wales Trunk Road Agent (SWTRA) on behalf of the Welsh Government to undertake a Combined Stage 1 & 2 Road Safety Audit of the proposed M4 J23a Magor Interchange Temporary Signals Scheme.

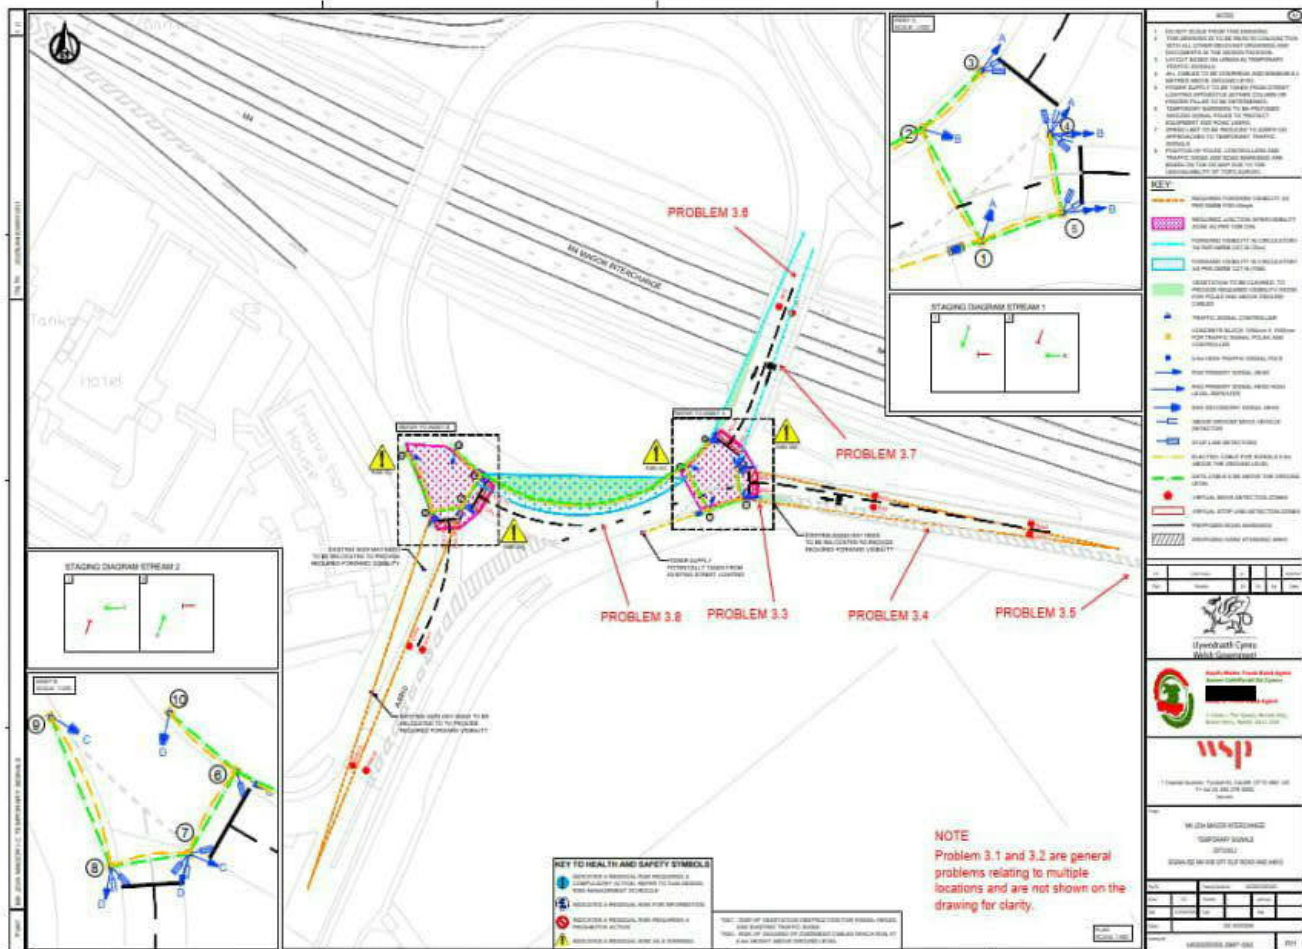
Option 2

| No MOVA detection zones are shown on the circulatory carriageway on the approach to the traffic signal junction with the A4810 entry. Traffic queuing at the red signal for stage C may block the exit to the A4810 leading to inappropriate manoeuvres and collisions. | | It is recommended to provide MOVA detection zones. |

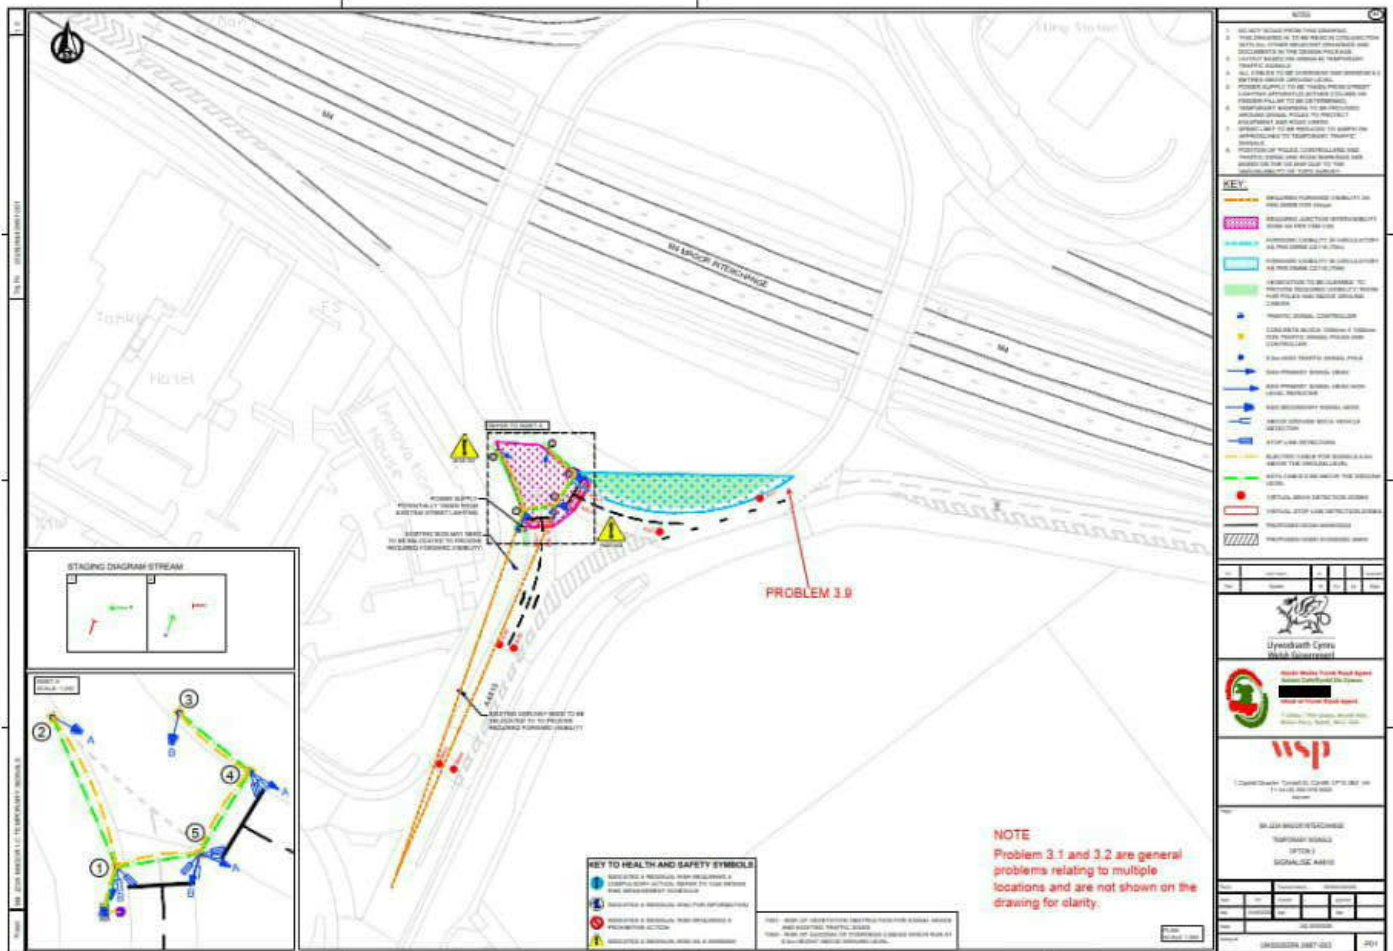
Option 3

| <p>There are proposed virtual MOVA detection zones on the circulatory carriageway approach to the traffic signals. However, vehicles in the traffic queue reaching the zone AX1 could be obscured from vehicles circulating the roundabout in the inside lane due to the extensive vegetation in the offside verge, leading to rear end shunts.</p> | | <p>It is recommended to clear visibility on the inside of the circulatory carriageway by cutting back all vegetation and provide additional traffic signals ahead/queuing traffic warning signs on the circulatory carriageway.</p> |
