A487 New Dyfi Bridge

Environmental Statement –
Volume 3: Appendix 10.1

Preliminary Sources Study Report

900237-ARP-ZZ-ZZ-RP-CG-00002

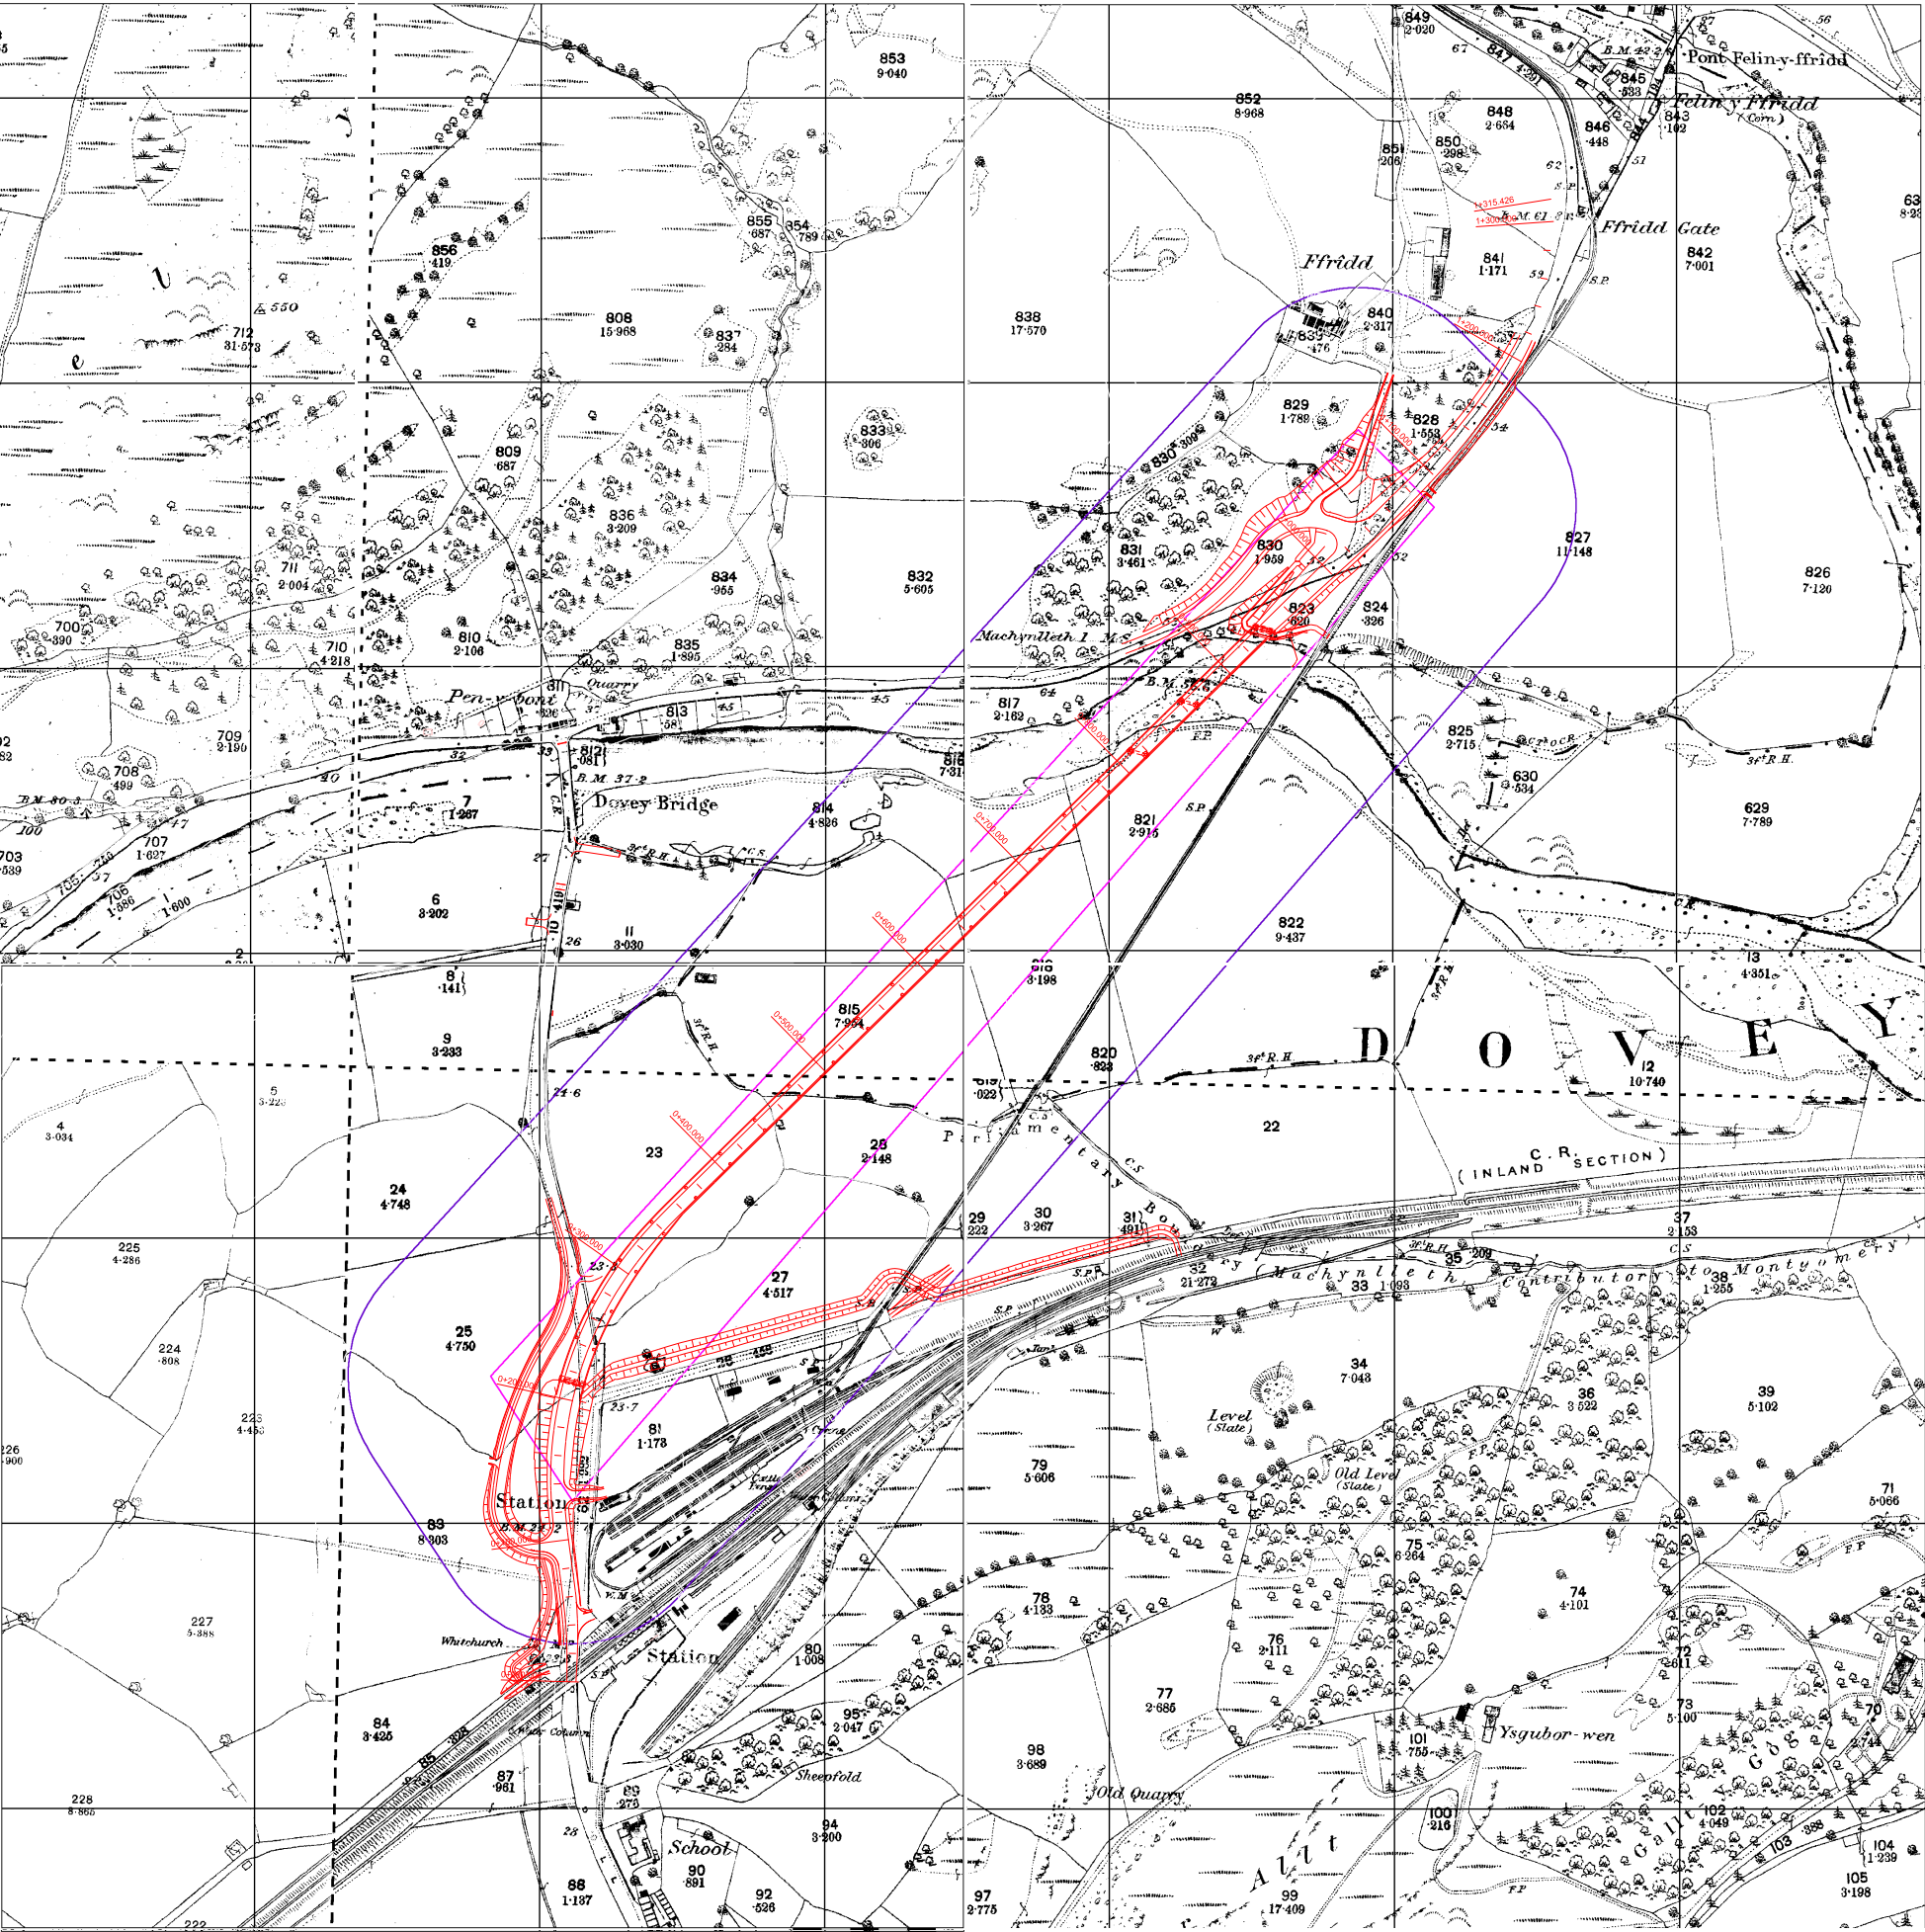
FIGURE 5A

The 1888/89 OS plan shows the study area to comprise predominantly fields; see Figure 5A. To the south west corner of the study area, a road is shown running from Machynlleth in the south to Dovey Bridge in the north along a similar alignment to the A487 today. A drain is shown on the eastern edge of the road. A track is present running in an eastern direction, which joins the main road at around Ch. 0+200m. To the south of the study area, the Machynlleth Railway Station and associated tracks are in place generally orientated in an eastern direction. Review of the Coflein database indicates that the station was constructed in 1863.

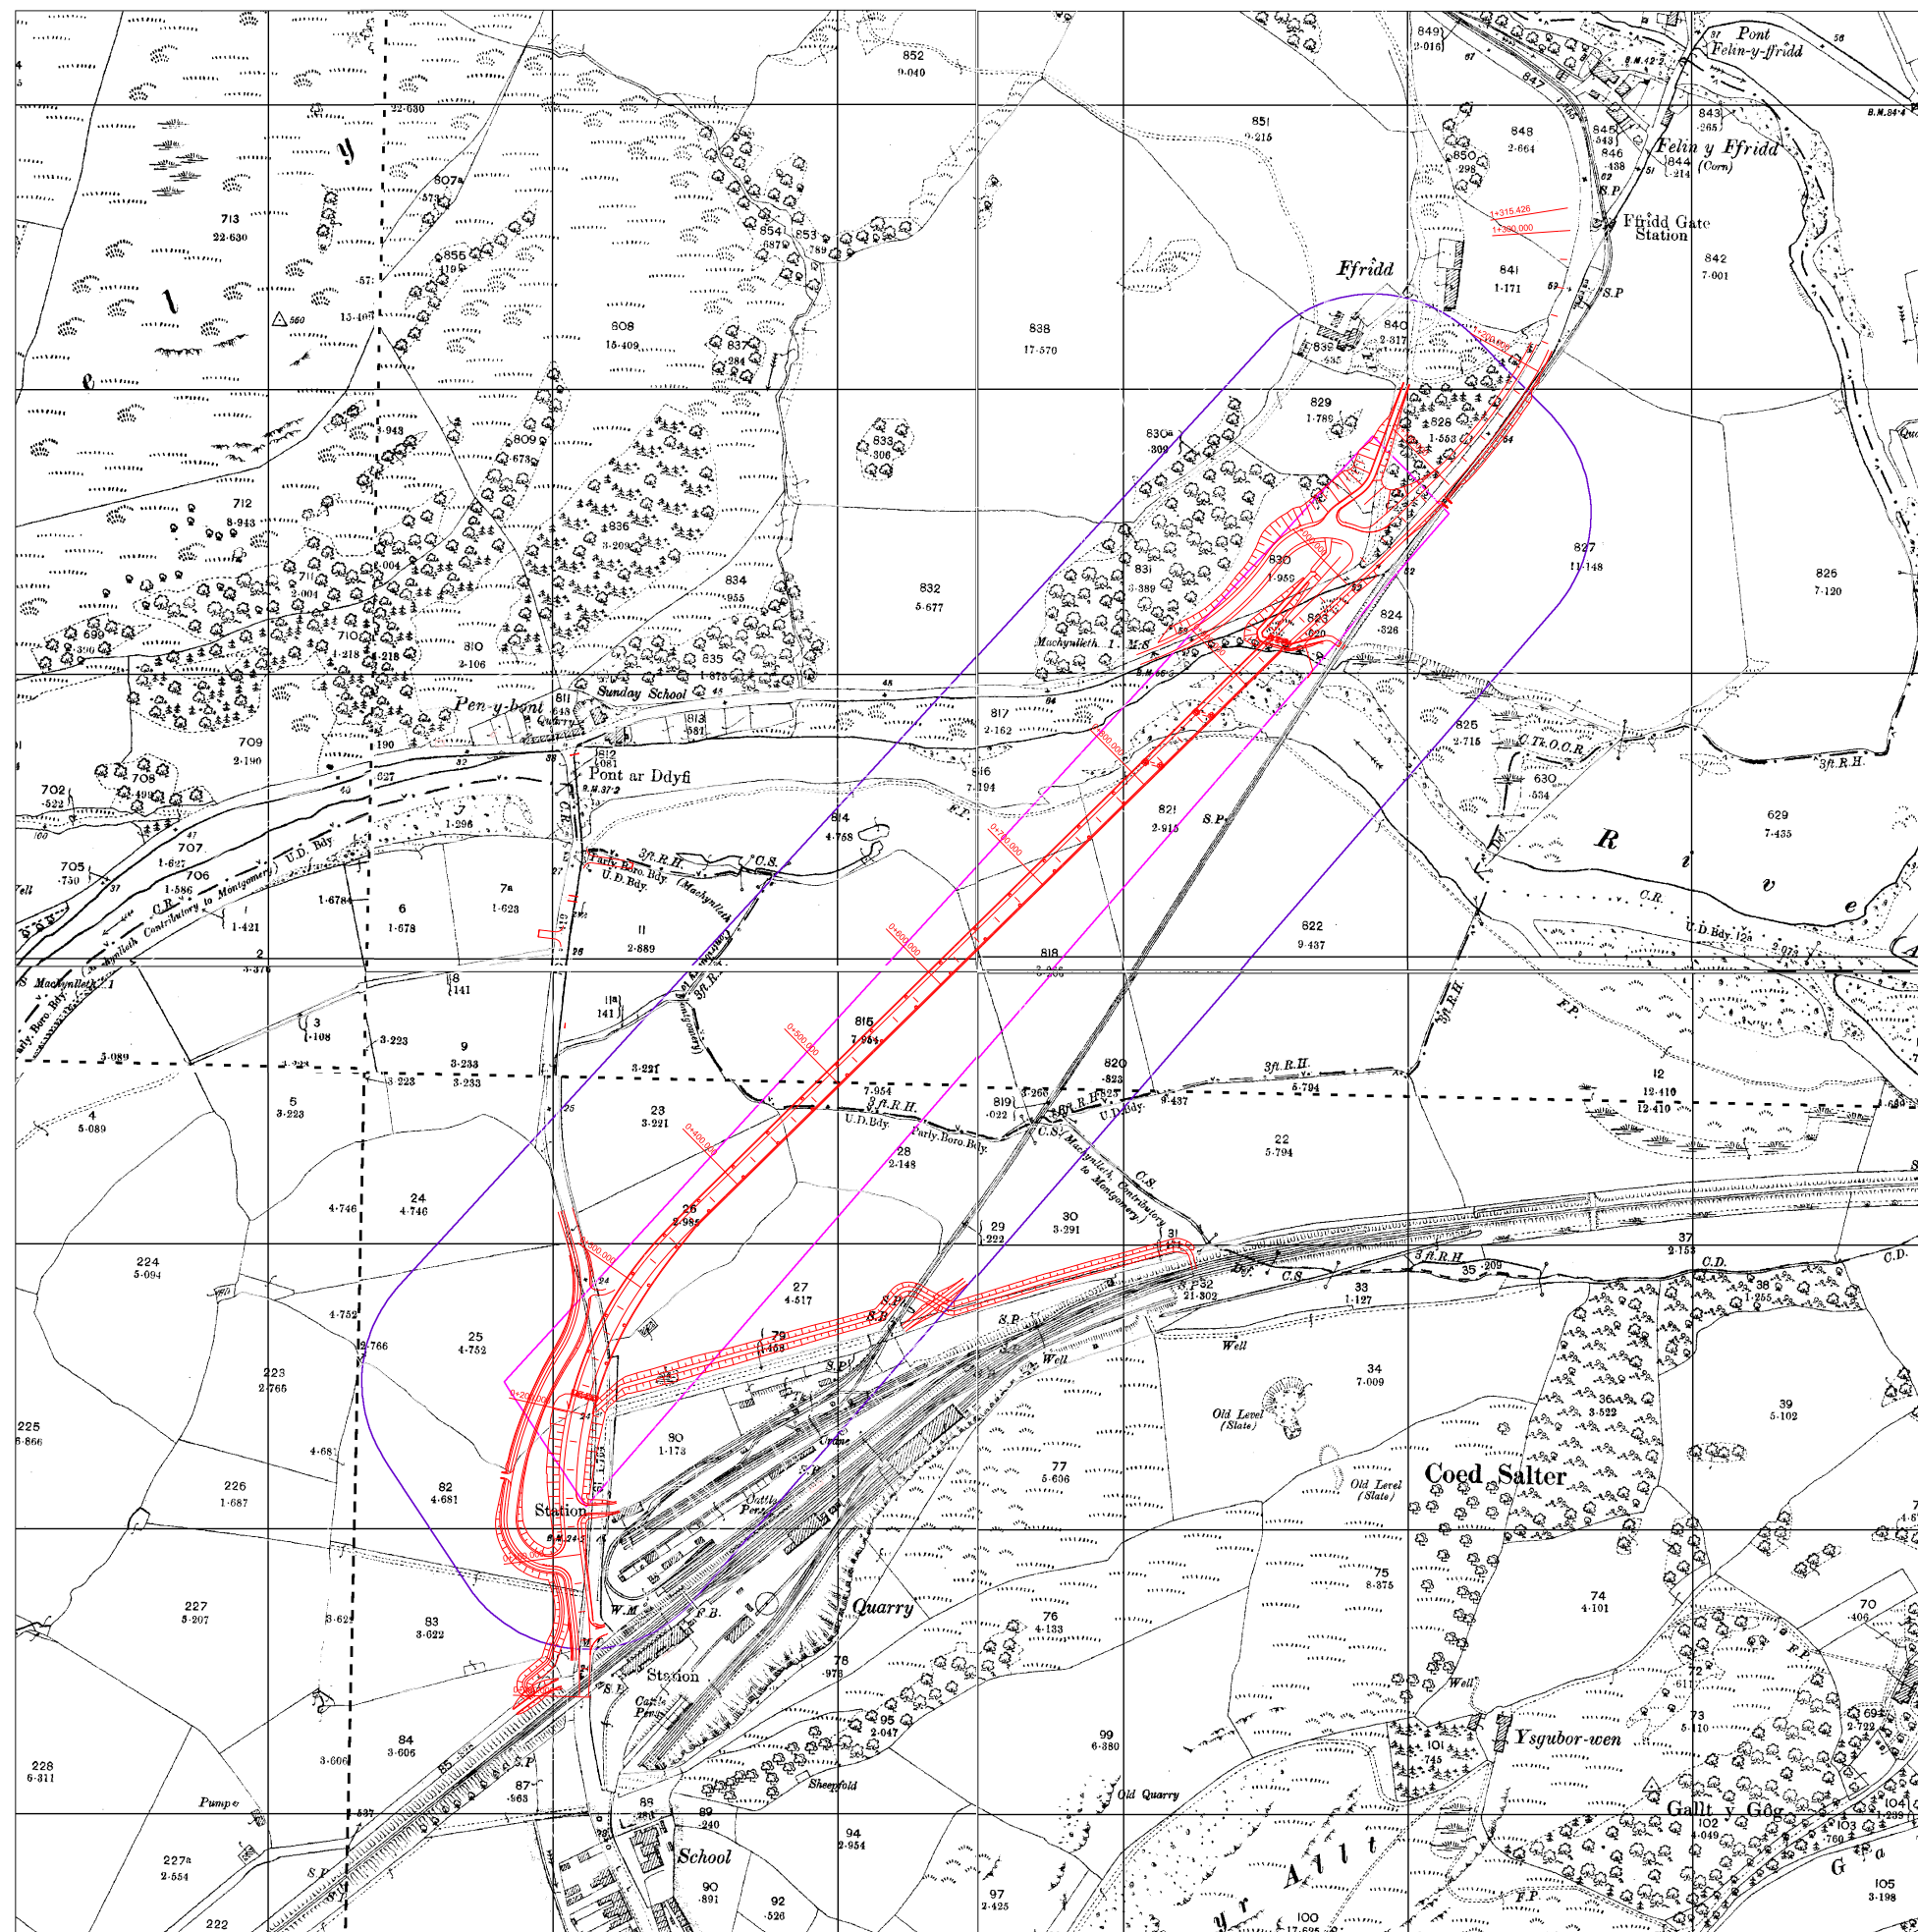
FIGURE 5B

There are no significant changes to the site by 1901; see Figure 5B. Two of the ponds in the south west of the site have been backfilled and a small rectangular water structure has been built to the north of the remaining pond. The shingle bars in the river now from around Ch. 0+880m to Ch. 0+930m have changed position indicating some changes in the river course. The fields at the north of the study area (Ch. 0+950m) are shown to be rough grassland. On the 1:10,000 scale OS plan the branch of the railway heading north east is shown as the Corris Railway.

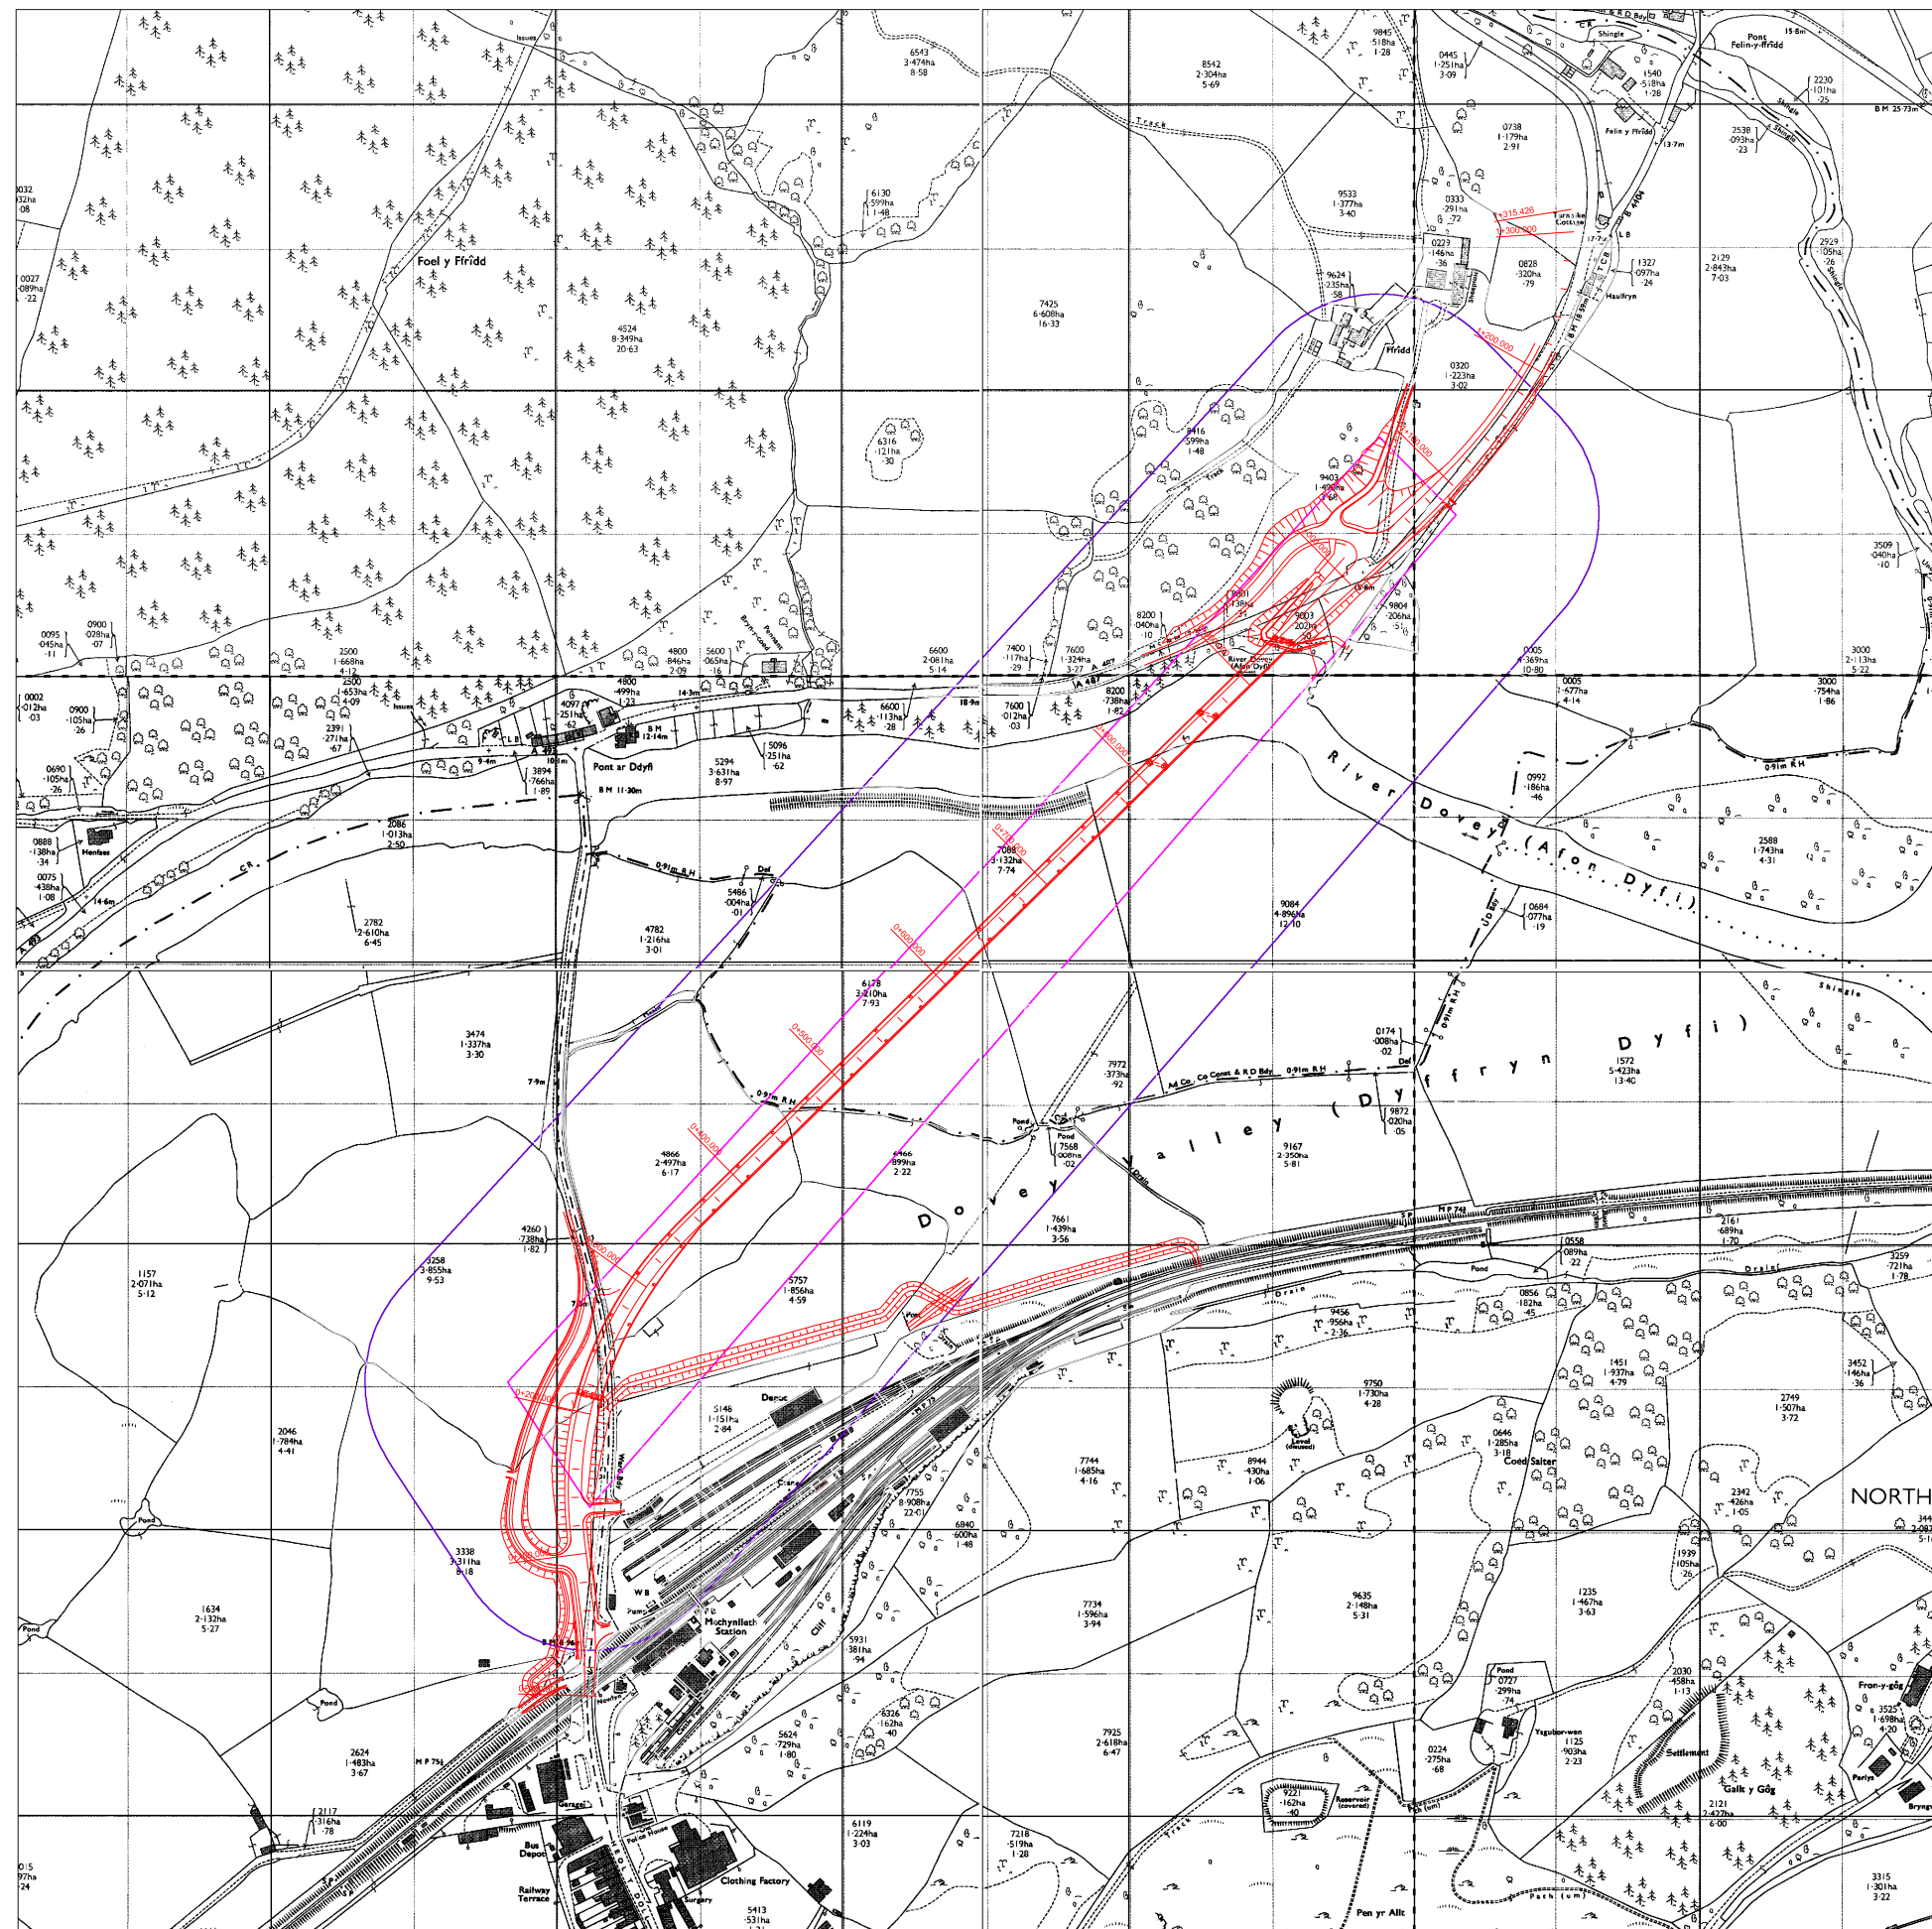
Site History - 1974/75
(not to scale)

There were no significant changes to the site between 1902 and 1974, by which time the Corris Railway had been dismantled; see Figure 5C, though there was still some evidence of its alignment on site. The historical plans for 1974 to 1975 show River Dovey to have cut into the northern bank at around Ch. 0+920m, increasing the width of the river. The shingle bars are also no longer shown, though they were visible during the site walkover. A flood bund, approximately 220m long, had been constructed along the southern bank of the river. The main road has been labelled A487. Along this road, spot levels of 7.3mOD and 15.8mOD are indicated in the southern and the northern end of the study area. The northern bank of the river is now shown as being wooded.

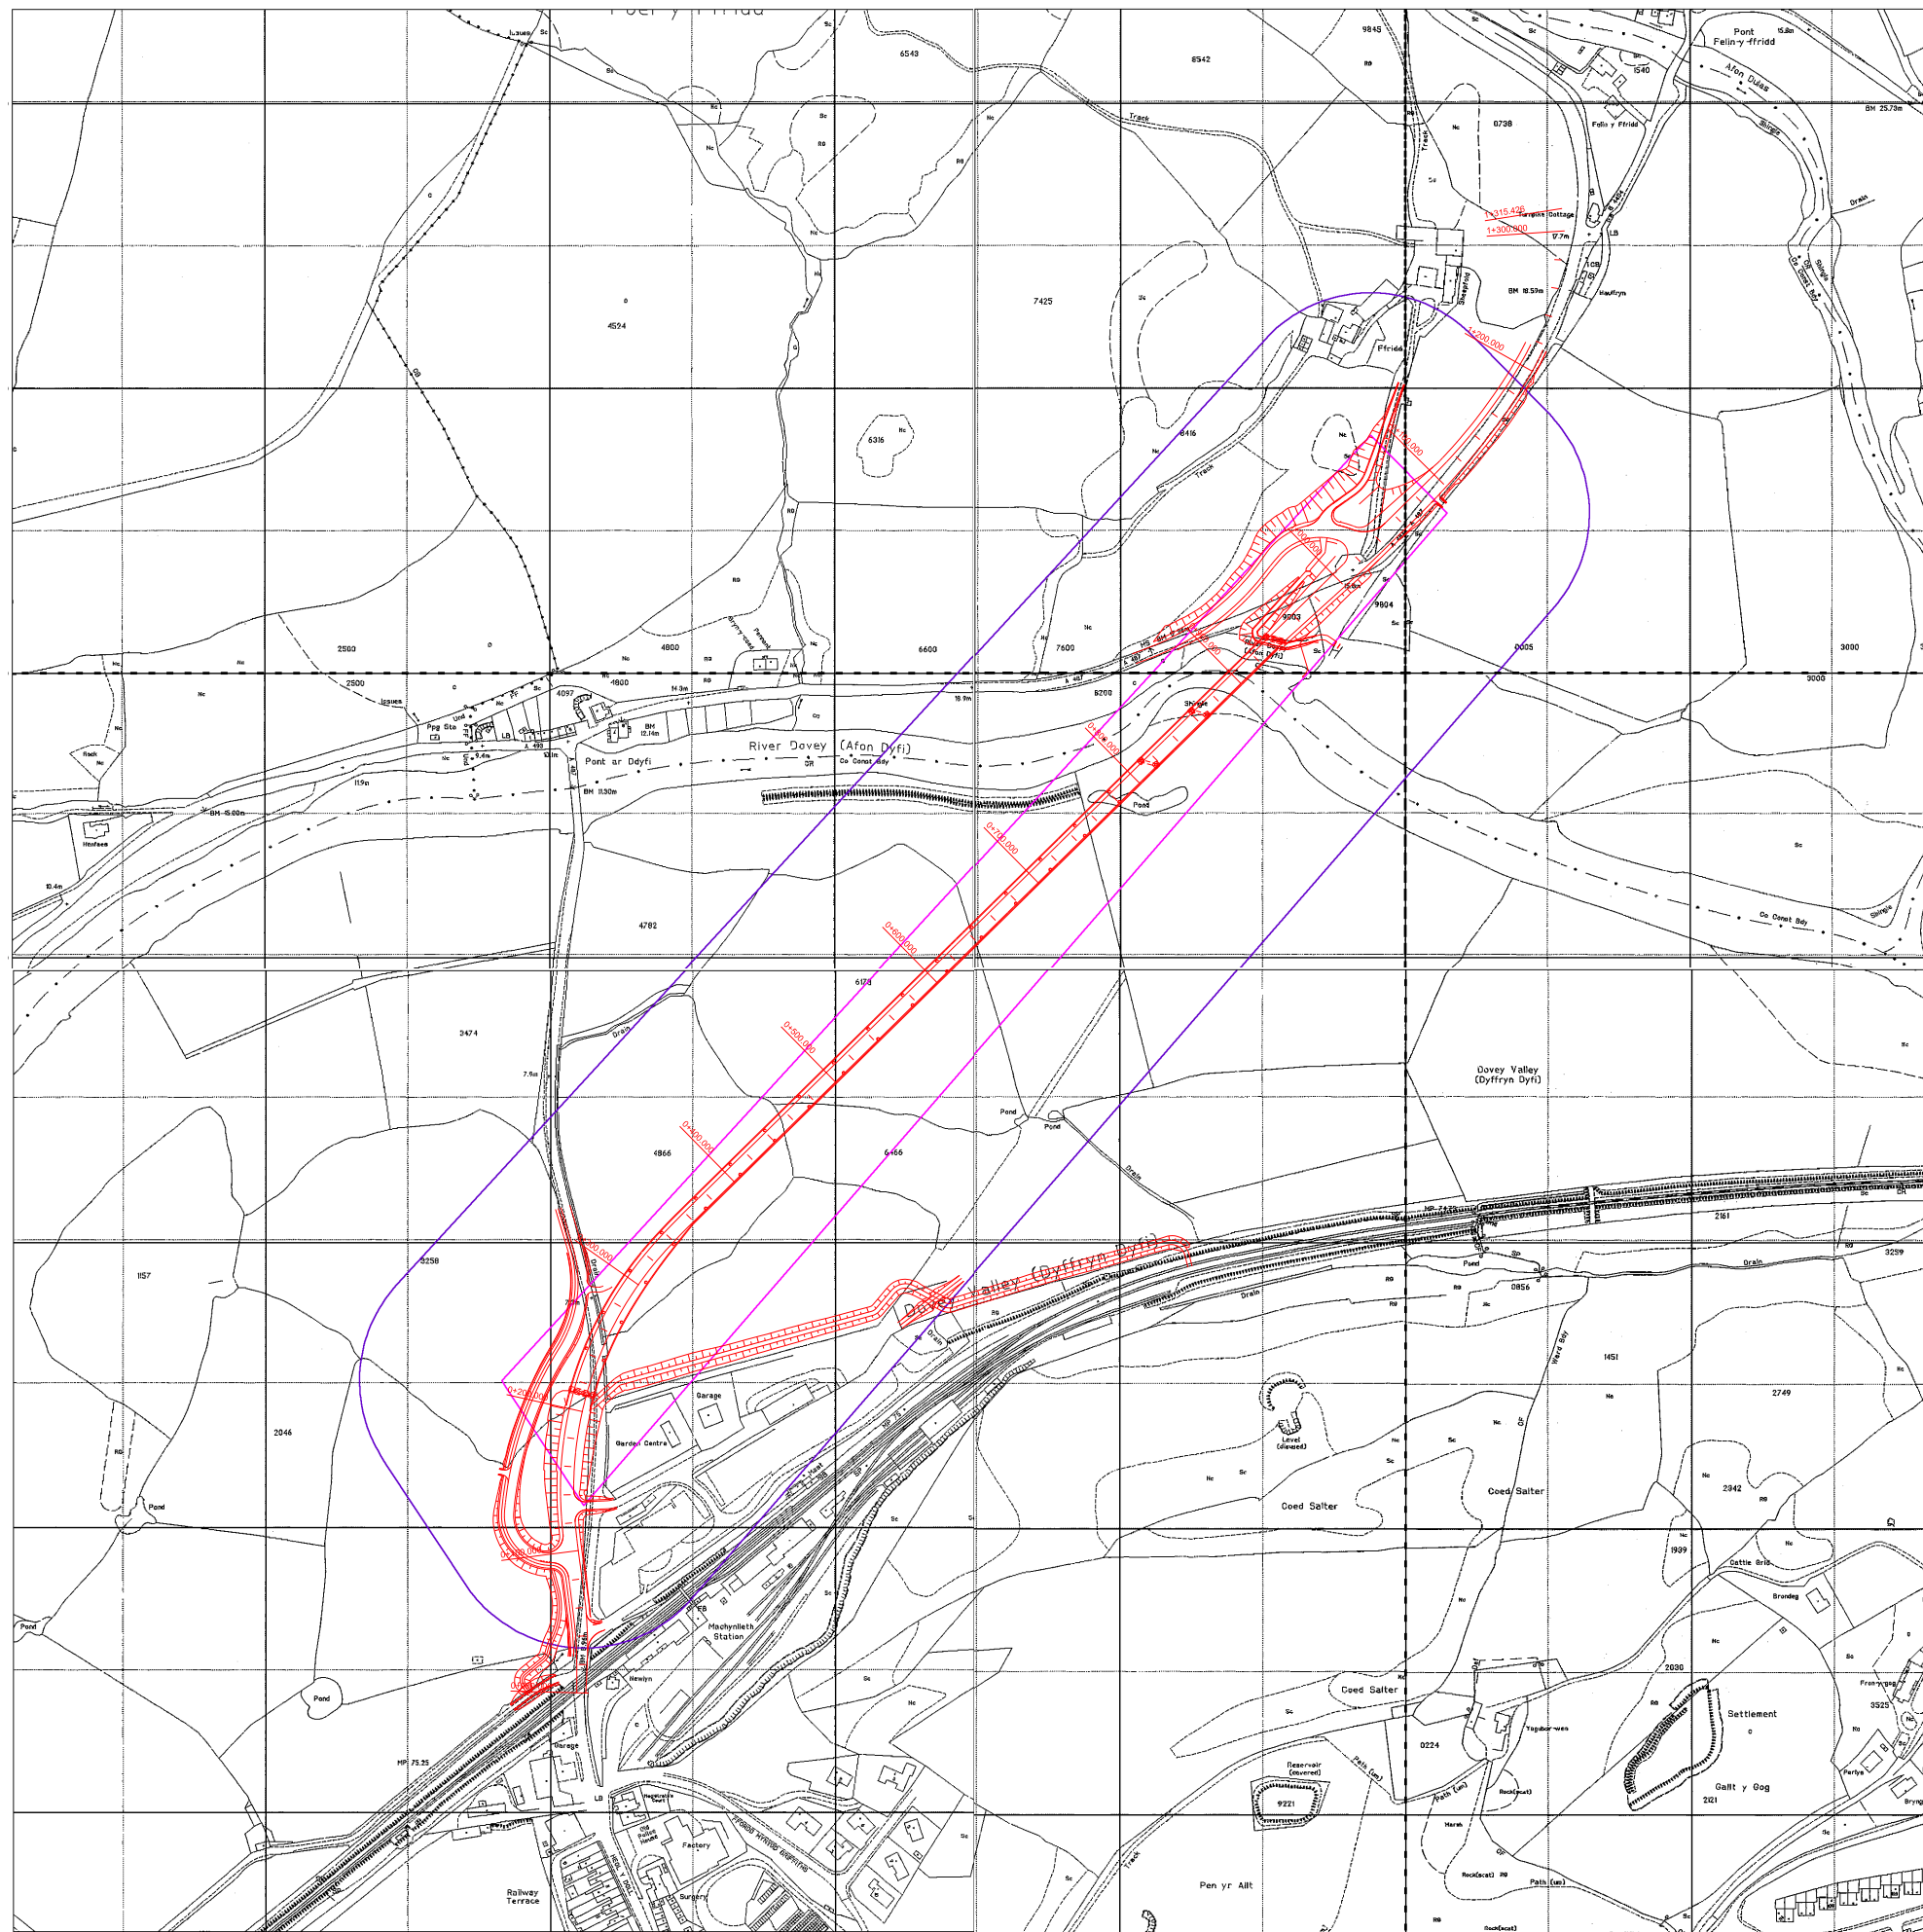
Site History - 1995
(not to scale)

By 1995, the railway sidings north of the existing railway lines at the southern end of the site has been removed and the area is occupied by a garden centre and a garage; see Figure 5E. A large pond was also present at the eastern end of the flood bund at approximately Ch. 0+780m to Ch. 0+800m. The shingle bars are on the southern edge of the River Dovey, causing narrowing of the channel at this point (Ch. 0+880). There were no other significant changes to the site.
