# REPORT OF INSPECTION 2024/5

by Joint Inspection Team for Building Safety (JIT)

**GARTH COURT,  
Abbey Road, Llandudno. LL30 2HF**

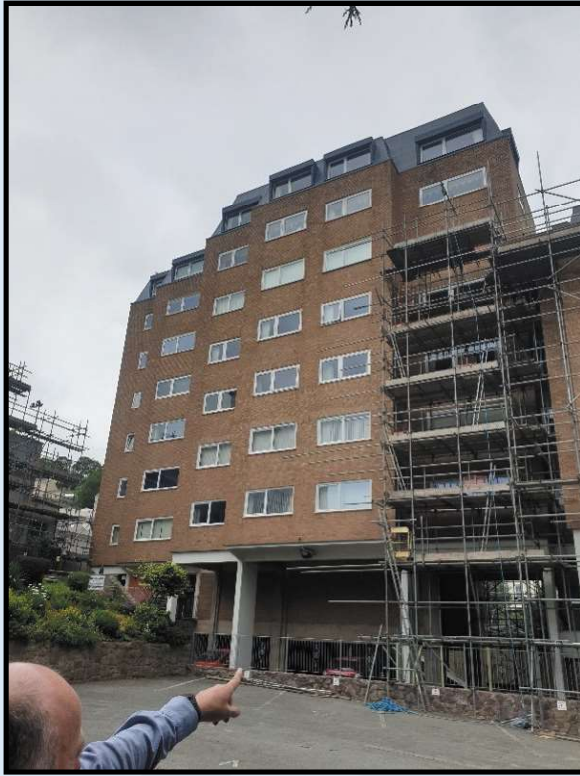
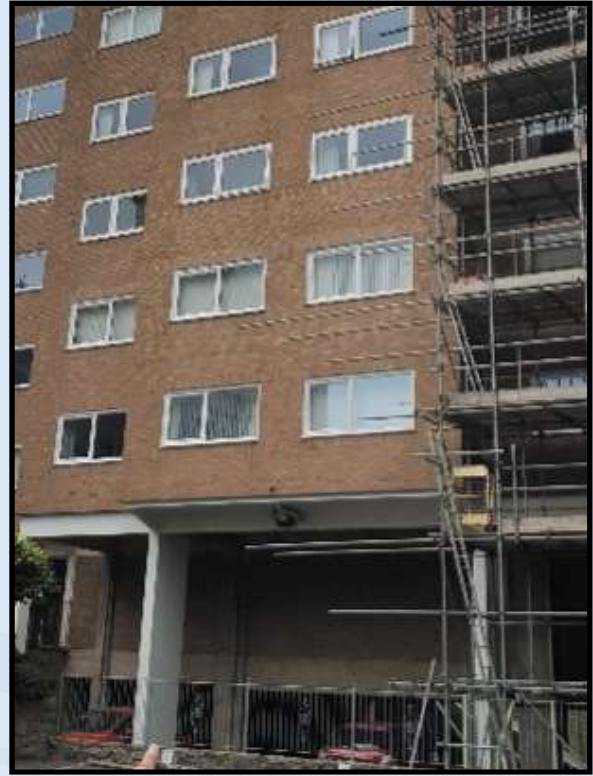
#### EXTERNAL FACADES

- o A visual examination of the block and of available documents established the external elements of the building consisted of:
- o Masonry 65%
- o Glazing with uPVC frames (estimated at 20%)
- o Flat roofing and wall systems (estimated at 15%)
