## Bishton-Llanmartin Overbridge M4 23A-24 51 Principal Inspection Report 2025/26

Service Provider/Consultant Name: Arcadis

Service Provider/Consultant Project Number: 30286543

T-WHIS Number: CTI/005

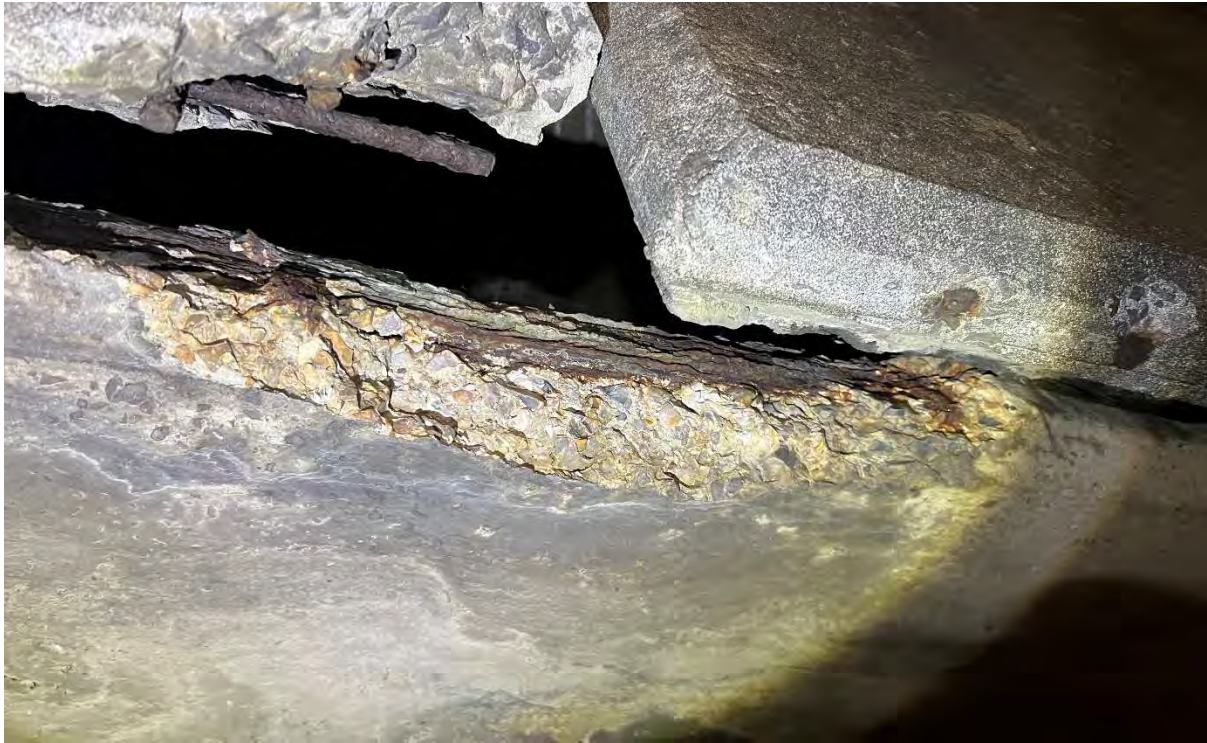
Photograph 9 - Span 2 W/B, beam 1. Area of spalling with exposed reinforcement exhibiting moderate corrosion, measuring 800x80x55mm.

| DEFECT REFERENCE TABLE | |
|---|---|
| 3 | Area of spalling with exposed reinforcement exhibiting minor corrosion, 800x80x55mm (Photo 9) |

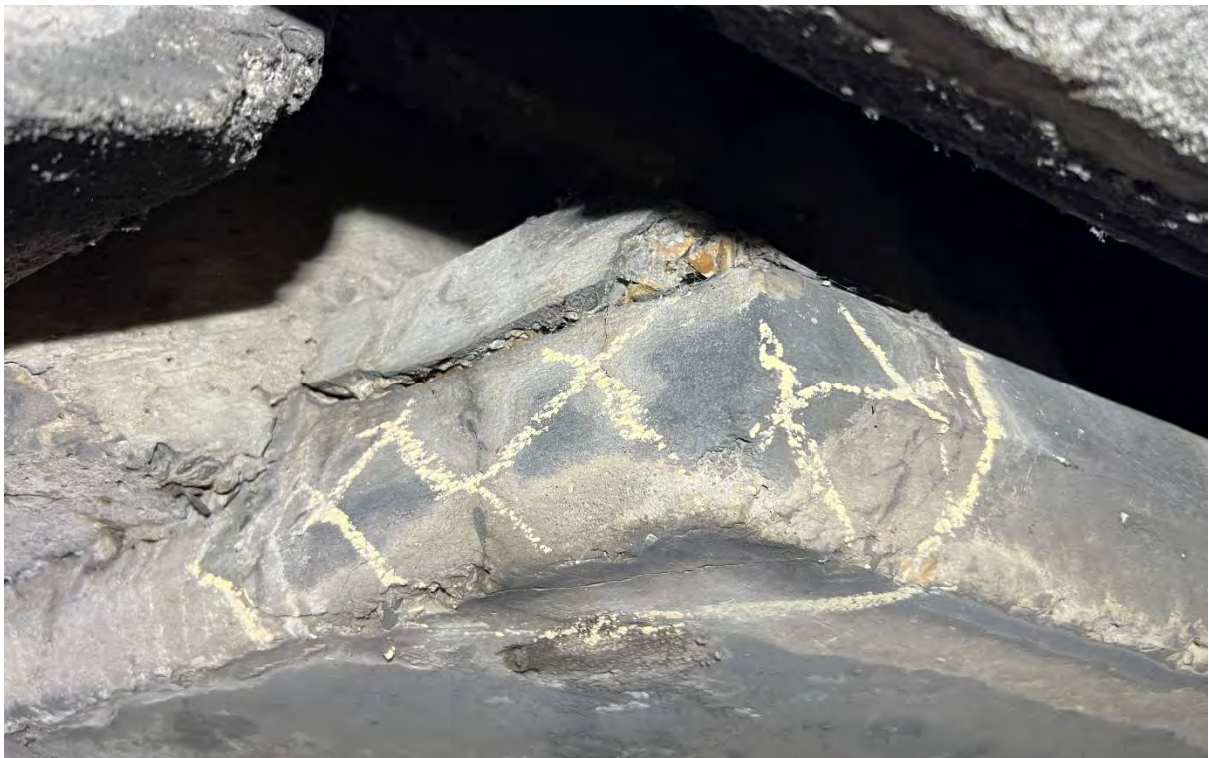
Photograph 24 - Span 2 E/B, beam 1. Area of delamination to end of beam, measuring 200x150mm.

| DEFECT REFERENCE TABLE | |
|---|---|
| 18 | Area of delamination at end of beam, 200x150mm (Photo 24) |

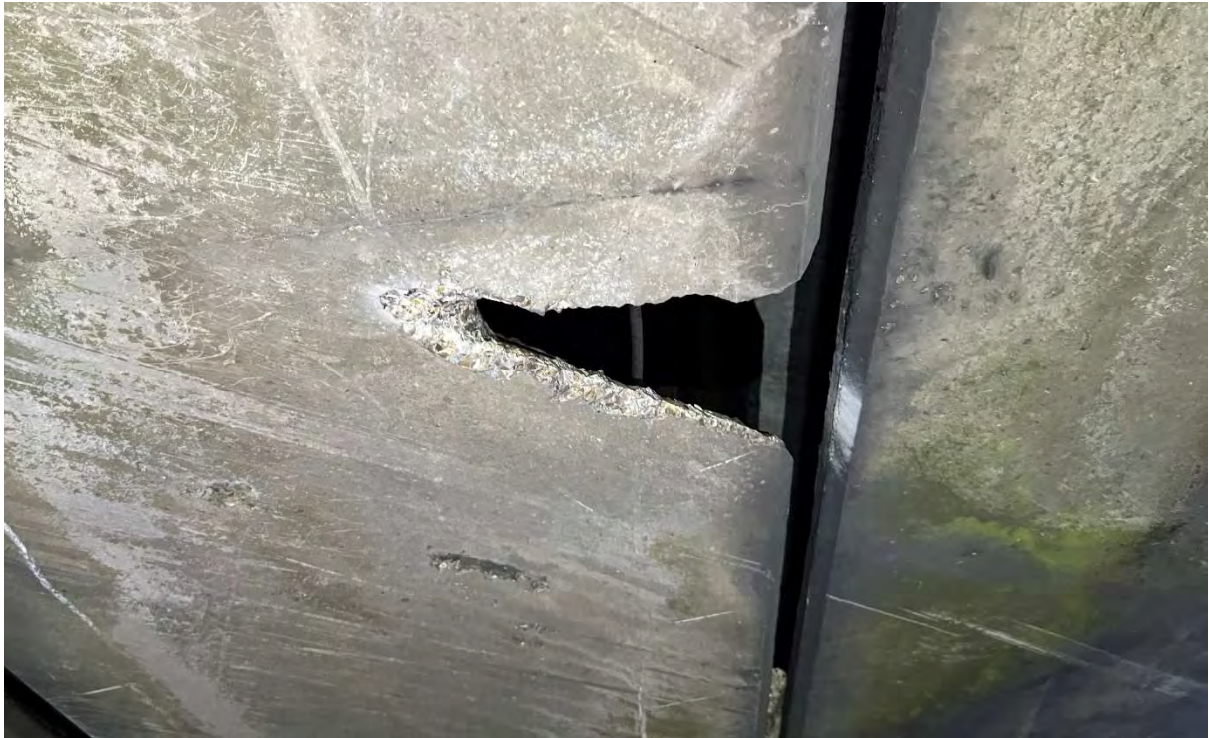
Photograph 27 - Span 2 E/B, beam 2. Area of spalling with exposed reinforcement exhibiting minor corrosion, measuring 500x300x100mm.

| 21 | Area of spalling with exposed reinforcement exhibiting minor corrosion, 500x300x100mm (Photo 27) |

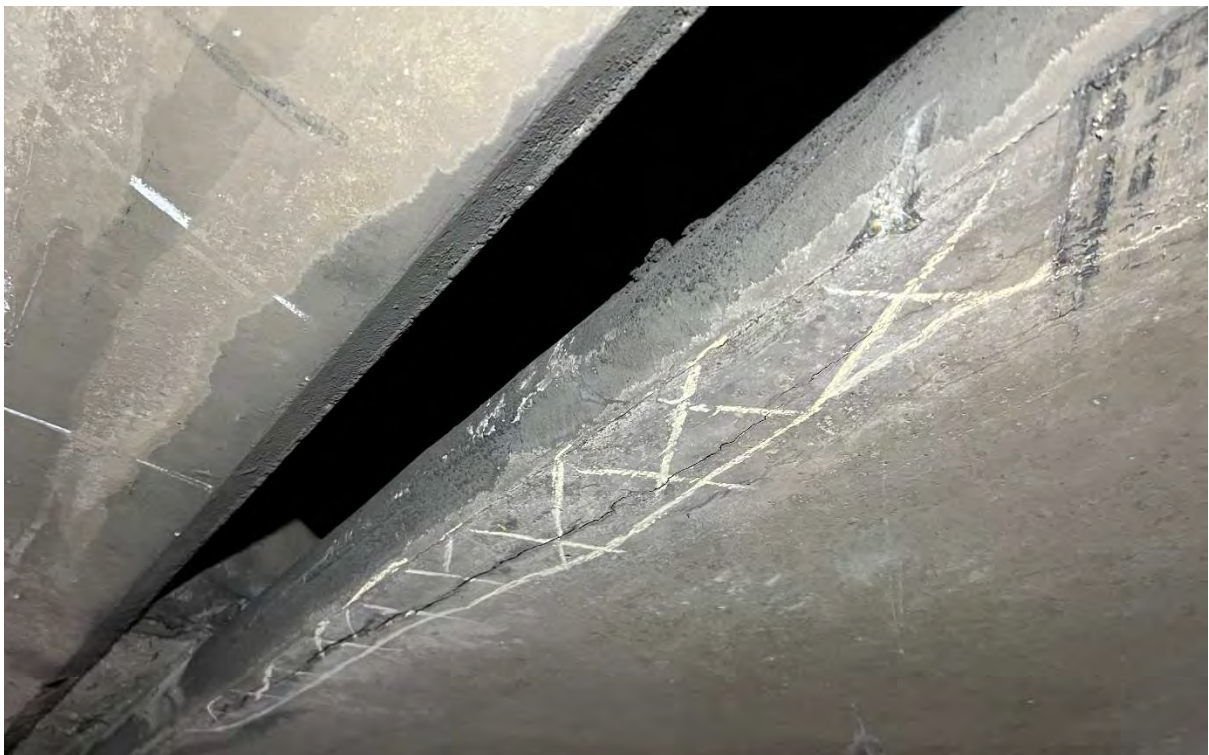
Photograph 32 - Span 2 E/B, beam 3. Area of delamination, measuring 1100x100mm.

| 26 | Area of delamination, measuring 1100x100mm (Photo 32) |

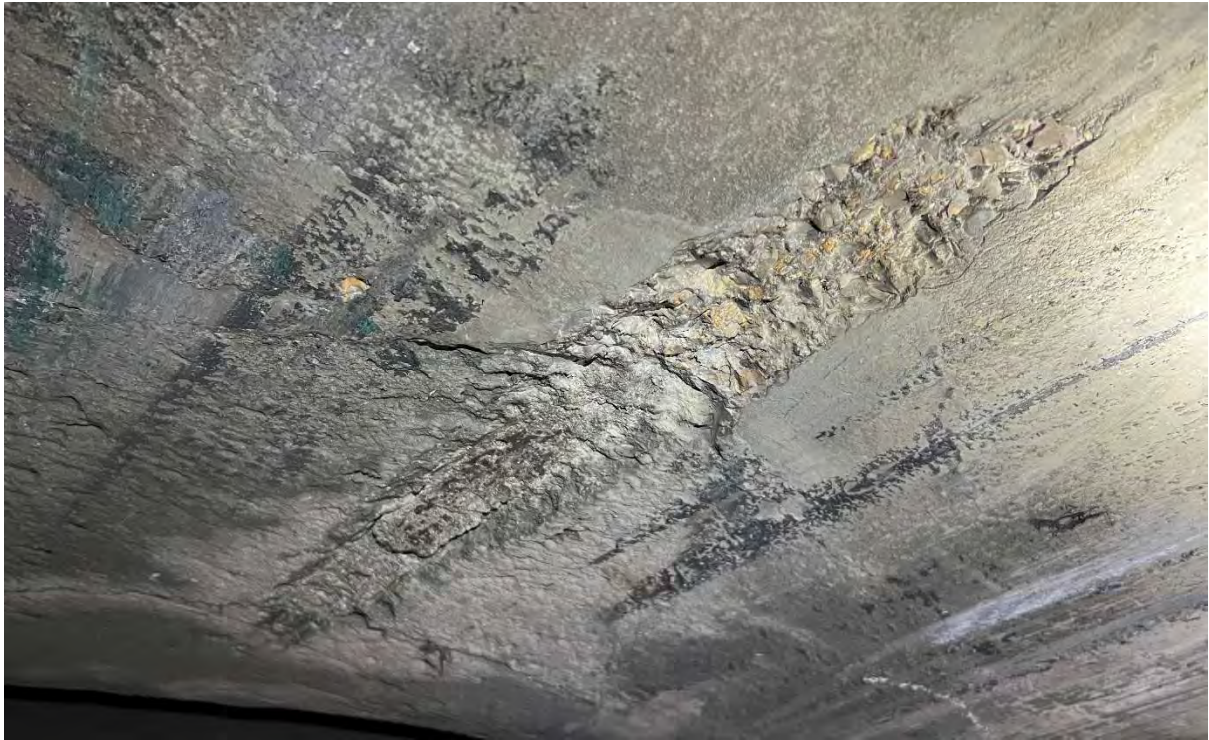
Photograph 39 - Span 2 E/B, beam 6. Area of spalling, measuring 400x100x10mm.

| 33 | Area of spalling, measuring 400x100x100mm (Photo 39) |

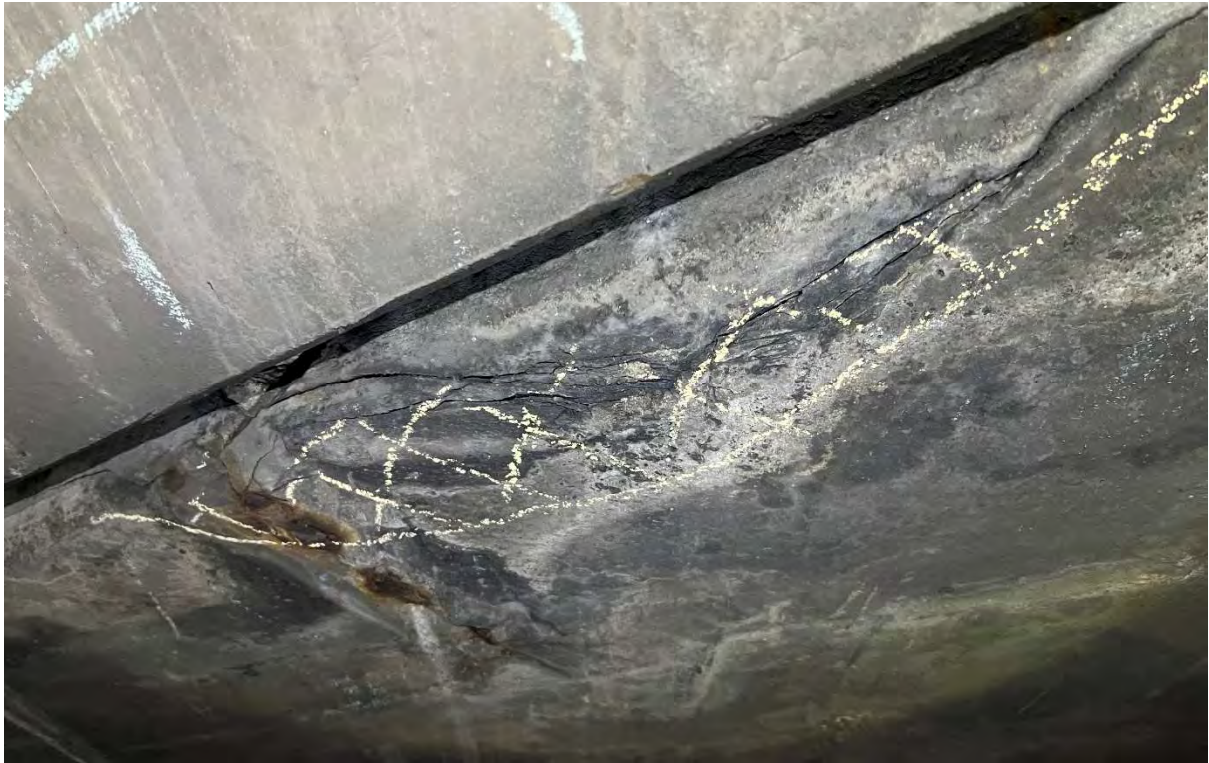
Photograph 43 - Span 2 E/B, beam 8. Area of delamination, measuring 800x200mm.

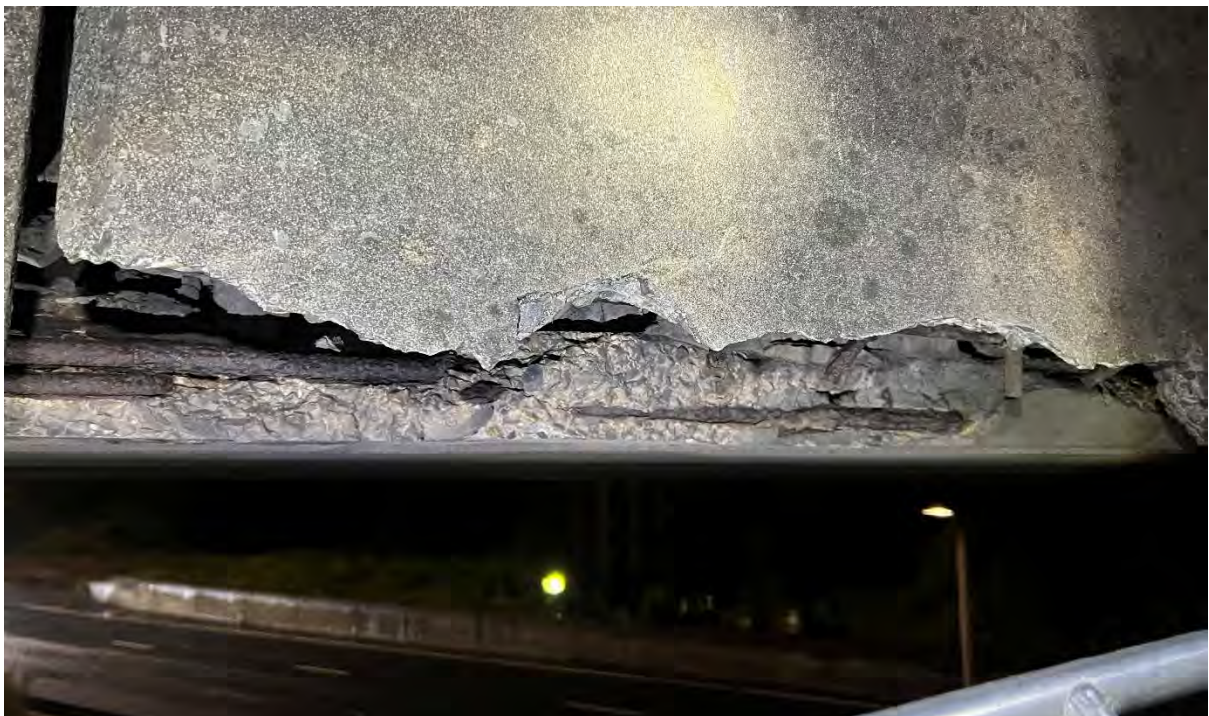
Photograph 54 - Span 2 W/B, east parapet fascia panel. Area of spalling with exposed reinforcement exhibiting minor corrosion, measuring 900x75x75mm.

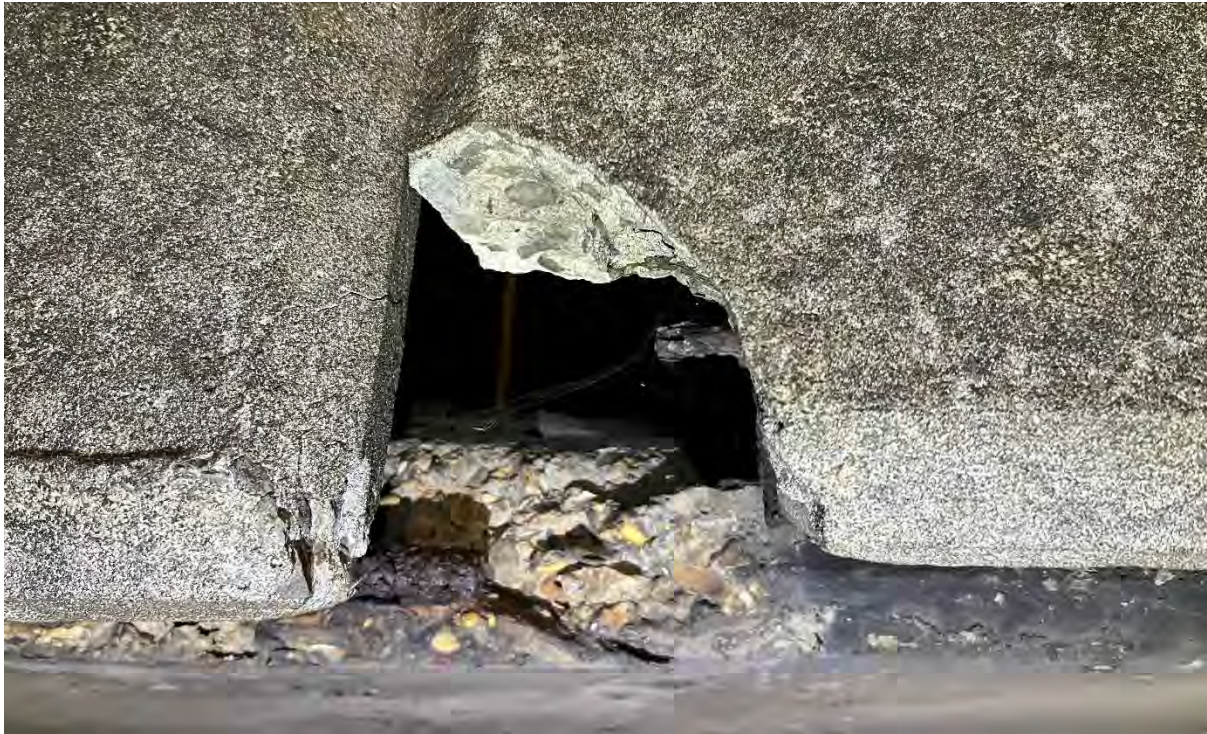
Photograph 57 - Span 2 W/B, west parapet fascia panel. Area of spalling with exposed reinforcement exhibiting minor corrosion, measuring 100x120x75mm.

| 50 | Area of spalling with exposed reinforcement exhibiting minor corrosion, 100x120x75mm (Photo 57) |

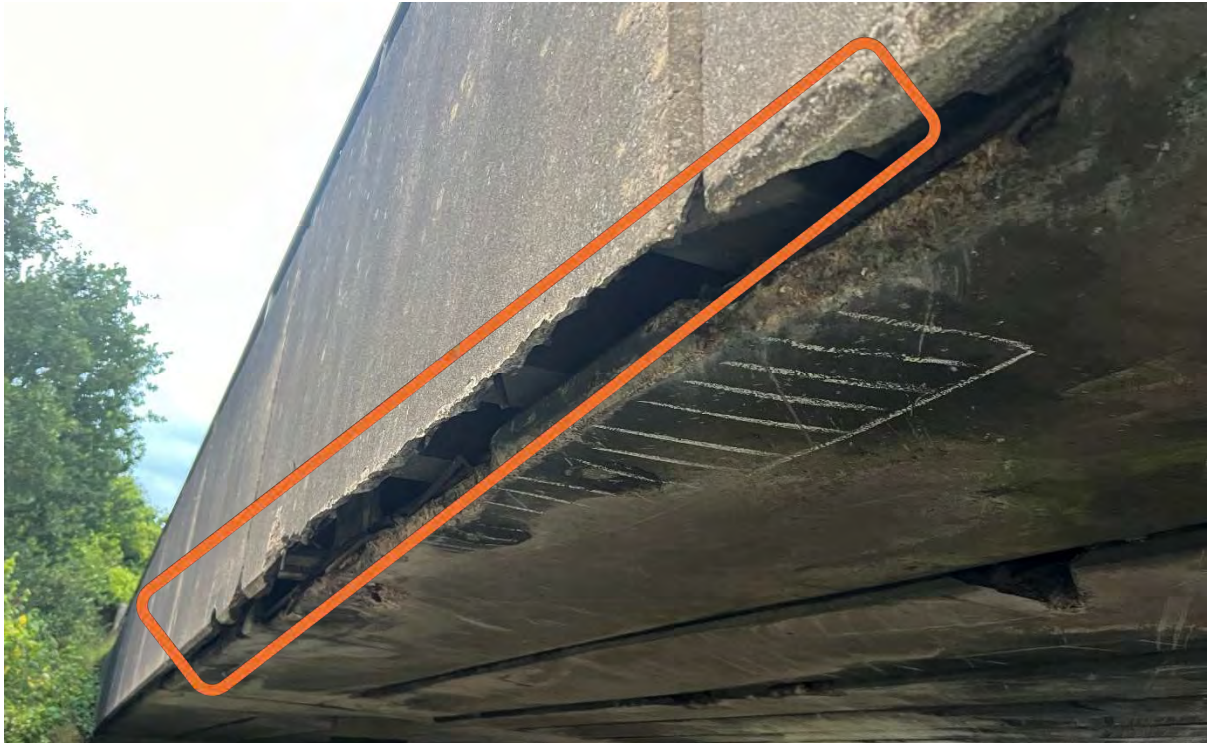
Photograph 59 - Span 2 E/B, west parapet fascia panel. Three areas of spalling exposing reinforcement exhibiting minor corrosion, measuring 1200x100x75mm, 2500x100x75mm, and 300x75x75mm.

| 52 | Three areas of spalling exposing reinforcement exhibiting minor corrosion (Photo 59) |

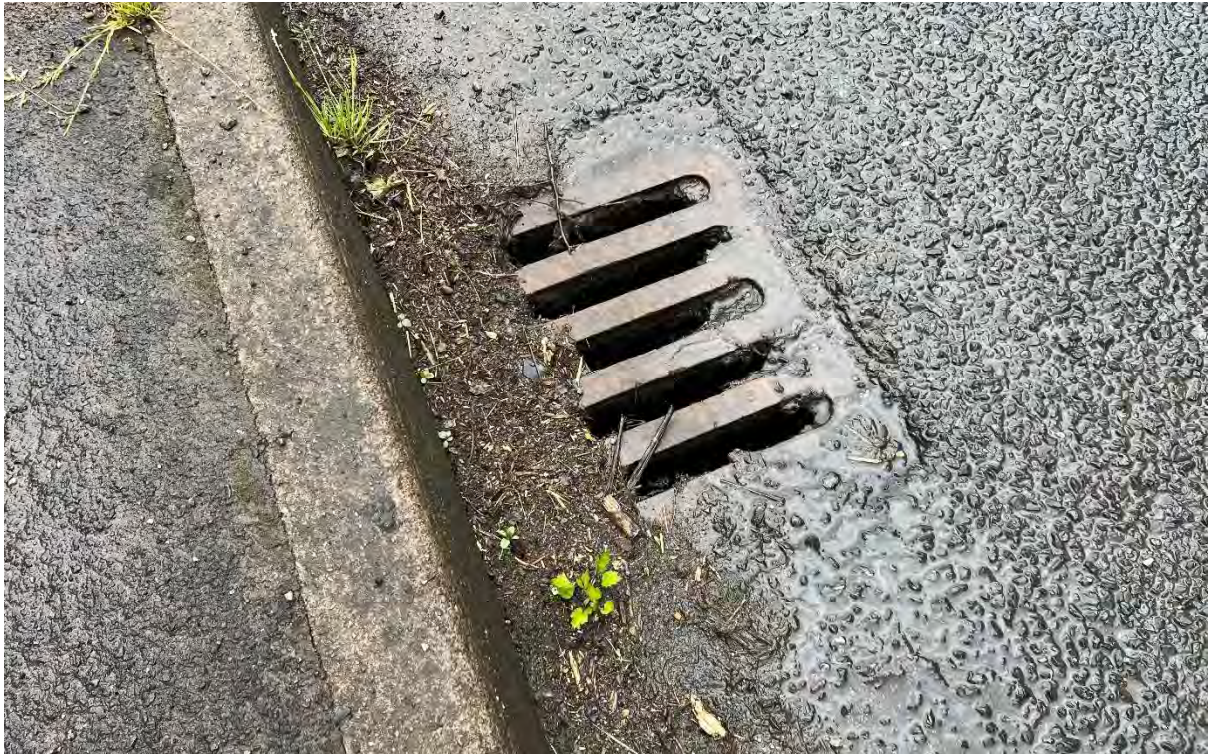
Photograph 71 – Drainage gully partially blocked by vegetation and debris.

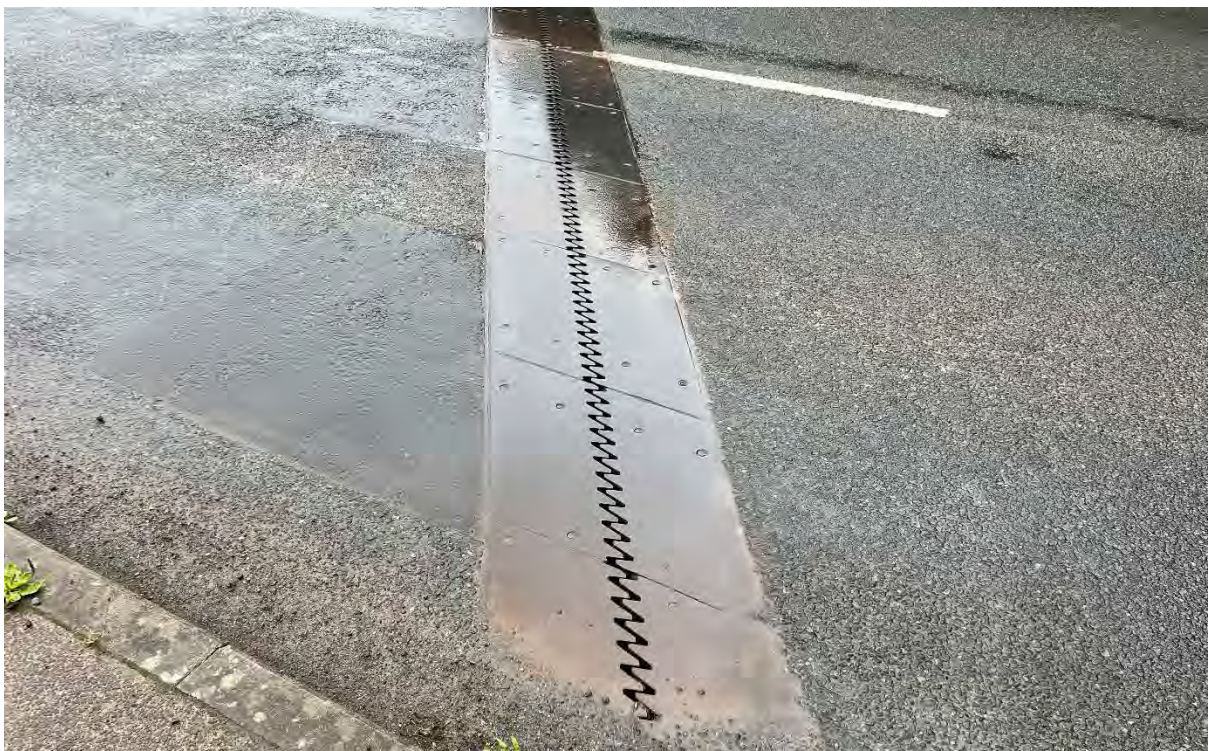
Photograph 72 - Span 1. South expansion joint.

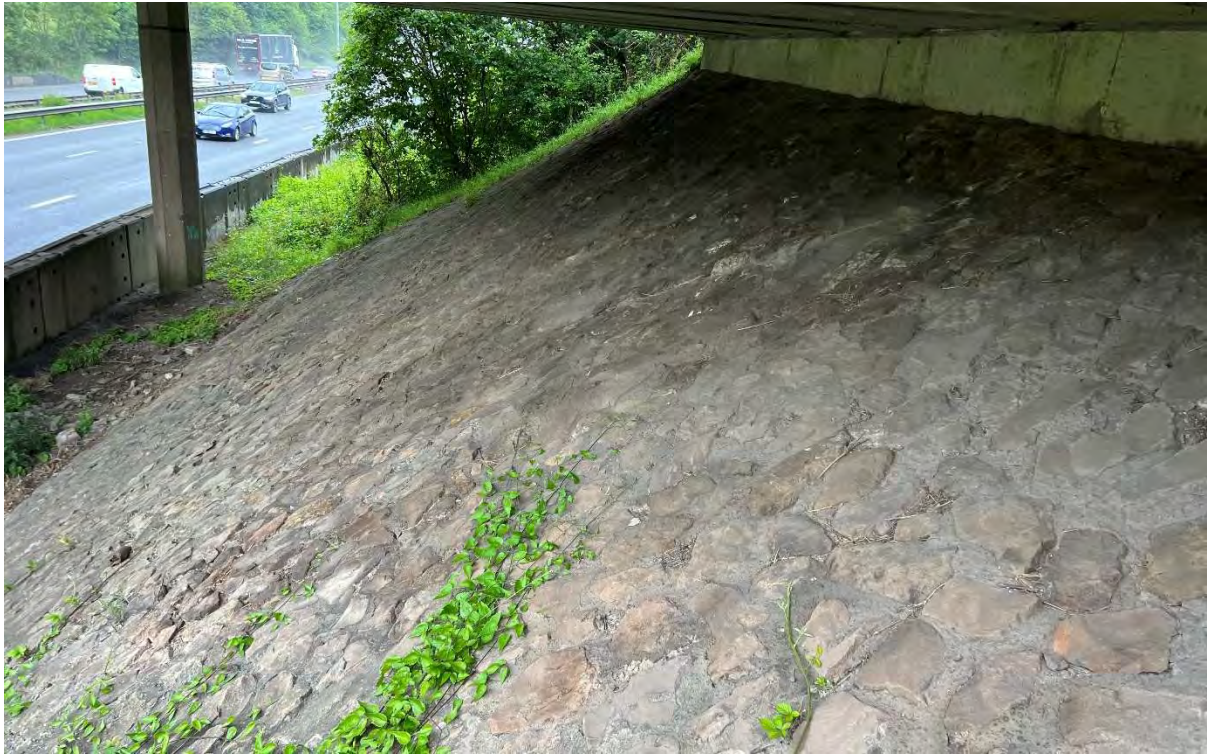
Photograph 85 - Span 3 - Minor vegetation growth to north revetment.

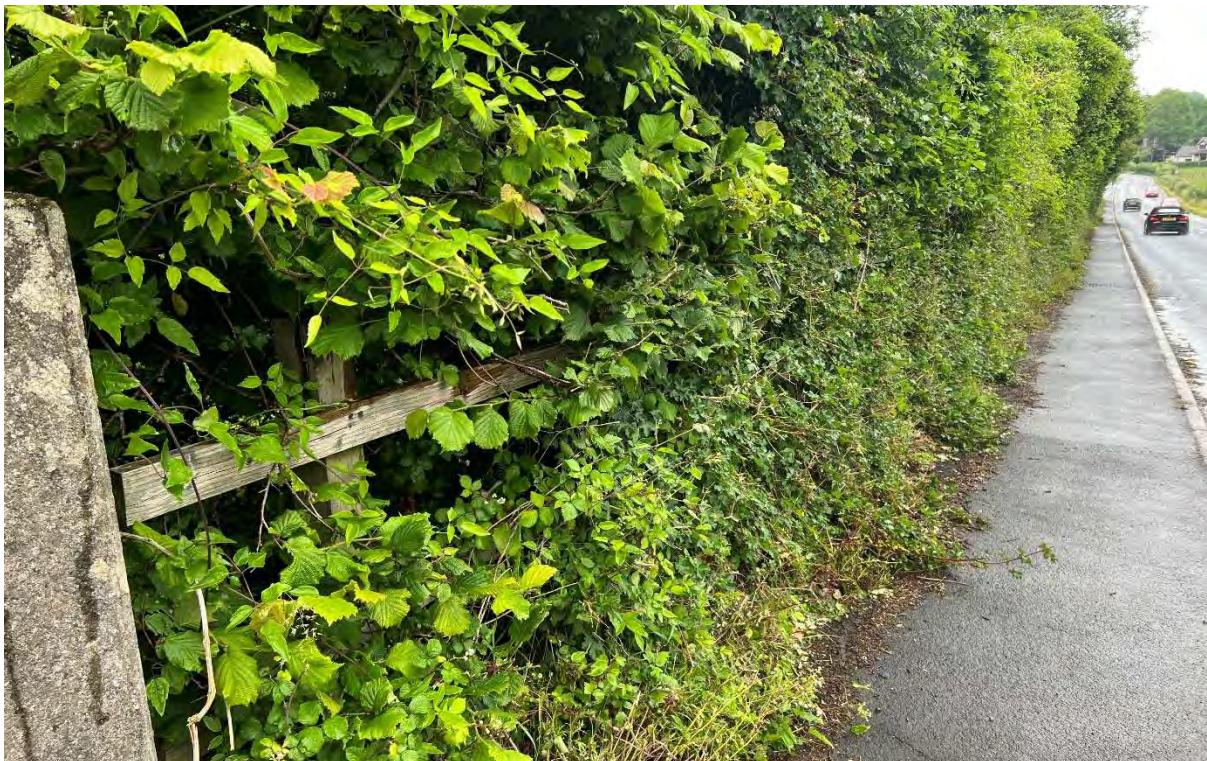
Photograph 86 - Dense vegetation growth to spans 1 & 3 approach fencing.

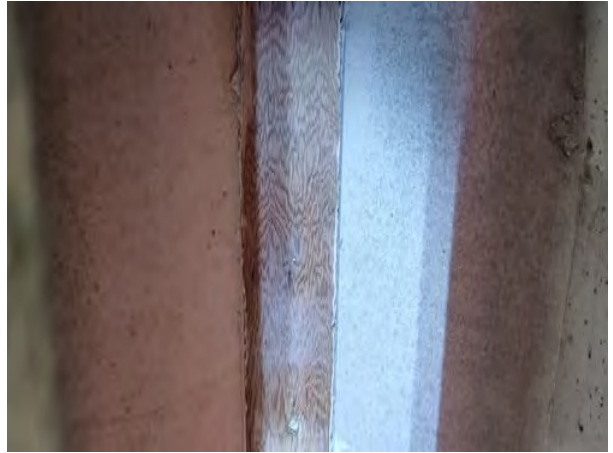
| Asset | Structure | Inspection Point | Component Examined | Sample No. | Findings Source | Component Material Description | Fibre Type | Material Score | Extent | Action Level | Recommended Initial Control Actions | Photograph |
|---|---|---|---|---|---|---|---|---|---|---|---|---|
| M4 23a - 24 51 Bishton Llanmartin Waltwood Road | Bridge | substructure | Sealant to timber permanent shuttering between deck beam gap | N/A | Onsite Findings | Asbestos-containing Mastic | Presume Chrysotile | 3 | Extensive | B | Manage | |

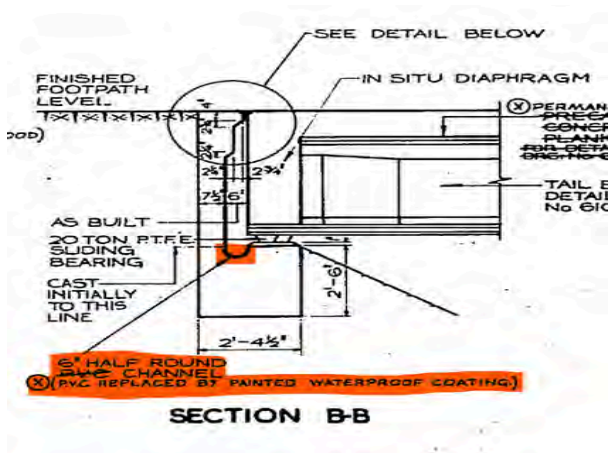
| Asset | Structure | Inspection Point | Component Examined | Sample No. | Findings Source | Component Material Description | Fibre Type | Material Score | Extent | Action Level | Recommended Initial Control Actions | Photograph |
|---|---|---|---|---|---|---|---|---|---|---|---|---|
| M4 23a - 24 51 Bishton Llanmartin Waltwood Road | Bridge | substructure | Drainage Channels in abutments | N/A | Desktop Findings | Asbestos-containing Bitumous paint replacing PVC | Chrysotile | 3 | Extensive | B | Manage | |

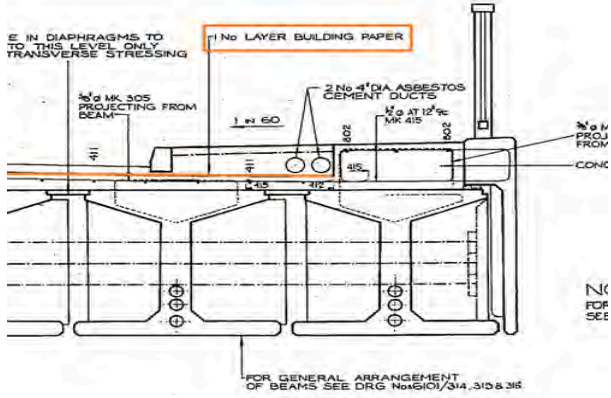
| Asset | Structure | Inspection Point | Component Examined | Sample No. | Findings Source | Component Material Description | Fibre Type | Material Score | Extent | Action Level | Recommended Initial Control Actions | Photograph |
|---|---|---|---|---|---|---|---|---|---|---|---|---|
| M4 23a - 24 51<br>Bishton<br>Llanmartin<br>Waltwood Road | Bridge | superstructure | Building paper beneath verges | N/A | Desktop Findings | Asbestos-containing Paper | Chrysotile | 5 | Extensive | B | Manage | |

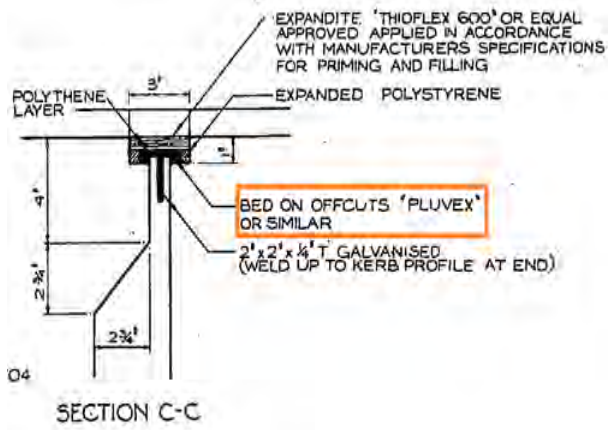
| Asset | Structure | Inspection Point | Component Examined | Sample No. | Findings Source | Component Material Description | Fibre Type | Material Score | Extent | Action Level | Recommended Initial Control Actions | Photograph |
|---|---|---|---|---|---|---|---|---|---|---|---|---|
| M4 23a - 24 51<br>Bishton<br>Llanmartin<br>Waltwood Road | Bridge | superstructure | Expansion joint in footpaths bed on offcuts | N/A | Desktop Findings | Asbestos-containing Pluvex or similar | Chrysotile | 3 | Extensive | B | Manage | |

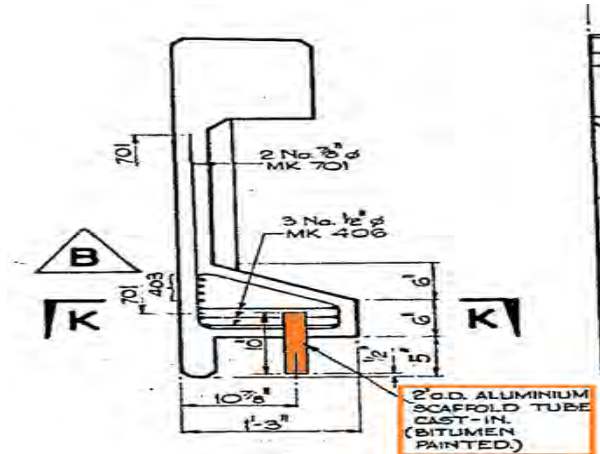
| Asset | Structure | Inspection Point | Component Examined | Sample No. | Findings Source | Component Material Description | Fibre Type | Material Score | Extent | Action Level | Recommended Initial Control Actions | Photograph |
|---|---|---|---|---|---|---|---|---|---|---|---|---|
| M4 23a - 24 51 Bishton Llanmartin Waltwood Road | Bridge | superstructure | Coating to Aluminium scaffolding tube fixings | N/A | Desktop Findings | Asbestos-containing bitumen paint | Chrysotile | 3 | Extensive | B | Manage | |

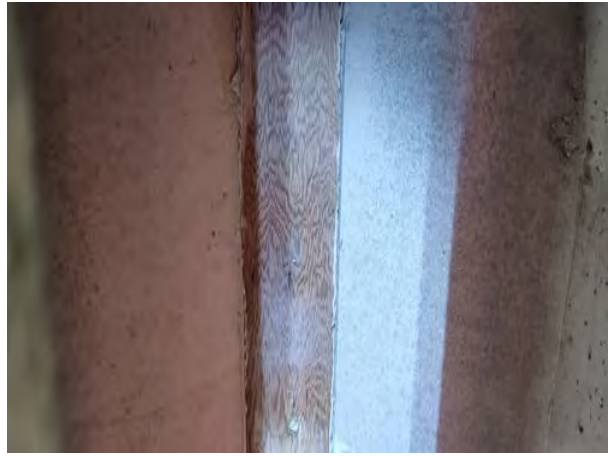
| Asset | Structure | Inspection Point | Component Examined | Accessibility | Access Comments | Photograph |
|---|---|---|---|---|---|---|
| M4 23a - 24 51 Bishton<br>Llanmartin Waltwood Road | Bridge | substructure | Sealant to timber permanent shuttering between deck beam gap | Limited Access | Could not be sampled due to reasons of height | |

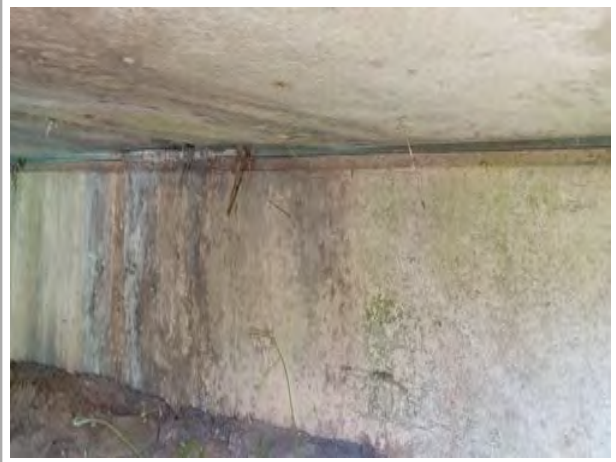
| Asset | Structure | Inspection Point | Component Examined | Accessibility | Access Comments | Photograph |
|---|---|---|---|---|---|---|
| M4 23a - 24 51 Bishton<br>Llanmartin Waltwood Road | Bridge | substructure | Sealant to south joint between deck beams and Abutment | Limited Access | Physically restricted space | |
| | | | | 🗨 Sample taken from accessible areas where material was present. No asbestos detected in sample. | | |

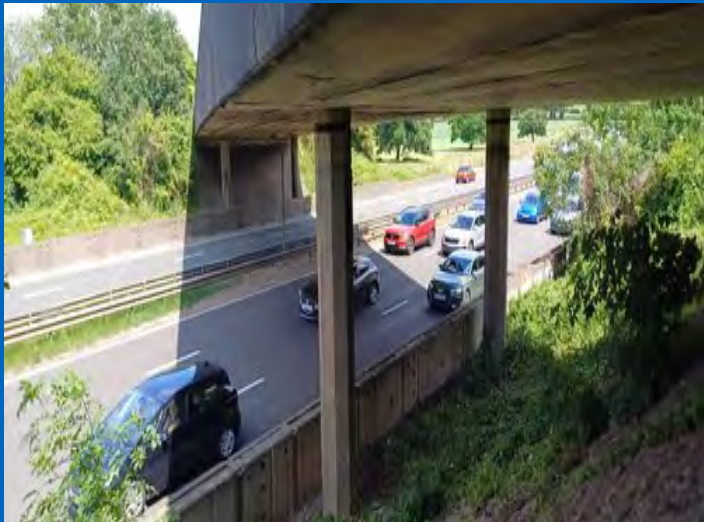
⚠ Limited Access: unable to access within deck beam gap

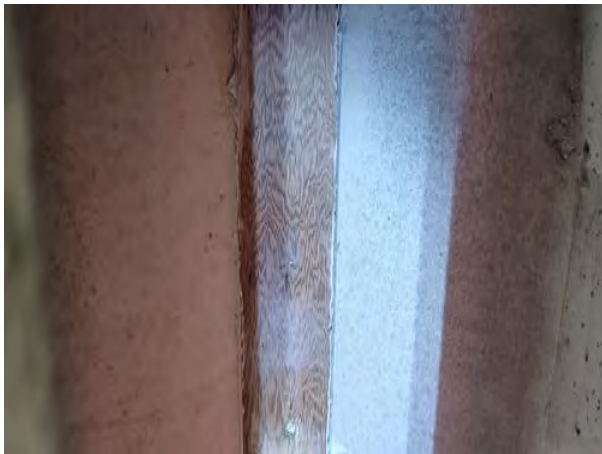
| Asset: M4 23a - 24 51 Bishton Llanmartin Waltwood Road | | | | | Structure: Bridge | | | Inspection Point: substructure | | | | |
|---|---|---|---|---|---|---|---|---|---|---|---|---|
| Sealant to timber permanent shuttering between deck beam gap | Asbestos-containing Mastic | Presume | N/A | Onsite Findings | Extensive | 1 | 1 | 0 | Presume Chrysotile | 3 | Low | |
| <div> Limited Access: Could not be sampled due to reasons of height</div> | | | | | | | | | | | | |
| <div>B</div> | | | | | | | | | | | | |

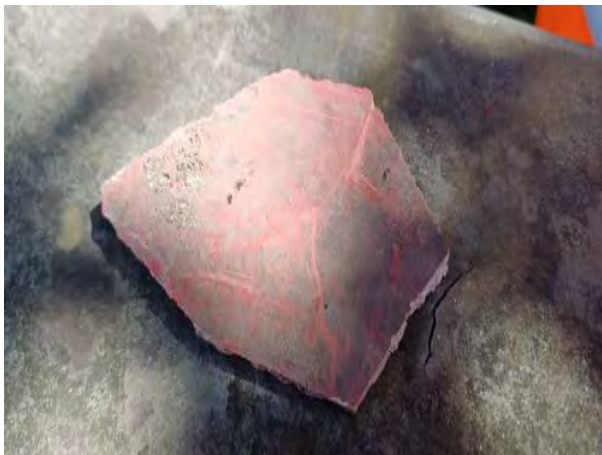
| Asset: M4 23a - 24 51 Bishton Llanmartin Waltwood Road | | | | | Structure: Bridge | | | Inspection Point: substructure | | | | |
|---|---|---|---|---|---|---|---|---|---|---|---|---|
| Red coated cement debris to Revetment | Cement | Sample | 681715-4 | Onsite Findings | N/A | N/A | N/A | N/A | N/A | N/A | | |
| No asbestos detected in sample | | | | | | | | | | | | NAD |

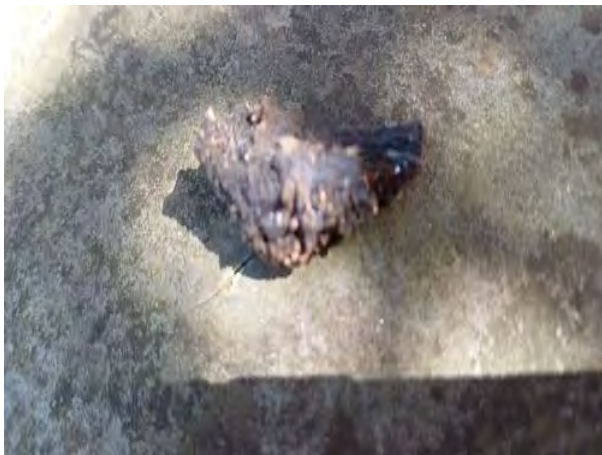
| Asset: M4 23a - 24 51 Bishton Llanmartin Waltwood Road | | | | | Structure: Bridge | | | | | Inspection Point: substructure | | |
|---|---|---|---|---|---|---|---|---|---|---|---|---|
| Sealant between abutment and deck joint | Bituminous product | Sample | 681715-5 | Onsite Findings | N/A | N/A | N/A | N/A | N/A | N/A | | |
| <p> No asbestos detected in sample</p> | | | | | | | | | | | | NAD |

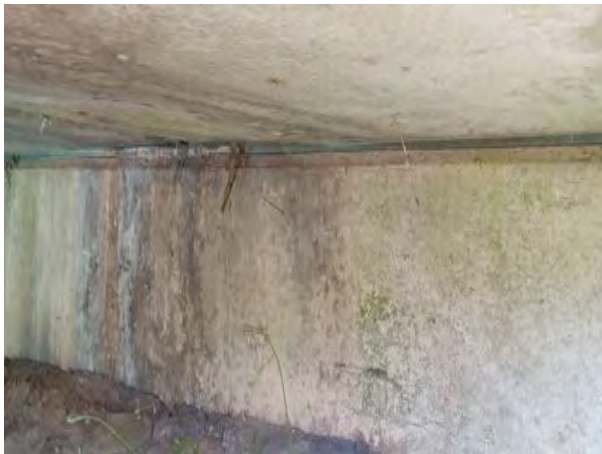
| Asset: M4 23a - 24 51 Bishton Llanmartin Waltwood Road | | | | | | | | | Structure: Bridge | | Inspection Point: substructure | |
|---|---|---|---|---|---|---|---|---|---|---|---|---|
| Sealant to south joint between deck beams and Abutment | Mastic | Sample | 681715-6 | Onsite Findings | N/A | N/A | N/A | N/A | N/A | N/A | | |
| <div>⛔ Limited Access: Physically restricted space 🗨️ Sample taken from accessible areas where material was present. No asbestos detected in sample.</div> | | | | | | | | | | | | NAD |

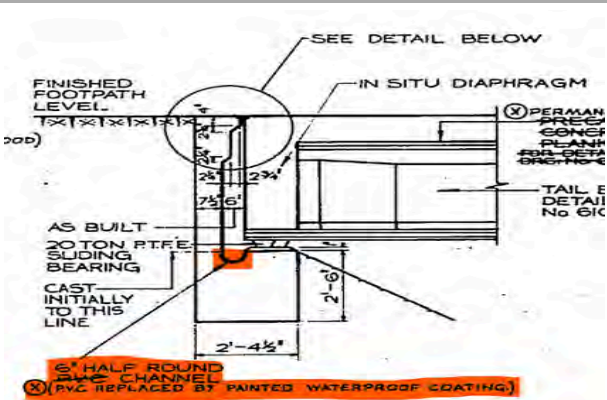
| Component Examined | Component Material Description | Strategy | Sample No. | Findings Source | Extent | Product Score | Material Condition | Surface Treatment | Fibre Id. | Material Score | Accessibility Score | Action Level |
|---|---|---|---|---|---|---|---|---|---|---|---|---|
| Drainage Channels in abutments | Asbestos-containing Bituminous paint replacing PVC | Desktop Finding | N/A | Desktop Findings | Extensive | 1 | 1 | 0 | Chrysotile | 3 | Low | |
| <div><div></div> Desktop study identifies item is asbestos containing but could not be sampled due to being a buried material and is therefore presumed to contain asbestos.</div> | | | | | | | | | | | | |

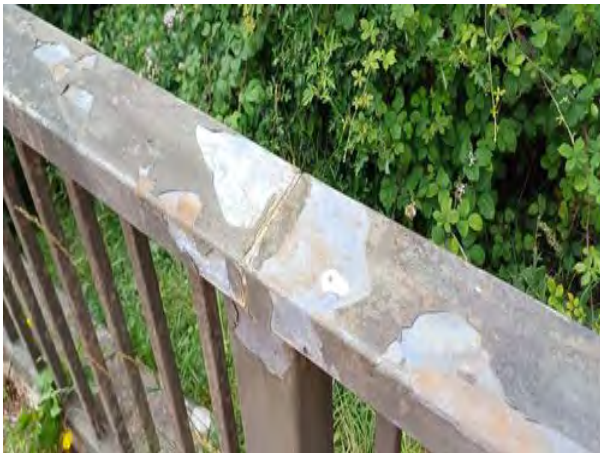
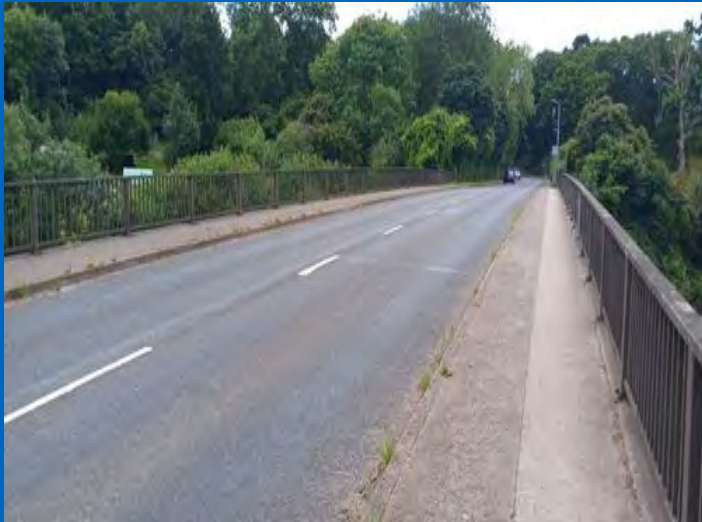
| Work Required | | | |
|---|---|---|---|
| 14 | RM – ROUTINE MAINTENANCE<br>(additional to CS 450) | 1 - Insignificant | £1 |
| 18 | RM – ROUTINE MAINTENANCE<br>(additional to CS 450) | 1 - Insignificant | £1 |

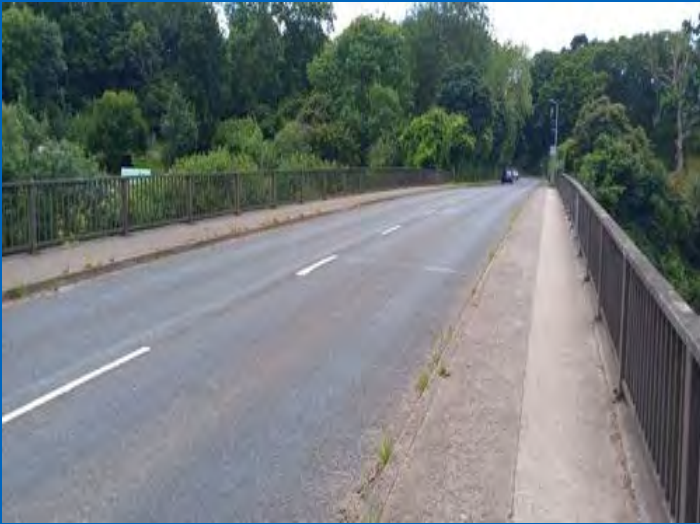
| Asset: M4 23a - 24 51 Bishton Llanmartin Waltwood Road | | | | | | | Structure: Bridge | | | Inspection Point: superstructure | | |
|---|---|---|---|---|---|---|---|---|---|---|---|---|
| Sealant to concrete section of walkway | Mastic | Sample | 681715-2 | Onsite Findings | N/A | N/A | N/A | N/A | N/A | N/A | | <div><div>NAD</div></div> <div><div>NAD</div></div> |

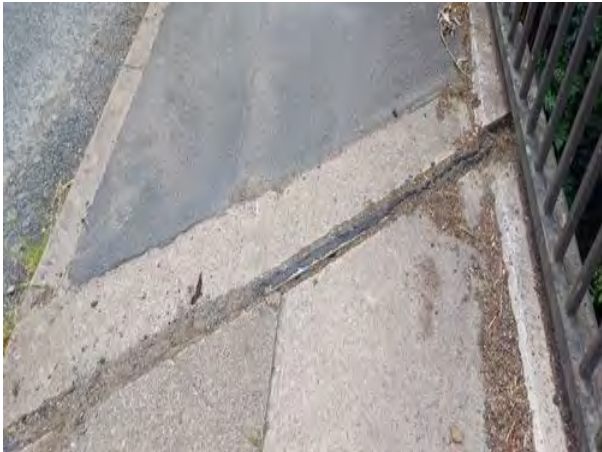
| Asset: M4 23a - 24 51 Bishton Llanmartin Waltwood Road | | | | | | Structure: Bridge | | | Inspection Point: superstructure | | | |
|---|---|---|---|---|---|---|---|---|---|---|---|---|
| Expansion Joint to walkway | Bituminous product | Sample | 681715-3 | Onsite Findings | N/A | N/A | N/A | N/A | N/A | N/A | | |
| <div> No asbestos detected in sample</div> | | | | | | | | | | | | <div>NAD</div> |

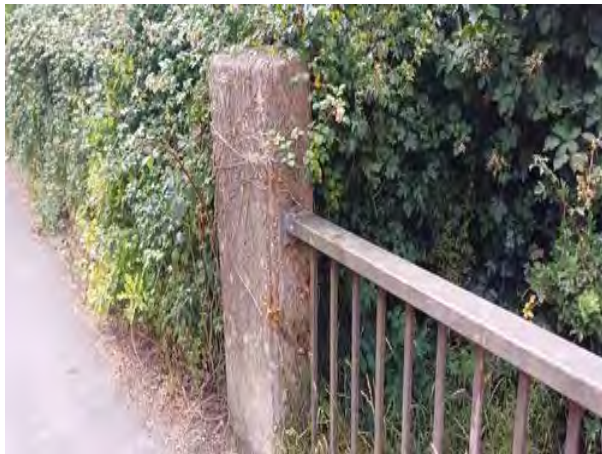
| Asset: M4 23a - 24 51 Bishton Llanmartin Waltwood Road | | | | | | | | | | Structure: Bridge | | Inspection Point: superstructure | |
|---|---|---|---|---|---|---|---|---|---|---|---|---|--|
| Parapet end columns | Concrete | No Asbestos Suspected | N/A | Onsite Findings | N/A | N/A | N/A | N/A | N/A | N/A | N/A | | |
| <div> Item is a known non-asbestos containing material.</div> | | | | | | | | | | | | | |

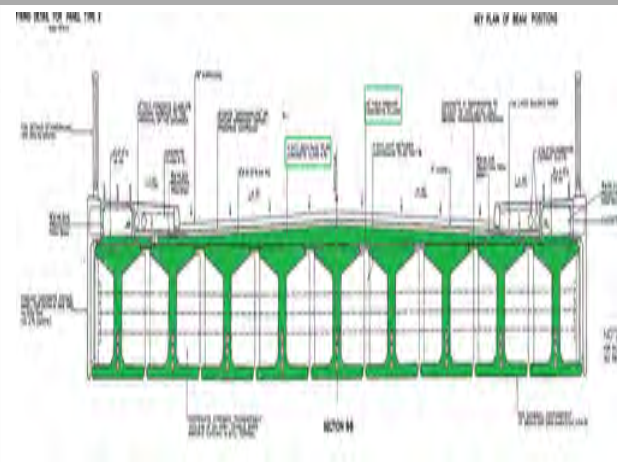
| Component Examined | Component Material Description | Strategy | Sample No. | Findings Source | Extent | Product Score | Material Condition | Surface Treatment | Fibre Id. | Material Score | Accessibility Score | Action Level |
|---|---|---|---|---|---|---|---|---|---|---|---|---|
| Deck | Concrete 'I' beams and planks topped with slab | NO: Desktop Finding | N/A | Desktop Findings | N/A | N/A | N/A | N/A | N/A | N/A | N/A | <div></div> |
| <div> Item is a known non-asbestos containing material</div> | | | | | | | | | | | | |

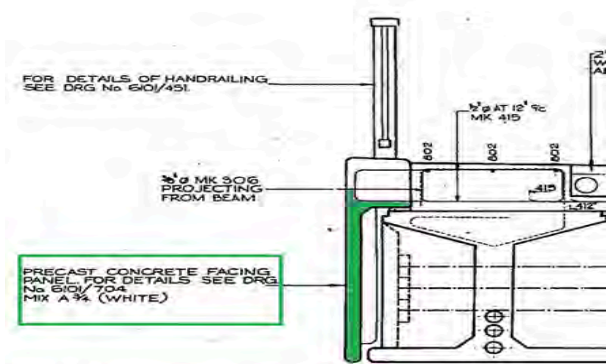
| Asset: M4 23a - 24 51 Bishton Llanmartin Waltwood Road | | | | | | | | Structure: Bridge | | Inspection Point: superstructure | | | |
|---|---|---|---|---|---|---|---|---|---|---|---|---|--|
| Facing panels | Precast Concrete | NO: Desktop Finding | N/A | Desktop Findings | N/A | N/A | N/A | N/A | N/A | N/A | N/A | | |
| <div> Item is a known non-asbestos containing material.</div> | | | | | | | | | | | | | |

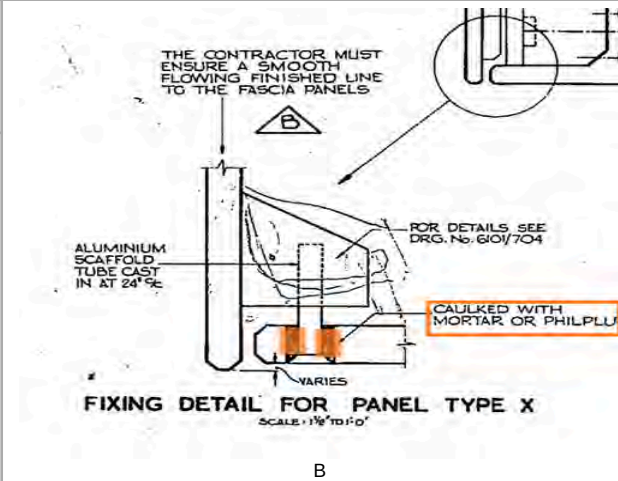
| Asset: M4 23a - 24 51 Bishton Llanmartin Waltwood Road | | | | | | | | | | | | | Structure: Bridge | | Inspection Point: superstructure | |
|---|---|---|---|---|---|---|---|---|---|---|---|---|---|--|---|--|
| Fixings for facing panels | Asbestos-containing Aluminium scaffold tube caulked with mortar or Philplug | Desktop Finding | N/A | Desktop Findings | Extensive | 1 | 1 | 0 | Chrysotile | 3 | Low | | | | | |
| <p> Philplug is known to contain asbestos. Element is presumed to contain asbestos containing material until tested otherwise.</p> | | | | | | | | | | | | | | | | |

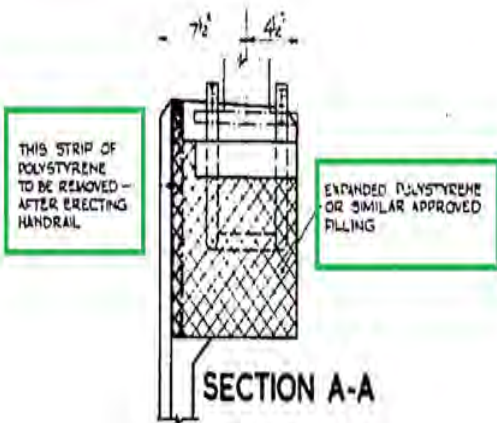
| Asset: M4 23a - 24 51 Bishton Llanmartin Waltwood Road | | | | | | | | | | Structure: Bridge | | Inspection Point: superstructure | |
|---|---|---|---|---|---|---|---|---|---|---|---|---|--|
| Filler behind facing panels | Expanded polystyrene | NO: Desktop Finding | N/A | Desktop Findings | N/A | N/A | N/A | N/A | N/A | N/A | N/A | | |
| Item is a known non-asbestos containing material. | | | | | | | | | | | | | |

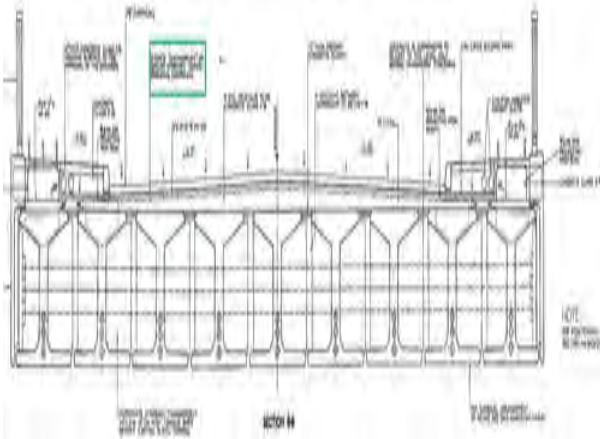
| Asset: M4 23a - 24 51 Bishton Llanmartin Waltwood Road | | | | | | Structure: Bridge | | | Inspection Point: superstructure | | | |
|---|---|---|---|---|---|---|---|---|---|---|---|---|
| Waterproofing to deck | Synthaprufe replaced with Dew Pitchmastic 2005 | NO: Desktop Finding | N/A | Desktop Findings | N/A | N/A | N/A | N/A | N/A | N/A | N/A | |
| Item is a known non-asbestos containing material. | | | | | | | | | | | | |

| Location Name | Component Name / Description | Findings Source | Survey Type | Sample Ref | Positive for ACM's | Material Assessment Score | Rating for Disturbance During Maintenance | Actions Necessary | Grounds for presumption (Section 2) or Grounds for presumed non ACM (section 3) |
|---|---|---|---|---|---|---|---|---|---|
| M4 23a - 24 51 Bishton<br>Llanmartin Waltwood Road - superstructure | Waterproofing to deck - Synthaprufe replaced with Dew Pitchmastic 2005 | Desktop Findings | M | N/A | N/A | N/A | N/A | A | Item is a known non-asbestos containing material. |

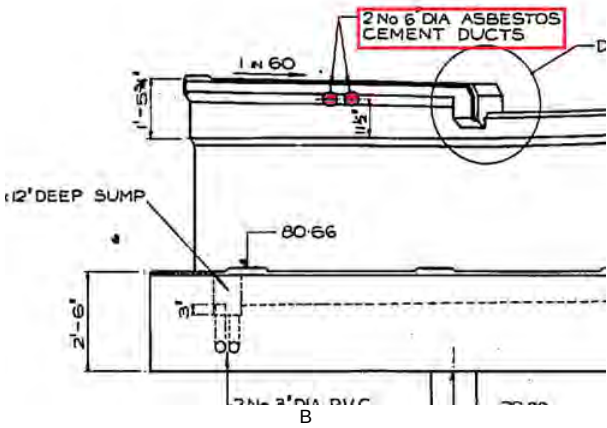
| Component Examined | Component Material Description | Strategy | Sample No. | Findings Source | Extent | Product Score | Material Condition | Surface Treatment | Fibre Id. | Material Score | Accessibility Score | Action Level |
|---|---|---|---|---|---|---|---|---|---|---|---|---|
| Ducts in verges | Asbestos-containing 4" asbestos cement | Desktop Finding | N/A | Desktop Findings | 2 No. | 1 | 1 | 1 | Crocidolite | 6 | Low | |
| <div> Desktop study identifies item is asbestos containing but could not be sampled due to being a buried material and is therefore presumed to contain asbestos.</div> | | | | | | | | | | | | |

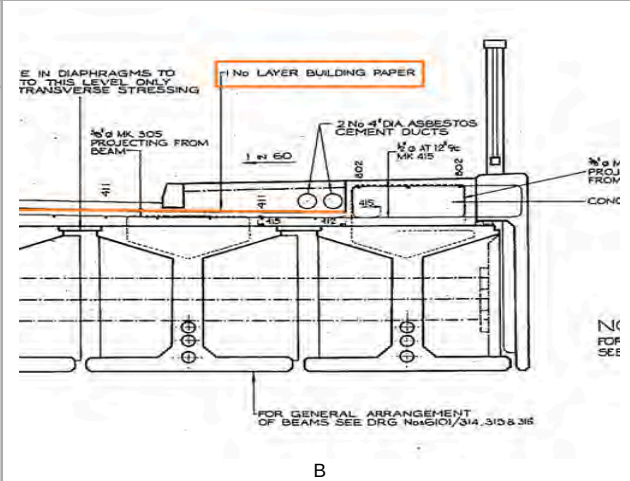
| Asset: M4 23a - 24 51 Bishton Llanmartin Waltwood Road | | | | | | Structure: Bridge | | | Inspection Point: superstructure | | | |
|---|---|---|---|---|---|---|---|---|---|---|---|---|
| Building paper beneath verges | Asbestos-containing Paper | Desktop Finding | N/A | Desktop Findings | Extensive | 2 | 1 | 1 | Chrysotile | 5 | Low | |
| <p> Desktop study identifies item is asbestos containing but could not be sampled due to being a buried material and is therefore presumed to contain asbestos.</p> | | | | | | | | | | | | |
