## Bishton-Llanmartin Overbridge M4 23A-24 51 Principal Inspection Report 2025/26

Service Provider/Consultant Name: Arcadis

Service Provider/Consultant Project Number: 30286543

T-WHIS Number: CTI/005

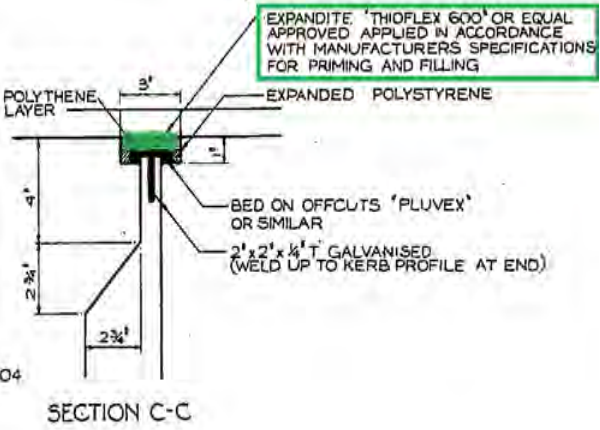
| Component Examined | Component Material Description | Strategy | Sample No. | Findings Source | Extent | Product Score | Material Condition | Surface Treatment | Fibre Id. | Material Score | Accessibility Score | Action Level |
|---|---|---|---|---|---|---|---|---|---|---|---|---|
| Expansion joint in footpaths | Expandite Thioflex or equally approved primer/filler with polyethylene bottom layer | NO: Desktop Finding | N/A | Desktop Findings | N/A | N/A | N/A | N/A | N/A | N/A | N/A | <div></div> |
| <div> Item is a known non-asbestos containing material.</div> | | | | | | | | | | | | |

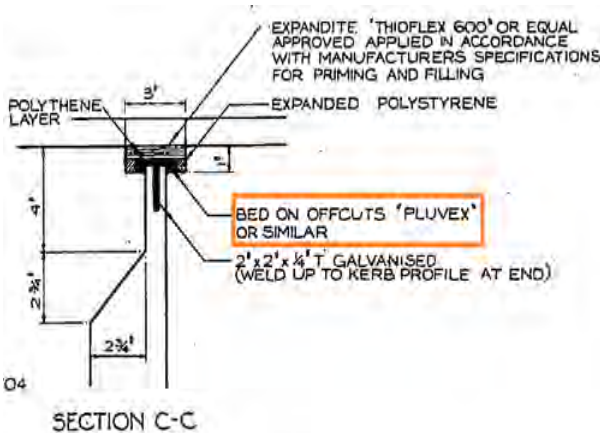
| Asset: M4 23a - 24 51 Bishton Llanmartin Waltwood Road | | | | | | | Structure: Bridge | | Inspection Point: superstructure | | | |
|---|---|---|---|---|---|---|---|---|---|---|---|---|
| Expansion joint in footpaths bed on offcuts | Asbestos-containing Pluvex or similar | Desktop Finding | N/A | Desktop Findings | Extensive | 1 | 1 | 0 | Chrysotile | 3 | Low | |
| <p>🗨️ Desktop study identifies item is asbestos containing but could not be sampled due to being a buried material and is therefore presumed to contain asbestos.</p> | | | | | | | | | | | | |

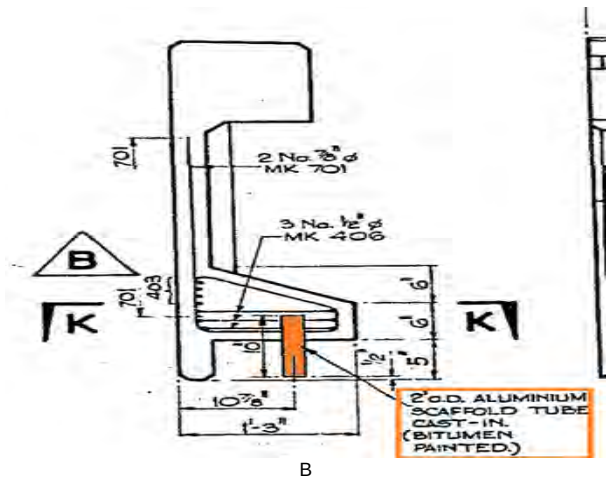
| Component Examined | Component Material Description | Strategy | Sample No. | Findings Source | Extent | Product Score | Material Condition | Surface Treatment | Fibre Id. | Material Score | Accessibility Score | Action Level |
|---|---|---|---|---|---|---|---|---|---|---|---|---|
| Coating to Aluminium scaffolding tube fixings | Asbestos-containing bitumen paint | Desktop Finding | N/A | Desktop Findings | Extensive | 1 | 1 | 0 | Chrysotile | 3 | Low | |
| <p> Desktop study identifies item is asbestos containing but could not be sampled due to being a buried material and is therefore presumed to contain asbestos.</p> | | | | | | | | | | | | |

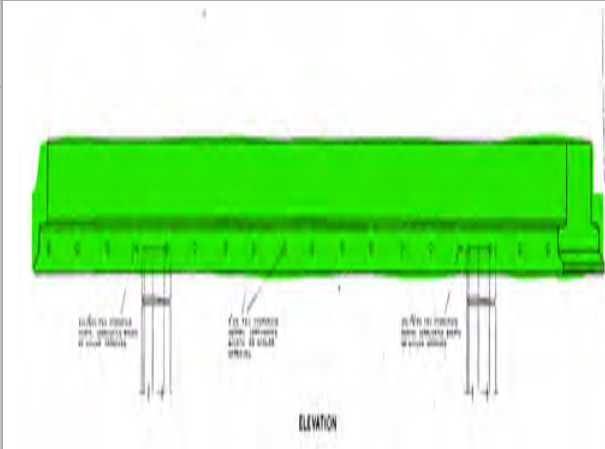
| Asset: M4 23a - 24 51 Bishton Llanmartin Waltwood Road | | | | | | | | | | | | Structure: Bridge | Inspection Point: superstructure |
|---|---|---|---|---|---|---|---|---|---|---|---|---|---|
| Crosshead | Concrete | NO: Desktop Finding | N/A | Desktop Findings | N/A | N/A | N/A | N/A | N/A | N/A | N/A | | |
| <div> Item is a known non-asbestos containing material.</div> | | | | | | | | | | | | | |

| Location Name | Component Name / Description | Findings Source | Survey Type | Sample Ref | Positive for ACM's | Material Assessment Score | Rating for Disturbance During Maintenance | Actions Necessary | Grounds for presumption (Section 2) or Grounds for presumed non ACM (section 3) |
|---|---|---|---|---|---|---|---|---|---|
| M4 23a - 24 51 Bishton<br>Llanmartin Waltwood Road - superstructure | Crosshead - Concrete | Desktop Findings | M | N/A | N/A | N/A | N/A | A | Item is a known non-asbestos containing material. |

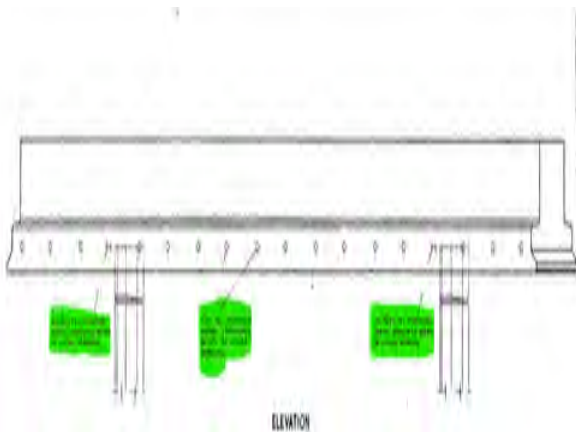
| Component Examined | Component Material Description | Strategy | Sample No. | Findings Source | Extent | Product Score | Material Condition | Surface Treatment | Fibre Id. | Material Score | Accessibility Score | Action Level |
|---|---|---|---|---|---|---|---|---|---|---|---|---|
| Crosshead corrugated sheaths | Hydragrid | NO: Desktop Finding | N/A | Desktop Findings | N/A | N/A | N/A | N/A | N/A | N/A | N/A | |
| <div> Item is a known non-asbestos containing material.</div> | | | | | | | | | | | | |

| Location Name | Component Name / Description | Findings Source | Survey Type | Sample Ref | Positive for ACM's | Material Assessment Score | Rating for Disturbance During Maintenance | Actions Necessary | Grounds for presumption (Section 2) or Grounds for presumed non ACM (section 3) |
|---|---|---|---|---|---|---|---|---|---|
| M4 23a - 24 51 Bishton<br>Llanmartin Waltwood Road - superstructure | Crosshead corrugated sheaths - Hydragrid | Desktop Findings | M | N/A | N/A | N/A | N/A | A | Item is a known non-asbestos containing material. |
