M48 Central Reserve Safety Barrier Review

Operational Risk Assessment

March 2022

Service Provider/Consultant Name:	WSP
Service Provider/Consultant Project Number	70090027
Scheme Reference:	21/SW/CSF/006
Programme:	CSF – Safety Fencing

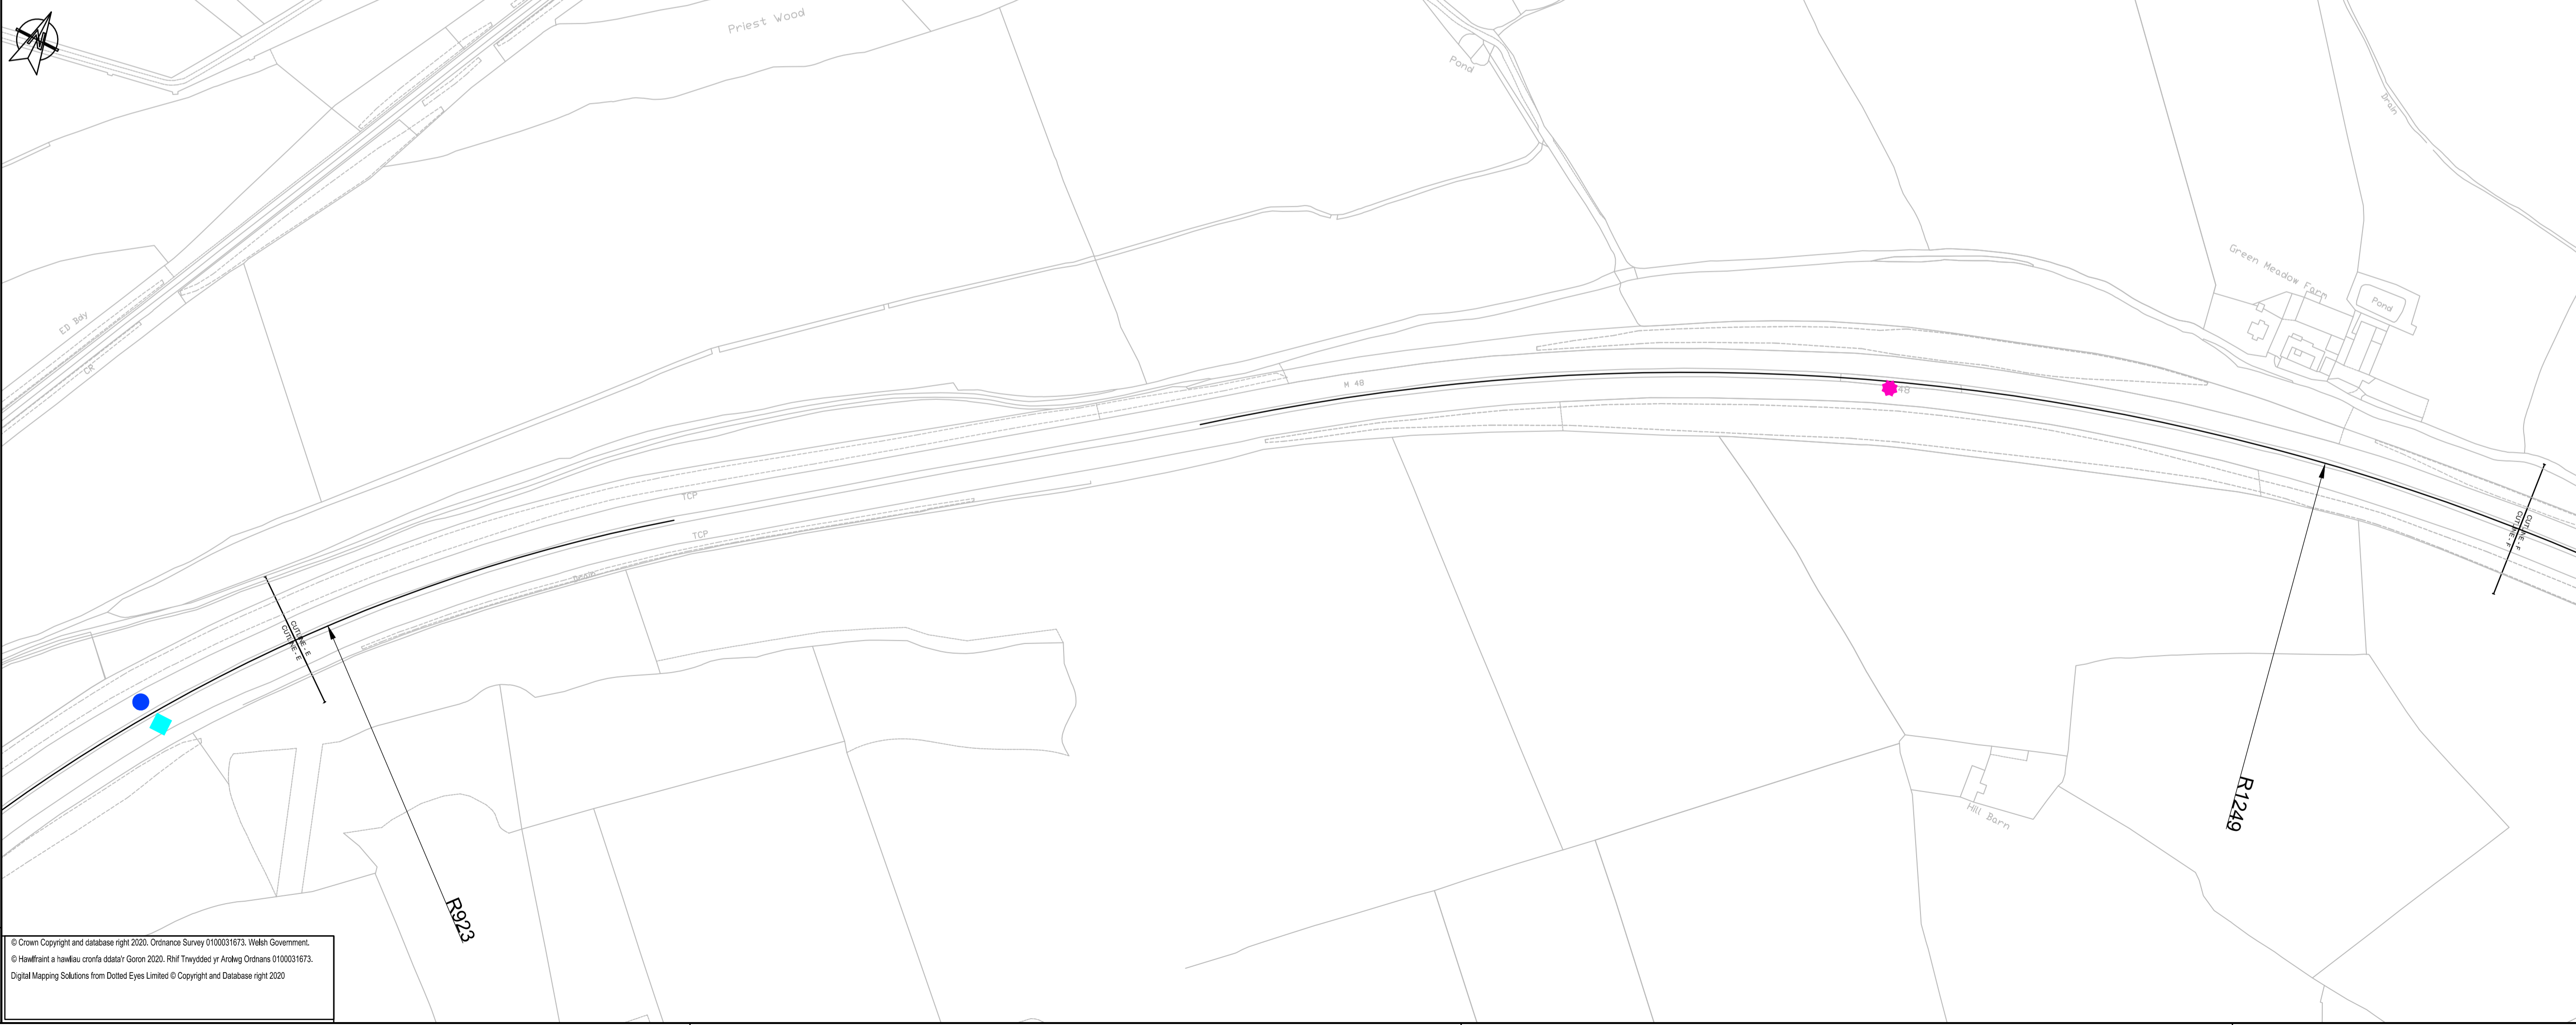
File No.	70090027	Financial Code No.	21/SW/CSF/006
Drawn	RE	Checked	AJ
Date	22/03/22	Date	22/03/22
Scale	1:2000	Approved	JT
Date	22/03/22	Date	22/03/22
Scale	1:2000		
Drawing No.	70090027-WSP-100-003		P01

- ★ WESTBOUND BARRIER DEFECT
- WESTBOUND SERIOUS ACCIDENT
- WESTBOUND SLIGHT ACCIDENT
- ★ EASTBOUND BARRIER DEFECT
- ▲ EASTBOUND FATAL ACCIDENT
- EASTBOUND SLIGHT ACCIDENT
- RXX RADIUS OF BEND (m)

M48 (EAST) CENTRAL AND VERGE
BARRIER REVIEW
M48 VEHICLE RESTRAINT SYSTEM REVIEW

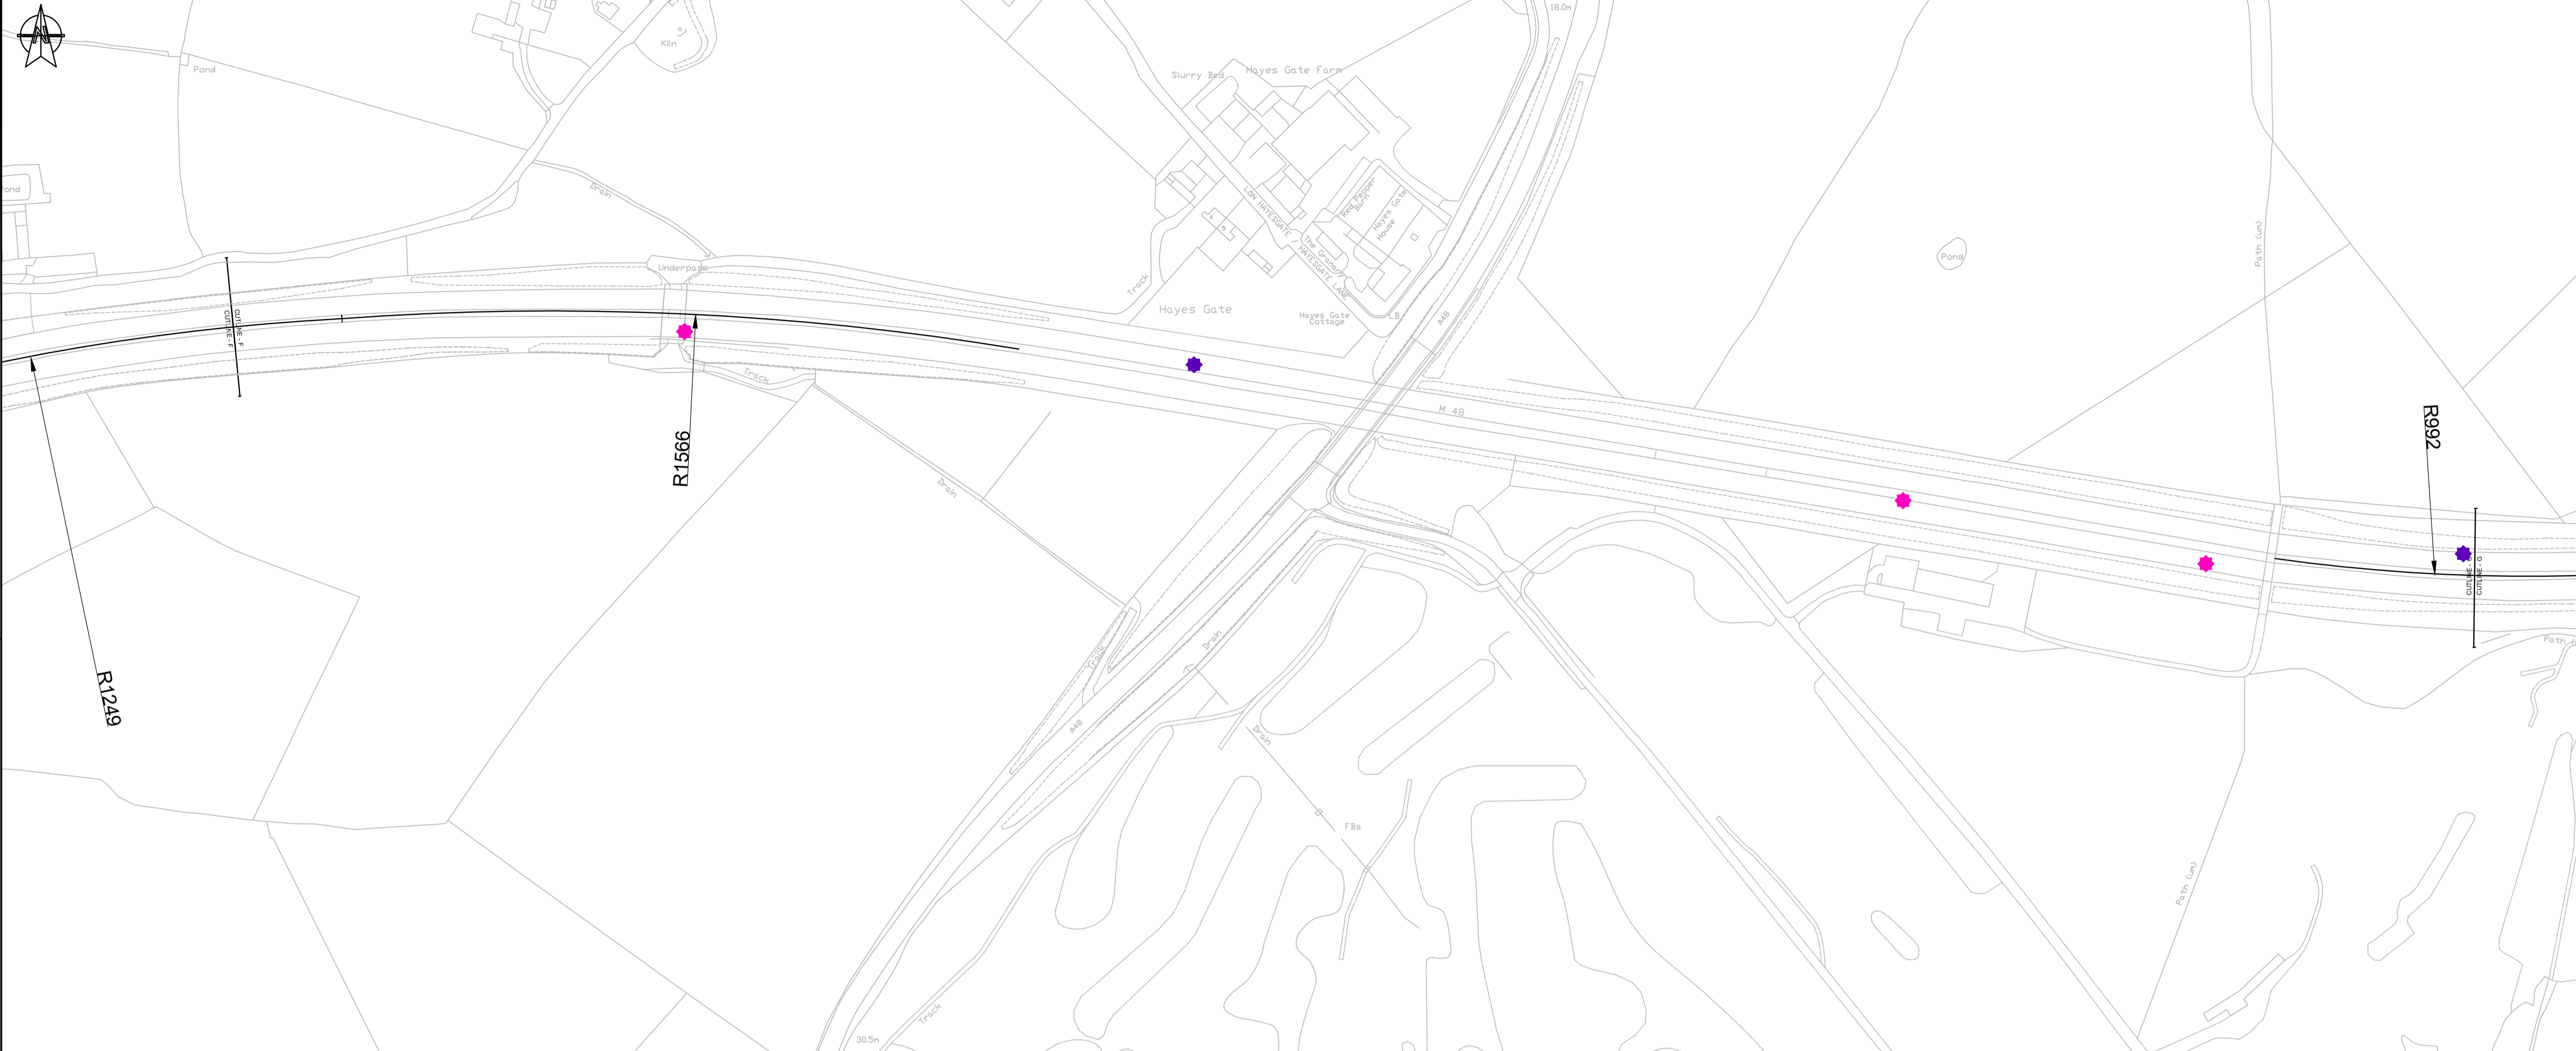
File No.	70090027	Financial Code No.	21/SW/CSF/006		
Drawn	RE	Checked	AJ	Approved	JT
Date	22/03/22	Date	22/03/22	Date	22/03/22
Scales	1:2000				
Drawing No.	70090027-WSP-100-004				P01

1. THIS IS A C.A.D. DRAWING AND SHOULD NOT BE AMENDED BY HAND
- KEY
- WESTBOUND BARRIER DEFECT
 - WESTBOUND SERIOUS ACCIDENT
 - WESTBOUND SLIGHT ACCIDENT
 - EASTBOUND BARRIER DEFECT
 - ▲ EASTBOUND FATAL ACCIDENT
 - EASTBOUND SLIGHT ACCIDENT
- RXX
 RADIUS OF BEND (m)

SHEET 4 OF 5
