Request for Information – ATISN 15226

You asked for the following information regarding the location with coordinates 51.77376307869509, -4.612627509558363, specifically the Red Roses junction of the A477 bypass:

The 36-month Stage 4 RSA did make some recommendations at the Red Roses junction as shown below.

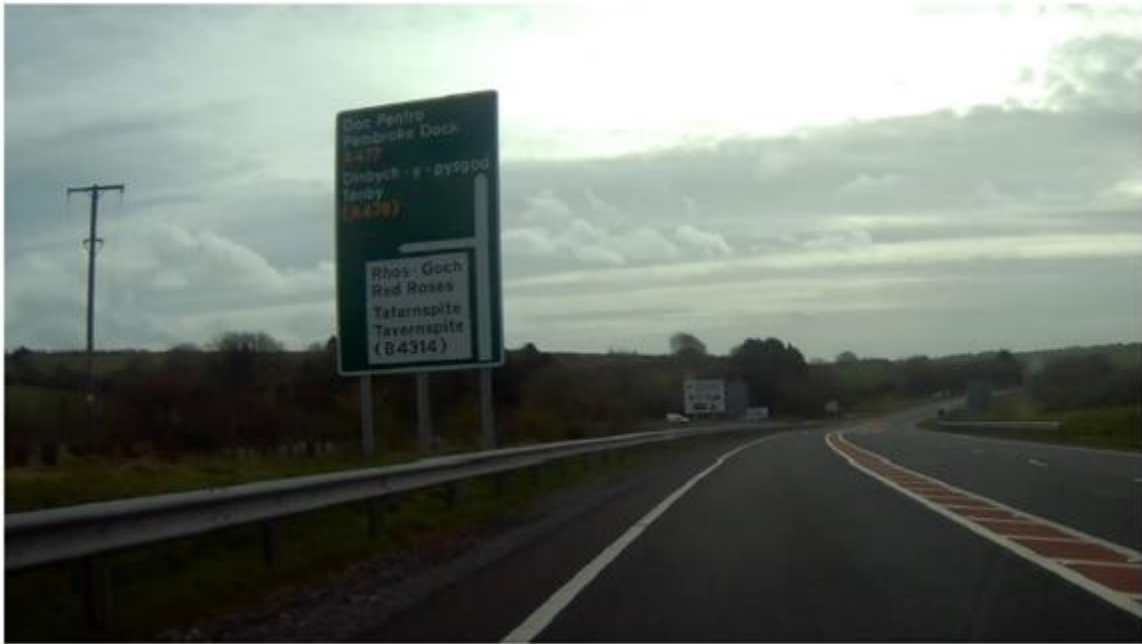
5.3 PROBLEM

Location: Red Roses Junction

Summary: Following the scheme opening, there were reports of westbound traffic making illegal traffic manoeuvres at the Red Roses Junction. Consequently, video footage was recorded at the junction. Several incidents have been recorded showing vehicles travelling westbound entering the ghost island junction and crossing the double white line in order to overtake vehicles turning left into Red Roses junction. Additional 'keep your distance' signage was later installed on the approach to the junction.

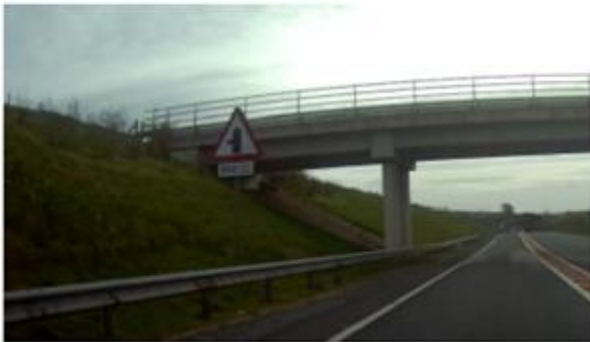
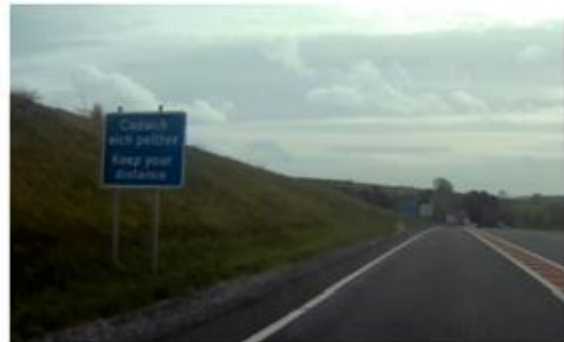
Signs with the legend "Keep your distance" are erected, downstream from the junction warning sign, on the westbound approach to Red Roses junction.

Road users may not be aware of the specific reason for this guidance or may not have a measure of the distance to be maintained.

Further ‘left turning traffic ahead’ and ‘keep your distance’ signs were considered but the need for drivers to keep their distance is not confined to the junction area so distance plates were not deemed appropriate. Drivers are given ample warning that there could be left turning traffic ahead, there being a standard junction warning sign with distance plate, a very large advance direction sign, a large local direction sign and a flag sign on the junction splitter island. It was therefore considered extremely unlikely that an additional text sign would have any material impact on driver behaviour. Furthermore, it would add sign clutter.

Provide further information, such as 'Left Turning Traffic Ahead', on the "Keep your distance" sign and erect distance plates with these signs.
