Site Solutions Combined

Land at Gileston Farm, Talybont on Usk, Brecon, LD3 7JE

Report Reference: 292426340

Date: 11 March 2022

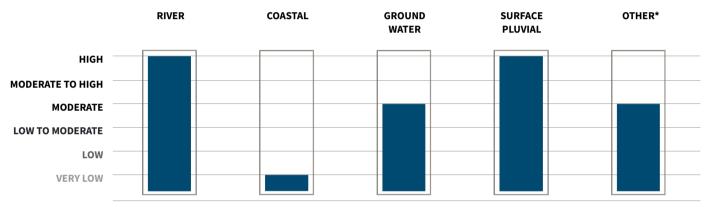
d Risk Assessment be required if development is proposed?	YES (Full)
sk of flooding in an undefended scenario or assuming defences fail?	нісн
ting flood defences within 500m of the Site?	YES
sk of flooding when these defences are operational?	HIGH

River	As the RIver Usk is located adjacent east the Site is at a high risk of flooding. Although defences are located in the wider area, the Site remains at a high risk. This indicates the defences are not providing adequate protection.
Coastal	No commentary required.
Groundwater	As the Site is located within a flood plain, the risk of groundwater flooding is expected to be linked to river flooding. As a result, high groundwater levels could prolong a flood event. This will be more of a problem if the property has a basement.
Surface Water	Depths from surface water may reach and exceed 1m during a flood event over a small area of the Site. A larger area is at risk of depths ranging from 0.3m to 1m during a flood event. Therefore, the overall risk is deemed moderate to high.
Other Factors	The Site flooded in 1979 from the adjacent river.

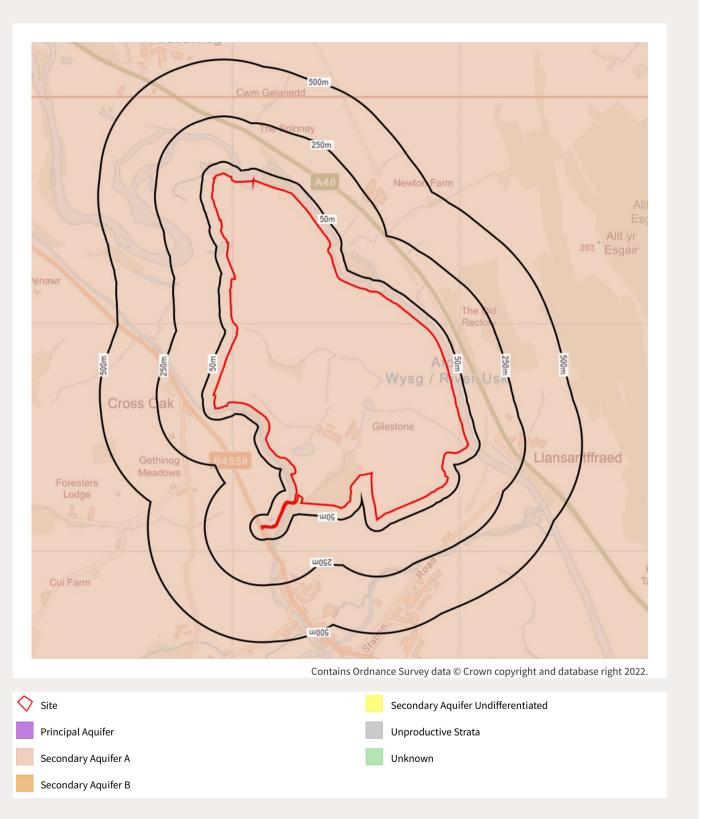
Bedrock

Details	Distance	Direction	Contact
Lex Code: SB Rock Name: Senni Formation Rock Type: Sandstone and [Subequal/subordinate] Argillaceous Rocks, Interbedded Min Age: Not Supplied Max Age: Pragian	0m	S	4
Lex Code: SMG Rock Name: St Maughans Formation Rock Type: Argillaceous Rocks and [Subequal/Subordinate] Sandstone, Interbedded Min Age: Not Supplied Max Age: Early Devonian	0m	SW	4
Lex Code: SMG Rock Name: St Maughans Formation Rock Type: Argillaceous Rocks and [Subequal/Subordinate] Sandstone, Interbedded Min Age: Not Supplied Max Age: Early Devonian	0m	W	4
Lex Code: SMG Rock Name: St Maughans Formation	0m	N	4

Rock Type: Argillaceous Rocks and [Subequal/Subordinate] Sandstone, Interbedded

Min Age: Not Supplied Max Age: Early Devonian

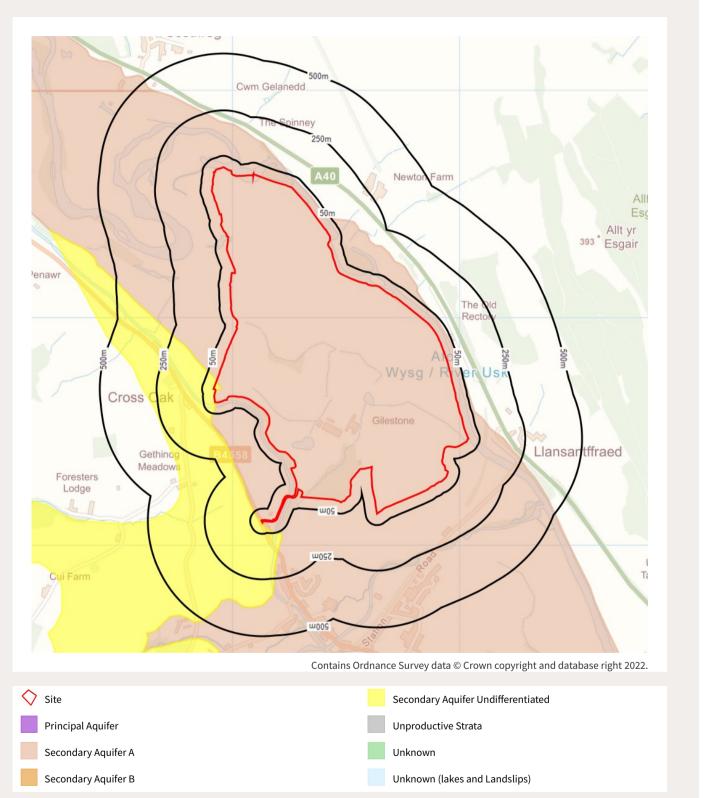
Superficial

Details	Distance	Direction	Contact
Lex Code: ALF Rock Name: Alluvial Fan Deposits Rock Type: Sand and Gravel Min Age: Not Supplied Max Age: Quaternary	0m	SE	4
Lex Code: HMGDD Rock Name: Hummocky (Moundy) Glacial Deposits, Devensian Rock Type: Diamicton, Sand and Gravel Min Age: Not Supplied Max Age: Devensian	0m	S	4
Lex Code: ALV Rock Name: Alluvium Rock Type: Clay, Silt, Sand and Gravel Min Age: Not Supplied Max Age: Holocene	0m	N	4
Lex Code: TILLD Rock Name: Till Devension	0m	W	4
