# Considering repair, maintenance and adaptation priorities for older properties

Factsheet for asset managers and retrofit coordinators.

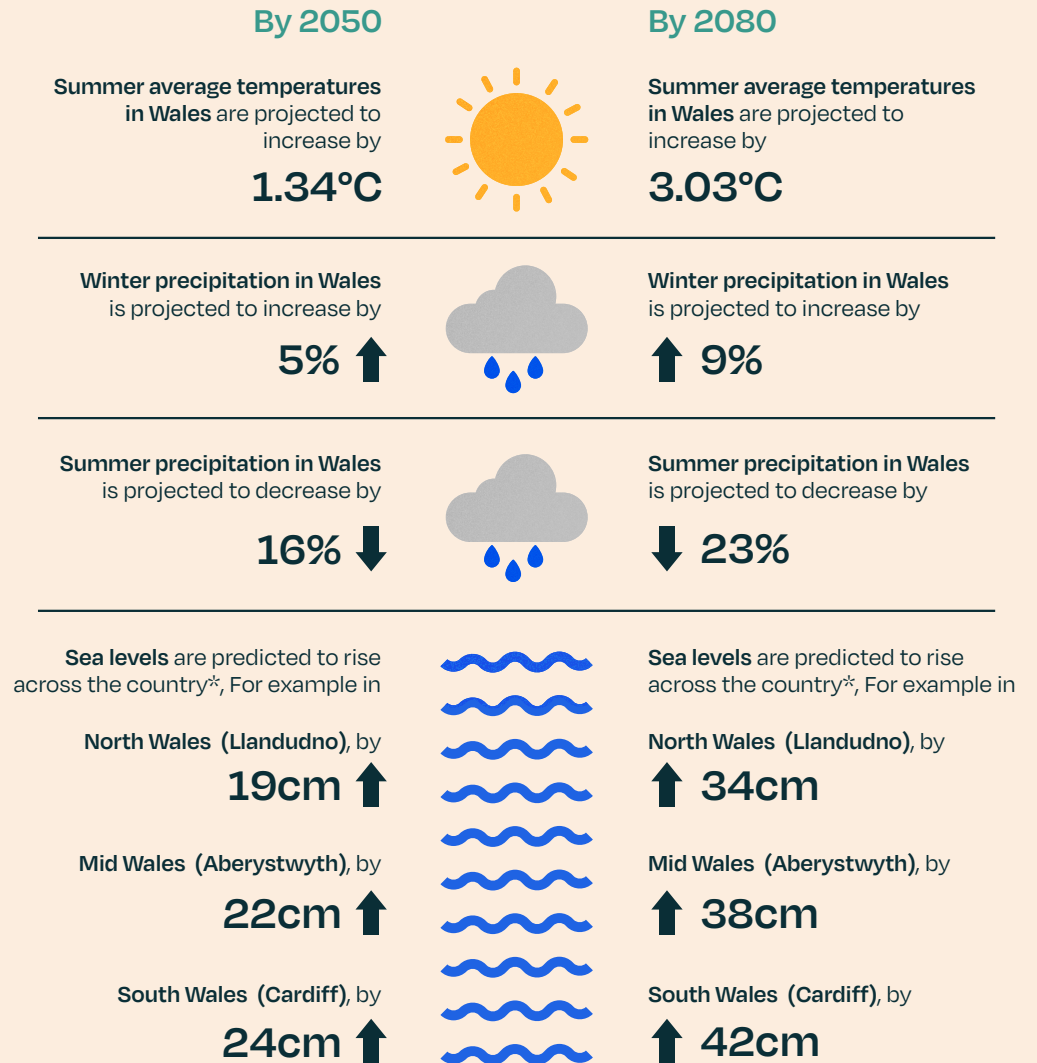
Figure 1: Climate Change predictions by 2050 and 2080 taken from the UK Climate Projections (UKCP18) dataset.<sup>1</sup>

Current international decarbonisation efforts are unlikely to hold global warming to 1.5°C. Accordingly, we need to plan for **warmer, wetter weather in Wales** (Figure 1), and with this more extreme weather patterns including high winds, storm surges and intense precipitation. Our summers will be hotter, drier, and we are likely to experience heatwave episodes. We need to prepare for these changing weather patterns and adapt our homes accordingly.

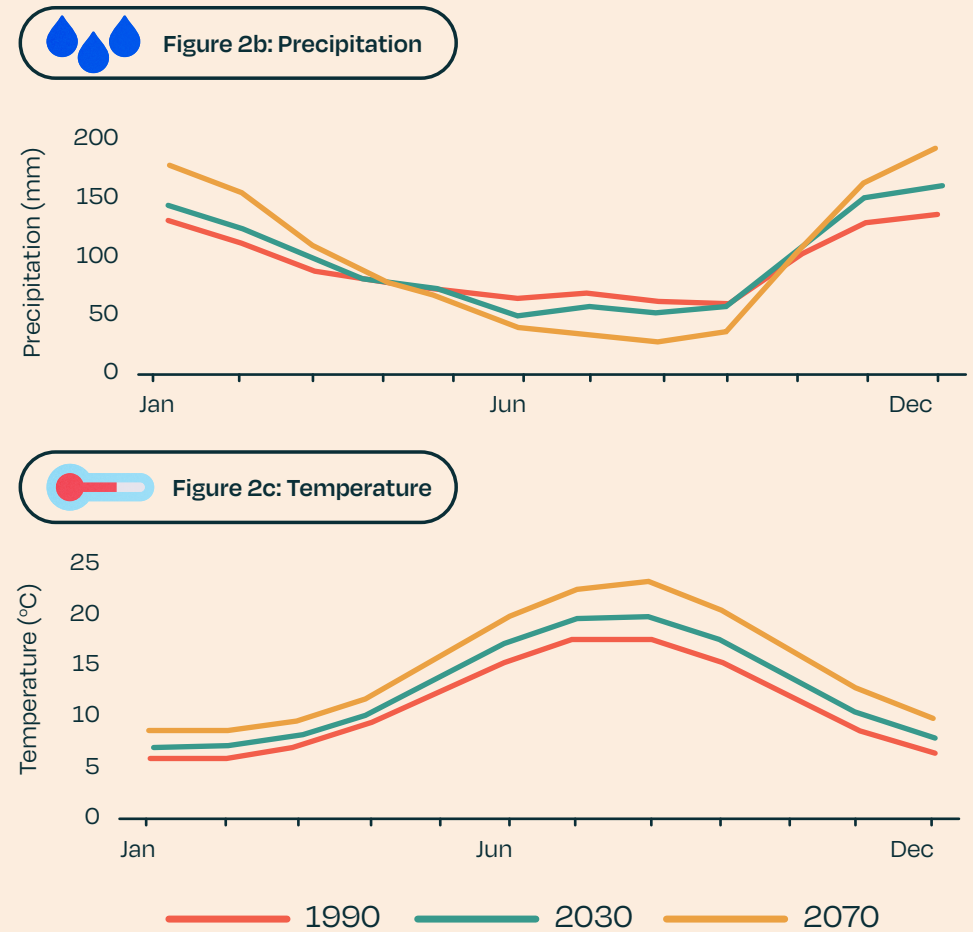
**Figure 2: Modelling Cardiff's building fabric vulnerabilities for temperature and precipitation projections**

**Climate vulnerability modelling** (Hayles et al., 2022) has demonstrated that the service life of the principal building materials used in our homes will be reduced as a consequence of climate change. There will be a cost attached to this. Therefore, it is more important than ever to consider how we repair, maintain and adapt our buildings to address the challenges caused by a changing climate.

Understanding present and future climate stressors, particularly those associated with precipitation, temperature and solar flux, will help inform climate mitigation and adaptation approaches and how to tackle these concurrently.

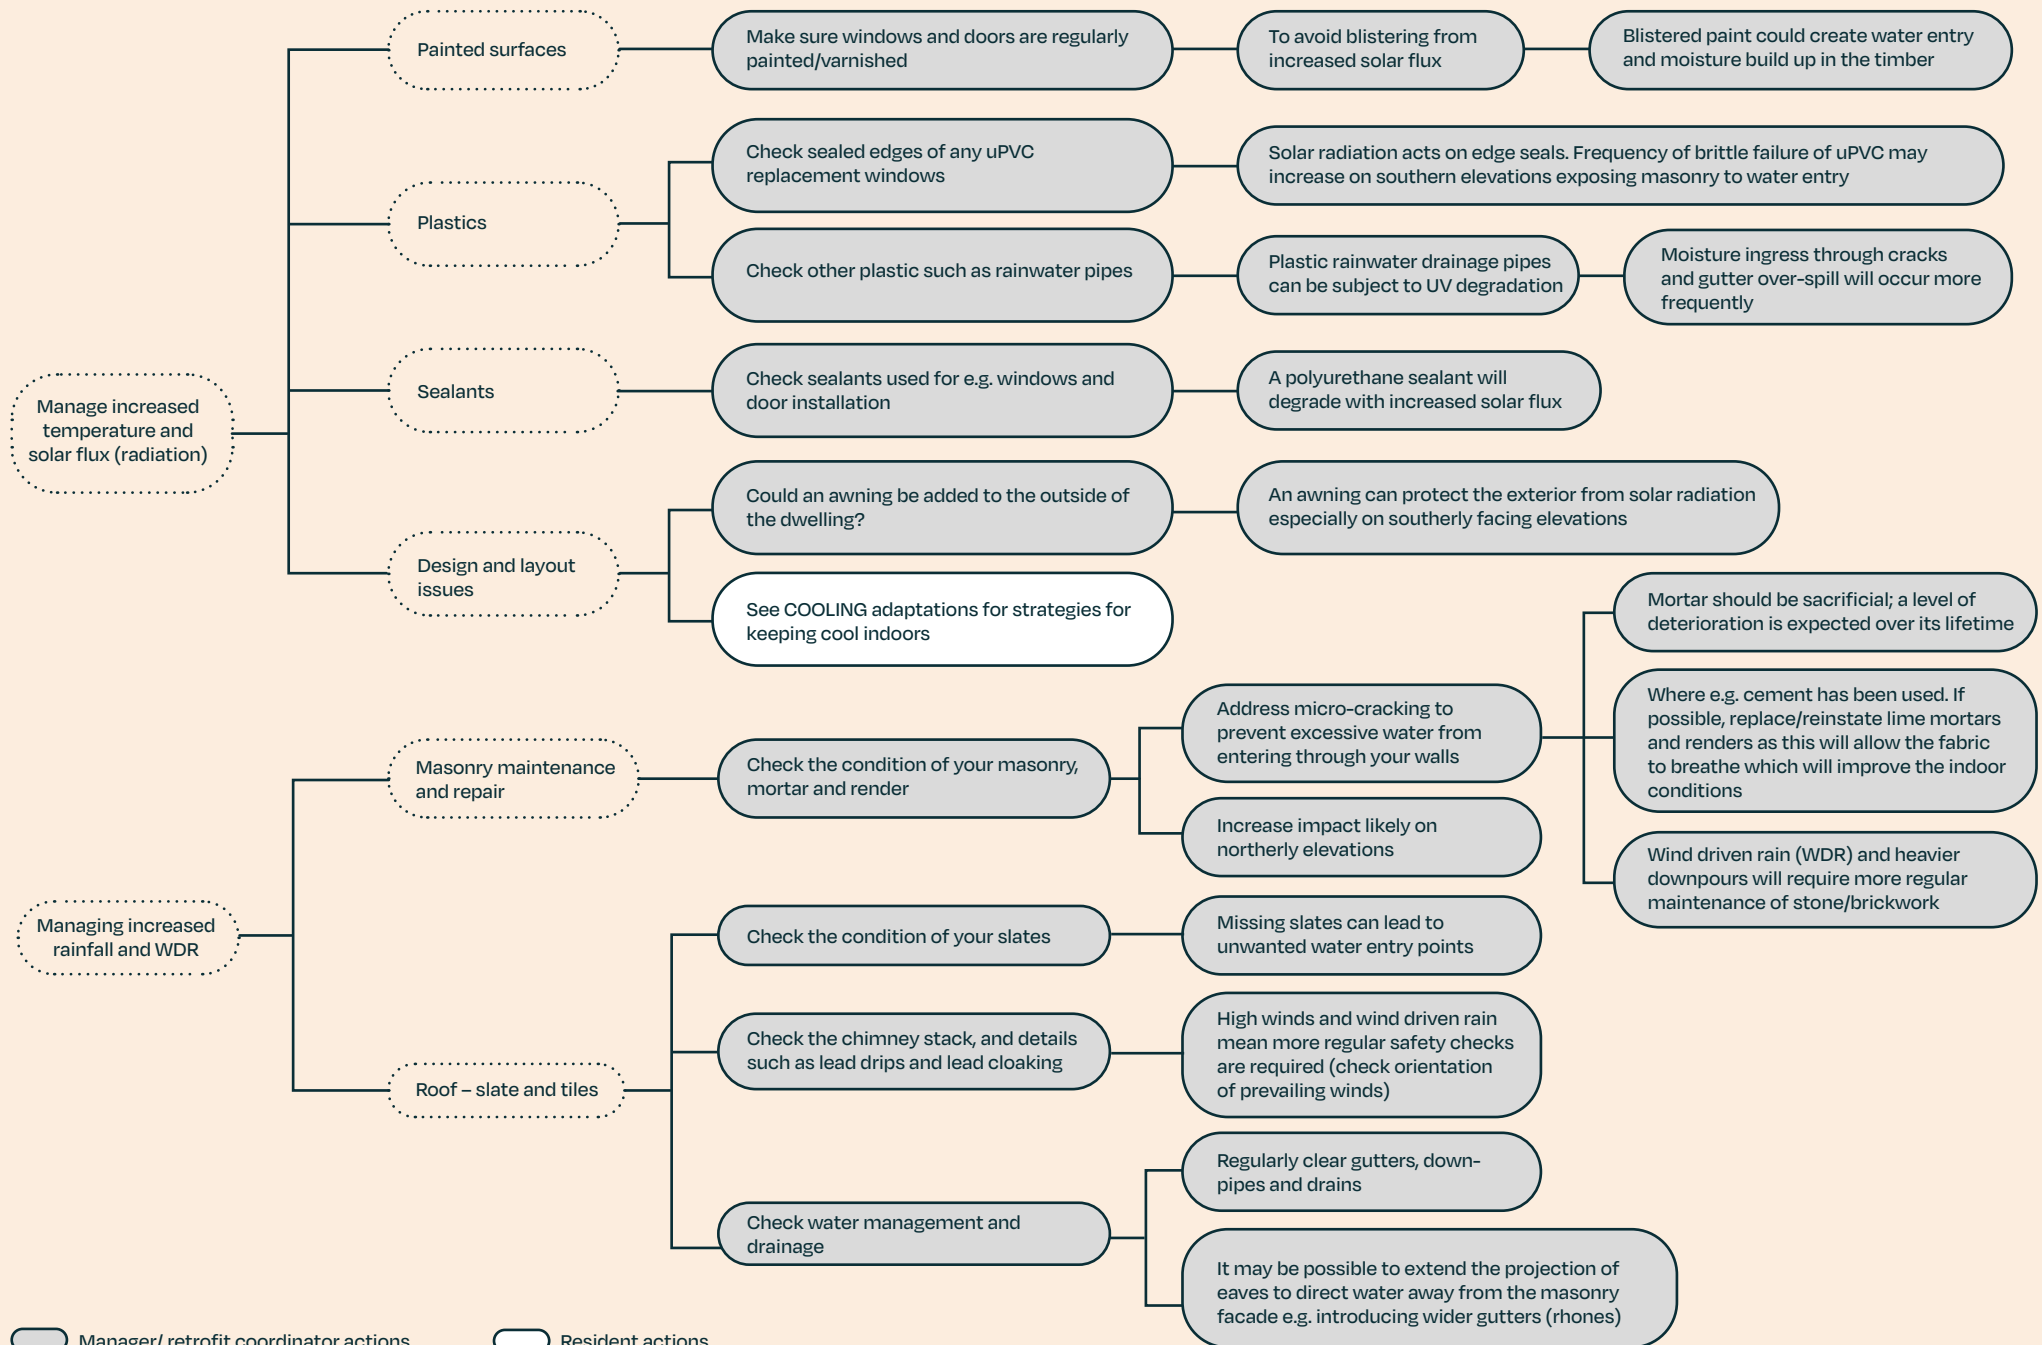
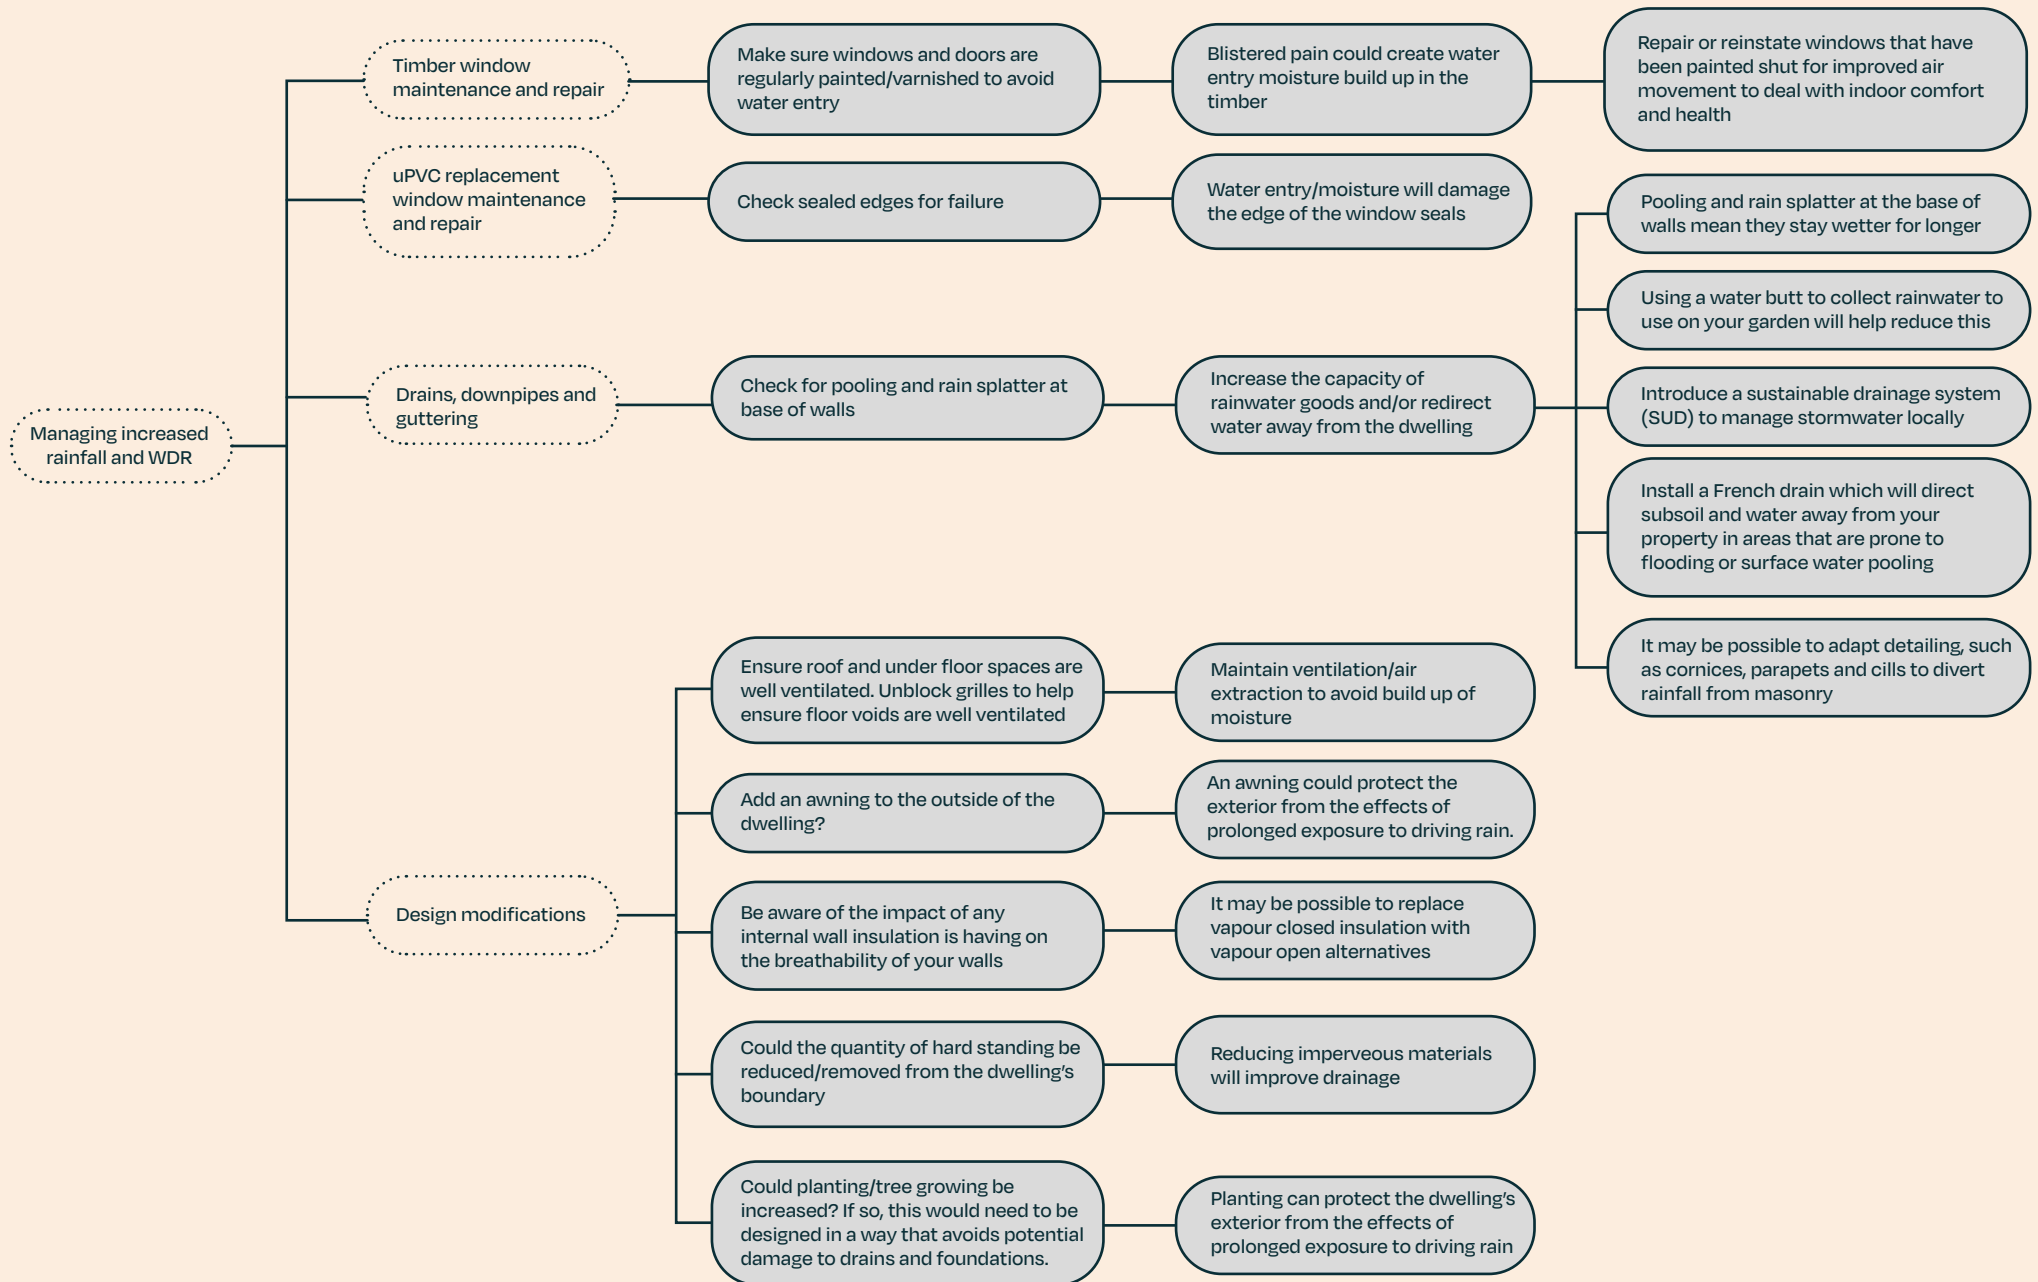
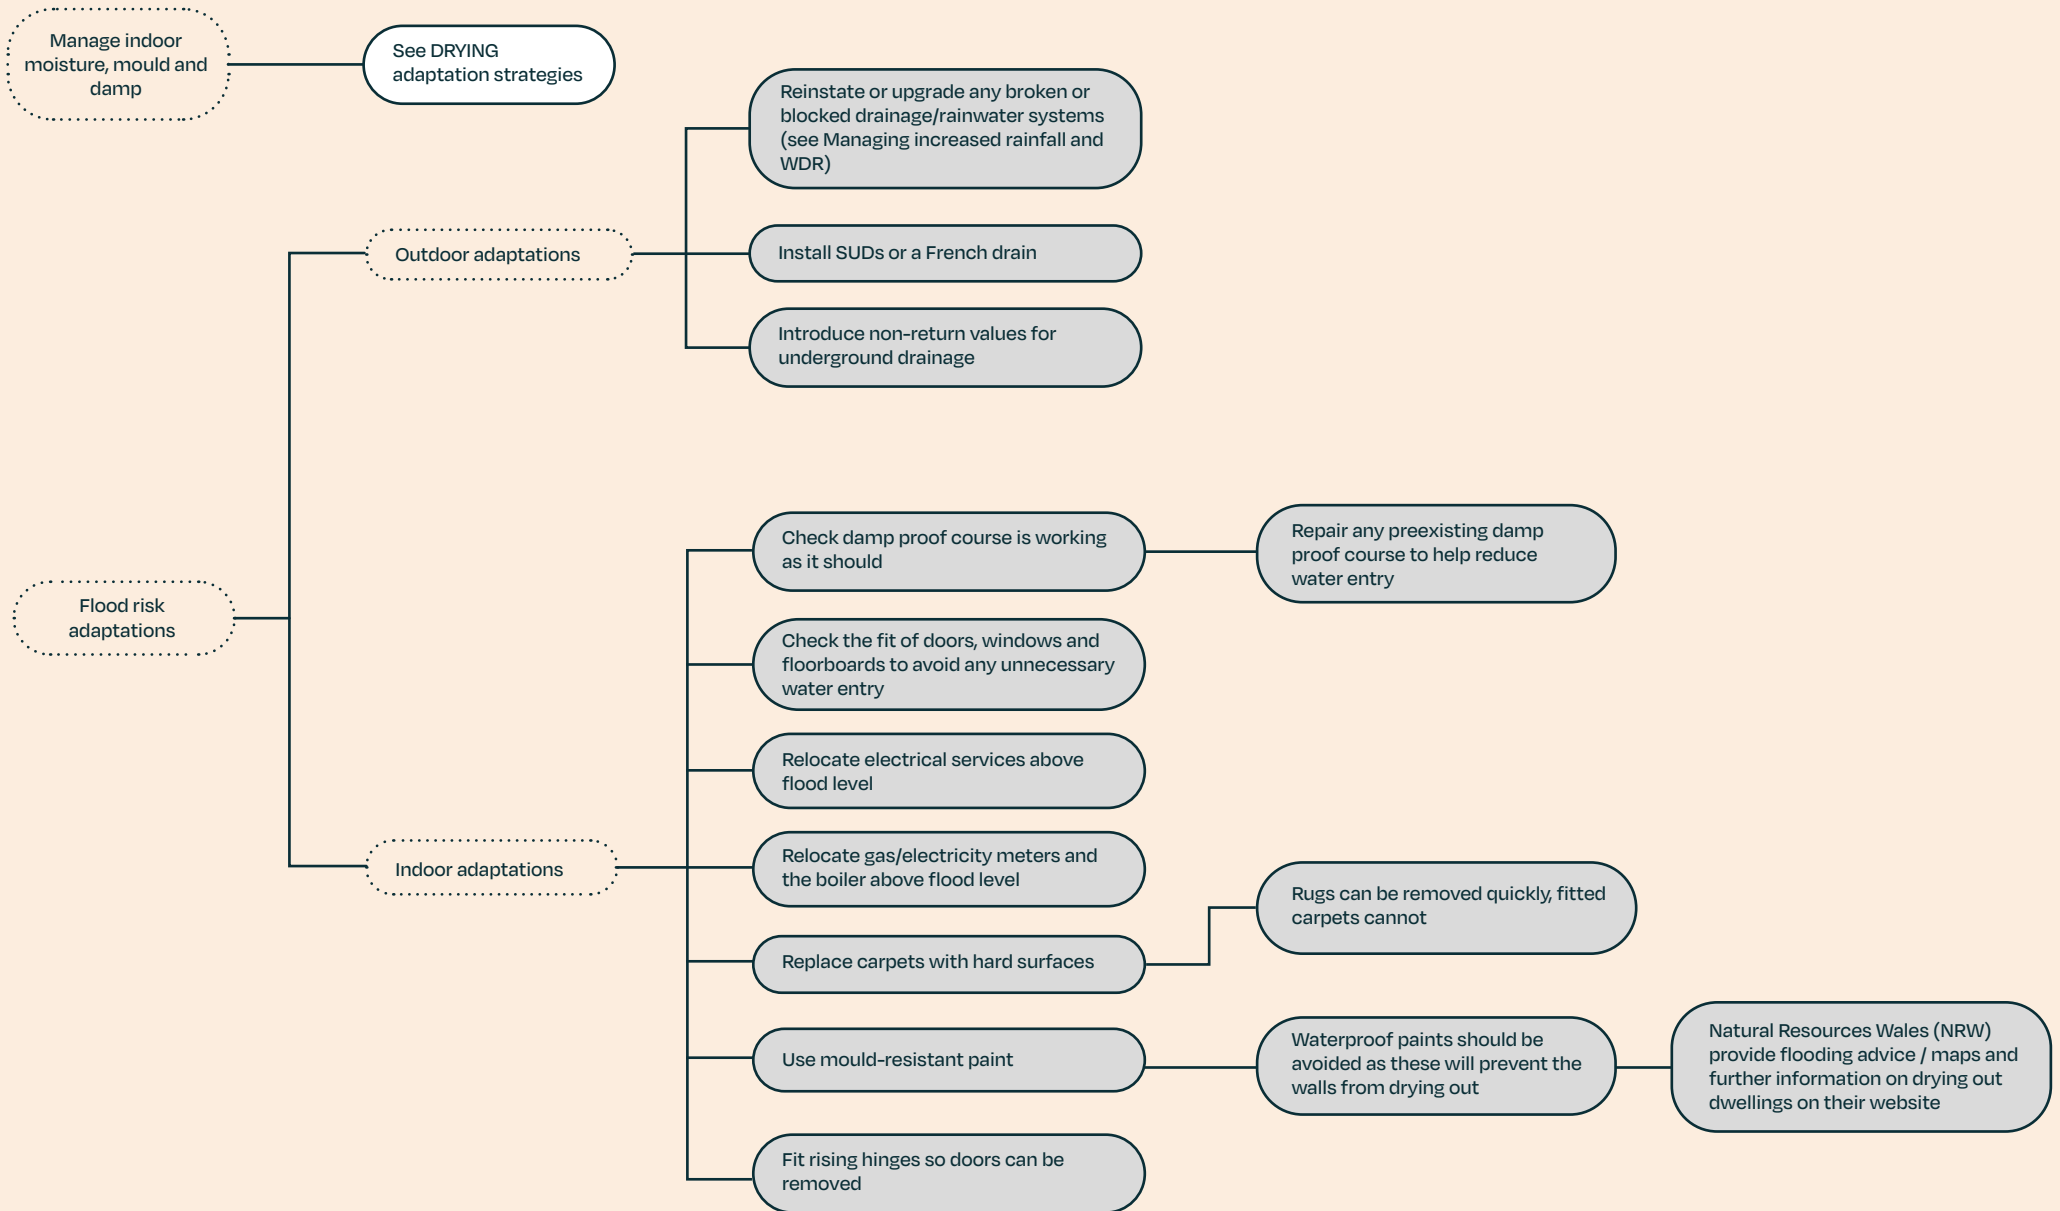
Figure 3: Building Fabric Climate Vulnerabilities and Adaptations for Pre 1919 Dwellings

Climate stressor data (Hayles et al., 2022) can be used in combination with existing knowledge and understanding of building fabric performance and deterioration mechanisms to better inform frequency of repair, maintenance, and adaptation, to mitigate further or future damage (see Table 1 and Figure 3).
